Re: Monitoring Point Inspection – May 2024

NABORS Landfill (AFIN 03-00051)

1320 Landfill Road, Mountain Home, Arkansas 72653

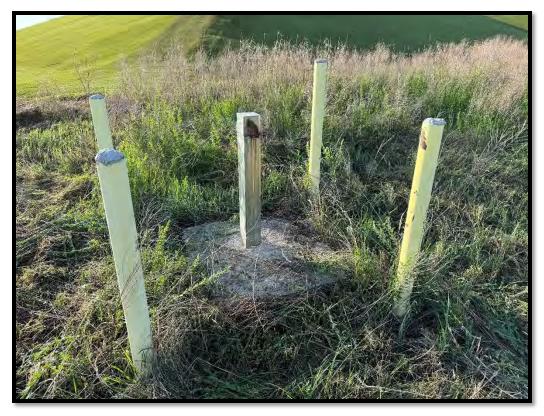
**Photo No.** 4 **Date**: 5/13/2024 **Well ID**: MW-1

MW-1	36.460833	-92.447222	77.2	Υ	N	Well intact and accessible by vehicle — near leachate tanks	_	Well intact and accessible by vehicle	
MW-1R	36.460556	-92.447222	78.6	Y	N	Well intact and accessible by vehicle — near leachate tanks	Consider adding well identification labeling/painting	Well intact and accessible by vehicle	
MW-2	36.459842	-92.449760	48.7	Y	Foot	This well is intact but is down a steep, uneven, rocky slope that is highly overgrown with underbrush. Access is difficult and by foot only as it is behind a narrow gate in the fence.	_	Well intact and accessible by foot — behind new-chain link fence	
MW-3	36.459167	-92.451389	39.6	Y	Y	This well was extended vertically during the landfill closure. The casing is bent slightly(but still can be sampled) and is situated on the side of a steep slope. Access is via ATV only along sloped pathway.	_	Well has been extended and is accessible by ATV — behind new chain-link fence

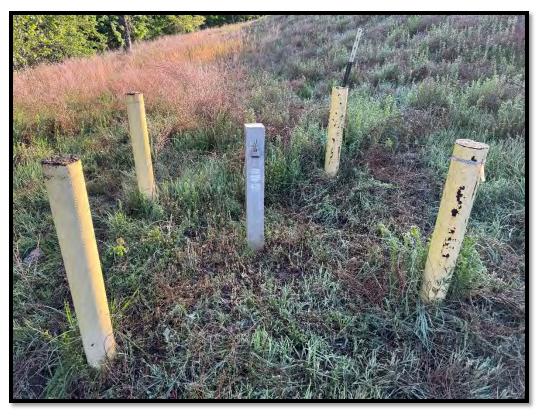
**Photo No.** 8 **Date:** 5/13/2024 **Well ID:** MW-4

MW-4	36.460556	-92.451944	99.9	Y	Y	Well intact and accessible by vehicle; however, ATV access preferable	_	Well intact and accessible by ATV — behind new-chain link fence	
MW-5	36.461944	-92.451944	89.0	Υ	Υ	Well intact and accessible by ATV via difficult, sloped pathway — try accessing from MW-4	_	Well intact and behind new chain-link fence, but direct access blocked due to erosion — equipment was carried on foot	
MW-6	36.462500	-92.449444	68.3	Y	Y	Well intact and accessible by vehicle; however, ATV access preferable	_	Well intact and accessible by ATV — access road needs clearing	
MW-7	36.463056	-92.445833	22.9	Υ	Υ	Well intact and accessible by vehicle; however, ATV access preferable	_	Well intact and accessible by ATV — access road needs clearing	
MW-509D	36.460833	-92.445000	39.7	Υ	Y	Well intact and accessible by ATV only via difficult, sloped pathway	Consider adding well identification labeling/painting	Well on top of topographic mound, but mostly accessible by ATV — grading would help access

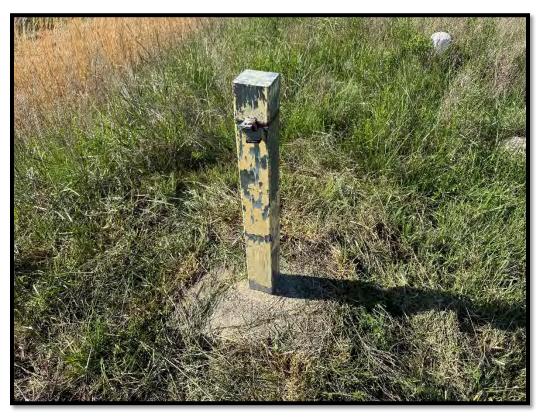
**Photo No.** 13 **Date:** 5/13/2024 **Well ID:** MW-577

MW-577	36.459722	-92.443056	55.2	Υ	Y	Well intact and accessible by ATV only via difficult, sloped pathway	Consider adding well identification labeling/painting	Well on top of topographic mound, but mostly accessible by ATV — grading would help access	
MW-633D	36.458056	-92.447222	88.1	Υ	N	Well intact and accessible by vehicle; however, ATV access preferable but vehicle is fine	_	Well intact and accessible by vehicle	
MW-689D	36.457500	-92.443333	43.8	Y	N	Well intact and accessible by vehicle; however, ATV access preferable	_	Well intact and accessible by ATV — access road needs clearing	
NAB-2	36.460556	-92.445000	102.8	Y	Y	This is one of the wells extended during the landfill closure. The casing is bent slightly and is situated on the side of a steep slope, but can still be sampled. Access is via ATV only along a sloped pathway.	_	Well has been extended and is accessible by ATV	
NAB-3	36.458333	-92.442778	46.3	Y	N	Well intact and accessible by vehicle; however, ATV access preferable	Consider adding well identification labeling/painting	Well intact and accessible by ATV — access road needs clearing

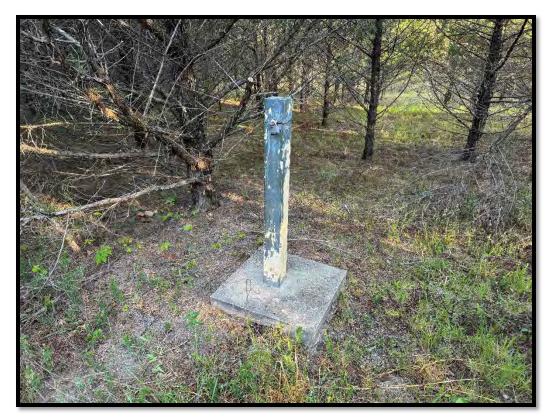
**Photo No.** 18 **Date:** 5/13/2024 **Well ID:** NAB-4

- Landfill groundwater monitoring well NAB-4 is damaged. The well casing is bent and cannot be locked; however, the well can still be sampled.
- Landfill gas monitoring well GP-16R is damaged. The well casing is bent and cannot be locked and the concrete pad is significantly cracked. The integrity of this location has been compromised.
- A number of monitoring wells lack identification.
- A number of well casings and bollards show signs of deteriorating or peeling/cracked paint.

NAB-4	36.458056	-92.445833	140.0	Y	Y	This is one of the wells extended during the landfill closure. The casing is severely bent (but can be sampled) and is situated on the side of a steep, rocky slope. The well lid can not be closed. Access is on foot via a gate.	It is recommended that the existing well completion (3-foot by 3-foot above grade completion) be reinstalled as an above grade completion so that the well lid can be closed and the integrity of the well can be confirmed.	Well has been extended but is on steep slope with dense vegetation; partially accessible by ATV — behind new chainlink fence	
NAB-7	36.462500	-92.446667	43.7	Υ	Υ	Well intact and accessible by vehicle; however, ATV access is preferable. This well is located in a dense cedar grove and is hard to locate.	Consider adding well identification labeling/painting	Well intact and accessible by ATV — access road needs clearing

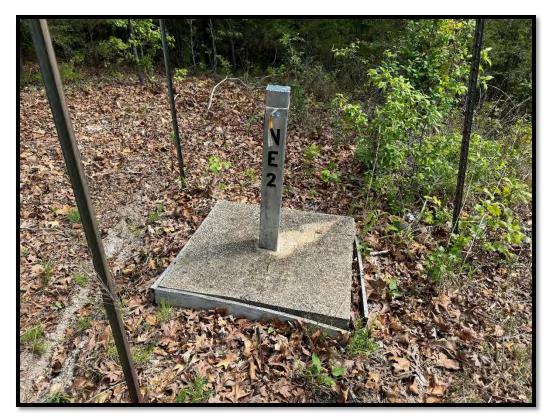
**Photo No.** 20 **Date:** 5/13/2024 **Well ID:** NAB-8

NAB-8	36.461111	-92.451944	85.6	Y	Y	The well is accessible by vehicle, with less than 3 feet of water, and is purged and sampled with a bailer. The well goes dry and recovers slowly. It is typically sampled on the next day.	_	Well accessible by vehicle — purged and sampled with bailer	
NE-2	36.460833	-92.444167	63.0	Y	Υ	Well intact and accessible by ATV only via difficult, sloped pathway	_	Well intact and accessible by foot only — need better access The well is purged and sampled with a bailer.	
NE-3	36.455000	-92.443056	27.8	Υ	Y	Well intact and accessible by vehicle; however, ATV access preferable — access is from NAB-3	_	Well intact and accessible by ATV — access road needs clearing	
NE-4	36.461762	-92.444888	112.2	Y	Y	Well intact and accessible by ATV only via difficult, sloped pathway	_	Well intact and accessible by foot only — need better access	
NE-6	36.457222	-92.452500	18.2	Υ	Υ	Well intact and accessible by ATV only via steeply sloped pathway along power easement.	_	Well intact and mostly accessible by ATV.
