**Subject:** RE: Nabors Bi-weekly Site Visit

**RE:** Bi-weekly Site Inspection  
NABORS Landfill  
Mountain Home, AR

Harbor visited the NABORS landfill in Mountain Home, Arkansas on April 20, 2023, to conduct the bi-weekly landfill inspection. Findings and observations from the landfill inspection are summarized below:

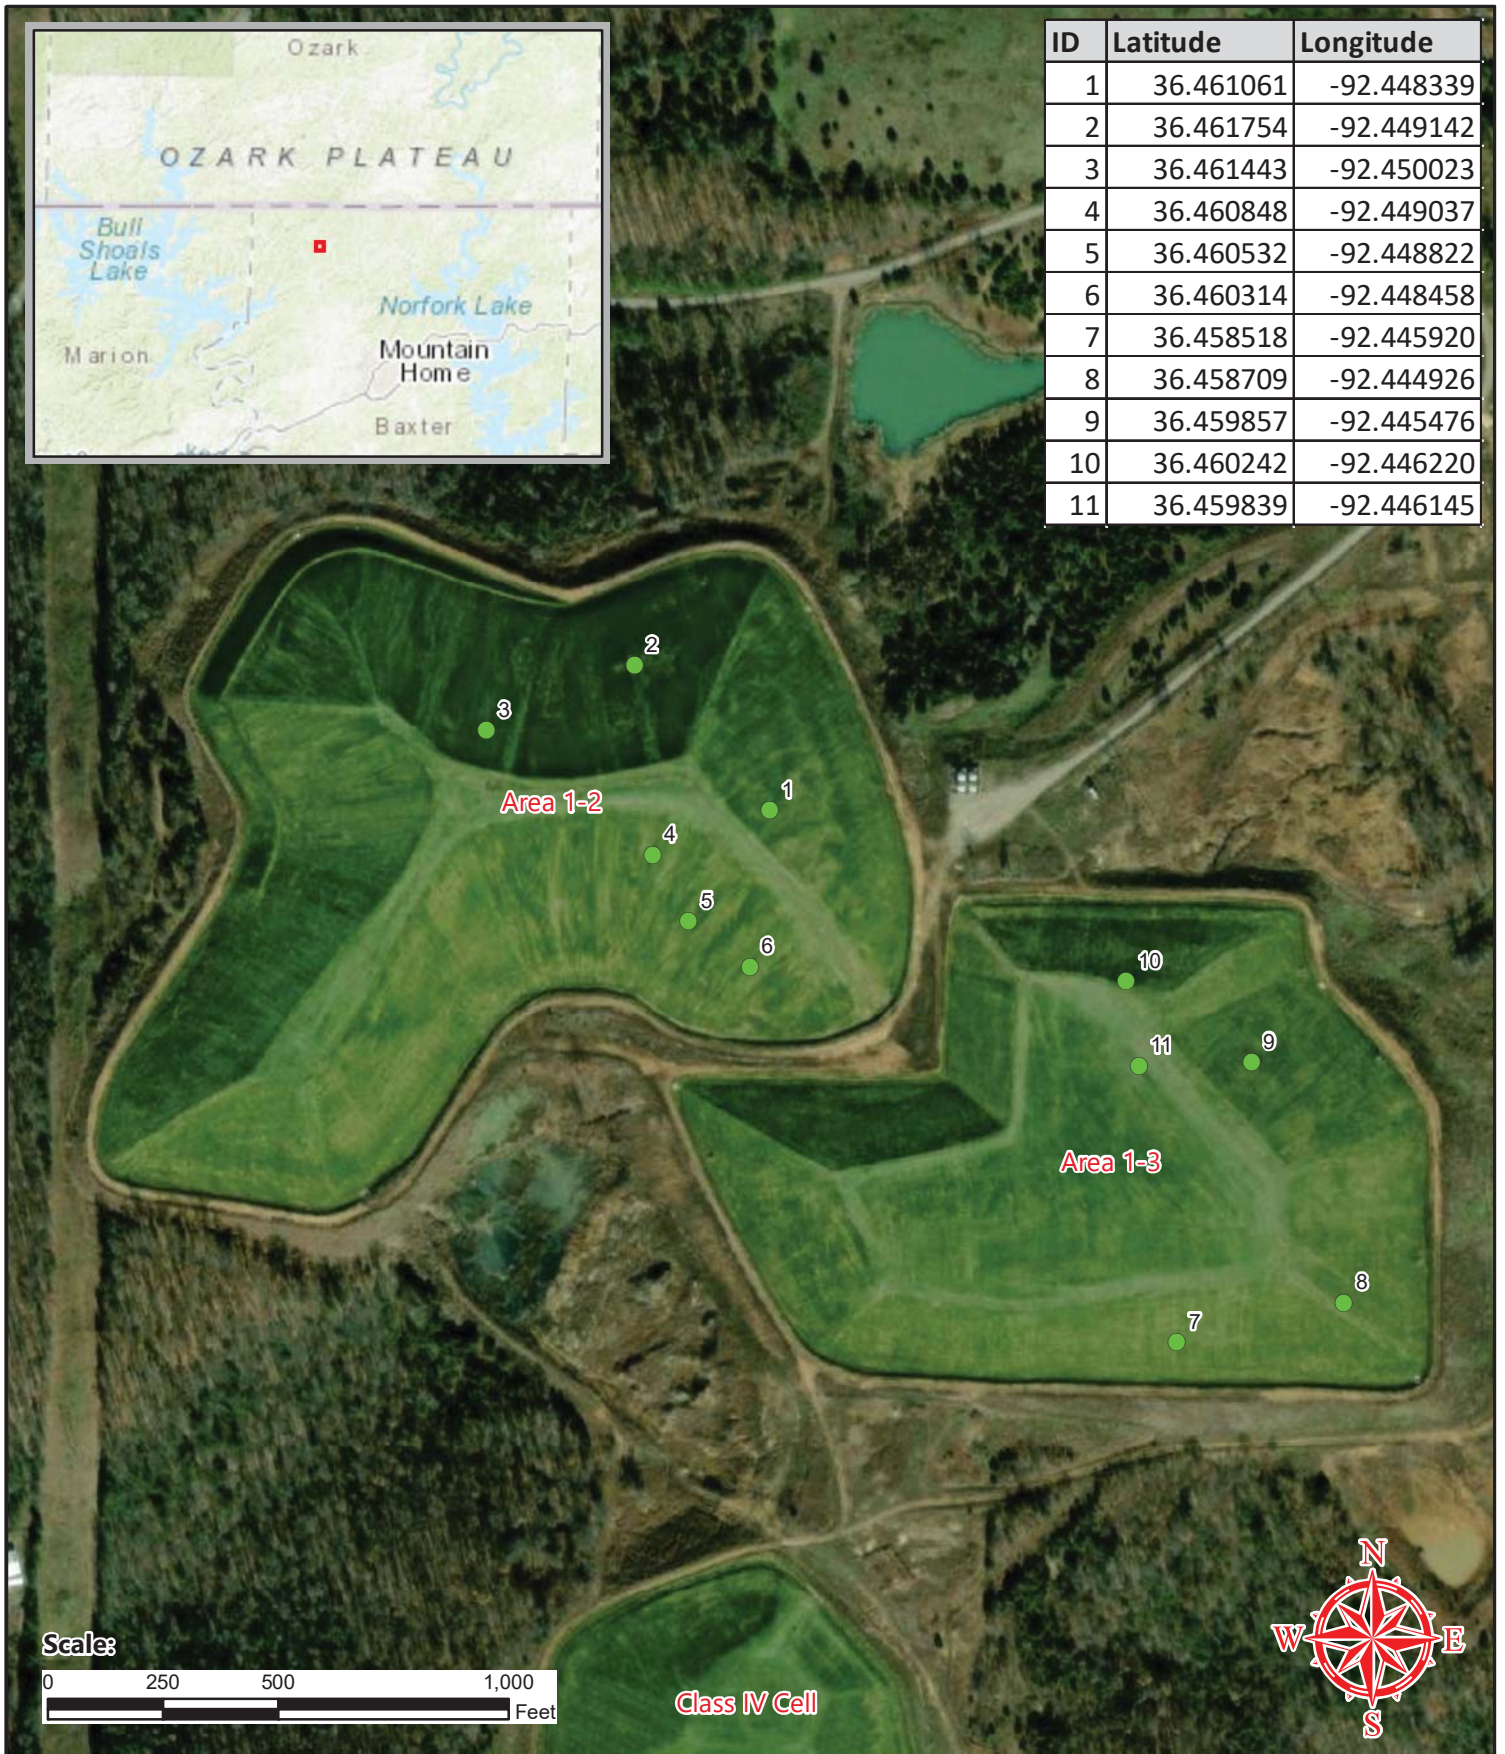
**Figure 1: Damaged Liner Points**

Photographs are included in Attachment A. A copy of the field notes and the leachate collection system status form are included in Attachment B. Locations of bent/absent vent pipes and closure turf tears are included in Attachment C.

- Liner Damage Points
