MEMORANDUM

SUBJECT: Tucker Lumber Company, LLC

Water Division NPDES Photographic Evidence Sheet**Location:** Tucker Lumber Company, LLC**Photographer:** John W. Lamb**Witness:** None**Photo #** 1 **Of** 22**Date:** 3/30/09 **Time:** 12:55**Description:** On Ms. Staten's Property looking onto Tucker Lumber's Wet deck for log storage, sprinkler head within 10 feet of property line.

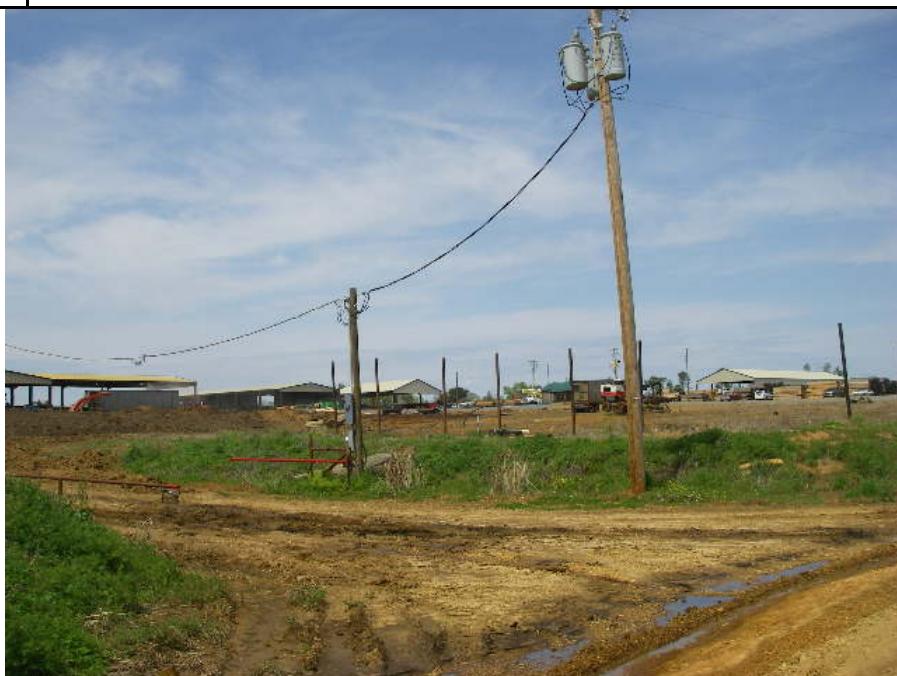
**Photographer:** John W. Lamb **Witness:** None**Photo # 22** Of 22 **Date:** 3/30/09 **Time:** 13:15**Description:** Looking onto site of saw mill.
