RE: Storm Water Inspection

AFIN: None NPDES Permit No.: None

Water Division NPDES Photographic Evidence Sheet							
Location: On the south side of Greers Ferry, Arkansas on Highway #16 (Cleburne County)							
Photographer: Mike Kennedy Witness: None

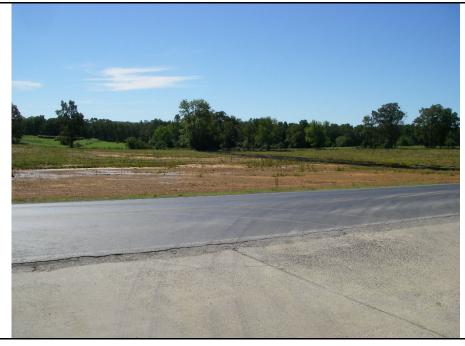
Photo #
 1
 Of
 8
 Date:
 10-10-07
 Time:
 1220

Description: This view shows the property looking south from the north side of Highway #16.
