**Mitigation Action Completion
Report**

Mayflower Pipeline Incident Response
Mayflower, Arkansas

March 2015

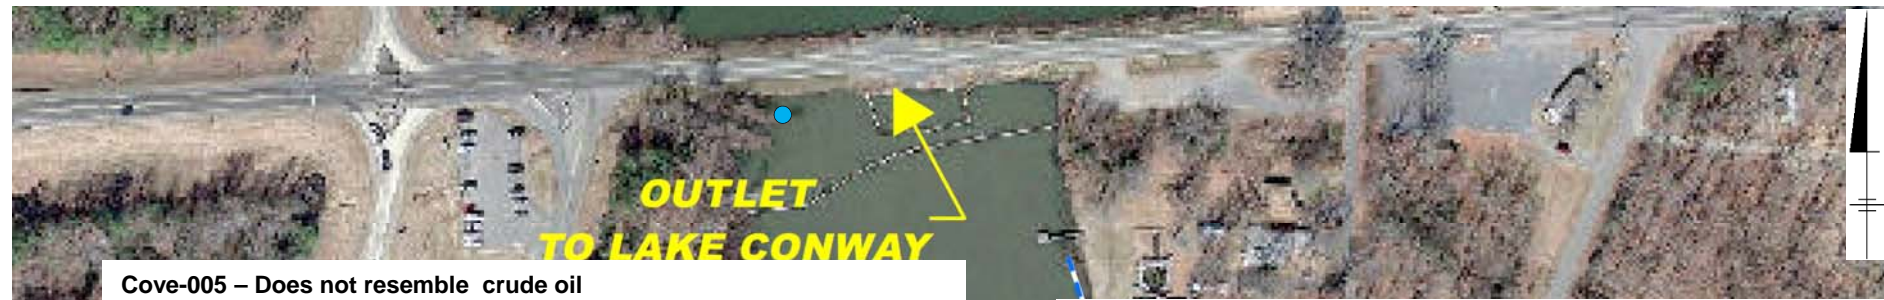
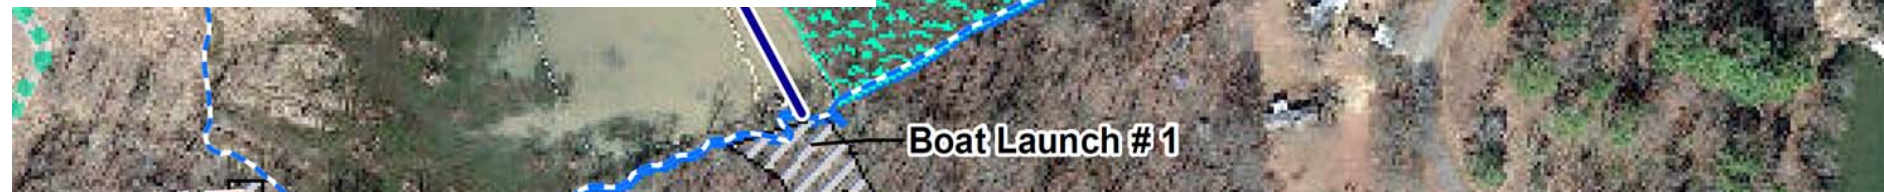
FIGURE
 3-2

Following in-situ amendment placement in the Heavily Vegetated Area, sheen monitoring and removal activities were conducted in this area three times per week. During the construction activities, brittle and non-brittle sheens were observed at four locations within this area between October 23 and December 18, 2014. These sheens included patches/streamers of metallic/rainbow or silver gray-colored sheens. The results of the sheen monitoring within the Heavily Vegetated Area are summarized in Table 3-1 and shown on Figure 3-2.

Cove-005 – Does not resemble crude oil

Patches of Non-Brittle Rainbow/Silver Gray Sheen
