**ExxonMobil Environmental Services  
Company**

**Mitigation Action Completion  
Report**

Mayflower Pipeline Incident Response  
Mayflower, Arkansas

April 2015

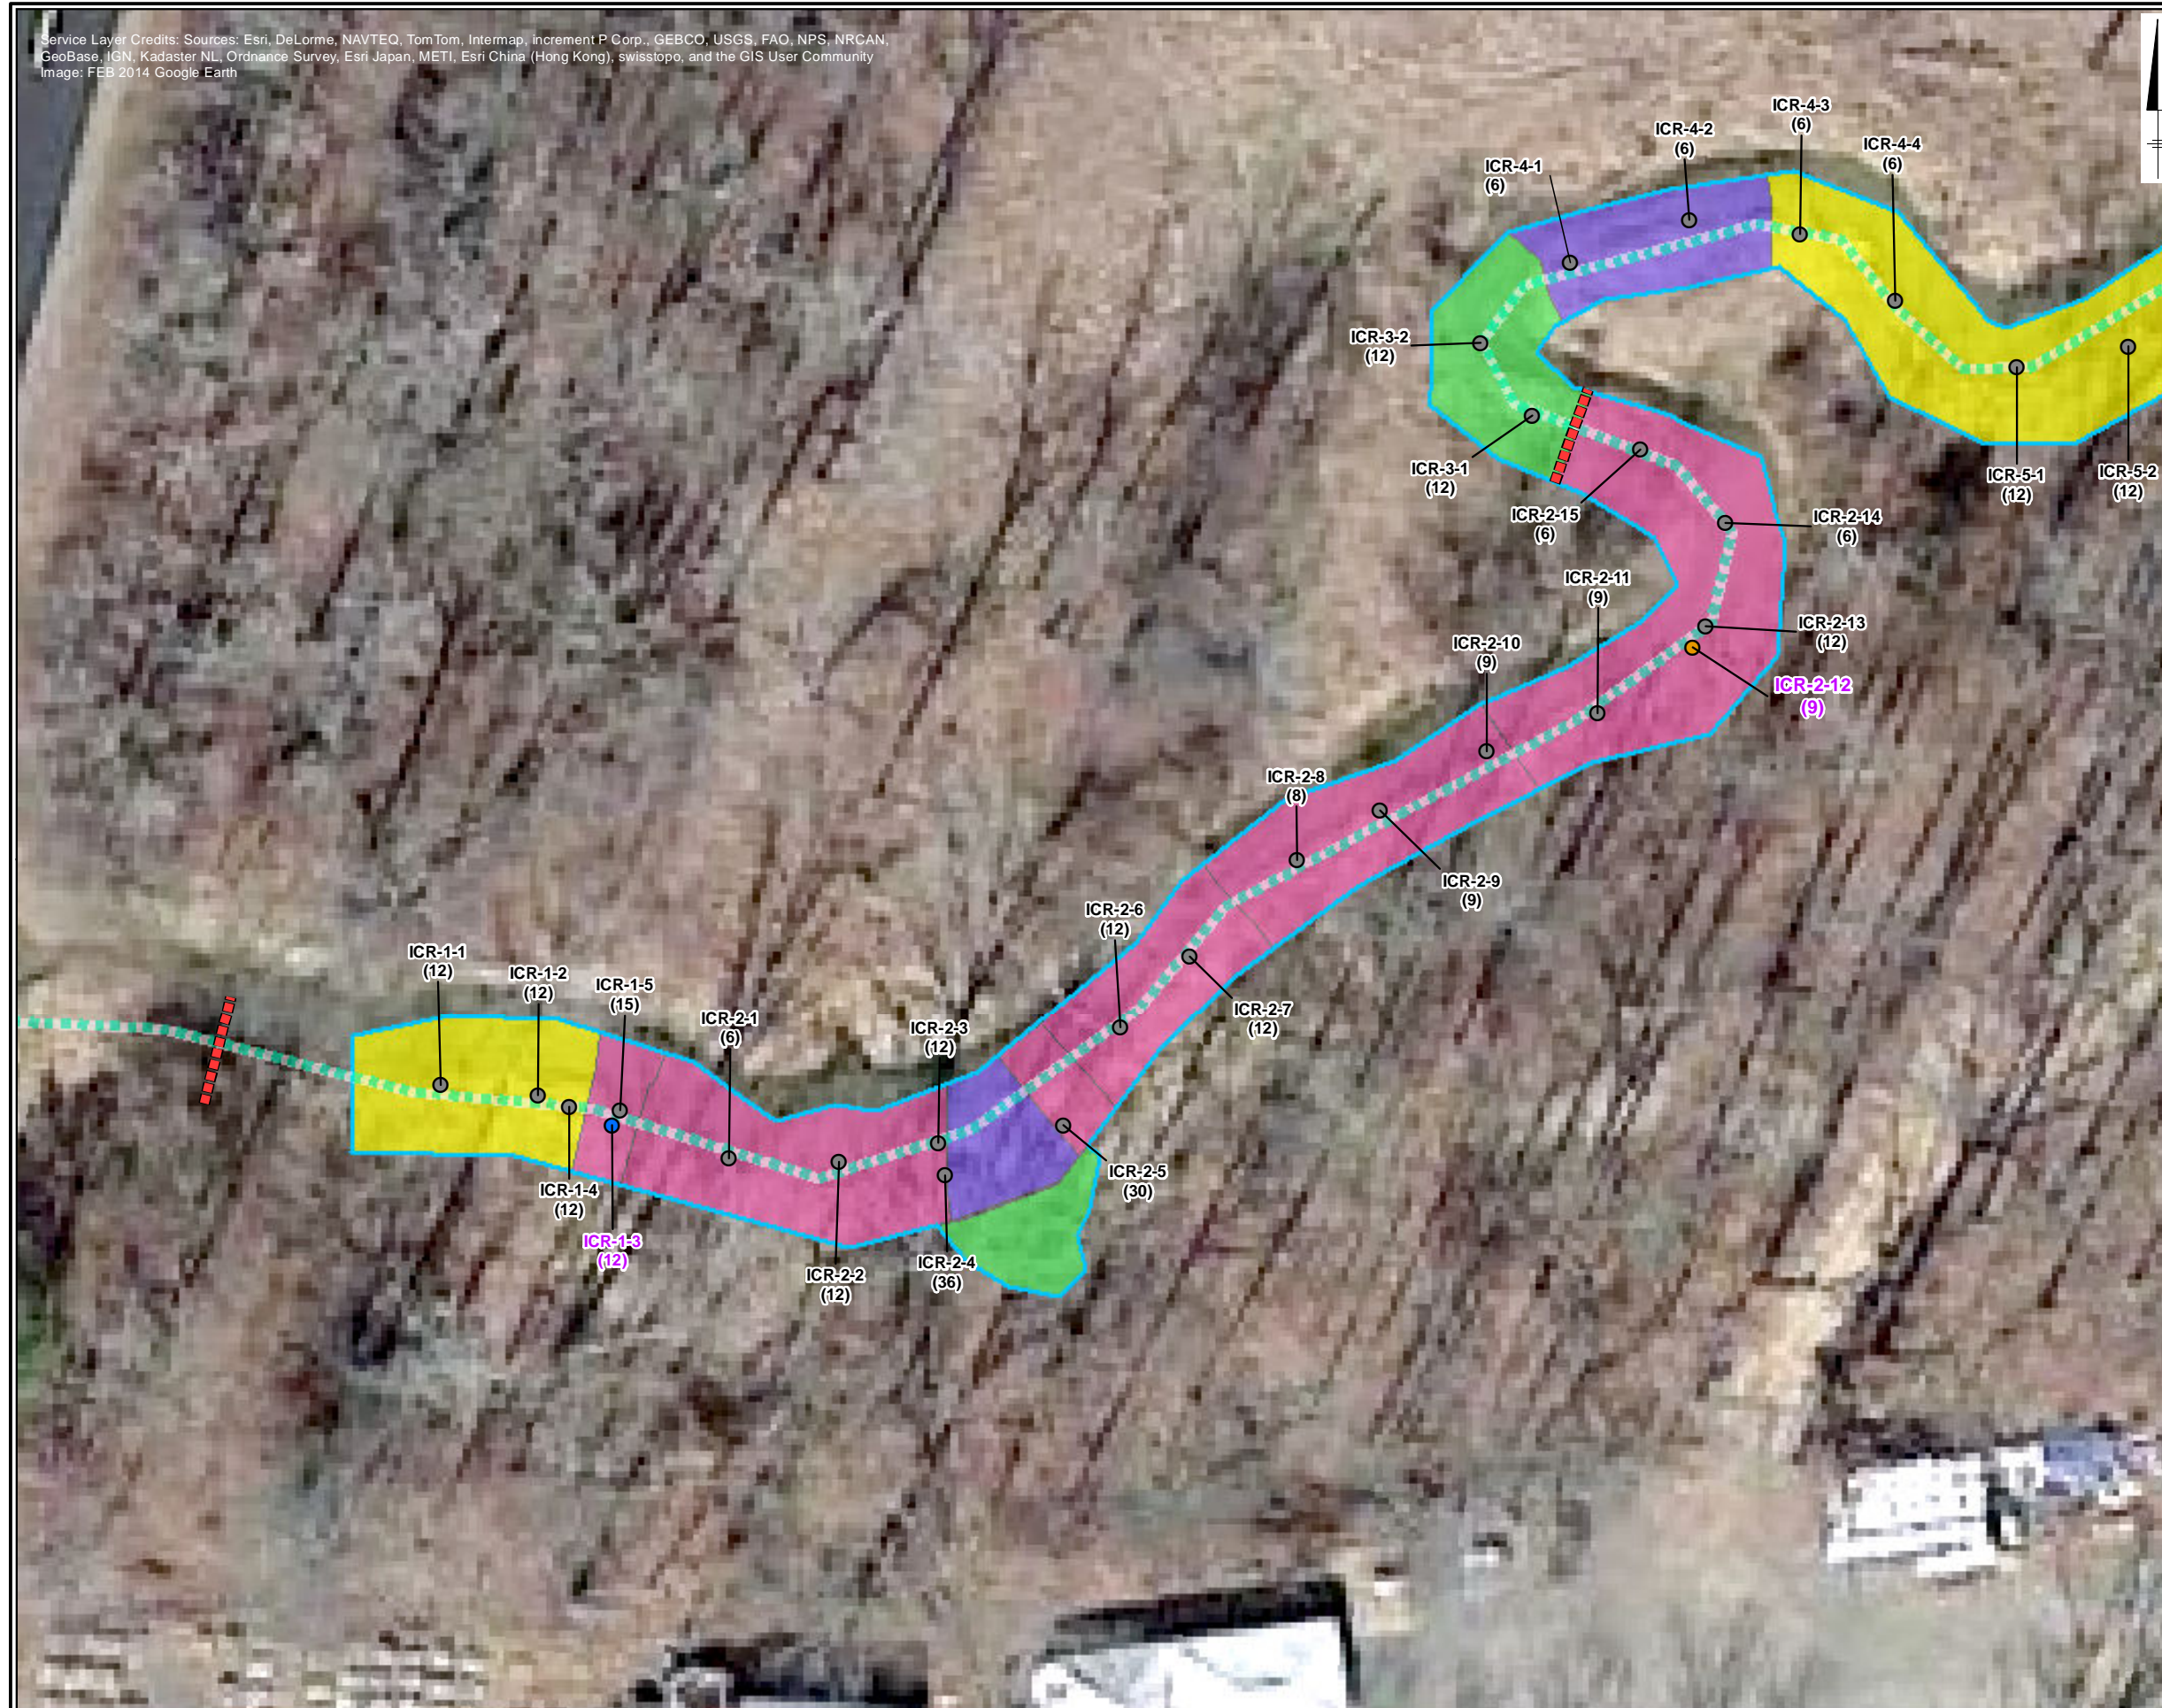
**FIGURE**  
**2-2a**

Based on the pre-design study results, the vertical extent of sheen-bearing sediment in the Inlet Channel was estimated to vary from 6 to 18 inches (0.5 to 1.5 feet), as described in the action plan (ARCADIS 2014c). However, the actual excavation depths varied from 3 to 36 inches (0.25 to 3 feet) because the observed depth of sheen-bearing sediment was deeper in certain areas (Figures 2-2a through 2-2c). Approximately 800 cubic yards of sediment was excavated from the Inlet Channel for disposal at an off-site landfill facility (Appendix C).

A summary of the confirmation sampling is included in Table 2-1, and a layout of confirmation sample locations is presented on Figures 2-2a through 2-2c.

As described in the action plan (ARCADIS 2014c), the targeted sediment removal was conducted to remove sheen-bearing sediment in the Inlet Channel. The removal activities also included excavation of sheen-bearing materials along the banks, as needed, in some areas of the Inlet Channel. Between September 5 and 25, 2014, sediment was excavated along the approximately 1,300-foot-long Inlet Channel, located between I-40 and the Open Water Area as shown on Figures 2-2a through 2-2c. The excavated areas with excavation depths greater than 0.5 foot below original grade were backfilled using clean borrow material (general fill/clay).

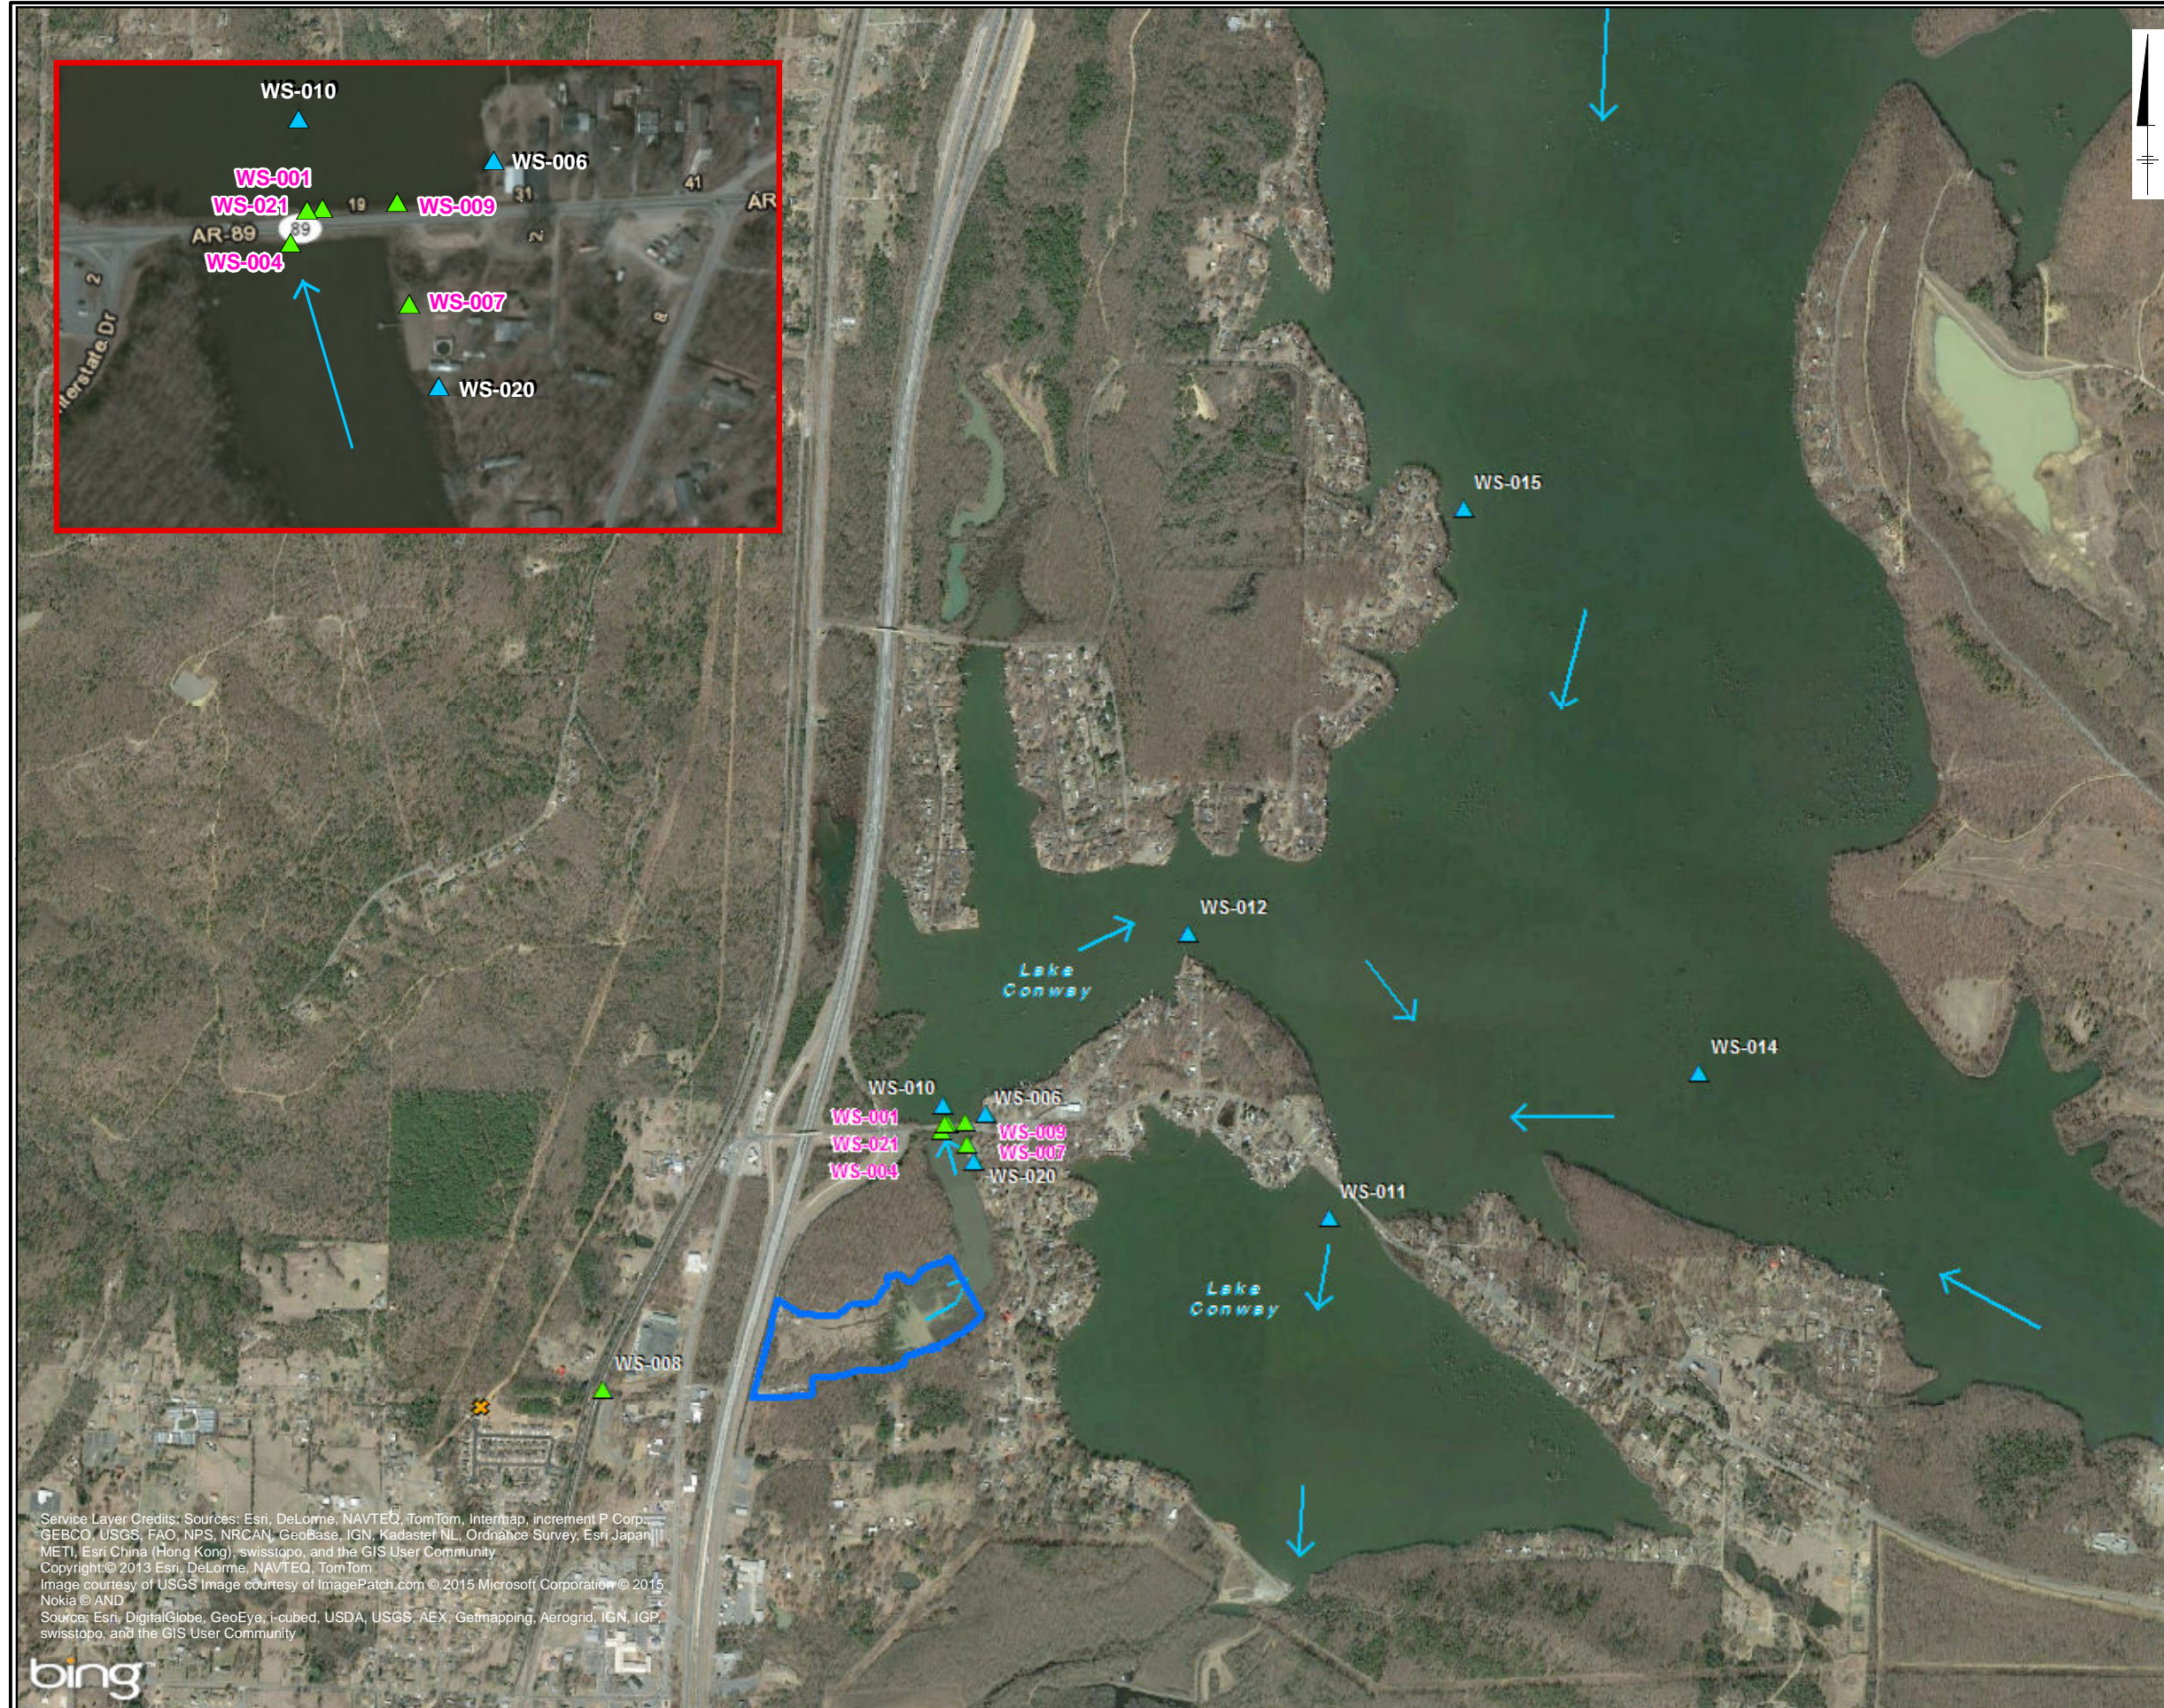
FIGURE  
 3-2

Following in-situ amendment placement in the Heavily Vegetated Area, sheen monitoring and removal activities were conducted in this area three times per week. During the construction activities, brittle and non-brittle sheens were observed at four locations within this area between October 23 and December 18, 2014. These sheens included patches/streamers of metallic/rainbow or silver gray-colored sheens. The results of the sheen monitoring within the Heavily Vegetated Area are summarized in Table 3-1 and shown on Figure 3-2.
