**PRE-CERCLA SCREENING ASSESSMENT
FOR**

**Lewis Lumber and Manufacturing Company
136 West Mill Street
Cove, Polk County
Arkansas, 71937**

July 2018

**Prepared by:
Arkansas Department of Environmental Quality
5301 Northshore Drive
North Little Rock, AR 72118**

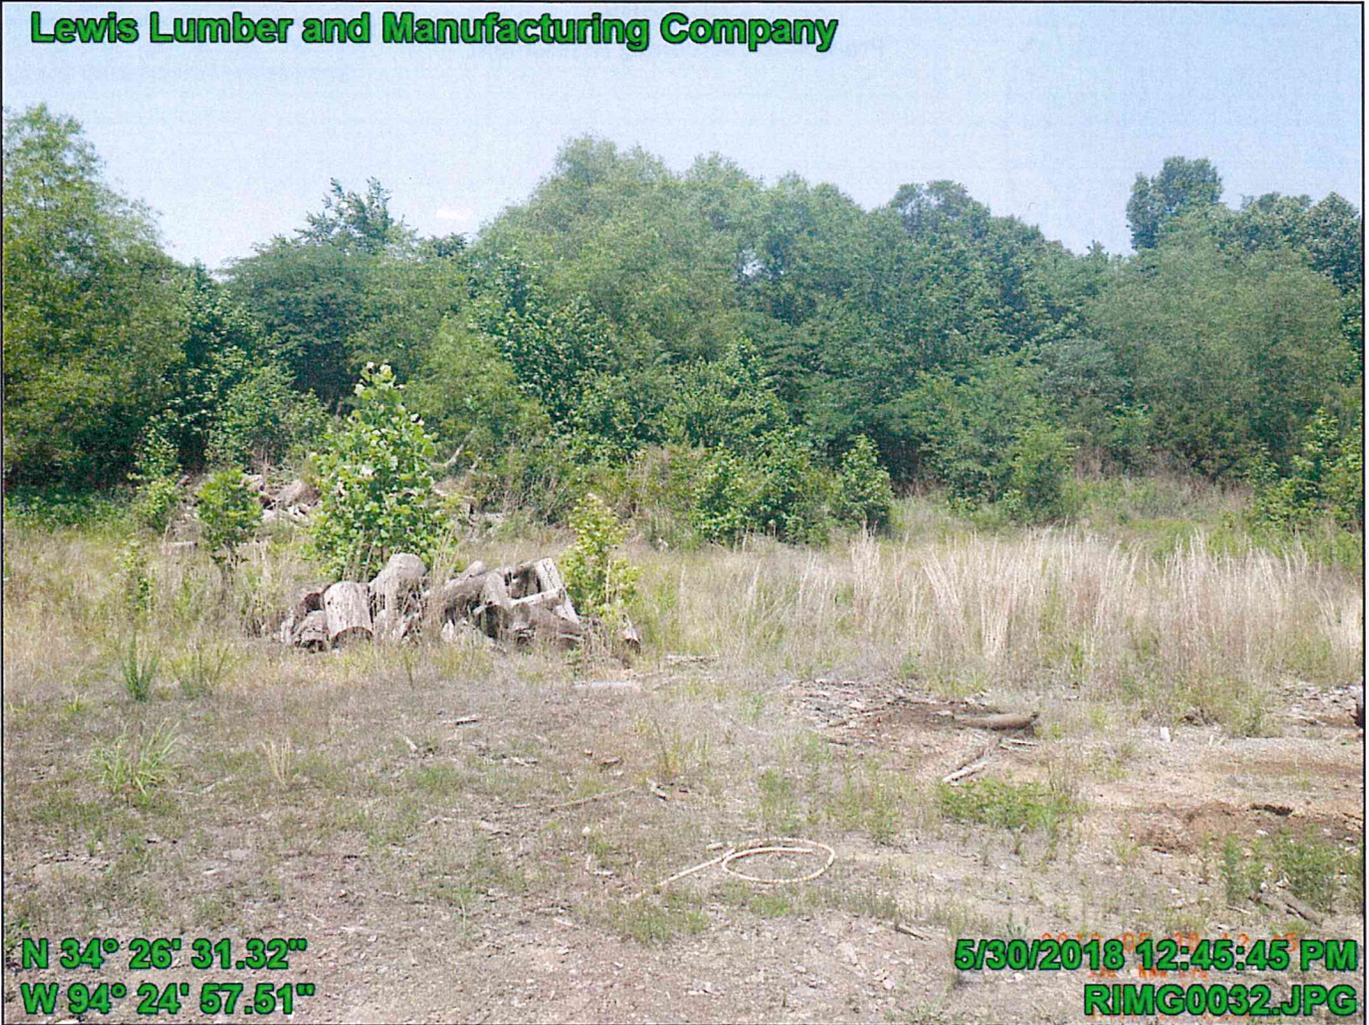
Attributes	
Photo Number	1
Facility	Lewis Lumber and Manufacturing Company
Event	Pre-CERCLA Screening Assessment
AFIN	57-00020
Photographer	Joshua Graham <i>JG</i>
Witness	Katie Kreps <i>KK</i>
Site Location	Cove, AR
Date/Time	5/30/2018 12:45:45 PM
Make	RICOH
Model	G700 SE
File Name	RIMG0032.JPG
Subject	Wooded area north of the site; staining and debris piles containing wood

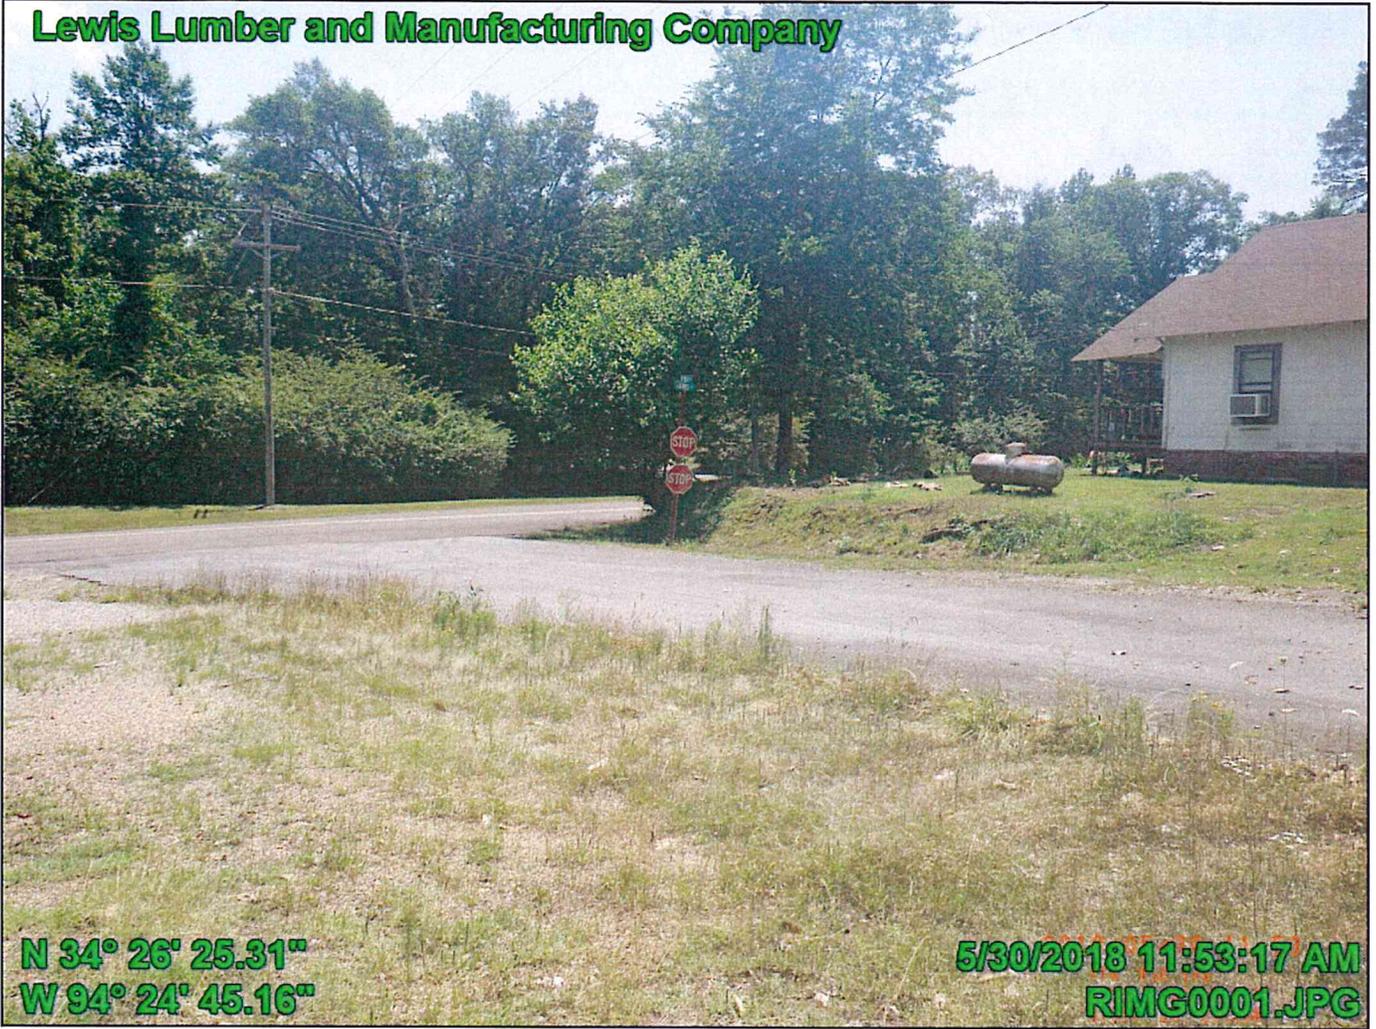
Attributes	
Photo Number	2
Facility	Lewis Lumber and Manufacturing Company
Event	Pre-CERCLA Screening Assessment
AFIN	57-00020
Photographer	Joshua Graham <i>JG</i>
Witness	Katie Kreps <i>KK</i>
Site Location	Cove, AR
Date/Time	5/30/2018 11:53:17 AM
Make	RICOH
Model	G700 SE
File Name	RIMG0001.JPG
Subject	North Lewis Street and residence east of the site

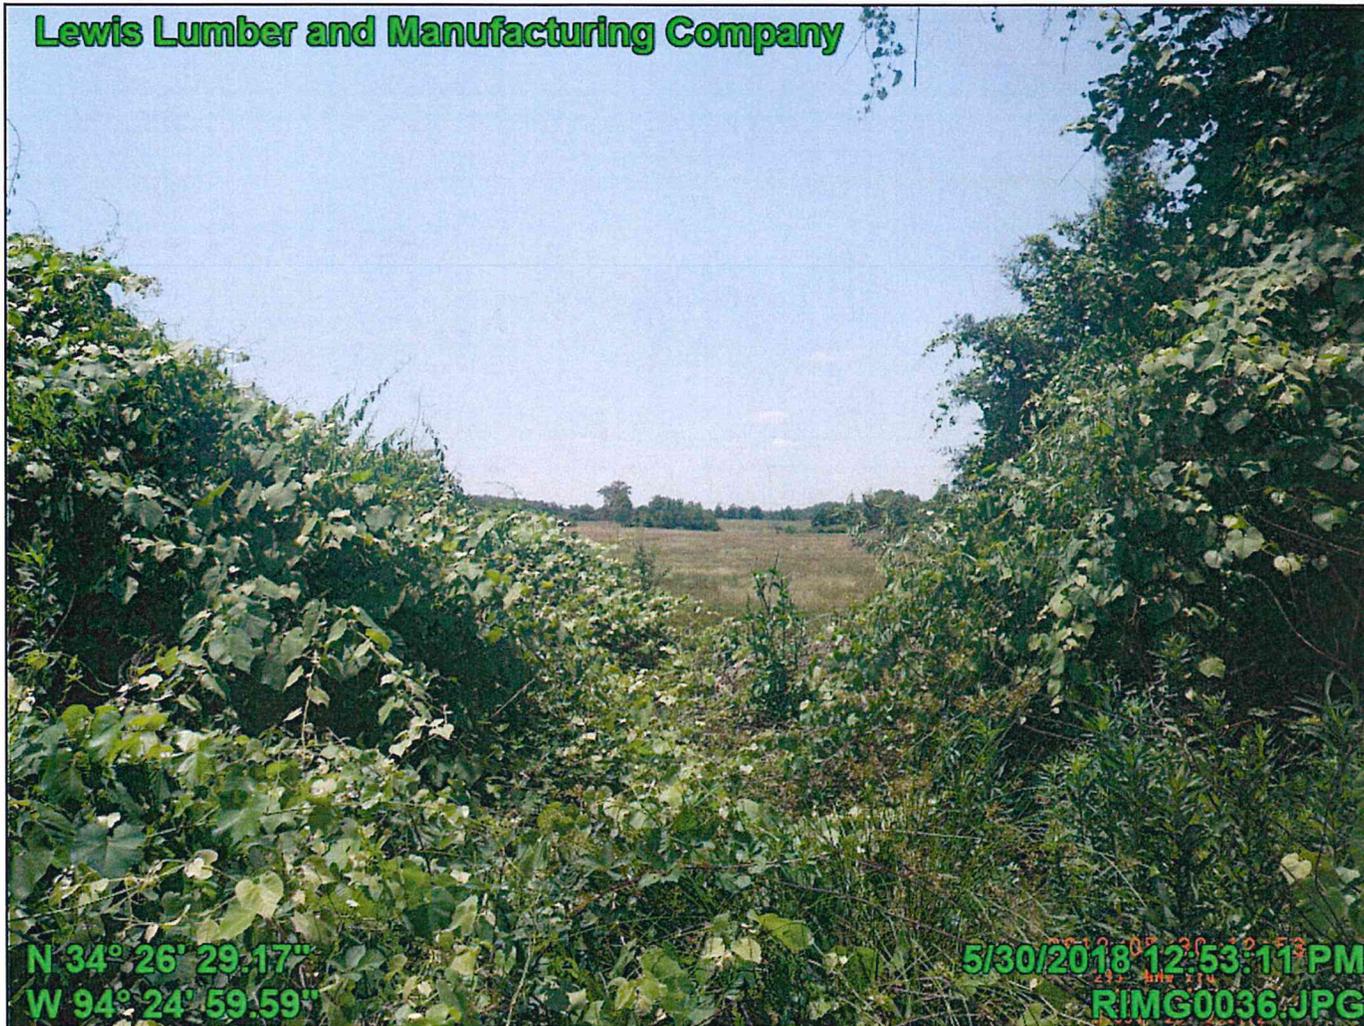
Attributes	
Photo Number	4
Facility	Lewis Lumber and Manufacturing Company
Event	Pre-CERCLA Screening Assessment
AFIN	57-00020
Photographer	Joshua Graham
Witness	Katie Kreps <i>KK</i>
Site Location	Cove, AR
Date/Time	5/30/2018 12:53:11 PM
Make	RICOH
Model	G700 SE
File Name	RIMG0036.JPG
Subject	Open vegetated field west of the site

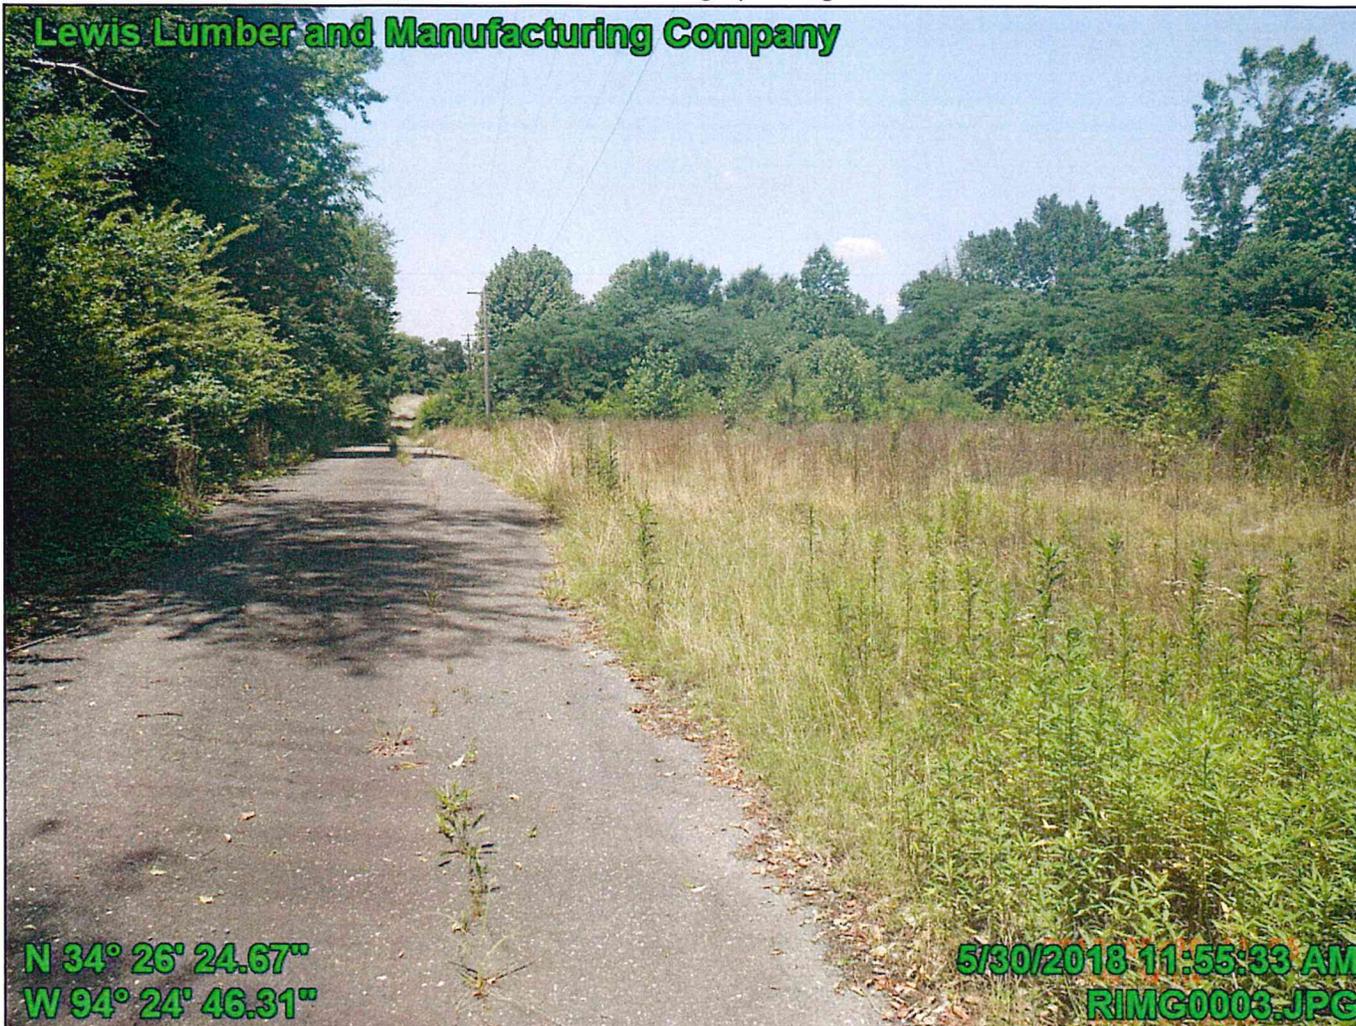
Attributes	
Photo Number	5
Facility	Lewis Lumber and Manufacturing Company
Event	Pre-CERCLA Screening Assessment
AFIN	57-00020
Photographer	Joshua Graham <i>JG</i>
Witness	Katie Kreps <i>KK</i>
Site Location	Cove, AR
Date/Time	5/30/2018 11:55:33 AM
Make	RICOH
Model	G700 SE
File Name	RIMG0003.JPG
Subject	West Mill Street intersecting the site

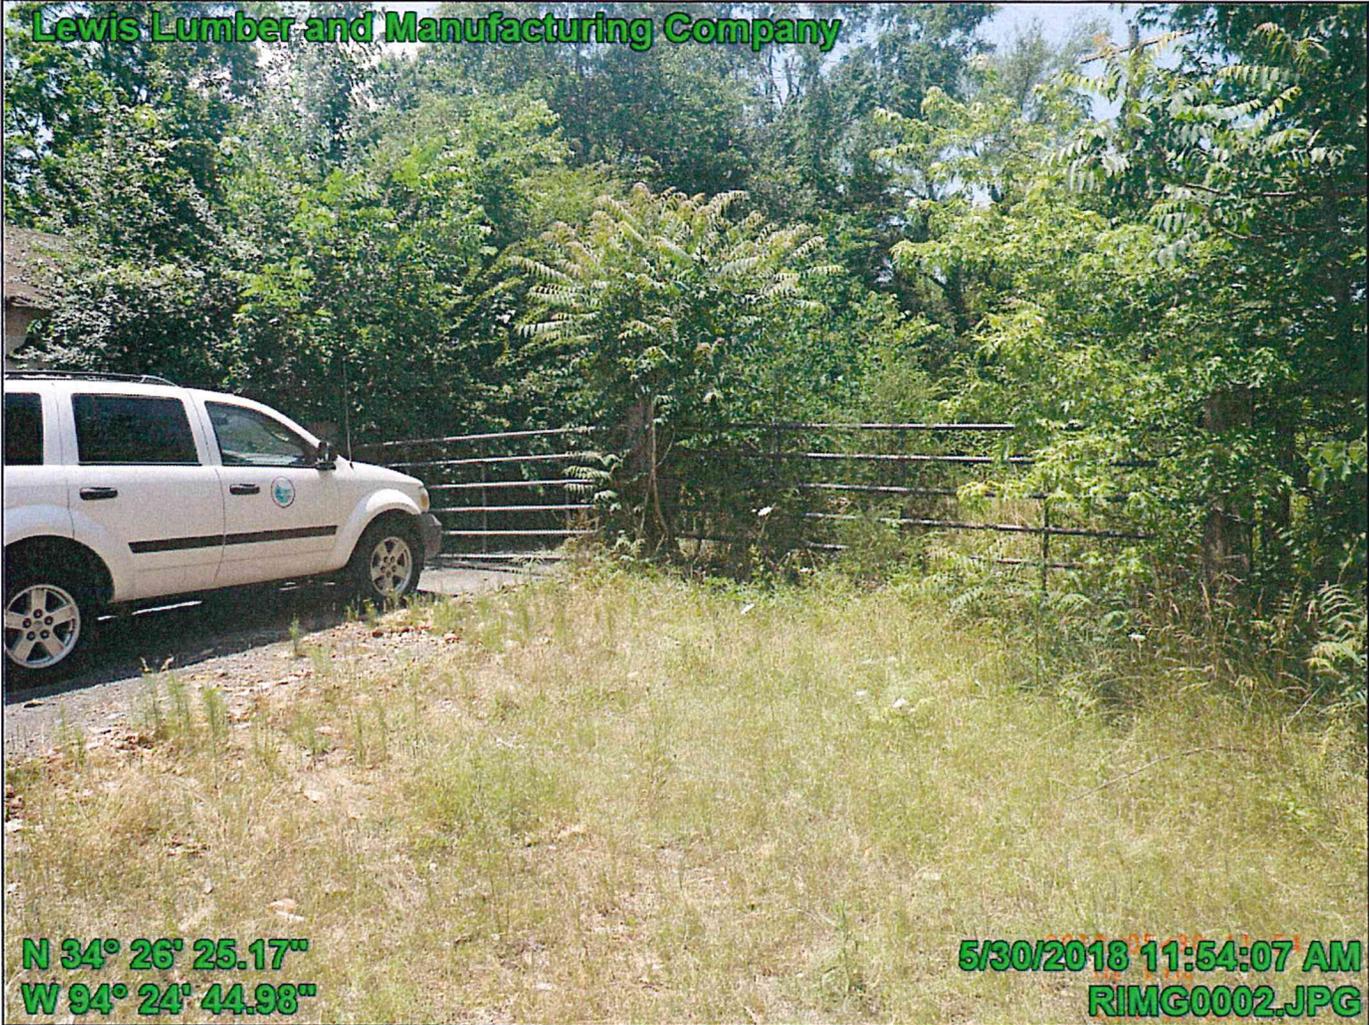
In addition to concrete foundations of former buildings, the remaining land cover at the site consists mostly of gravel and vegetated areas. The site is not fenced and is easily accessible to trespassers; however, a gate is located at the entrance to the site on West Mill Street. During reconnaissance, the gate was locked, making the site inaccessible by vehicle.

Attributes	
Photo Number	6
Facility	Lewis Lumber and Manufacturing Company
Event	Pre-CERCLA Screening Assessment
AFIN	57-00020
Photographer	Joshua Graham
Witness	Katie Kreps <i>KK</i>
Site Location	Cove, AR
Date/Time	5/30/2018 11:54:07 AM
Make	RICOH
Model	G700 SE
File Name	RIMG0002.JPG
Subject	Locked gate at the entrance to the site on West Mill Street

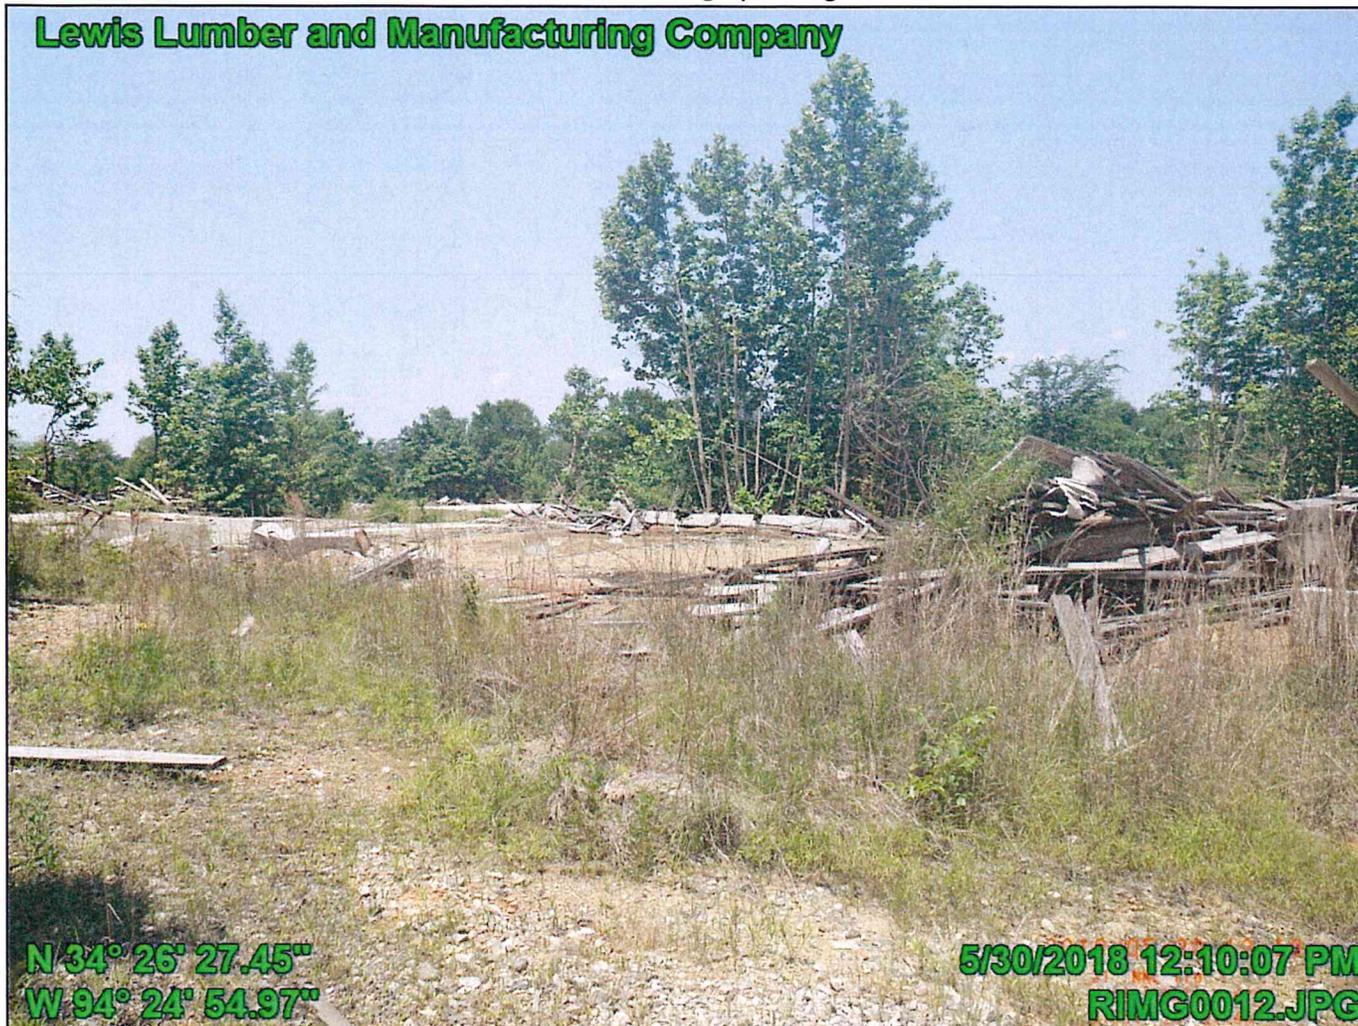
Attributes	
Photo Number	7
Facility	Lewis Lumber and Manufacturing Company
Event	Pre-CERCLA Screening Assessment
AFIN	57-00020
Photographer	Joshua Graham <i>JG</i>
Witness	Katie Kreps <i>KK</i>
Site Location	Cove, AR
Date/Time	5/30/2018 12:10:07 PM
Make	RICOH
Model	G700 SE
File Name	RIMG0012.JPG
Subject	Concrete foundation and demolition debris in location of former building on the north-central portion of the site

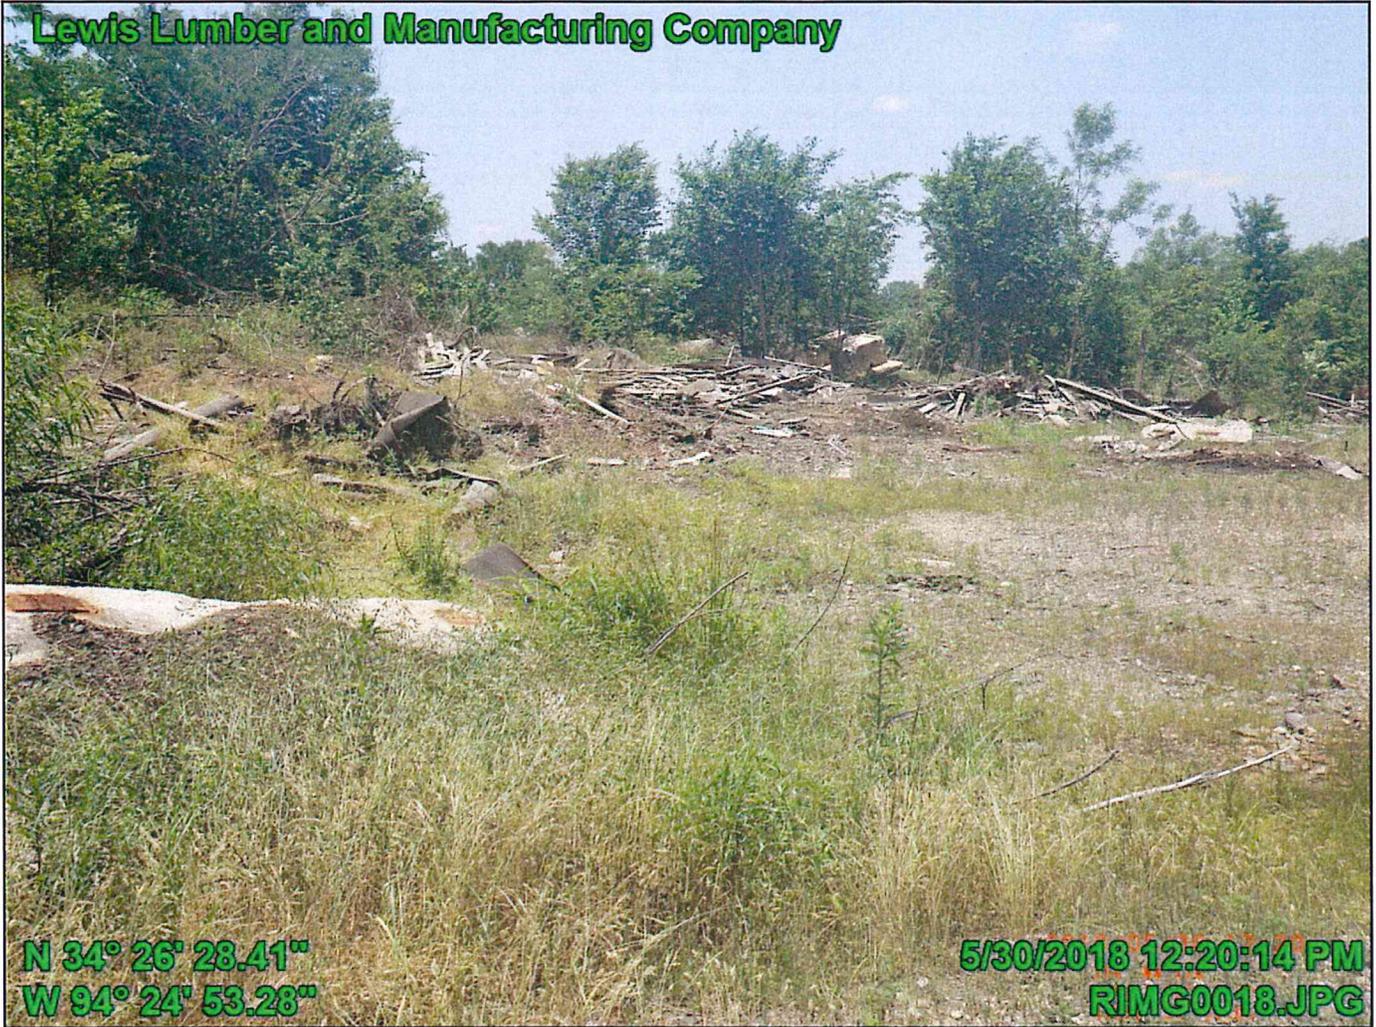
Attributes	
Photo Number	10
Facility	Lewis Lumber and Manufacturing Company
Event	Pre-CERCLA Screening Assessment
AFIN	57-00020
Photographer	Joshua Graham <i>JG</i>
Witness	Katie Kreps <i>KK</i>
Site Location	Cove, AR
Date/Time	5/30/2018 12:20:14 PM
Make	RICOH
Model	G700 SE
File Name	RIMG0018.JPG
Subject	Demolition debris in location of former building on the northeast portion of the site

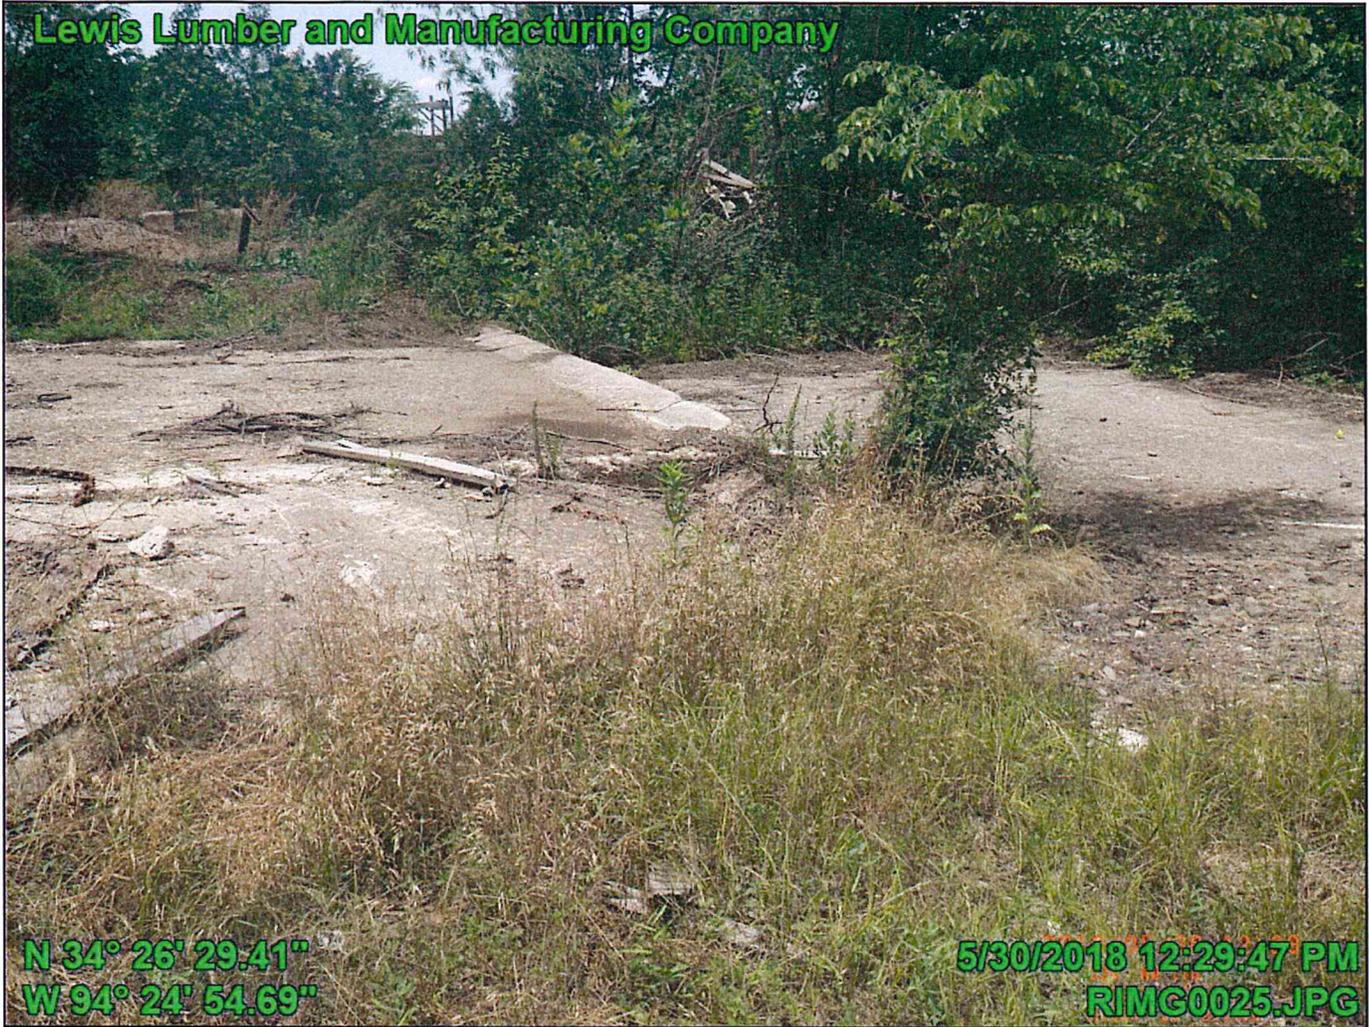
Attributes	
Photo Number	11
Facility	Lewis Lumber and Manufacturing Company
Event	Pre-CERCLA Screening Assessment
AFIN	57-00020
Photographer	Joshua Graham <i>JG</i>
Witness	Katie Kreps <i>KK</i>
Site Location	Cove, AR
Date/Time	5/30/2018 12:29:47 PM
Make	RICOH
Model	G700 SE
File Name	RIMG0025.JPG
Subject	Concrete foundation in location of former building on the north-central portion of the site

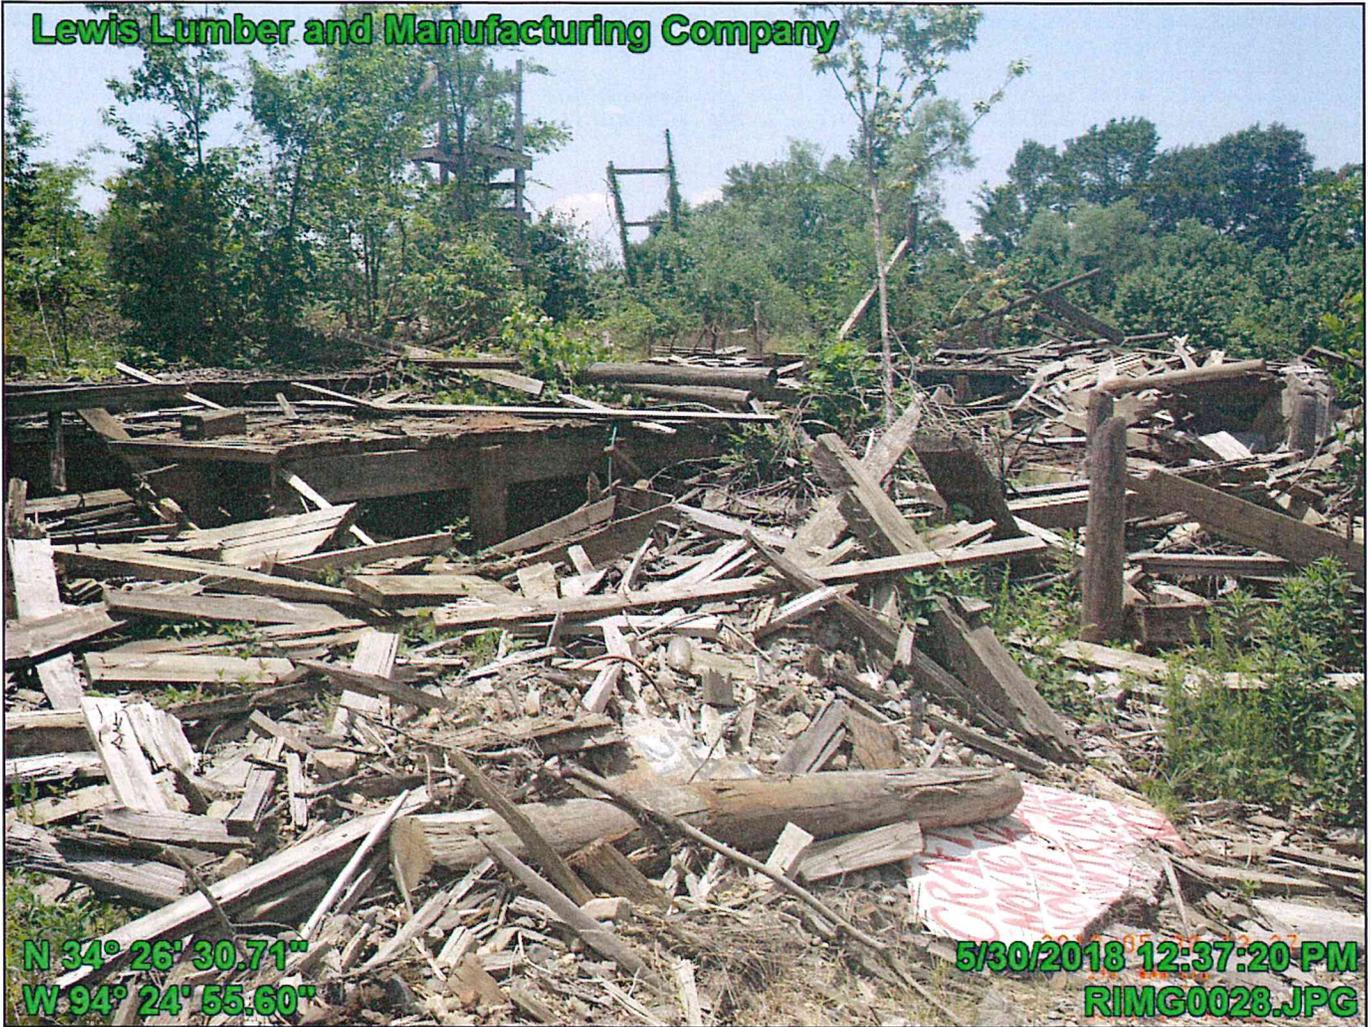
Attributes	
Photo Number	13
Facility	Lewis Lumber and Manufacturing Company
Event	Pre-CERCLA Screening Assessment
AFIN	57-00020
Photographer	Joshua Graham
Witness	Katie Kreps <i>KL</i>
Site Location	Cove, AR
Date/Time	5/30/2018 12:37:20 PM
Make	RICOH
Model	G700 SE
File Name	RIMG0028.JPG
Subject	Demolition debris in location of former building on the northern portion of the site

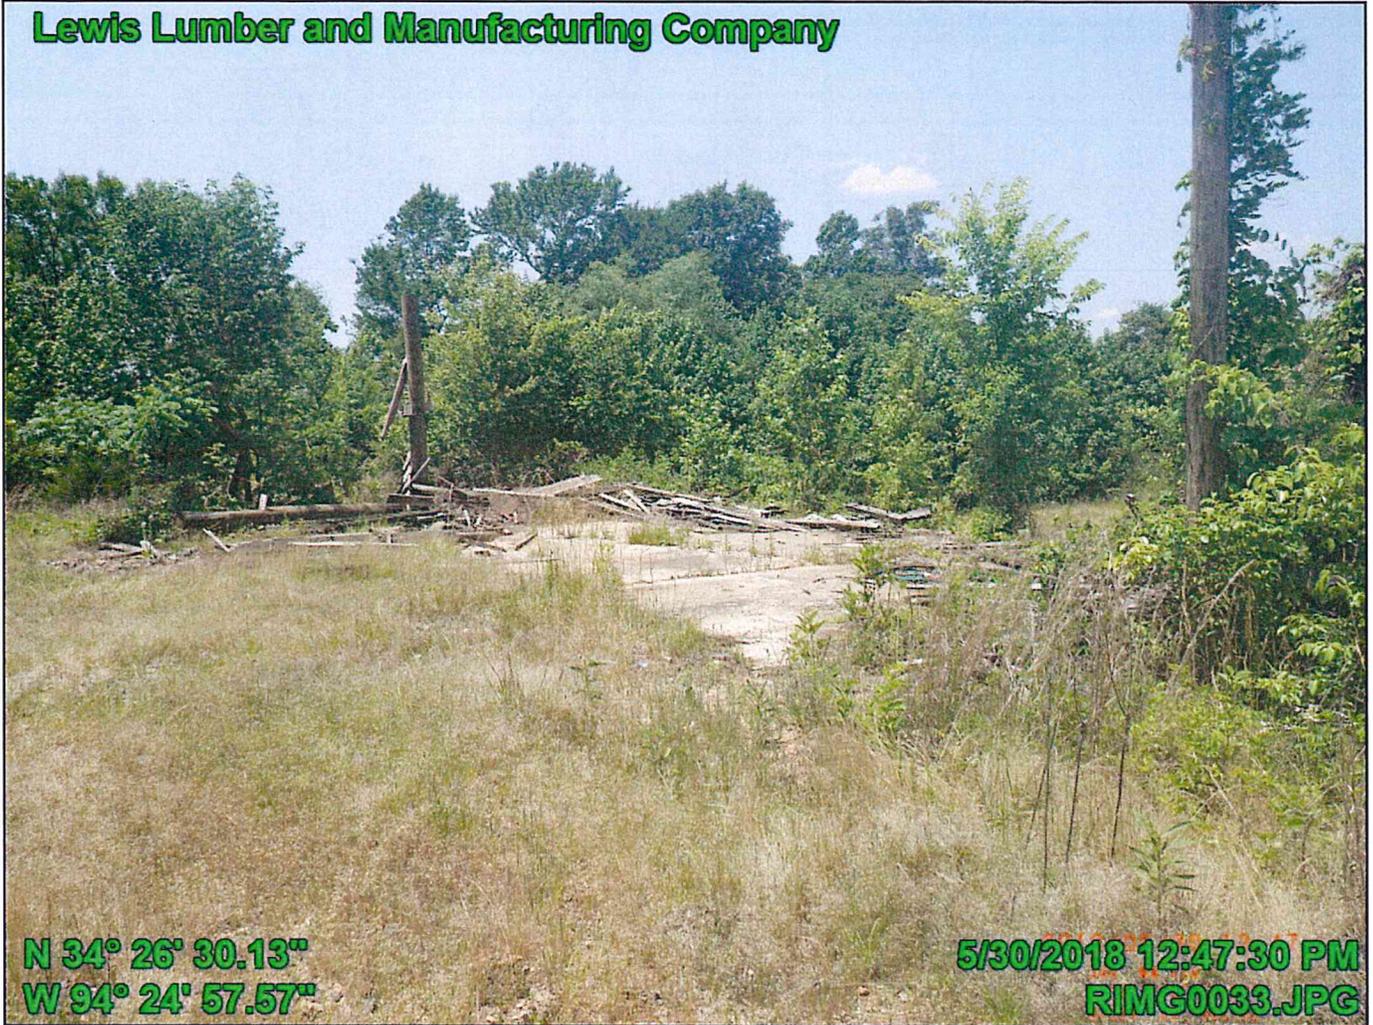
Attributes	
Photo Number	15
Facility	Lewis Lumber and Manufacturing Company
Event	Pre-CERCLA Screening Assessment
AFIN	57-00020
Photographer	Joshua Graham
Witness	Katie Kreps <i>KK</i>
Site Location	Cove, AR
Date/Time	5/30/2018 12:47:30 PM
Make	RICOH
Model	G700 SE
File Name	RIMG0033.JPG
Subject	Concrete foundation and demolition debris in location of former building on the northwest portion of the site

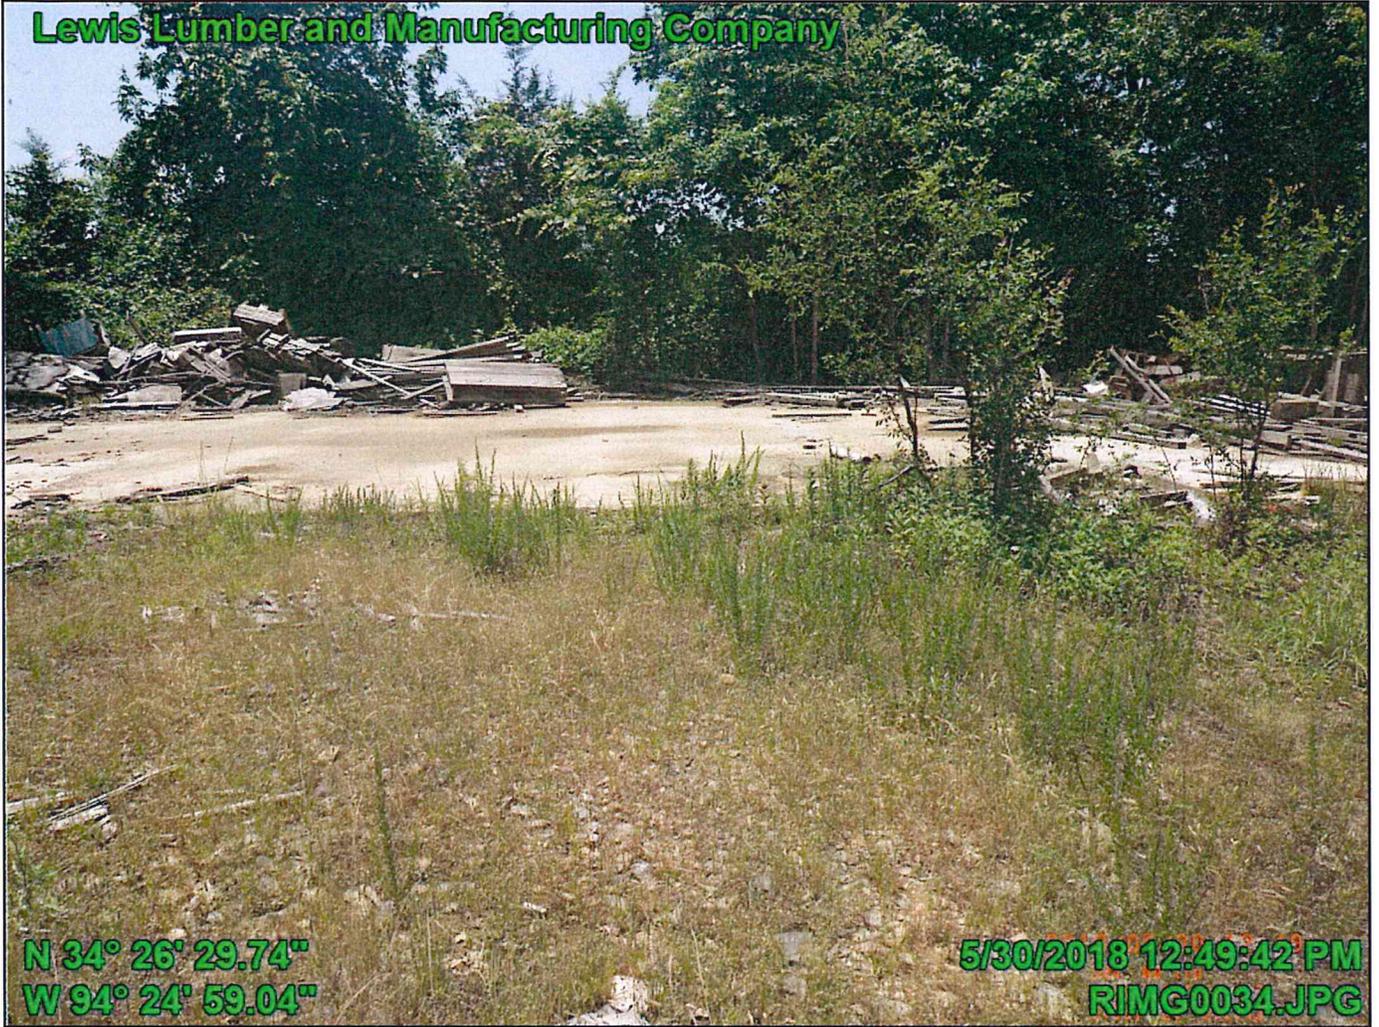
Attributes	
Photo Number	16
Facility	Lewis Lumber and Manufacturing Company
Event	Pre-CERCLA Screening Assessment
AFIN	57-00020
Photographer	Joshua Graham <i>JG</i>
Witness	Katie Kreps <i>KK</i>
Site Location	Cove, AR
Date/Time	5/30/2018 12:49:42 PM
Make	RICOH
Model	G700 SE
File Name	RIMG0034.JPG
Subject	Concrete foundation and demolition debris in location of former building on the northwest portion of the site

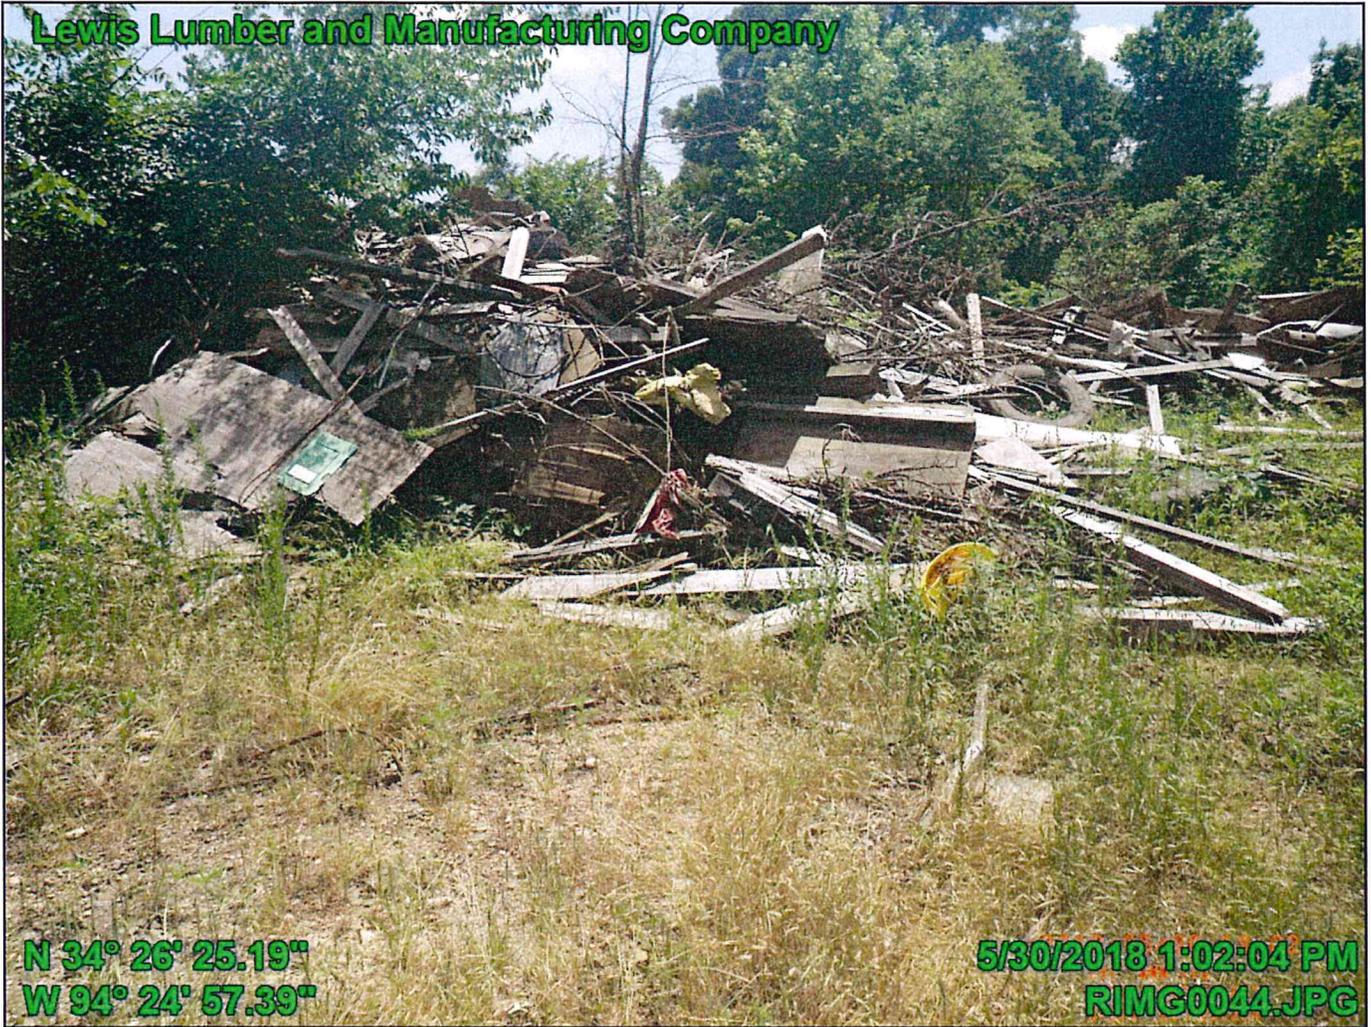
Attributes	
Photo Number	19
Facility	Lewis Lumber and Manufacturing Company
Event	Pre-CERCLA Screening Assessment
AFIN	57-00020
Photographer	Joshua Graham <i>JG</i>
Witness	Katie Kreps <i>KK</i>
Site Location	Cove, AR
Date/Time	5/30/2018 1:02:04 PM
Make	RICOH
Model	G700 SE
File Name	RIMG0044.JPG
Subject	Demolition debris in location of former building on the west portion of the site

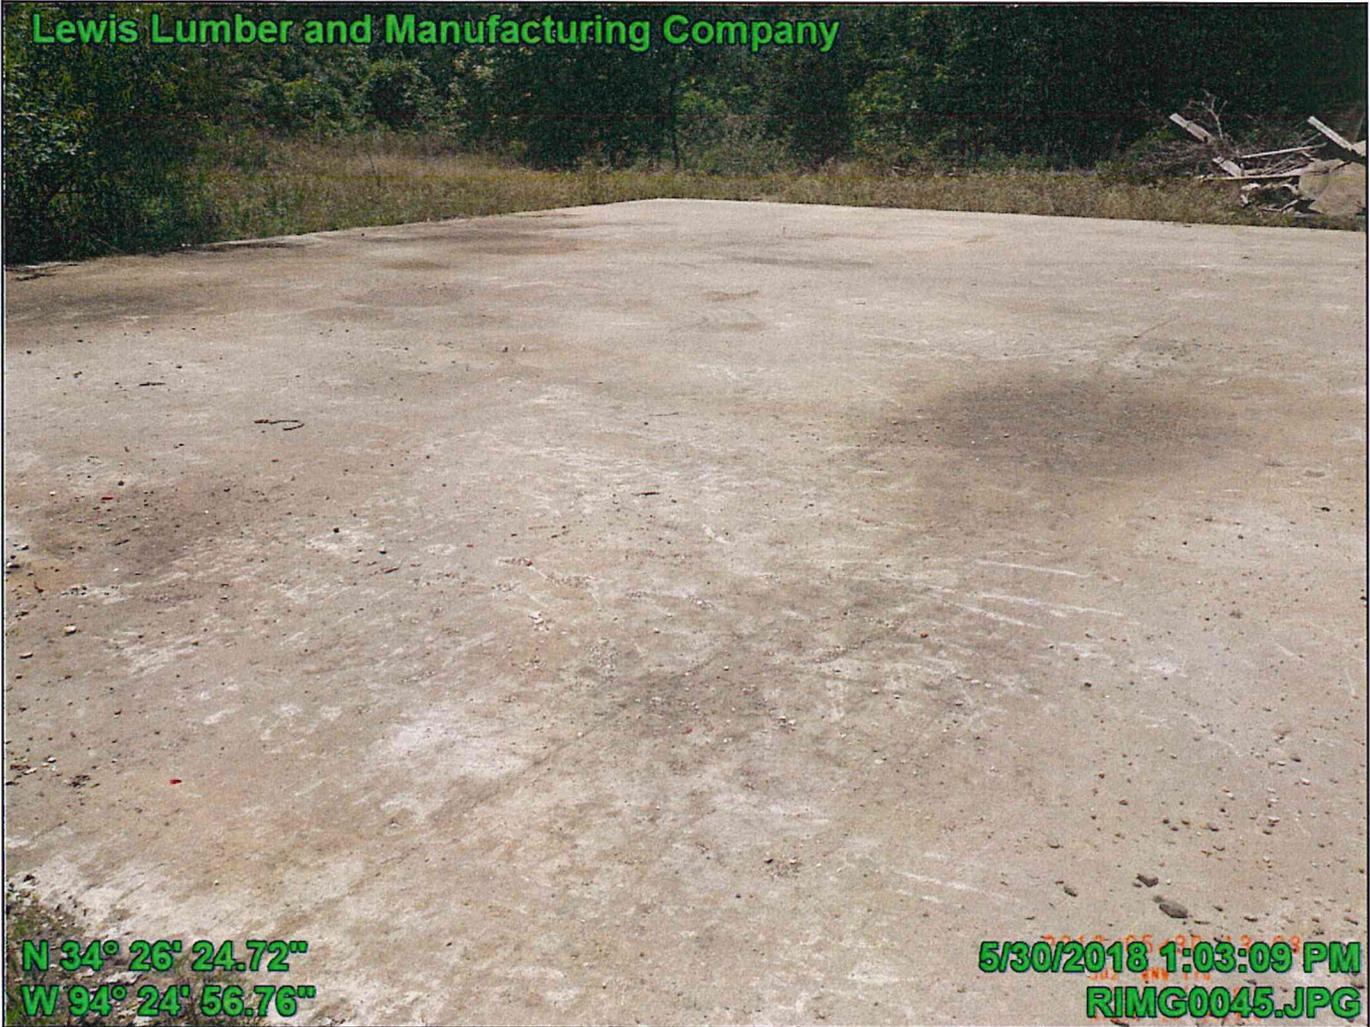
Attributes	
Photo Number	20
Facility	Lewis Lumber and Manufacturing Company
Event	Pre-CERCLA Screening Assessment
AFIN	57-00020
Photographer	Joshua Graham <i>JG</i>
Witness	Katie Kreps <i>KE</i>
Site Location	Cove, AR
Date/Time	5/30/2018 1:03:09 PM
Make	RICOH
Model	G700 SE
File Name	RIMG0045.JPG
Subject	Concrete foundation with staining in location of former building on the west portion of the site

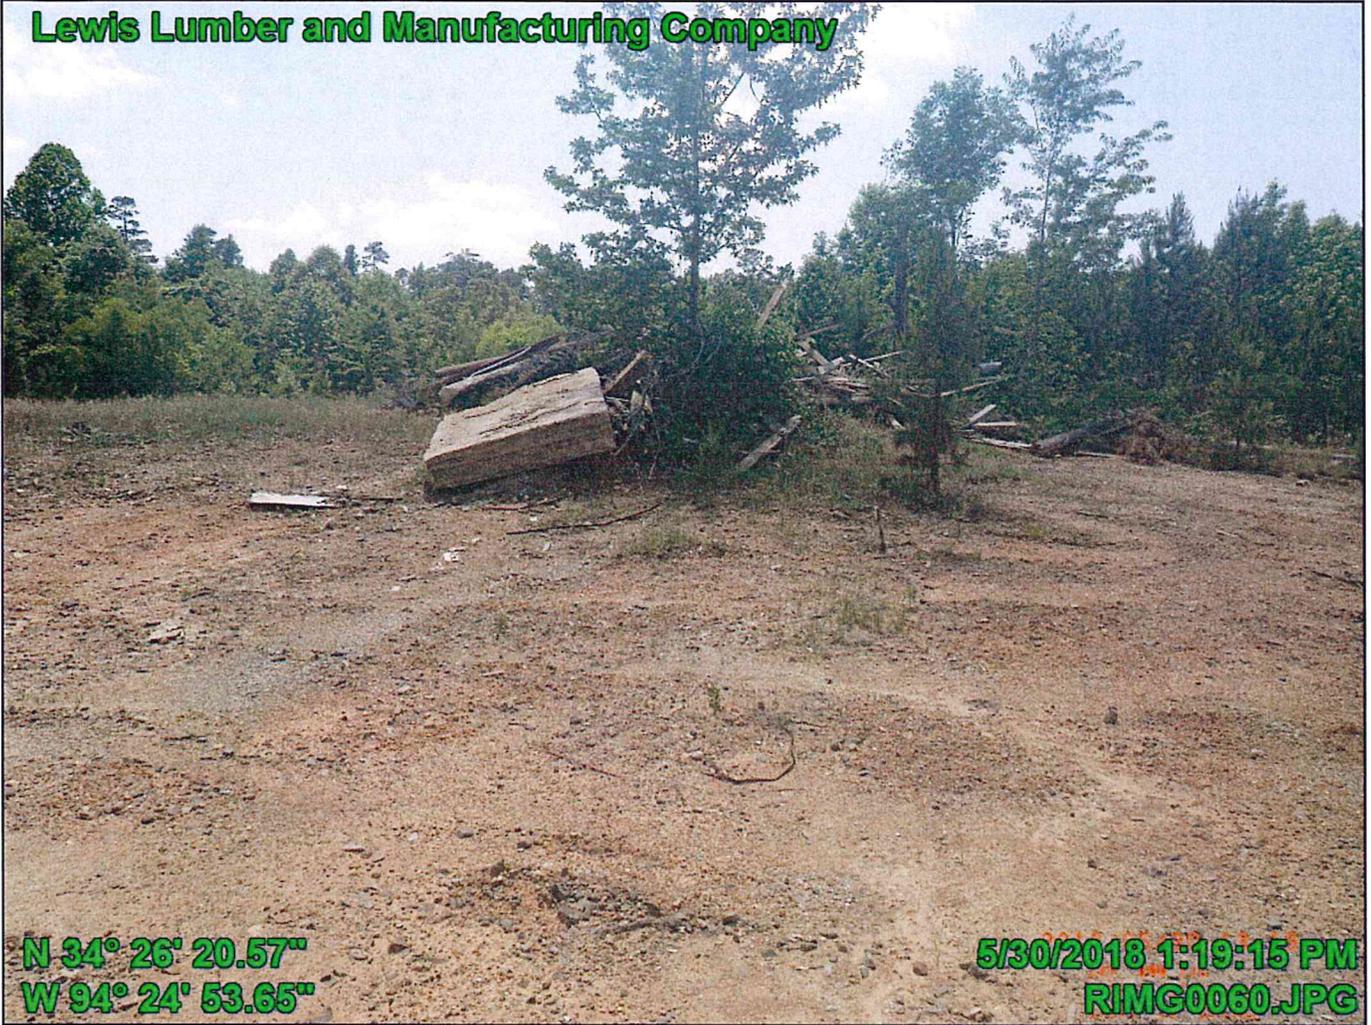
Attributes	
Photo Number	21
Facility	Lewis Lumber and Manufacturing Company
Event	Pre-CERCLA Screening Assessment
AFIN	57-00020
Photographer	Joshua Graham
Witness	Katie Kreps <i>KK</i>
Site Location	Cove, AR
Date/Time	5/30/2018 1:19:15 PM
Make	RICOH
Model	G700 SE
File Name	RIMG0060.JPG
Subject	Demolition debris in location of former building on the south-central portion of the site

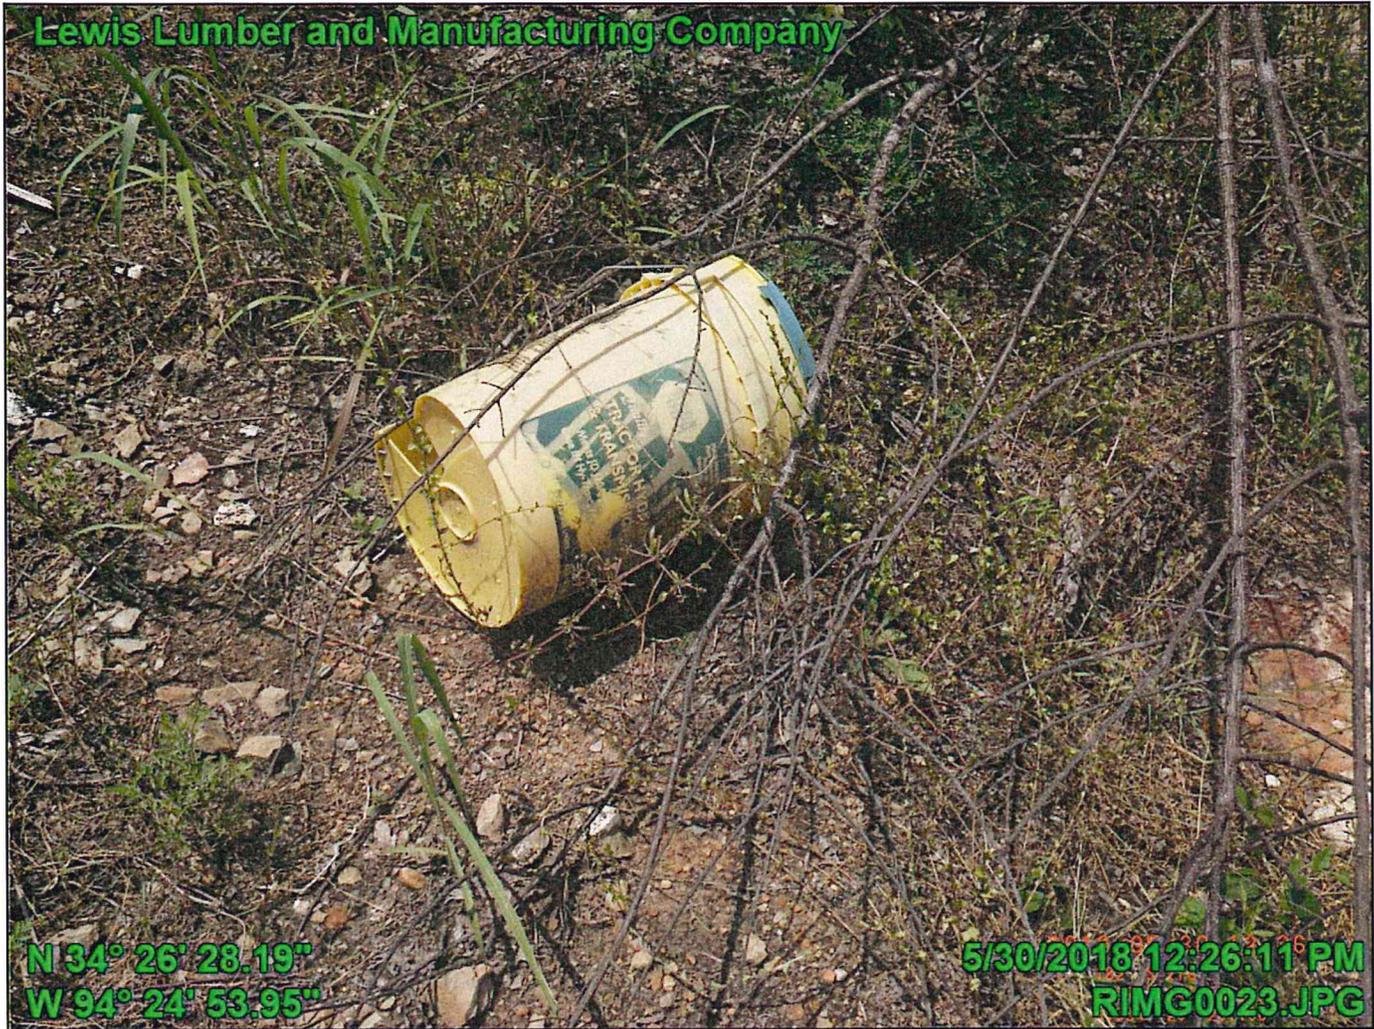
Attributes	
Photo Number	24
Facility	Lewis Lumber and Manufacturing Company
Event	Pre-CERCLA Screening Assessment
AFIN	57-00020
Photographer	Joshua Graham <i>JG</i>
Witness	Katie Kreps <i>KK</i>
Site Location	Cove, AR
Date/Time	5/30/2018 12:26:11 PM
Make	RICOH
Model	G700 SE
File Name	RIMG0023.JPG
Subject	Empty 5-gallon hydraulic fluid bucket near debris pile on the northeast portion of the site
