**PRE-CERCLA SCREENING ASSESSMENT
FOR**

**Lewis Lumber and Manufacturing Company
136 West Mill Street
Cove, Polk County
Arkansas, 71937**

July 2018

**Prepared by:
Arkansas Department of Environmental Quality
5301 Northshore Drive
North Little Rock, AR 72118**

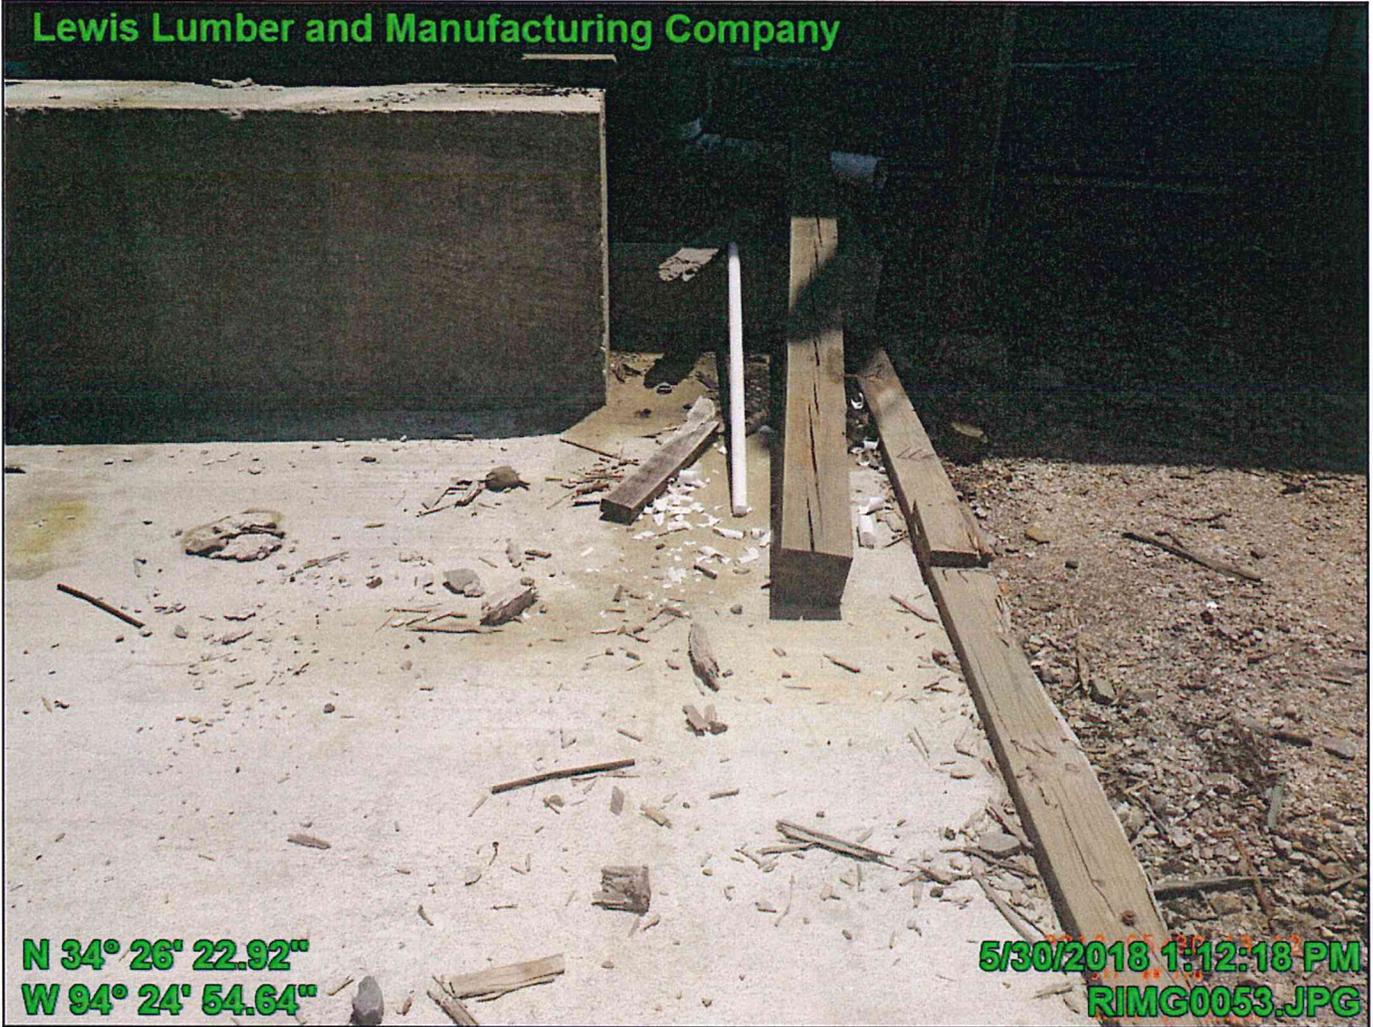
Attributes	
Photo Number	26
Facility	Lewis Lumber and Manufacturing Company
Event	Pre-CERCLA Screening Assessment
AFIN	57-00020
Photographer	Joshua Graham <i>JG</i>
Witness	Katie Kreps <i>KK</i>
Site Location	Cove, AR
Date/Time	5/30/2018 1:12:18 PM
Make	RICOH
Model	G700 SE
File Name	RIMG0053.JPG
Subject	Broken universal waste bulb near the CCA Treatment Building on the southern portion of the site

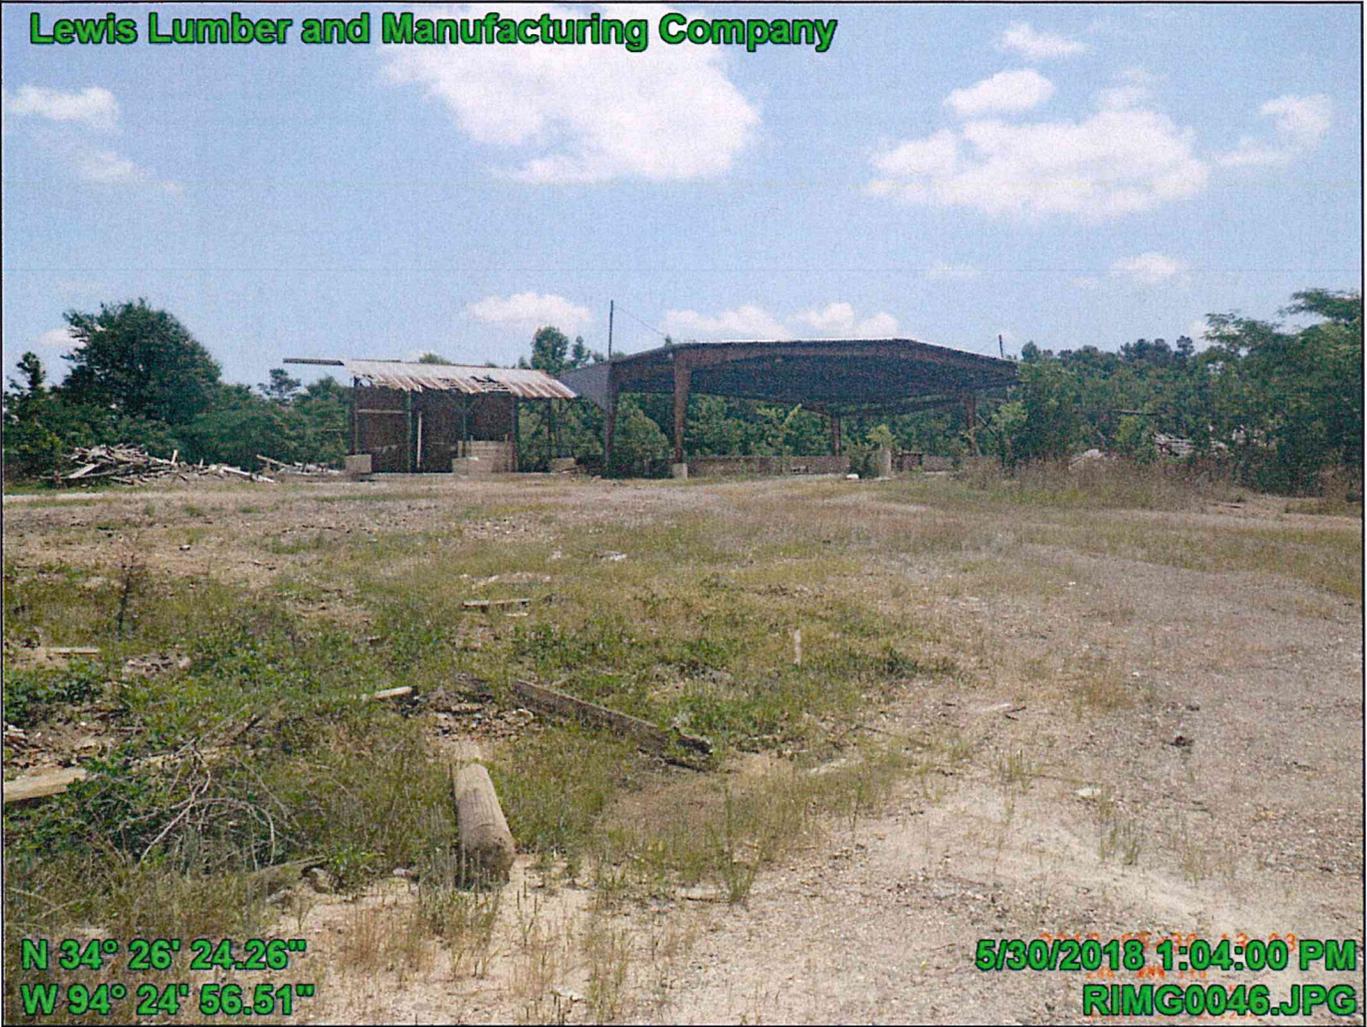
Attributes	
Photo Number	27
Facility	Lewis Lumber and Manufacturing Company
Event	Pre-CERCLA Screening Assessment
AFIN	57-00020
Photographer	Joshua Graham
Witness	Katie Kreps <i>KK</i>
Site Location	Cove, AR
Date/Time	5/30/2018 1:04:00 PM
Make	RICOH
Model	G700 SE
File Name	RIMG0046.JPG
Subject	CCA Treatment Building on the southern portion of the site

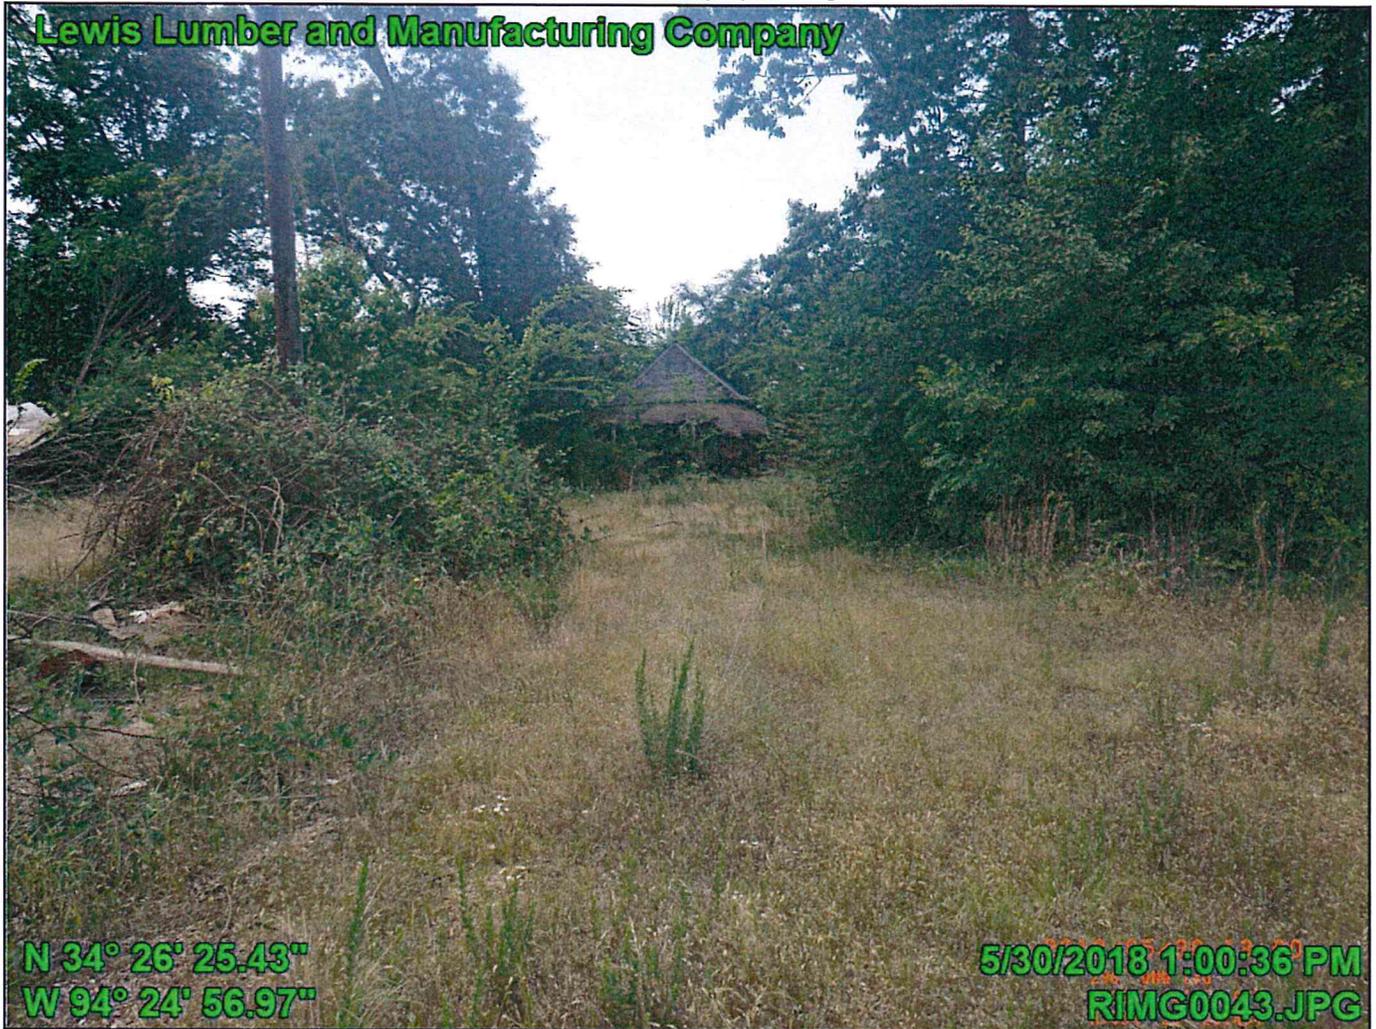
Attributes	
Photo Number	28
Facility	Lewis Lumber and Manufacturing Company
Event	Pre-CERCLA Screening Assessment
AFIN	57-00020
Photographer	Joshua Graham
Witness	Katie Kreps <i>KK</i>
Site Location	Cove, AR
Date/Time	5/30/2018 1:00:36 PM
Make	RICOH
Model	G700 SE
File Name	RIMG0043.JPG
Subject	Former residence on west portion of the site

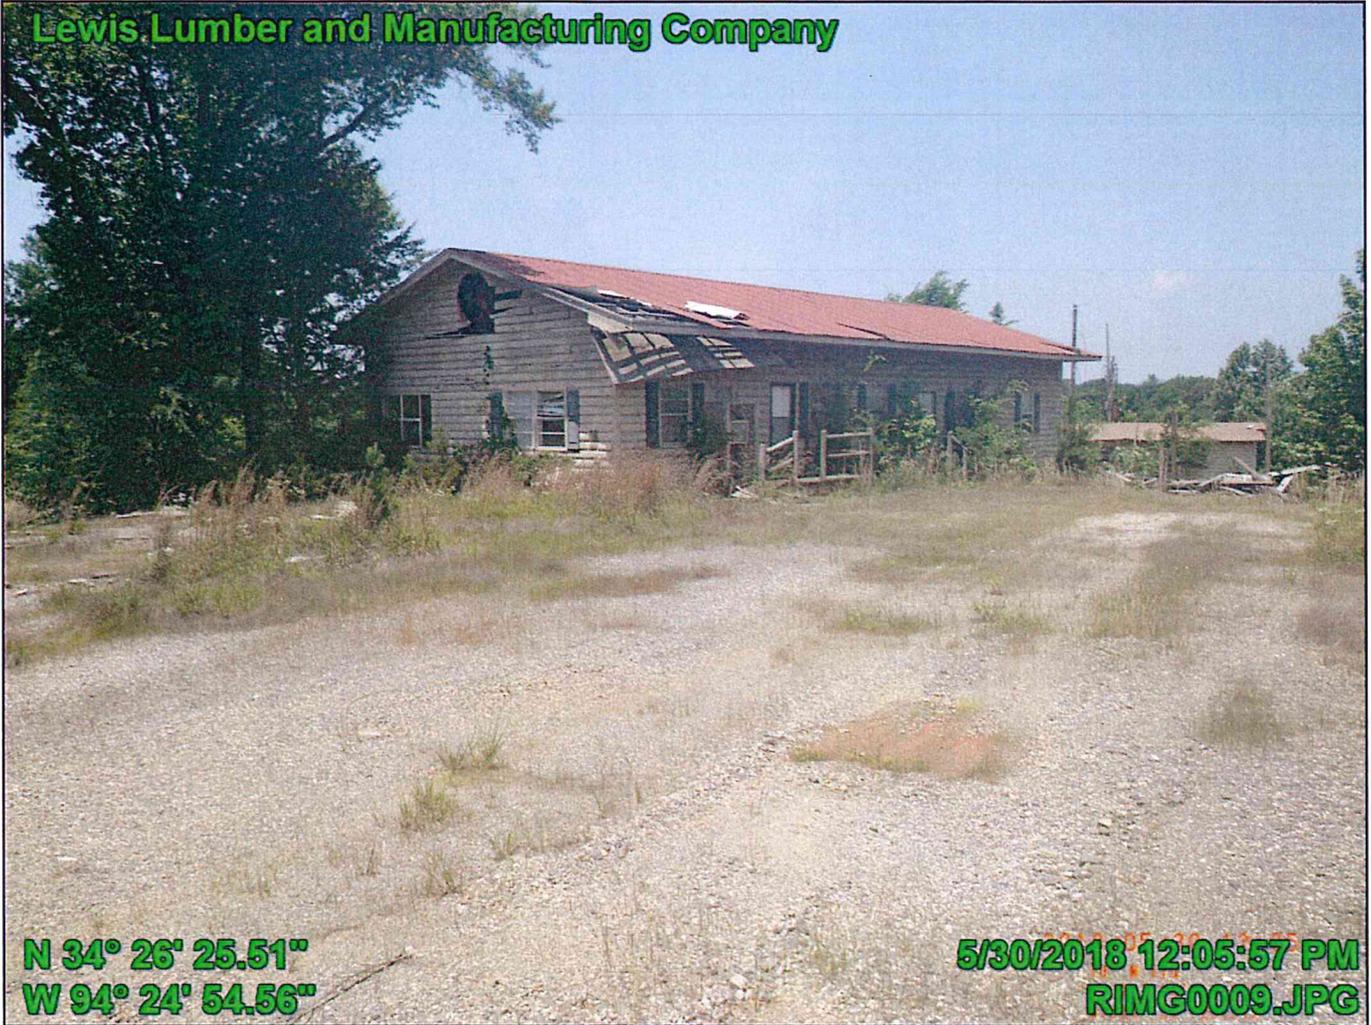
Attributes	
Photo Number	29
Facility	Lewis Lumber and Manufacturing Company
Event	Pre-CERCLA Screening Assessment
AFIN	57-00020
Photographer	Joshua Graham
Witness	Katie Kreps <i>KK</i>
Site Location	Cove, AR
Date/Time	5/30/2018 12:05:57 PM
Make	RICOH
Model	G700 SE
File Name	RIMG0009.JPG
Subject	Office on the northern portion of the site

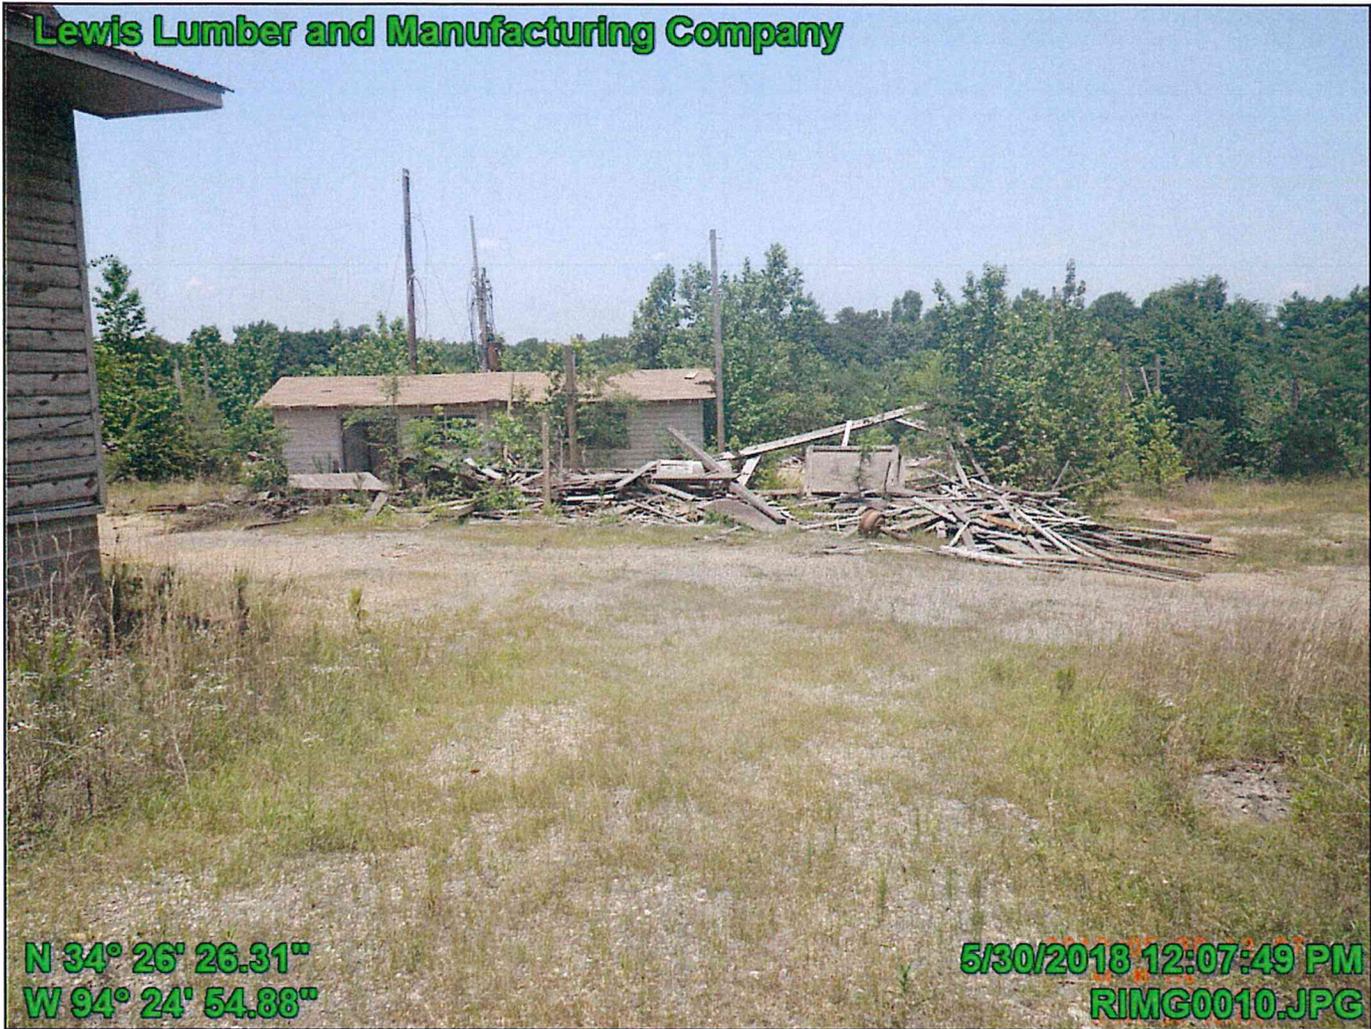
Attributes	
Photo Number	30
Facility	Lewis Lumber and Manufacturing Company
Event	Pre-CERCLA Screening Assessment
AFIN	57-00020
Photographer	Joshua Graham <i>JG</i>
Witness	Katie Kreps <i>KK</i>
Site Location	Cove, AR
Date/Time	5/30/2018 12:07:49 PM
Make	RICOH
Model	G700 SE
File Name	RIMG0010.JPG
Subject	Break building and debris pile on the northern portion of the site

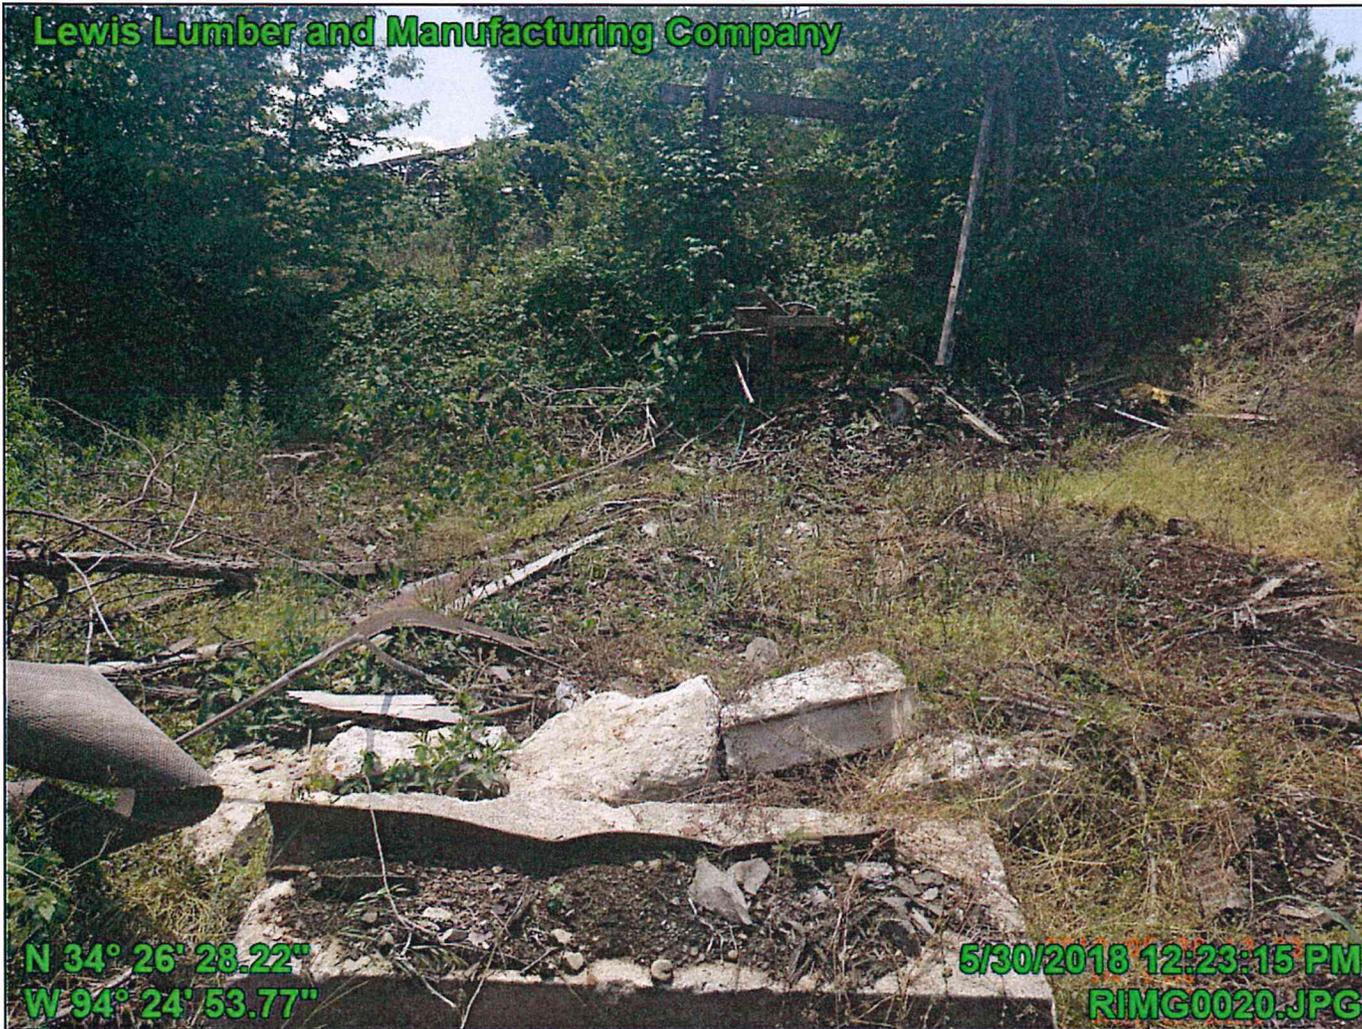
Attributes	
Photo Number	32
Facility	Lewis Lumber and Manufacturing Company
Event	Pre-CERCLA Screening Assessment
AFIN	57-00020
Photographer	Joshua Graham <i>JG</i>
Witness	Katie Kreps <i>KK</i>
Site Location	Cove, AR
Date/Time	5/30/2018 12:23:15 PM
Make	RICOH
Model	G700 SE
File Name	RIMG0020.JPG
Subject	Areas of staining and burn piles on the northeast portion of the site

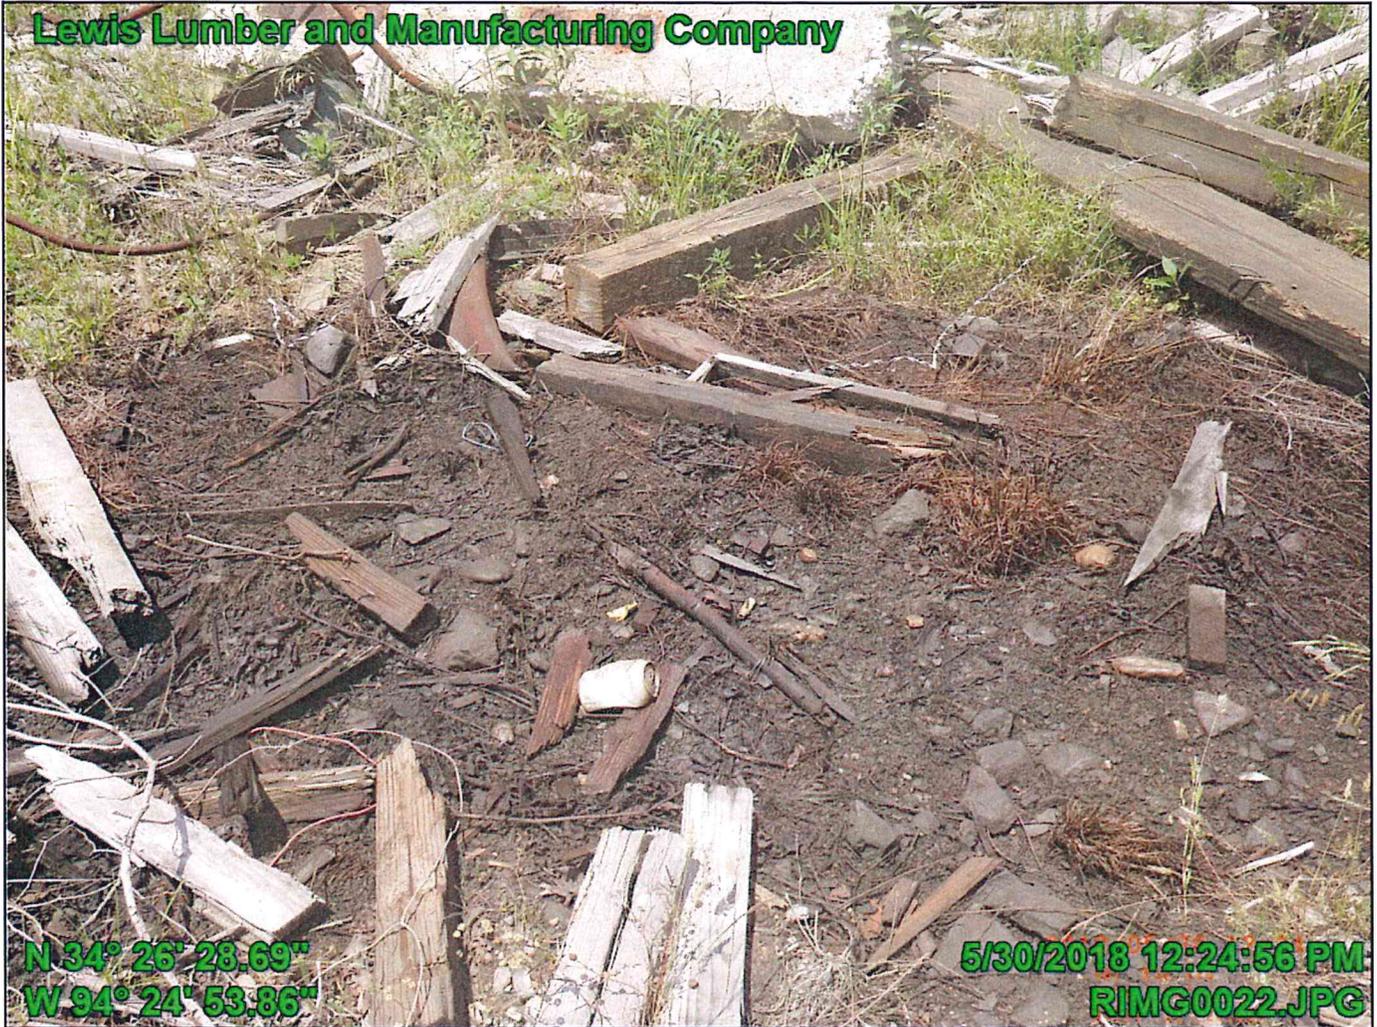
Attributes	
Photo Number	34
Facility	Lewis Lumber and Manufacturing Company
Event	Pre-CERCLA Screening Assessment
AFIN	57-00020
Photographer	Joshua Graham
Witness	Katie Kreps <i>KK</i>
Site Location	Cove, AR
Date/Time	5/30/2018 12:24:56 PM
Make	RICOH
Model	G700 SE
File Name	RIMG0022.JPG
Subject	Area of staining on the northeast portion of the site

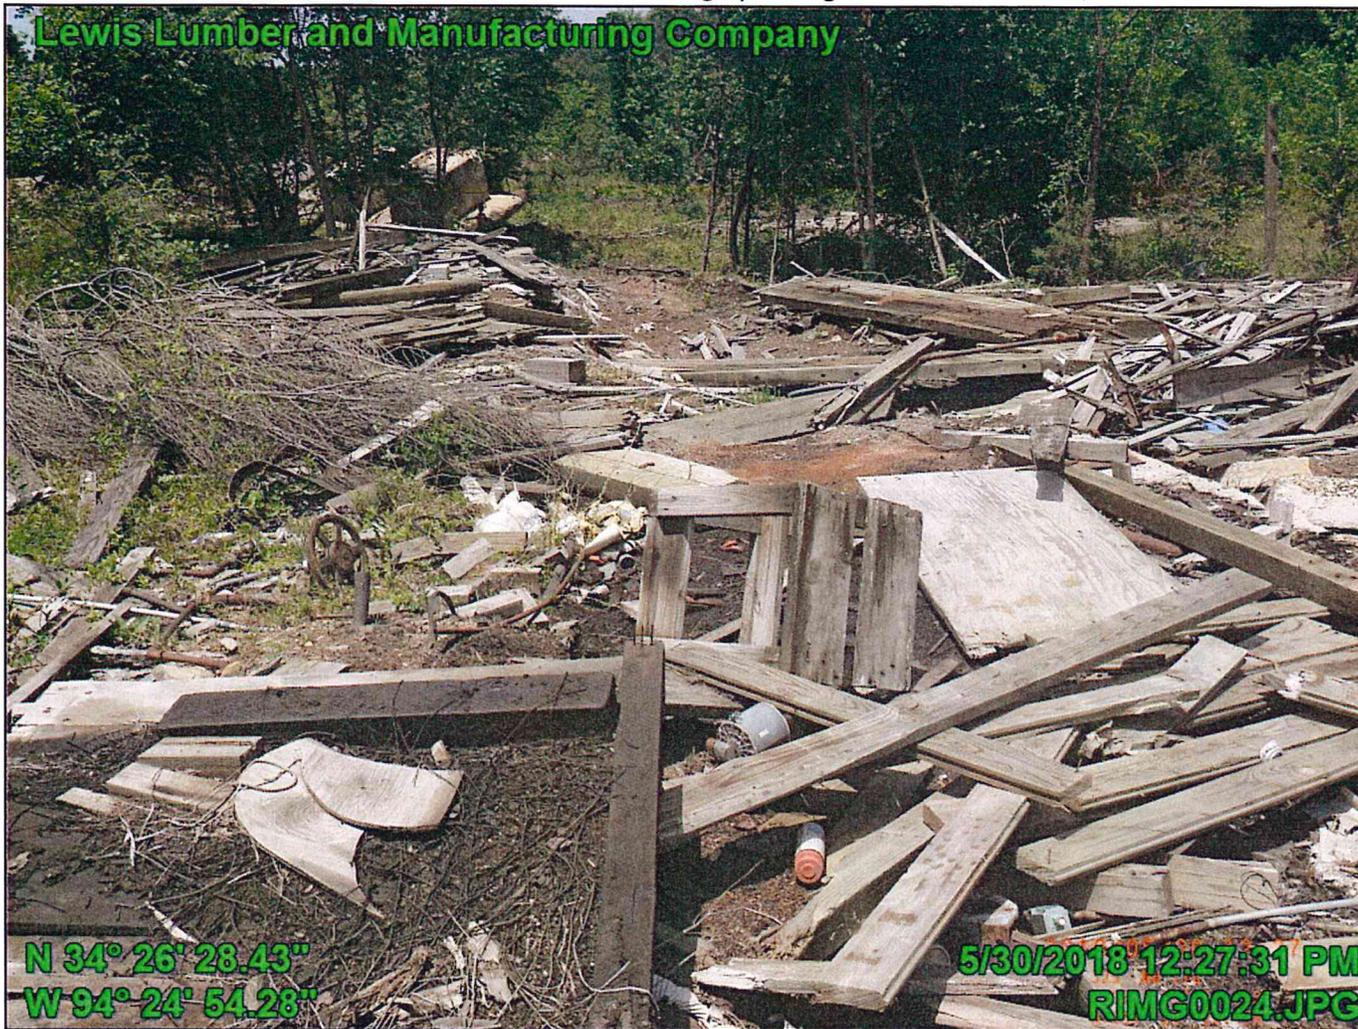
Attributes	
Photo Number	35
Facility	Lewis Lumber and Manufacturing Company
Event	Pre-CERCLA Screening Assessment
AFIN	57-00020
Photographer	Joshua Graham
Witness	Katie Kreps <i>KK</i>
Site Location	Cove, AR
Date/Time	5/30/2018 12:27:31 PM
Make	RICOH
Model	G700 SE
File Name	RIMG0024.JPG
Subject	Staining and demolition debris on the northeast portion of the site

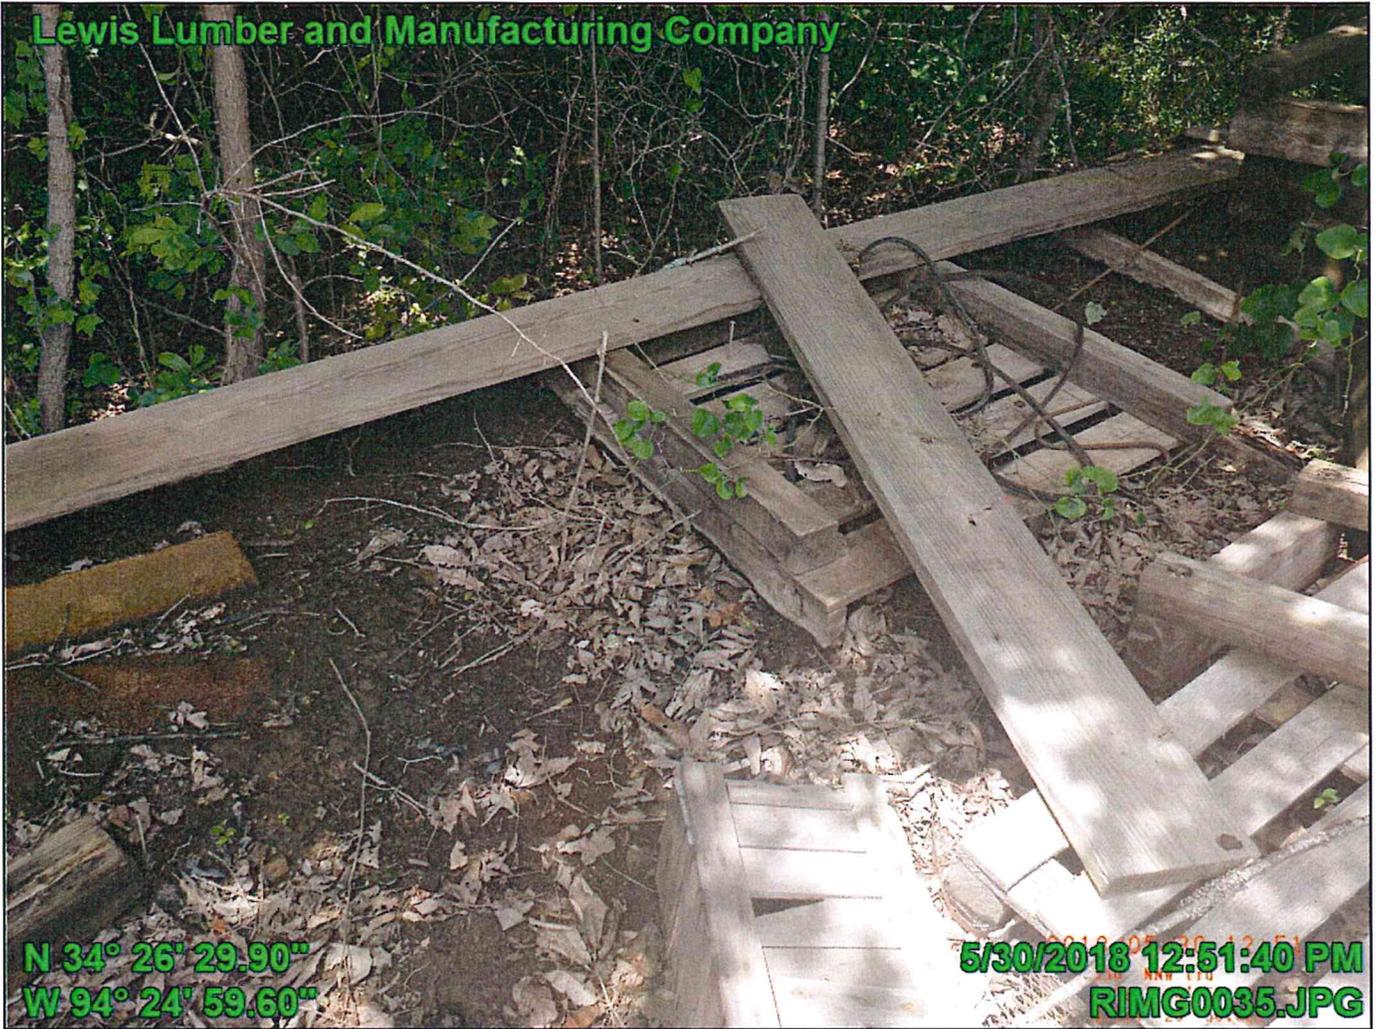
Attributes	
Photo Number	36
Facility	Lewis Lumber and Manufacturing Company
Event	Pre-CERCLA Screening Assessment
AFIN	57-00020
Photographer	Joshua Graham
Witness	Katie Kreps <i>KK</i>
Site Location	Cove, AR
Date/Time	5/30/2018 12:51:40 PM
Make	RICOH
Model	G700 SE
File Name	RIMG0035.JPG
Subject	Staining and debris on concrete foundation on the northwest portion of the site

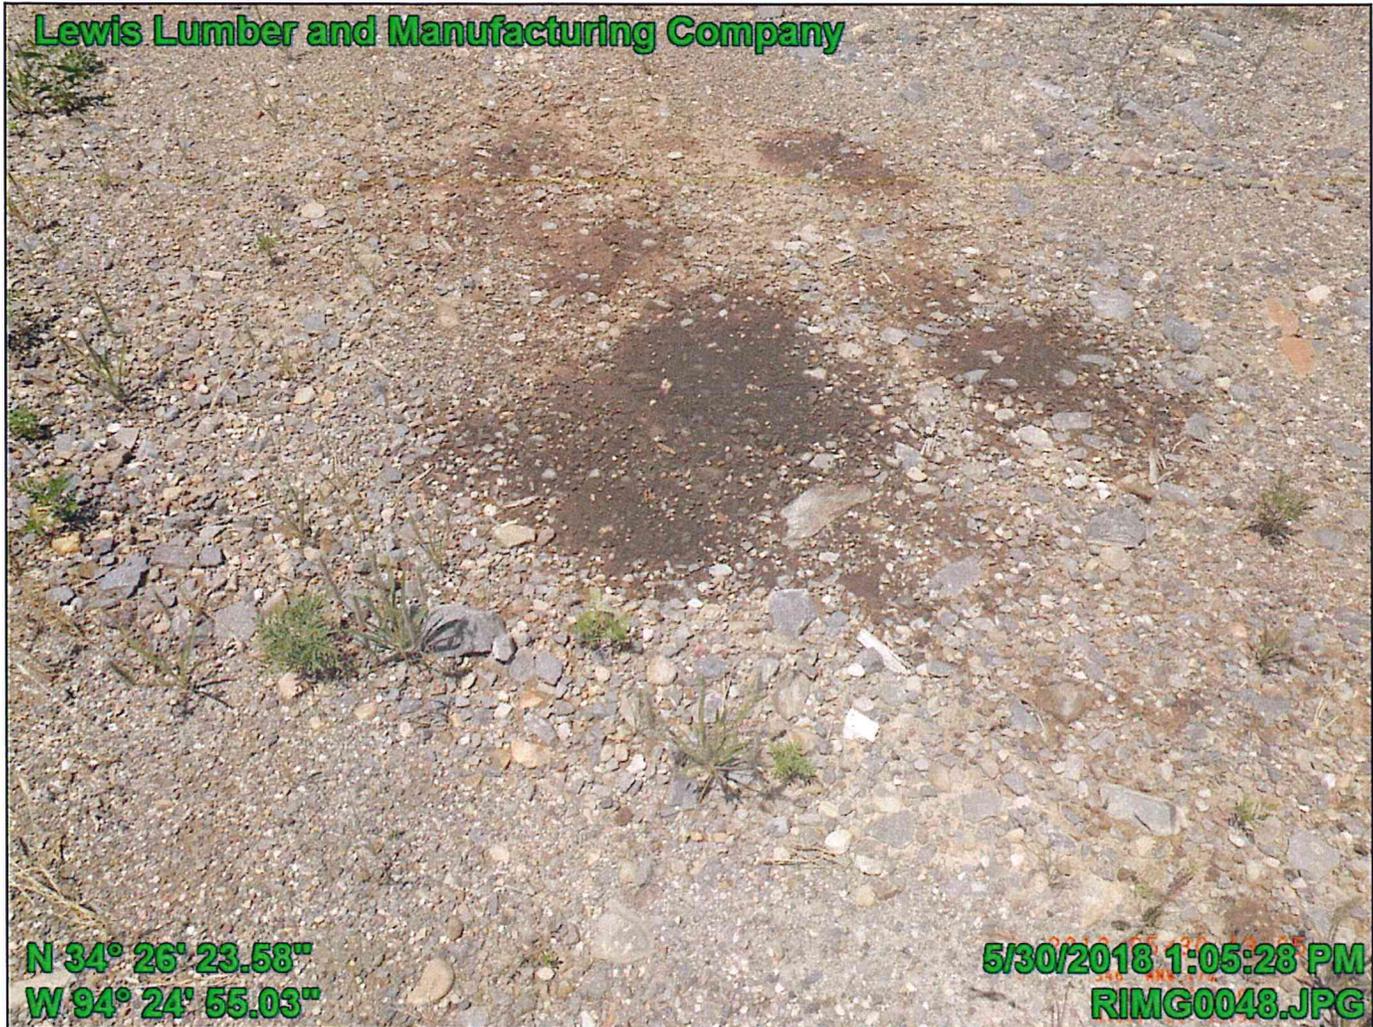
Attributes	
Photo Number	38
Facility	Lewis Lumber and Manufacturing Company
Event	Pre-CERCLA Screening Assessment
AFIN	57-00020
Photographer	Joshua Graham
Witness	Katie Kreps <i>KK</i>
Site Location	Cove, AR
Date/Time	5/30/2018 1:05:28 PM
Make	RICOH
Model	G700 SE
File Name	RIMG0048.JPG
Subject	Staining on the southern portion of the site, north of the CCA Treatment Building

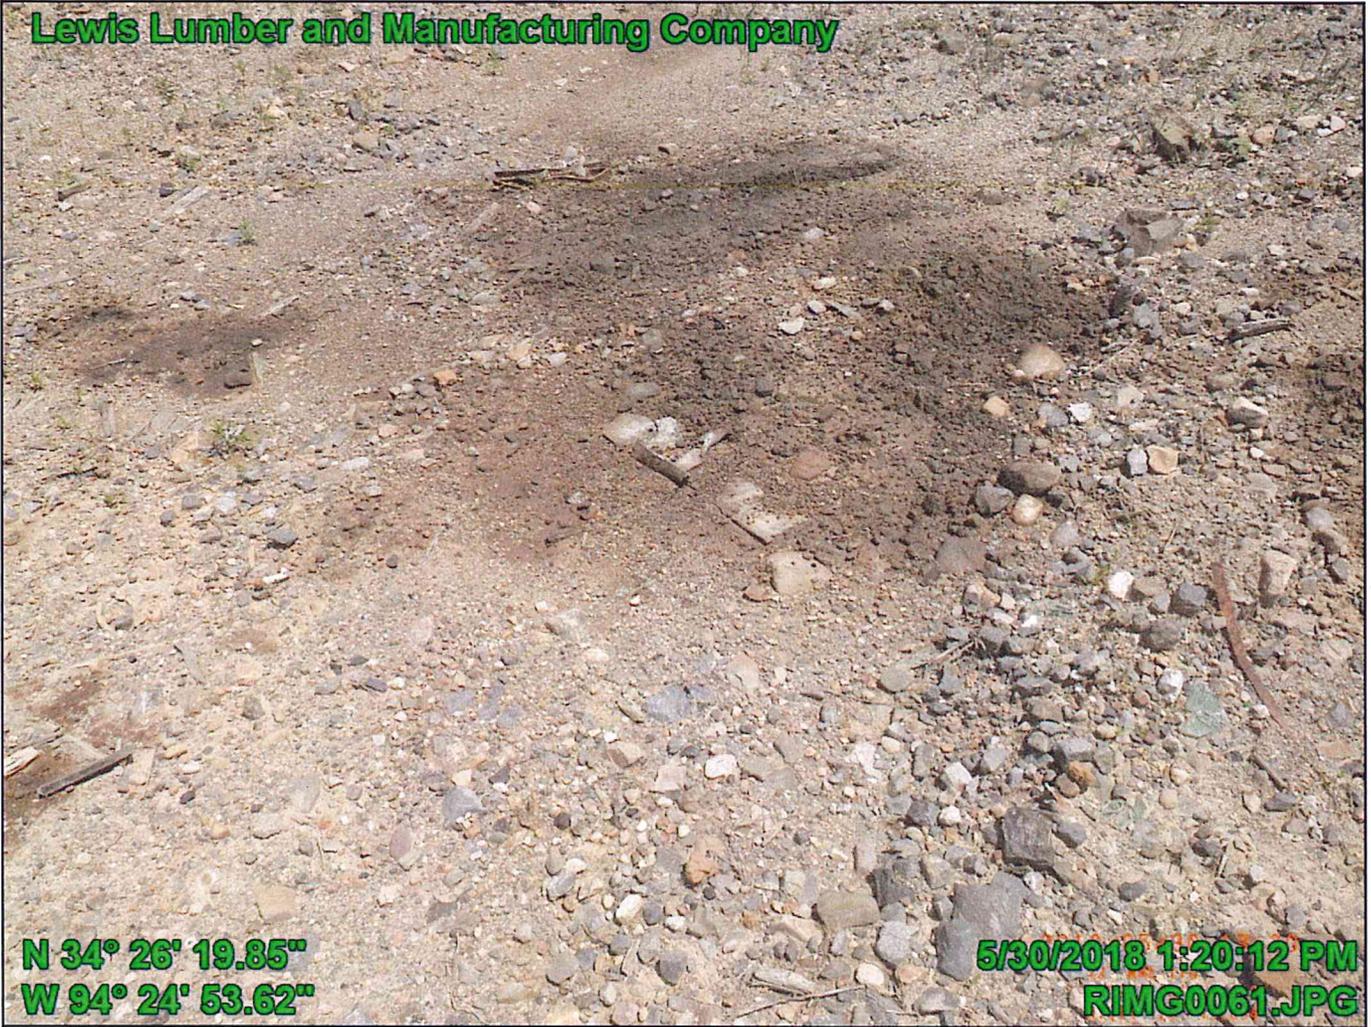
Attributes	
Photo Number	39
Facility	Lewis Lumber and Manufacturing Company
Event	Pre-CERCLA Screening Assessment
AFIN	57-00020
Photographer	Joshua Graham
Witness	Katie Kreps <i>KK</i>
Site Location	Cove, AR
Date/Time	5/30/2018 1:20:12 PM
Make	RICOH
Model	G700 SE
File Name	RIMG0061.JPG
Subject	Staining on the south-central portion of the site

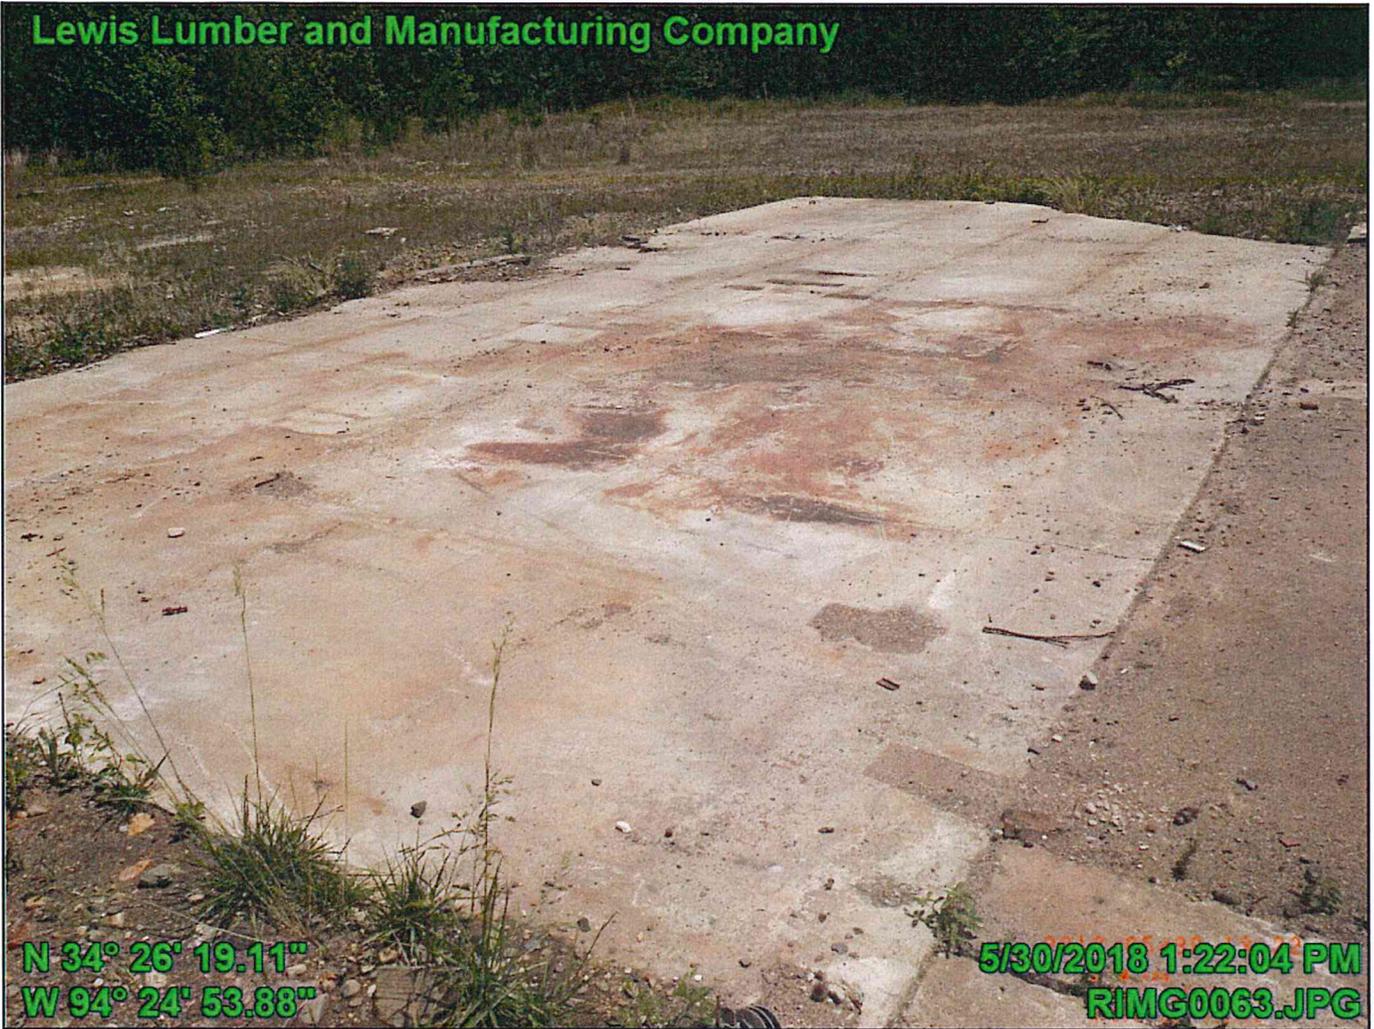
Attributes	
Photo Number	40
Facility	Lewis Lumber and Manufacturing Company
Event	Pre-CERCLA Screening Assessment
AFIN	57-00020
Photographer	Joshua Graham
Witness	Katie Kreps <i>KK</i>
Site Location	Cove, AR
Date/Time	5/30/2018 1:22:04 PM
Make	RICOH
Model	G700 SE
File Name	RIMG0063.JPG
Subject	Staining on concrete foundation of the former Dry Kiln on the southern portion of the site

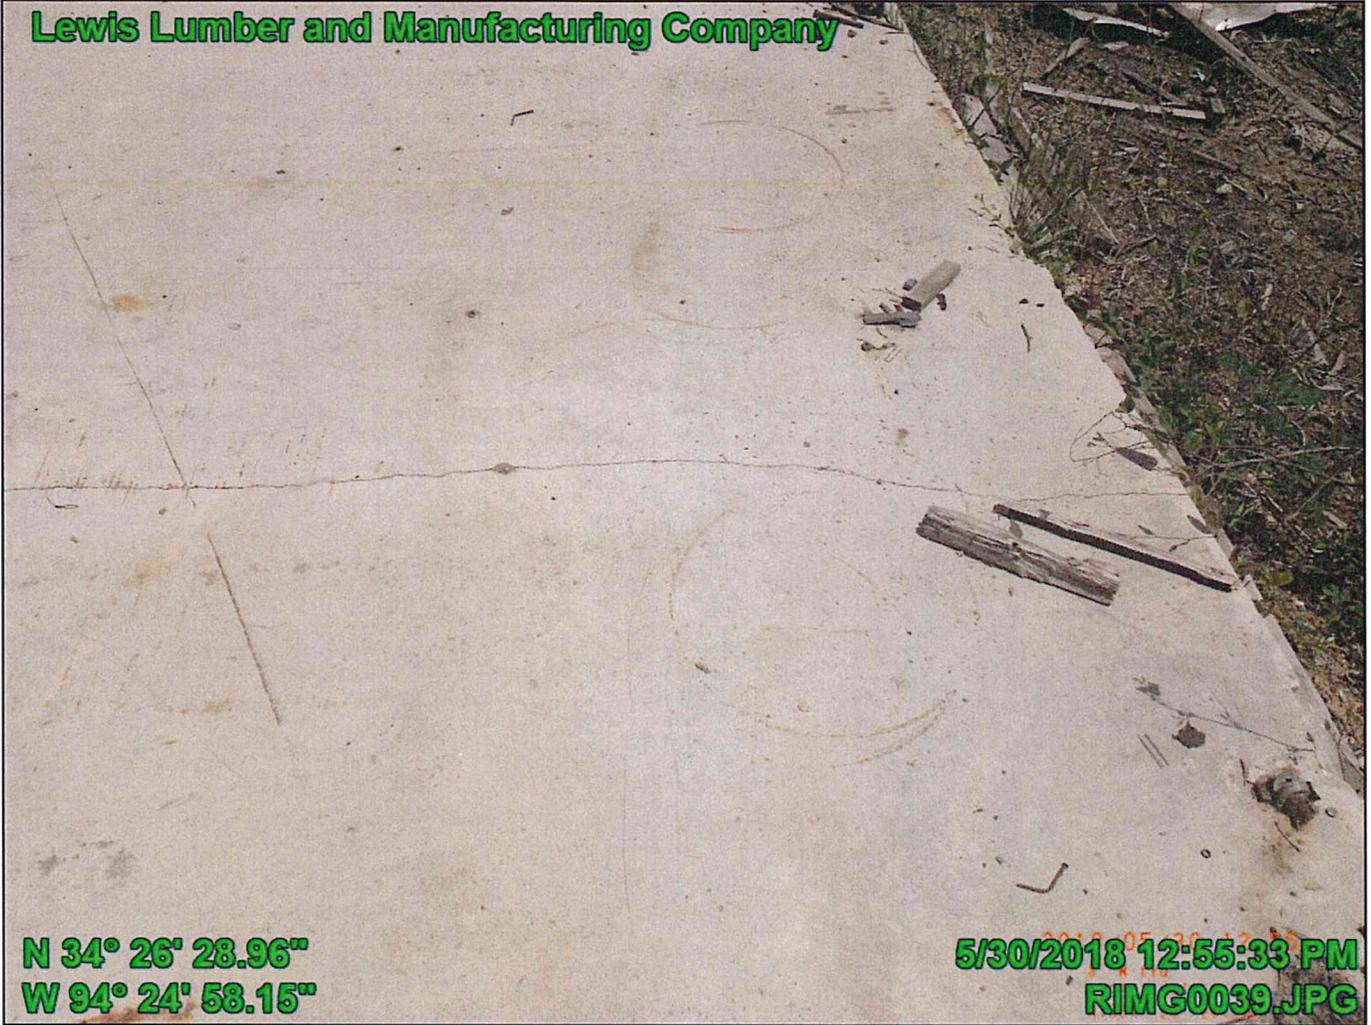
Attributes	
Photo Number	43
Facility	Lewis Lumber and Manufacturing Company
Event	Pre-CERCLA Screening Assessment
AFIN	57-00020
Photographer	Joshua Graham
Witness	Katie Kreps <i>KK</i>
Site Location	Cove, AR
Date/Time	5/30/2018 12:55:33 PM
Make	RICOH
Model	G700 SE
File Name	RIMG0039.JPG
Subject	Staining in the shape of rings on a concrete foundation on the northern portion of the site

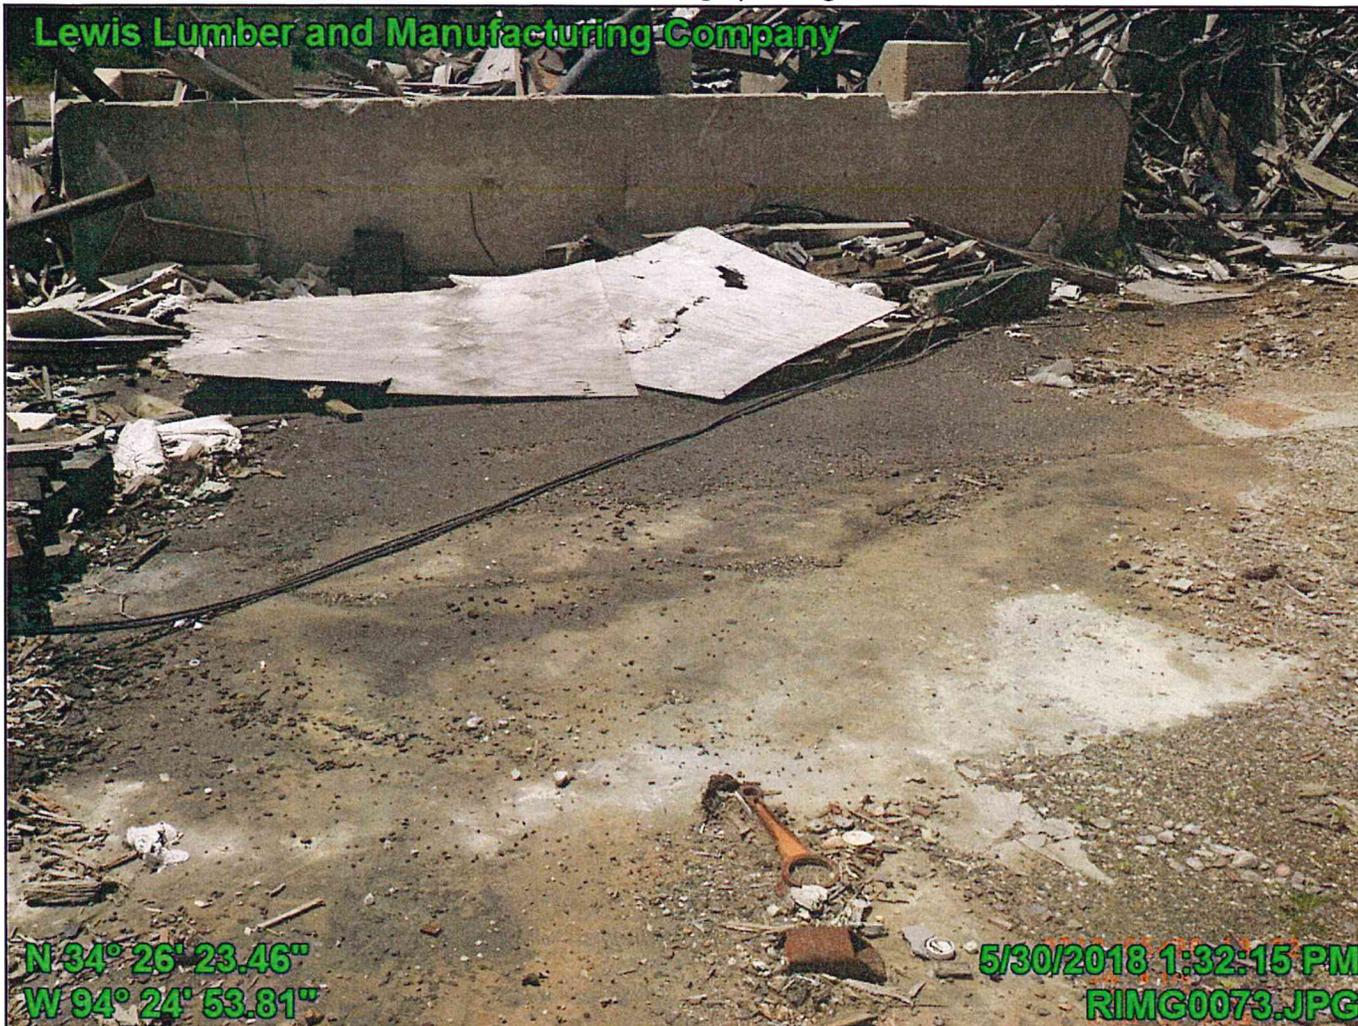
Attributes	
Photo Number	45
Facility	Lewis Lumber and Manufacturing Company
Event	Pre-CERCLA Screening Assessment
AFIN	57-00020
Photographer	Joshua Graham
Witness	Katie Kreps <i>KK</i>
Site Location	Cove, AR
Date/Time	5/30/2018 1:32:15 PM
Make	RICOH
Model	G700 SE
File Name	RIMG0073.JPG
Subject	Staining on concrete near the CCA Treatment Building

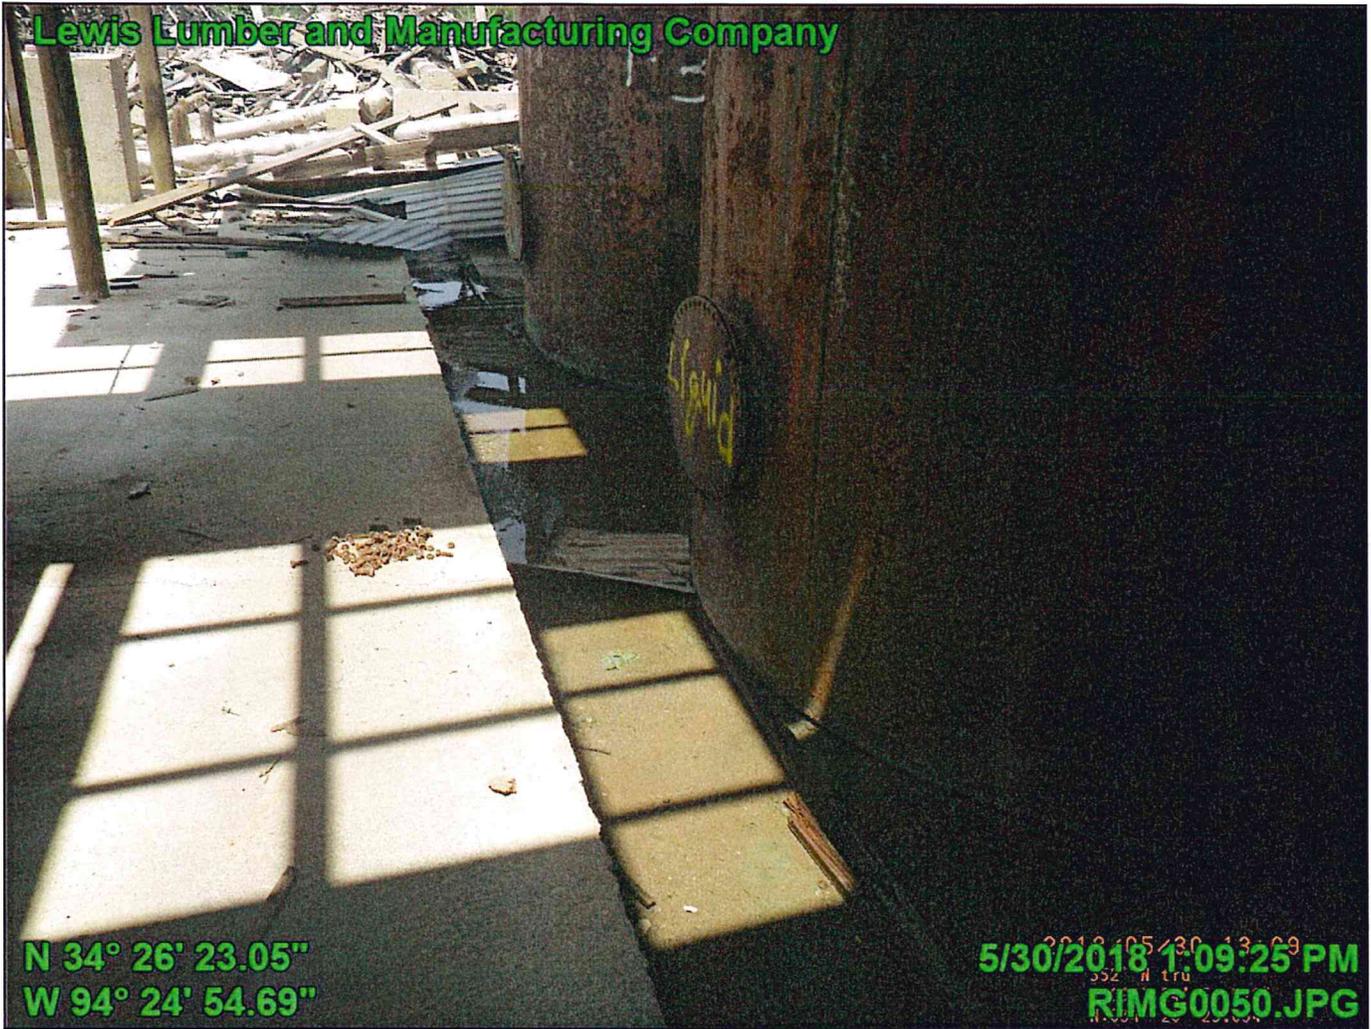
Attributes	
Photo Number	47
Facility	Lewis Lumber and Manufacturing Company
Event	Pre-CERCLA Screening Assessment
AFIN	57-00020
Photographer	Joshua Graham
Witness	Katie Kreps <i>KK</i>
Site Location	Cove, AR
Date/Time	5/30/2018 1:09:25 PM
Make	RICOH
Model	G700 SE
File Name	RIMG0050.JPG
Subject	Green staining on the CCA Tanks and inside the concrete containment area with liquid
