**PRE-CERCLA SCREENING ASSESSMENT
FOR**

**Lewis Lumber and Manufacturing Company
136 West Mill Street
Cove, Polk County
Arkansas, 71937**

July 2018

**Prepared by:
Arkansas Department of Environmental Quality
5301 Northshore Drive
North Little Rock, AR 72118**

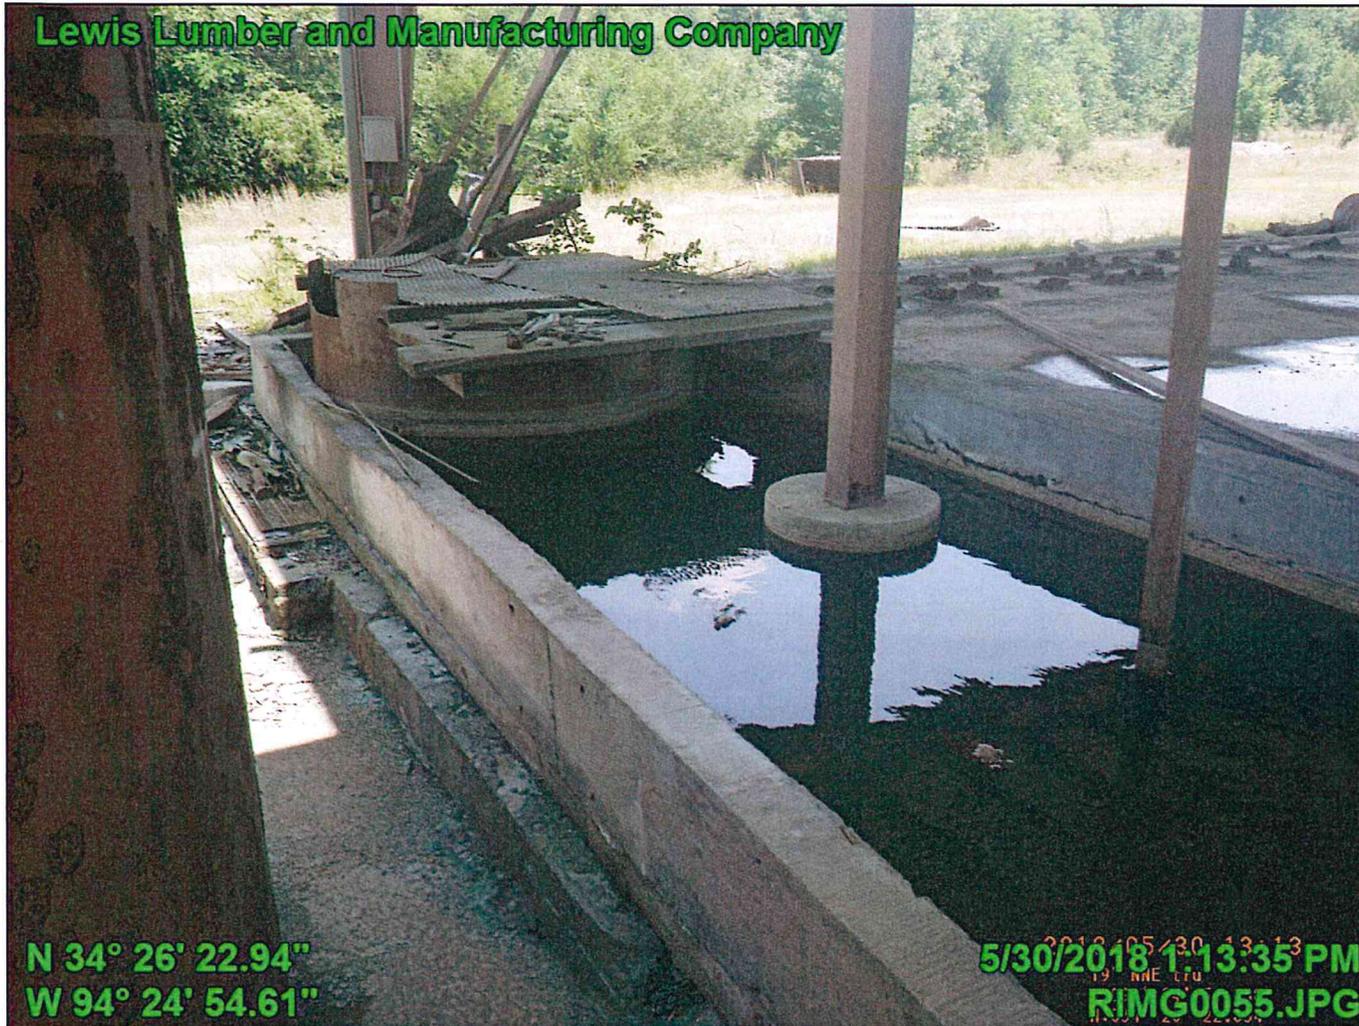
Attributes	
Photo Number	49
Facility	Lewis Lumber and Manufacturing Company
Event	Pre-CERCLA Screening Assessment
AFIN	57-00020
Photographer	Joshua Graham
Witness	Katie Kreps <i>KK</i>
Site Location	Cove, AR
Date/Time	5/30/2018 1:13:35 PM
Make	RICOH
Model	G700 SE
File Name	RIMG0055.JPG
Subject	Stained concrete catch/recirculation basin containing liquid

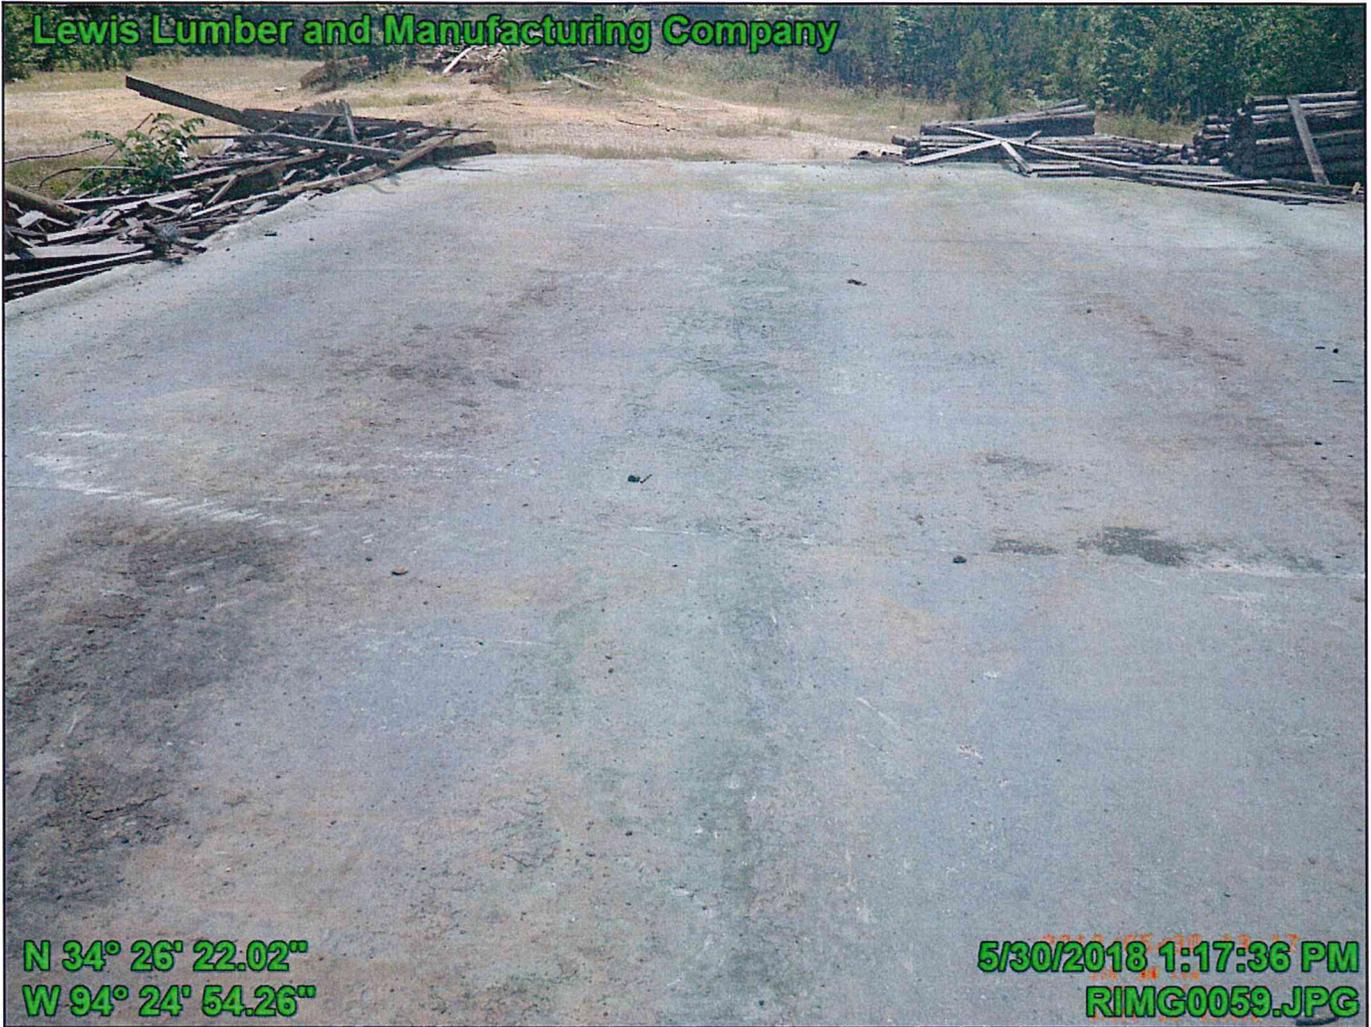
Attributes	
Photo Number	51
Facility	Lewis Lumber and Manufacturing Company
Event	Pre-CERCLA Screening Assessment
AFIN	57-00020
Photographer	Joshua Graham <i>JG</i>
Witness	Katie Kreps <i>KK</i>
Site Location	Cove, AR
Date/Time	5/30/2018 1:17:36 PM
Make	RICOH
Model	G700 SE
File Name	RIMG0059.JPG
Subject	Dense green staining on the south portion of the concrete drip pad

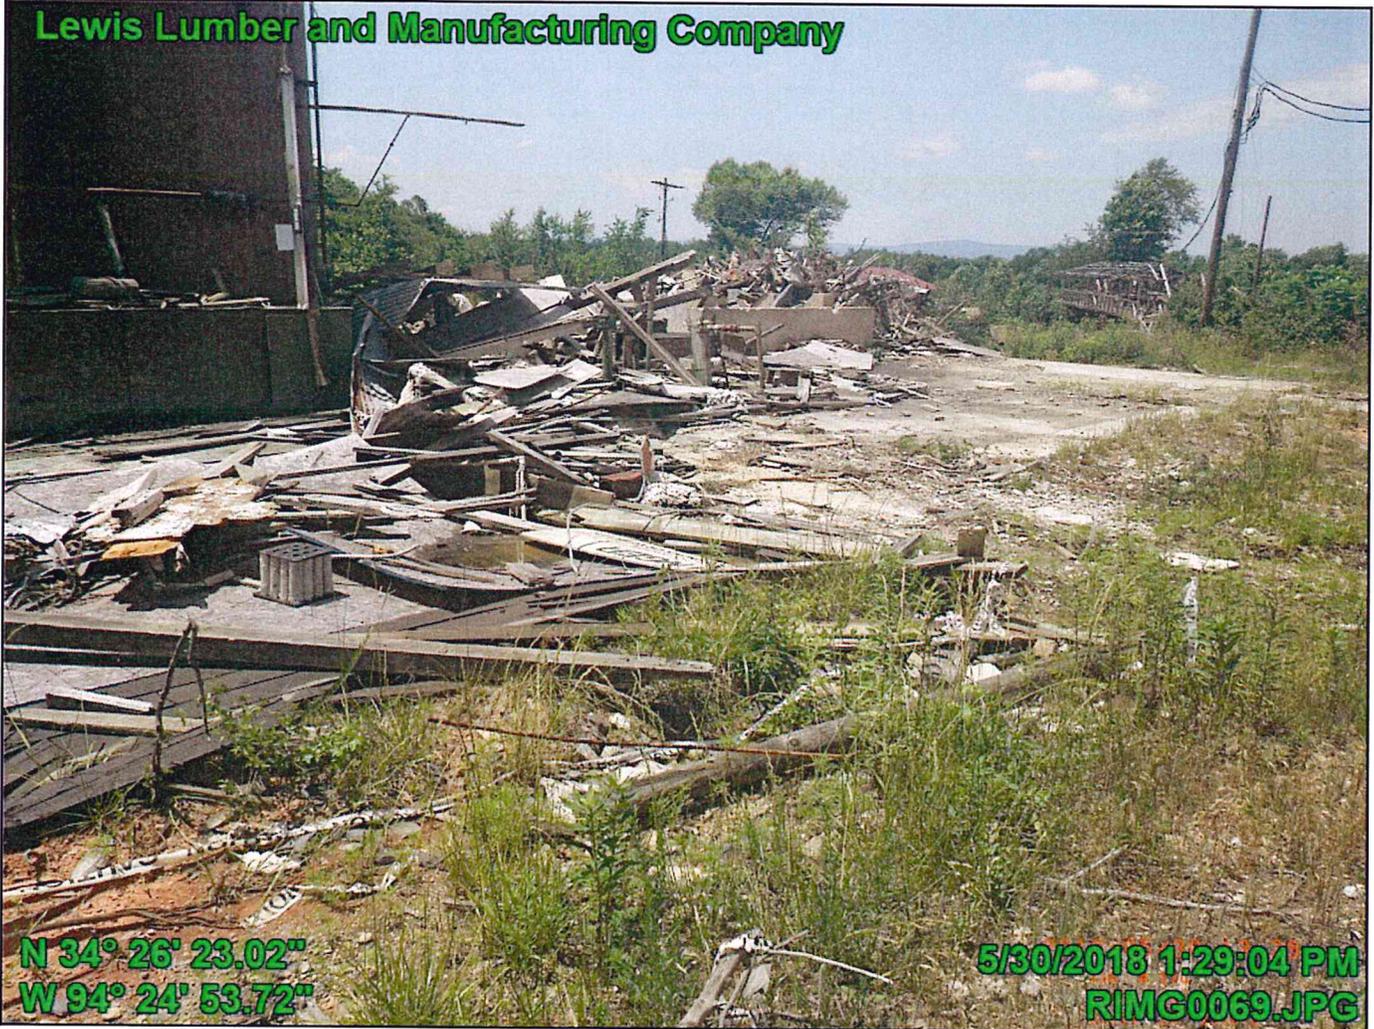
Attributes	
Photo Number	52
Facility	Lewis Lumber and Manufacturing Company
Event	Pre-CERCLA Screening Assessment
AFIN	57-00020
Photographer	Joshua Graham <i>JG</i>
Witness	Katie Kreps <i>KK</i>
Site Location	Cove, AR
Date/Time	5/30/2018 1:29:04 PM
Make	RICOH
Model	G700 SE
File Name	RIMG0069.JPG
Subject	Debris and approximately 18,000-gallon underground concrete containment area east of the CCA Tanks

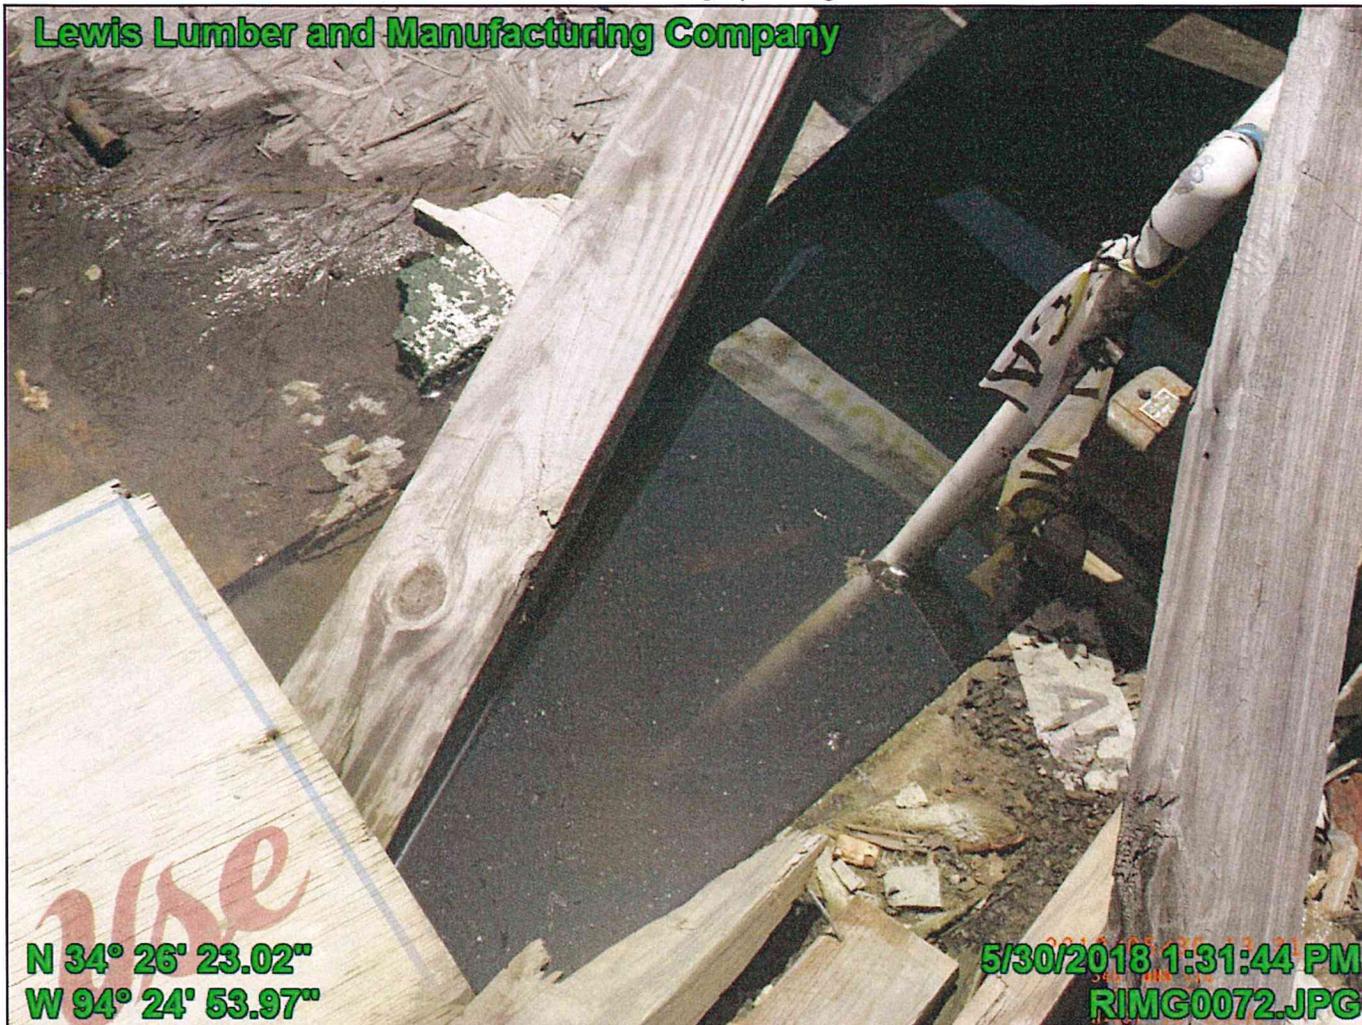
Attributes	
Photo Number	53
Facility	Lewis Lumber and Manufacturing Company
Event	Pre-CERCLA Screening Assessment
AFIN	57-00020
Photographer	Joshua Graham
Witness	Katie Kreps <i>KK</i>
Site Location	Cove, AR
Date/Time	5/30/2018 1:31:44 PM
Make	RICOH
Model	G700 SE
File Name	RIMG0072.JPG
Subject	Liquid with sheen on the surface in the approximately 18,000-gallon underground concrete containment area

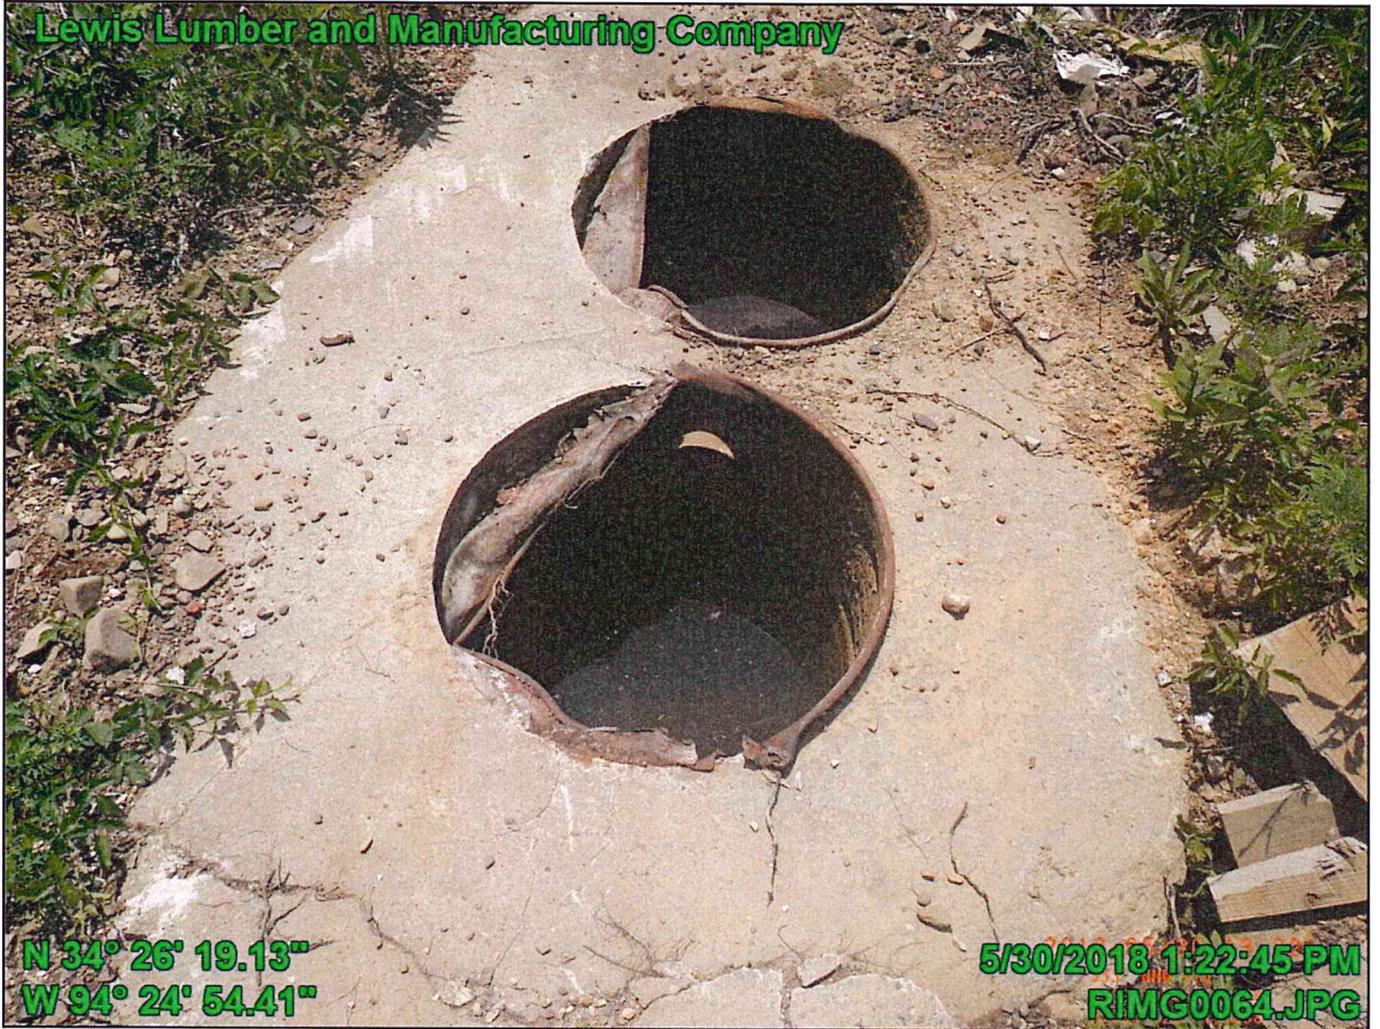
Attributes	
Photo Number	54
Facility	Lewis Lumber and Manufacturing Company
Event	Pre-CERCLA Screening Assessment
AFIN	57-00020
Photographer	Joshua Graham <i>JG</i>
Witness	Katie Kreps <i>KK</i>
Site Location	Cove, AR
Date/Time	5/30/2018 1:22:45 PM
Make	RICOH
Model	G700 SE
File Name	RIMG0064.JPG
Subject	Two underground 55-gallon drums surrounded by concrete near the south site boundary and location of former Dry Kiln
