**TO:** Katie Kreps  
Brownfield & Site Assessment Supervisor  
Office of Land Resources, Assessment and Remediation  
Arkansas Energy & Environment, Division of Environmental Quality

**FROM:** Adam Smith, Asbestos Inspector, Harbor

**DATE:** December 20, 2019

**RE:** Asbestos Survey – Former JT Parsons Cabinet Company  
420 West Ohlendorf Road, Osceola, AR 72370

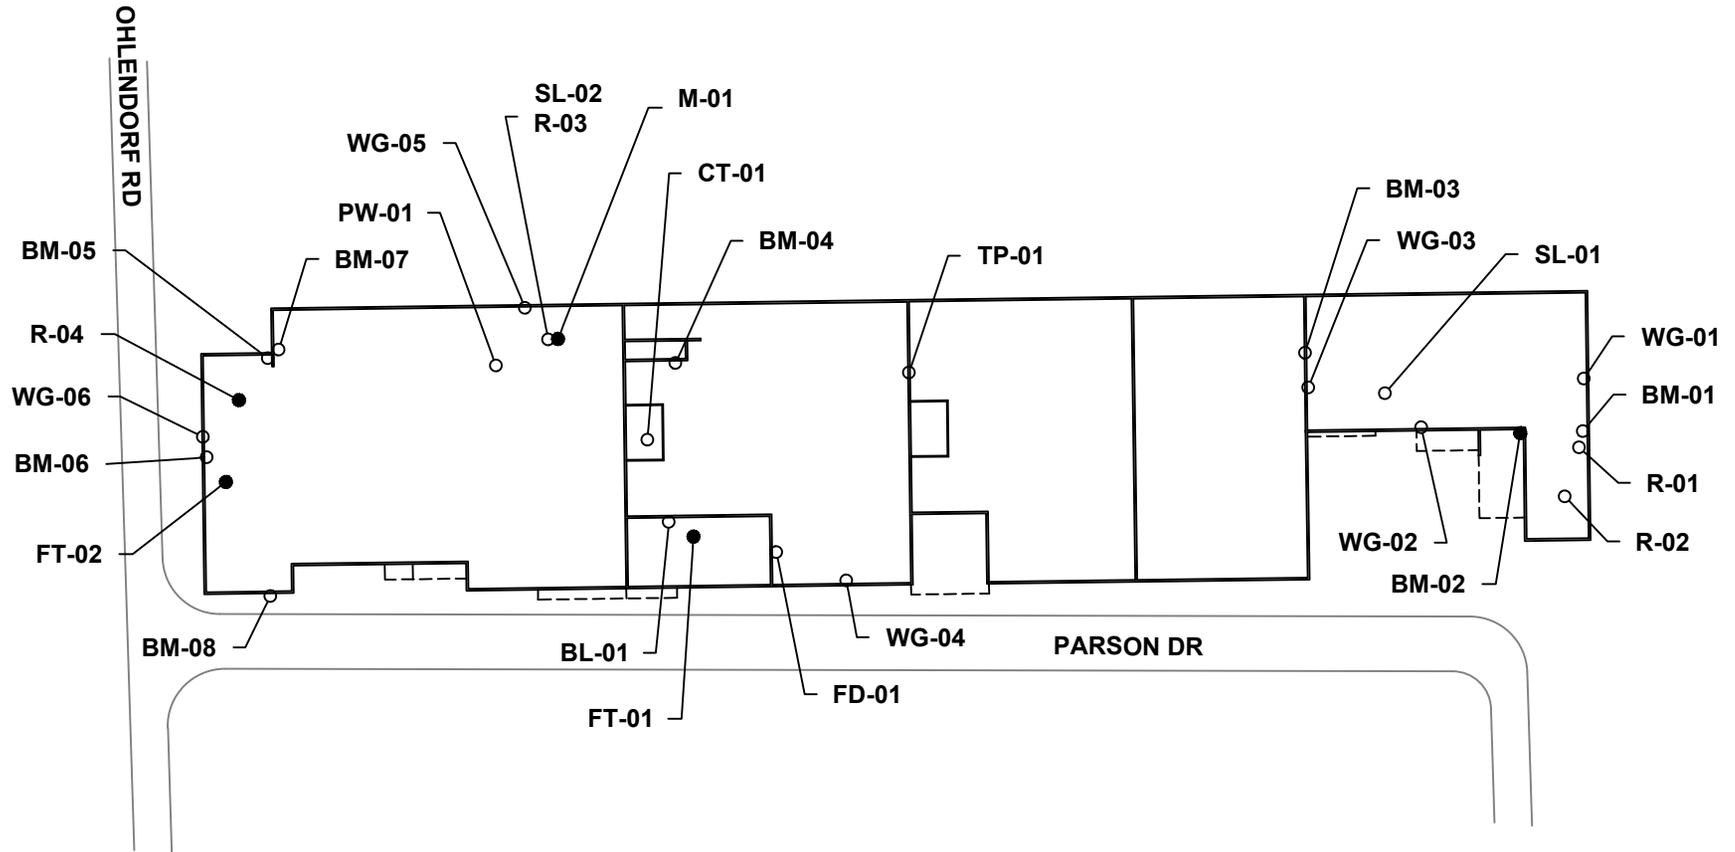
NO	REVISION DESCRIPTION	DATE
X		X-X-X
X		X-X-X
Date	Drafter	
12-4-19	AES	
HA1	Scale	
	1"=100'

**Samples BM-02, FT-01, M-01, R-04, and FT-02 contain asbestos above regulated limits. Sample BM-02 appeared to be a block wall repair patch and not part of the original construction of the building. Harbor has determined that this patched area is different from the other brick mortar sampled as the laboratory analysis indicates. Only this area of the building should be handled as ACM during renovation and demolition operations.**

Harbor recommends following DEQ regulations during renovation or demolition. If the materials have the potential to become friable or will be removed by sanding, grinding, cutting or abrading during the renovation project, a project design will be required, along with appropriately certified workers and contracting company. A notice of intent (NOI), along with a copy of the asbestos survey, is required to be filed with DEQ a minimum of 10 days prior to beginning work.
