# **TARGETED BROWNFIELDS ASSESSMENT**

## **Phase II Environmental Site Assessment Luxora Elementary School 406 Washington Avenue Luxora, Arkansas 72358**

**September 9, 2024**

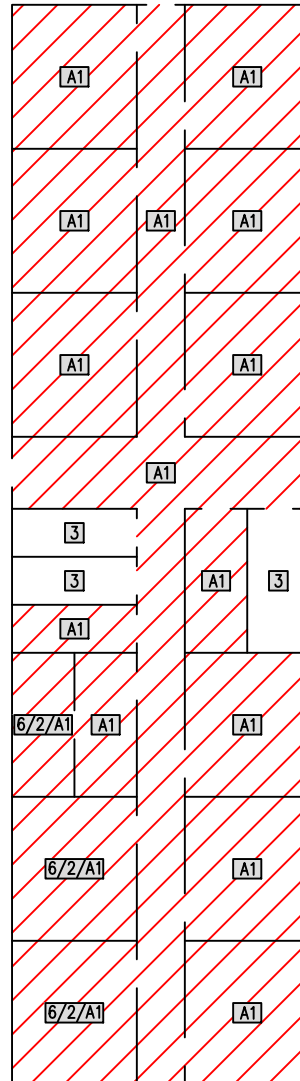
BUILDING B  
ASBESTOS FLOORING  
HOMOGENEOUS AREAS

ACM is present at the Subject Property in the 13,950-square foot classroom building (Figure 3, Building #7380, also referred to as Building B). The white 12x12 floor tile and associated mastic, sheetrock joint compound and the transite panels are considered Category I and Category II Non-Friable ACM in their current condition and state. The mudded pipe elbows identified in the boiler room are considered friable ACM. All ACM identified at the Subject Property was noted to be in fair to good condition at the time of the inspection.
