2018 ANNUAL REPORT

CITY OF FORT SMITH, ARKANSAS

Consent Decree Compliance Program and Infrastructure Improvements, 2018 Annual Report.

Condition Assessment Report
2018 Sanitary Sewer Assessment
Sub-Basins: M003, M005, RF01, and WL01

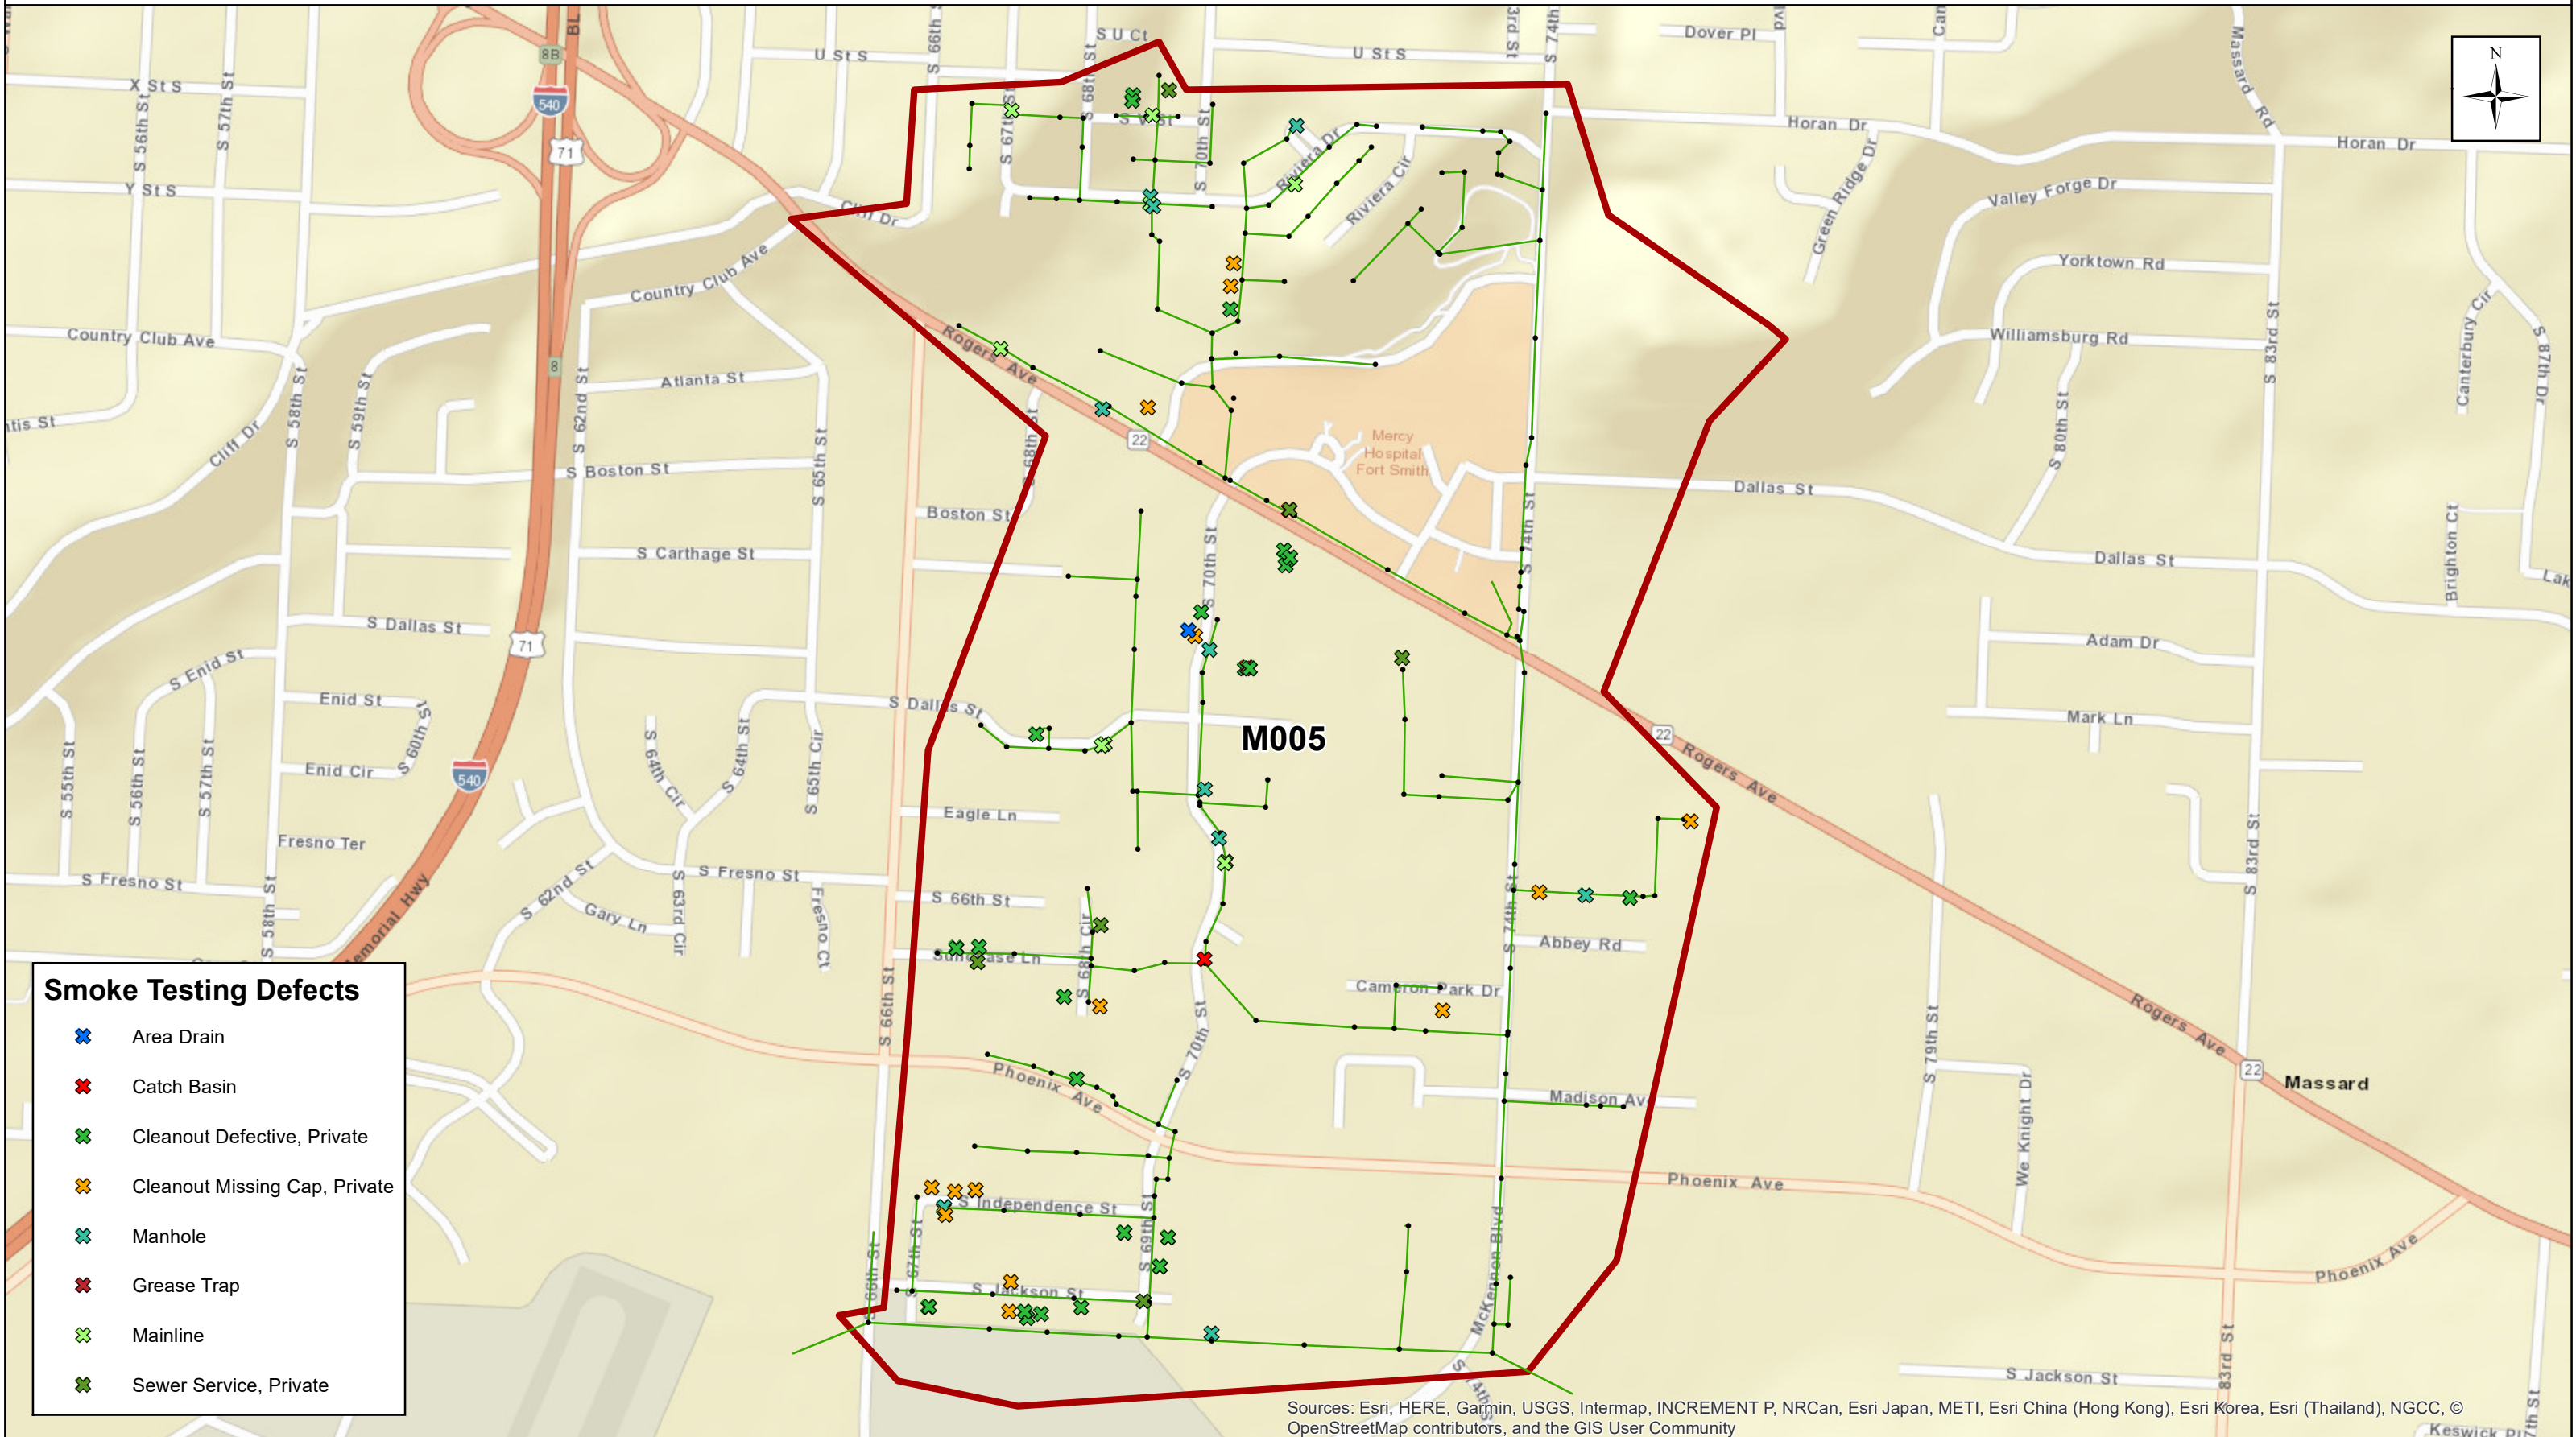
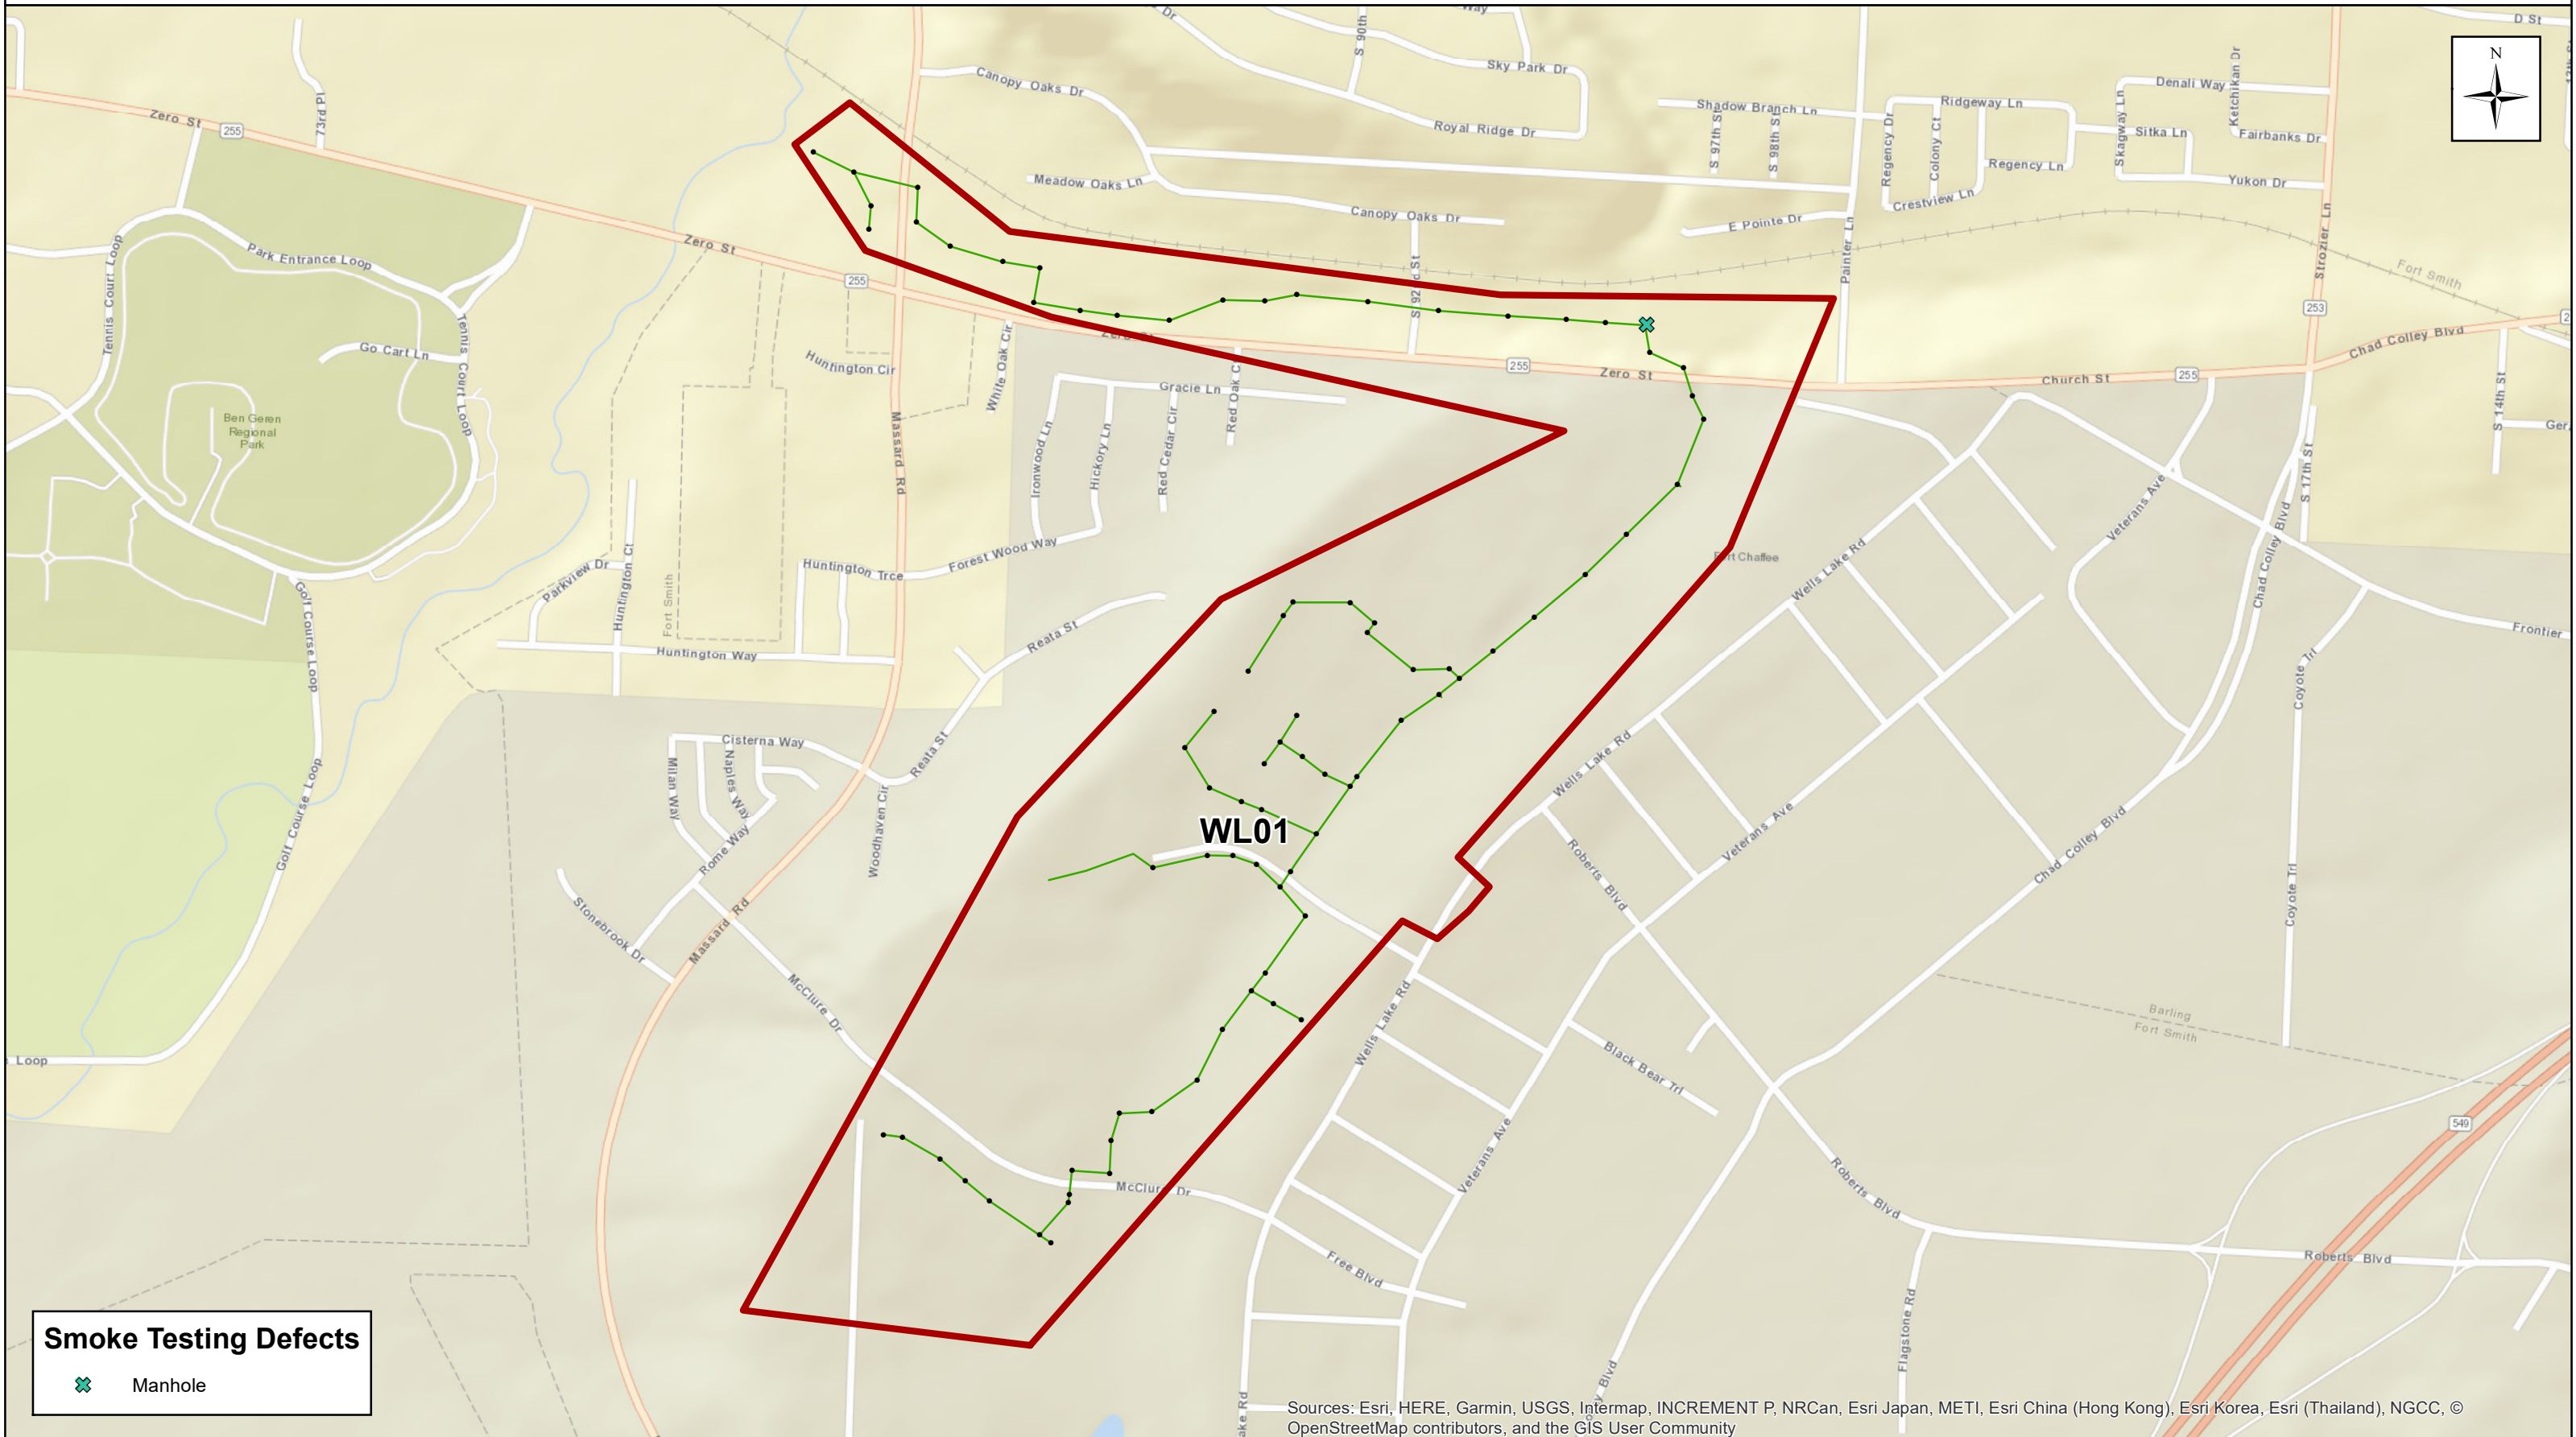
Smoke Testing Defects

- Area Drain
- Cleanout Defective, Private
- Cleanout Defective, Public
- Cleanout Missing Cap, Private
- Downspout Underground
- Manhole
- Mainline
- Sewer Service, Private

- ✕ Area Drain
- ✕ Catch Basin
- ✕ Cleanout Defective, Private
- ✕ Cleanout Missing Cap, Private
- ✕ Manhole
- ✕ Grease Trap
- ✕ Mainline
- ✕ Sewer Service, Private

- Area Drain
- Cleanout Defective, Private
- Cleanout Missing Cap, Private
- Downspout Underground
- Manhole
- Sewer Service, Private

A total of 266,972 linear feet (lf) of sanitary sewer lines were smoke tested within the four sub-basins. Table 6 outlines the linear footage per sub-basin. A list of sewer lines smoke tested is provided in Appendix C. Smoke testing uncovered 219 defects. Of the 219 defects, 142 were identified as public defects and 77 were identified as potential private defects. Table 7 provides a detailed breakdown of the types and quantity of defects identified per sub-basin. Appendix D contains a list of all smoke testing defects and their location. Figures 7 through 10 depict the locations of the defects.

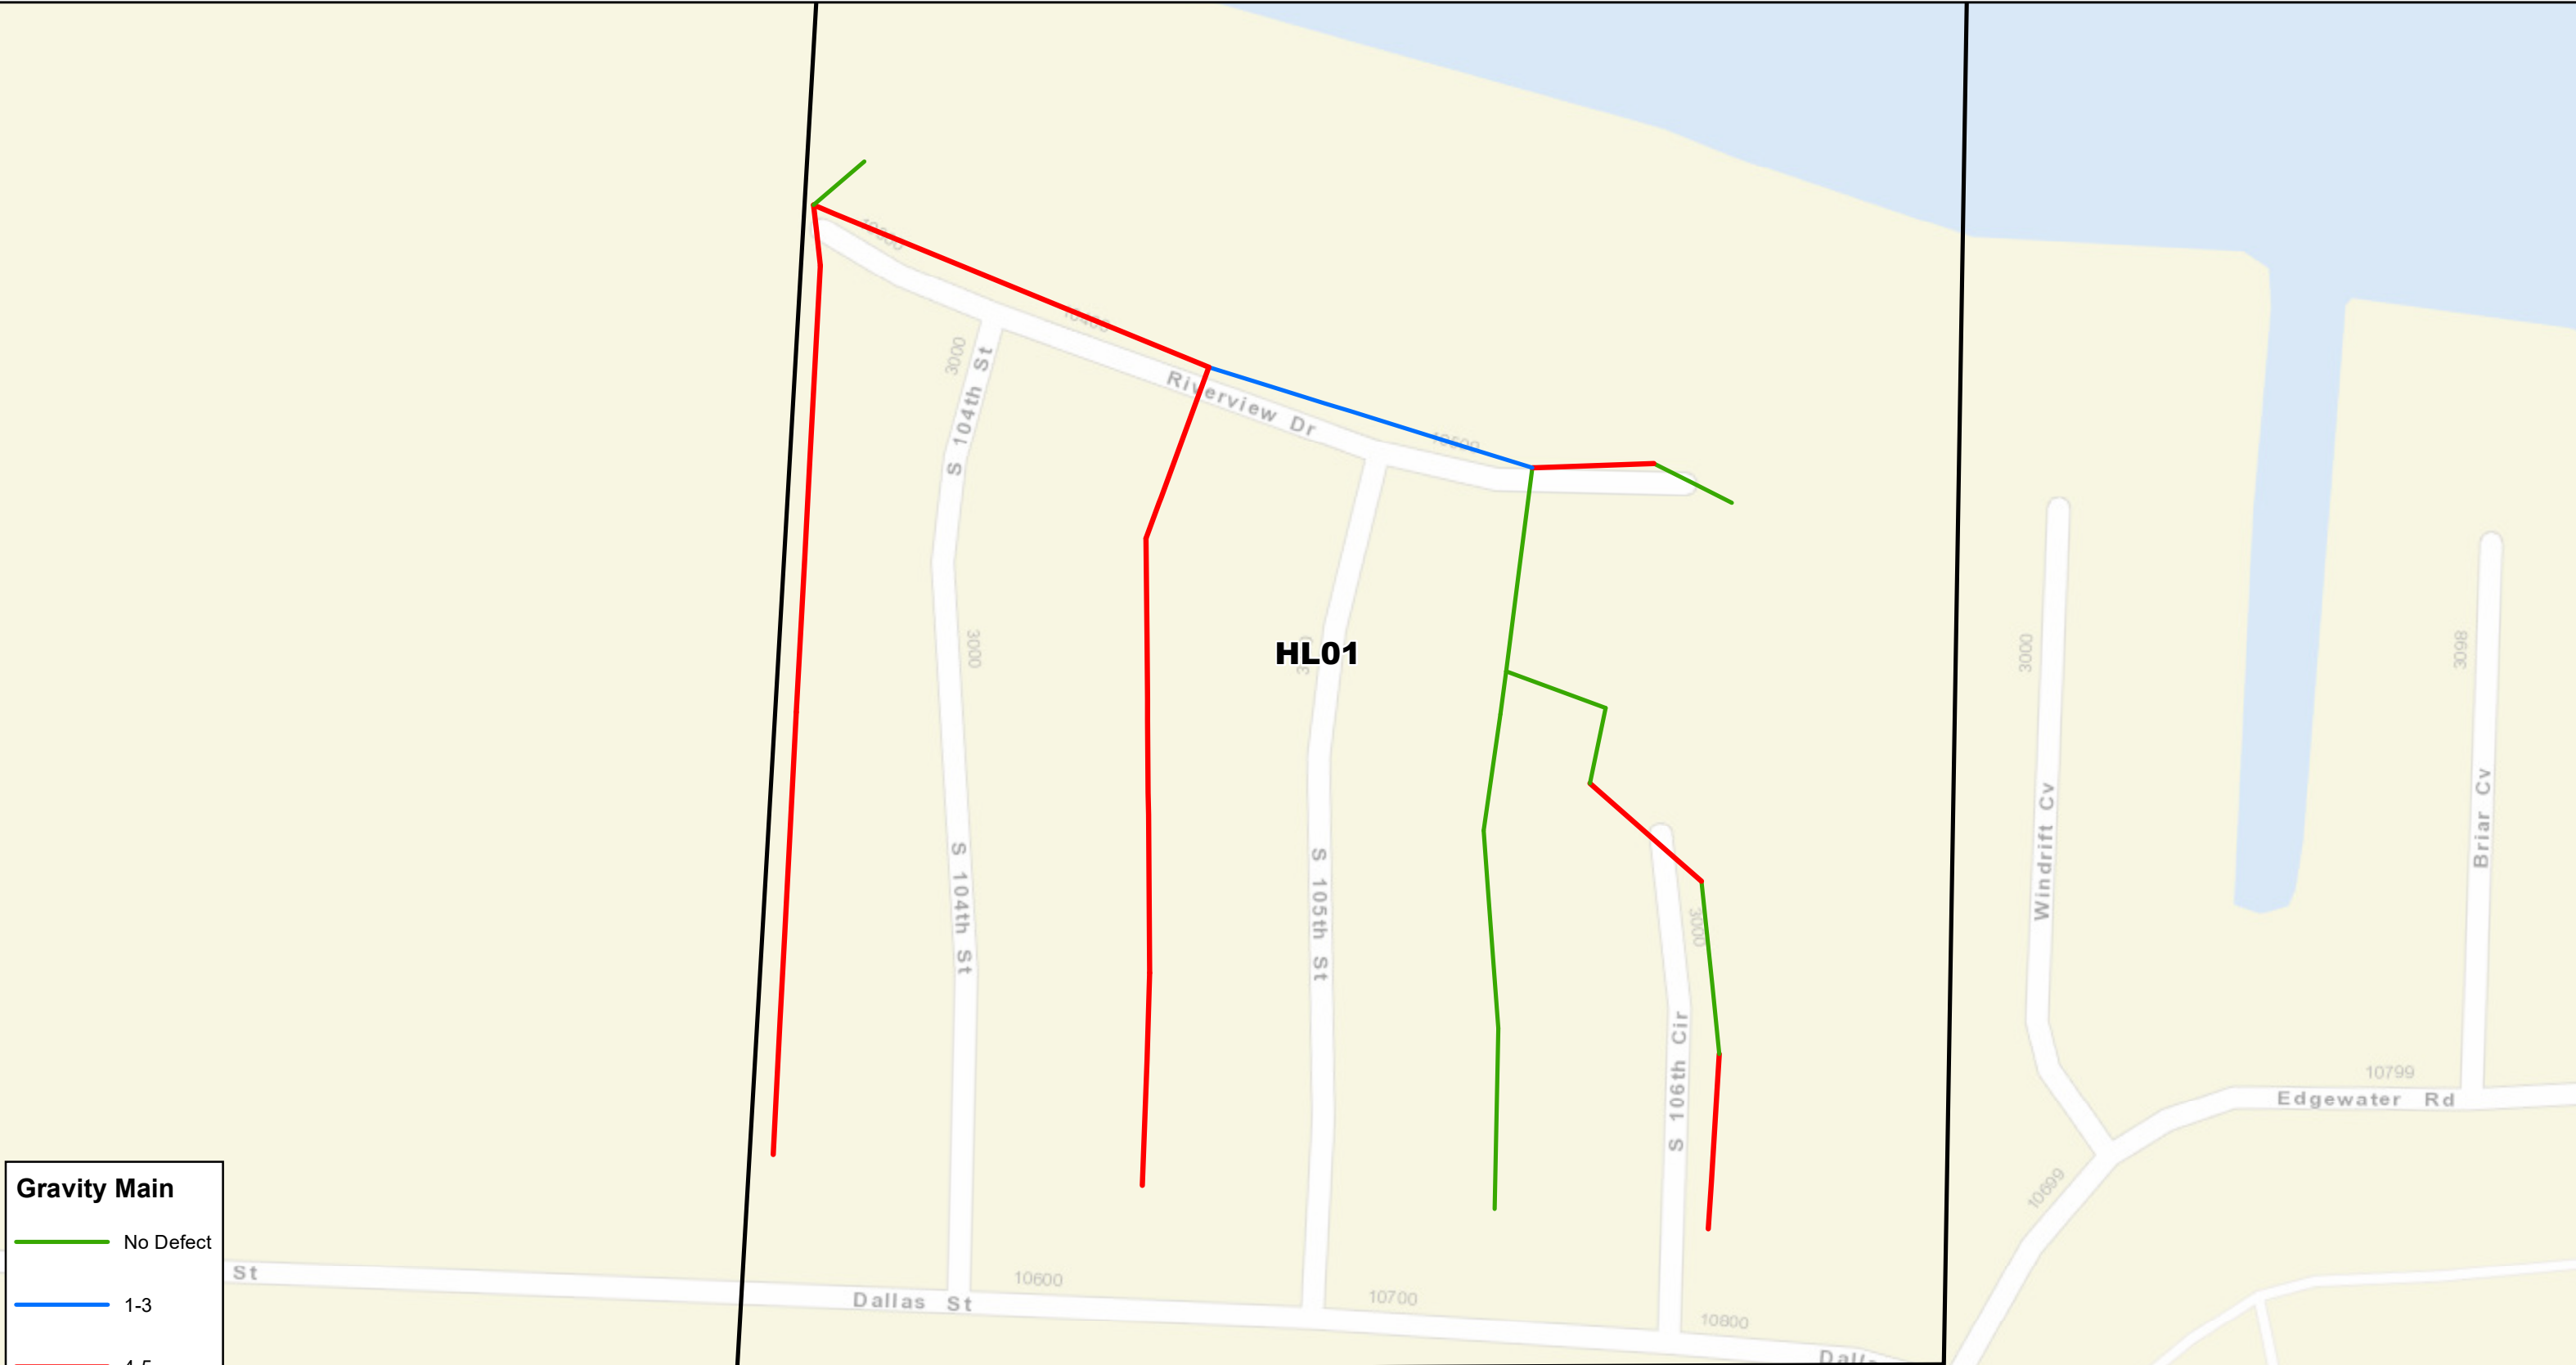
Figure 6.
PACP Scores
Sub-Basin D000

Gravity Main

- No Defect
- 1-3
- 4-5

NASSCO PACP defect grades were used to generate scores for all sewer lines. The peak defect grade was utilized to provide an overall score for each sewer line. Scores were on a scale of 1 to 5 with a score of 5 assigned to the sewer lines in the worst condition. The breakdown of linear footage in each sub-basin, by score, is shown in Table 7. A complete list of the NASSCO PACP score for every sewer line is provided in Appendix B. Figures 6, 7, and 8 show the distribution of scores for every sewer line.

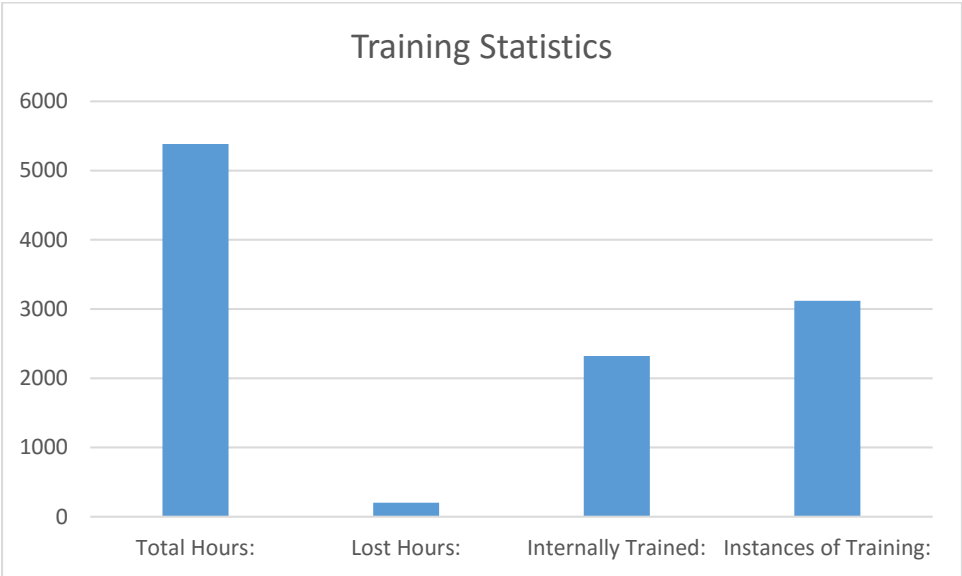
Hours Trained vs. Hours Lost

In the year 2018 we conducted more instances of training and opened a new platform to provide the training. We were able to continue to establish a culture of education and safety through training and a positive approach to staying safe. By keeping training current and consistent, we can keep employee awareness and education high.
