CITY WATER & LIGHT

JONESBORO, ARKANSAS

**2017 PROGRESS REPORT
CORRECTIVE ACTION PLAN**

SANITARY SEWER OVERFLOWS: SUMMARY OF ONGOING ACTIONS
AND PLAN FOR ADDITIONAL CORRECTIVE MEASURES

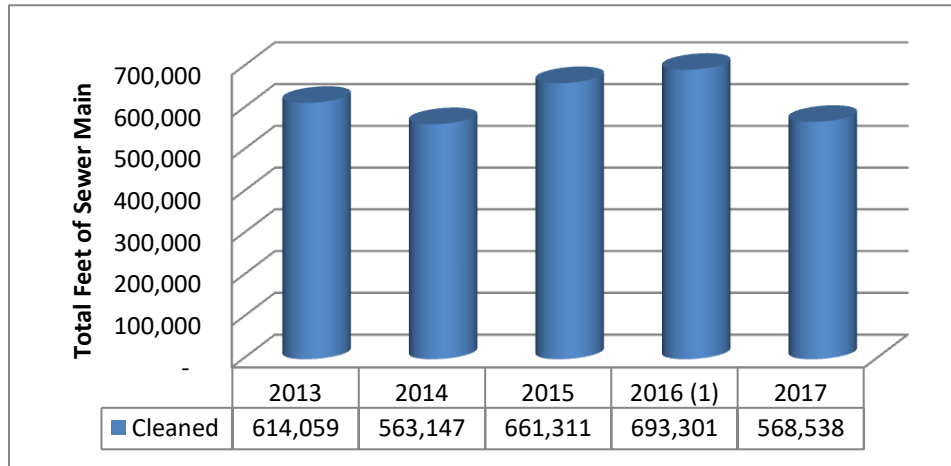
Graph 3-1: Sewer Mains Cleaned (2013 thru October 31, 2017)

Note:
Footage cleaned from November 2016 (60,910') and December 2016 (68,998') was added to the footage reported in the 2016 Progress Report - Total Feet of Sewer Main Cleaned in 2016 (563,393').

As presented in the CAP, CWL sewer service trucks maintain the system through routine cleaning. Graph 3-1 provides a summary of the past 4 year totals, along with the total footage cleaned for January 1st thru October 31st of 2017.

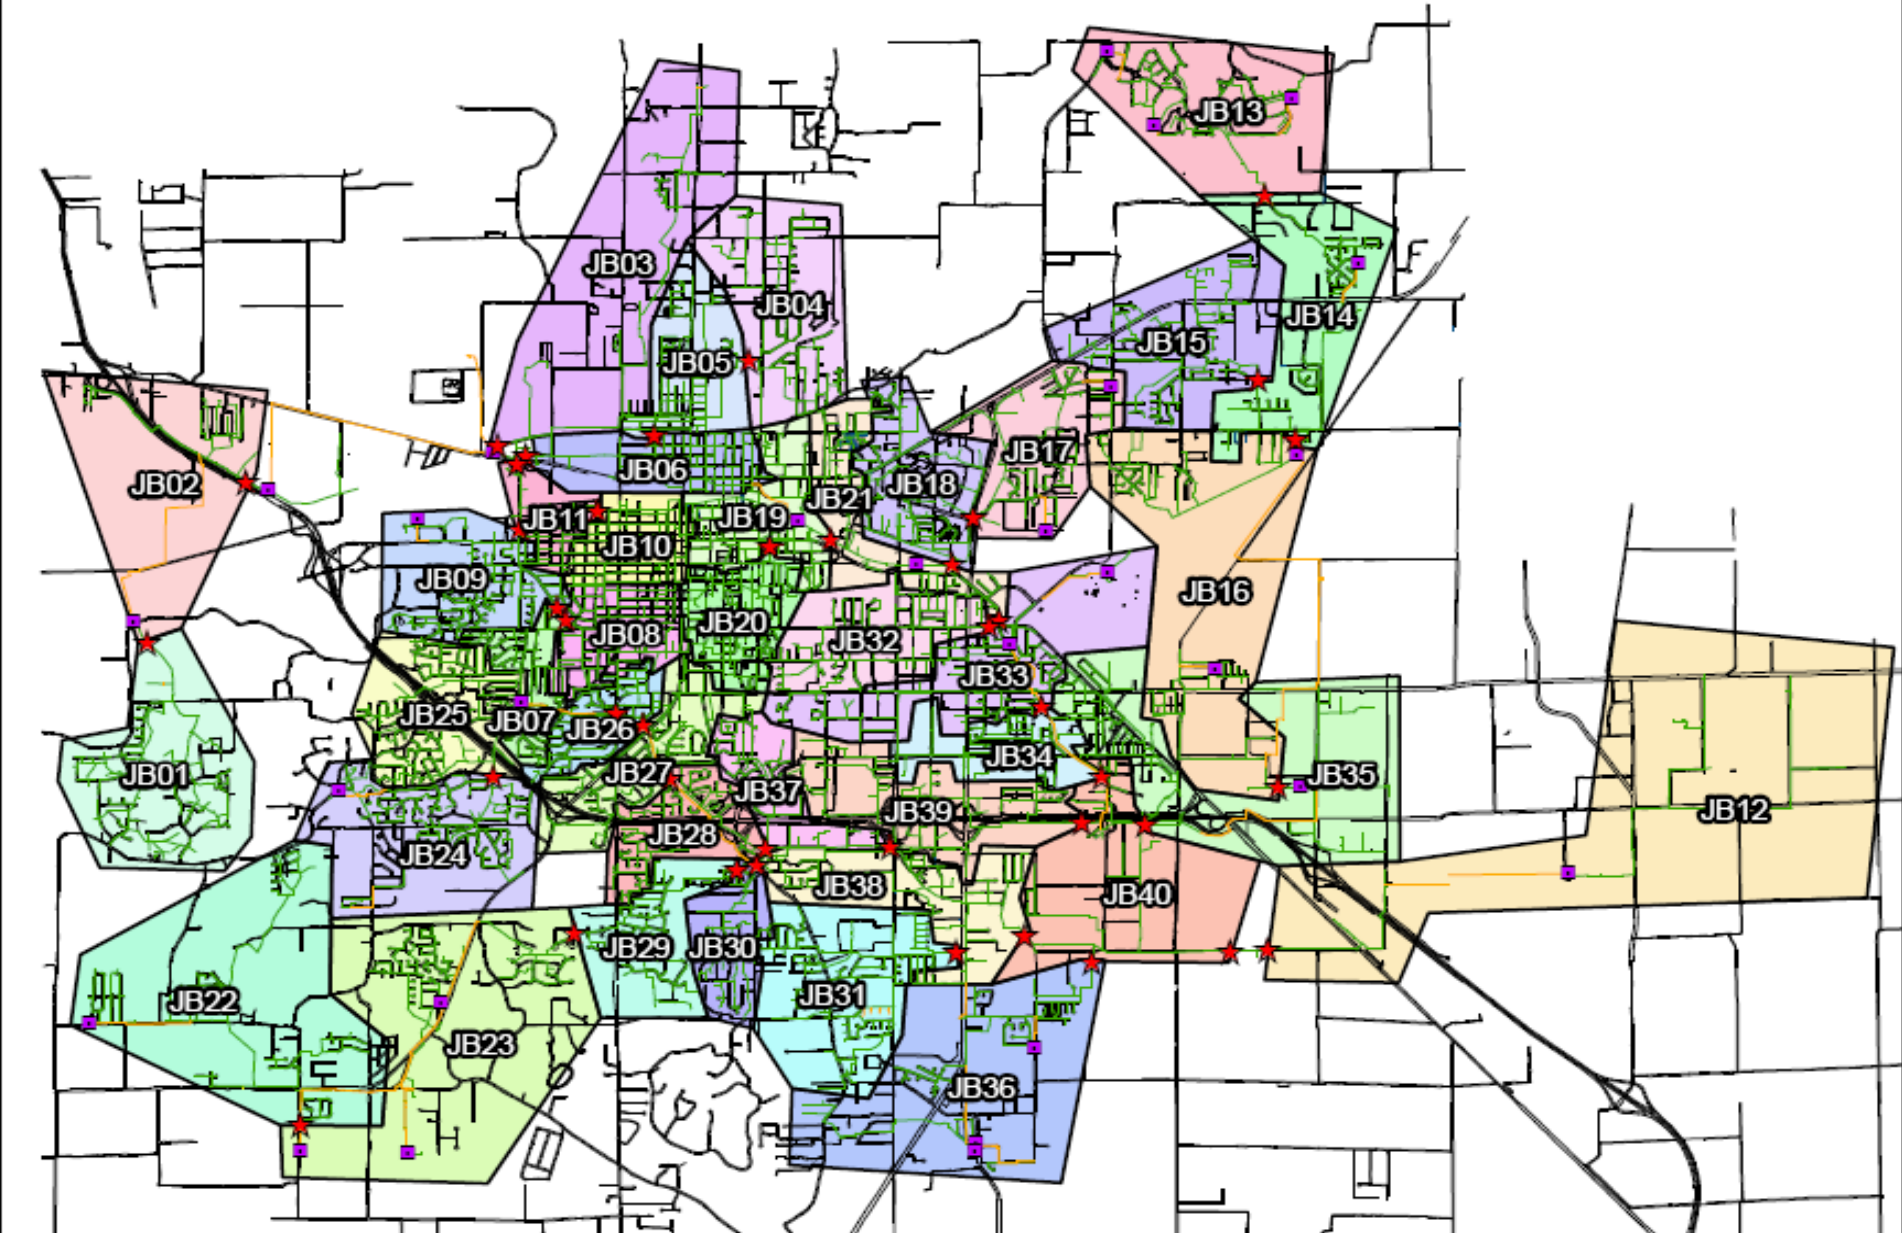
Basin Delineation

★ Meter Site — Force Mains □ R/JN Meter Basins
■ Lift Stations — Sewer Lines
