# TECHNICAL MEMORANDUM

ADEQ CAO RELEASE RESPONSE

ADEQ CAO Release Response - Hot Springs, AR

## POST-REHABILITATION STUDY

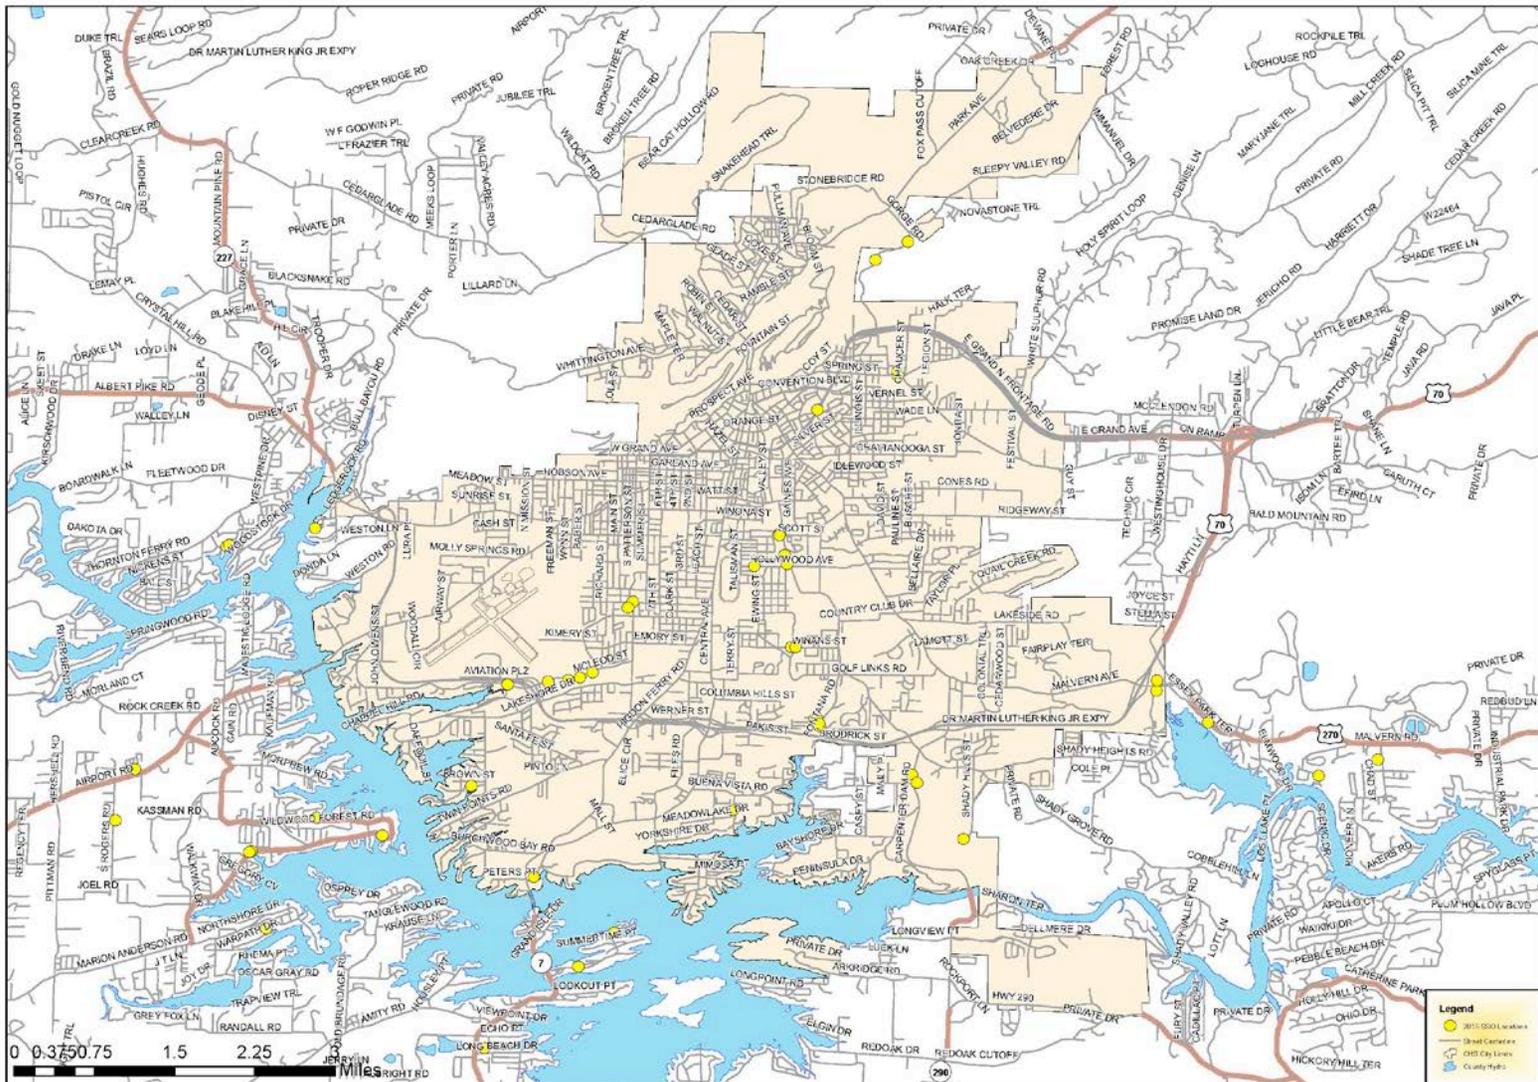
**2015 SSO CAPACITY RELATED EVENT LOCATIONS**

**City of Hot Springs**  
**2015 SSO Capacity Related Event Locations**  
 (164 Each)

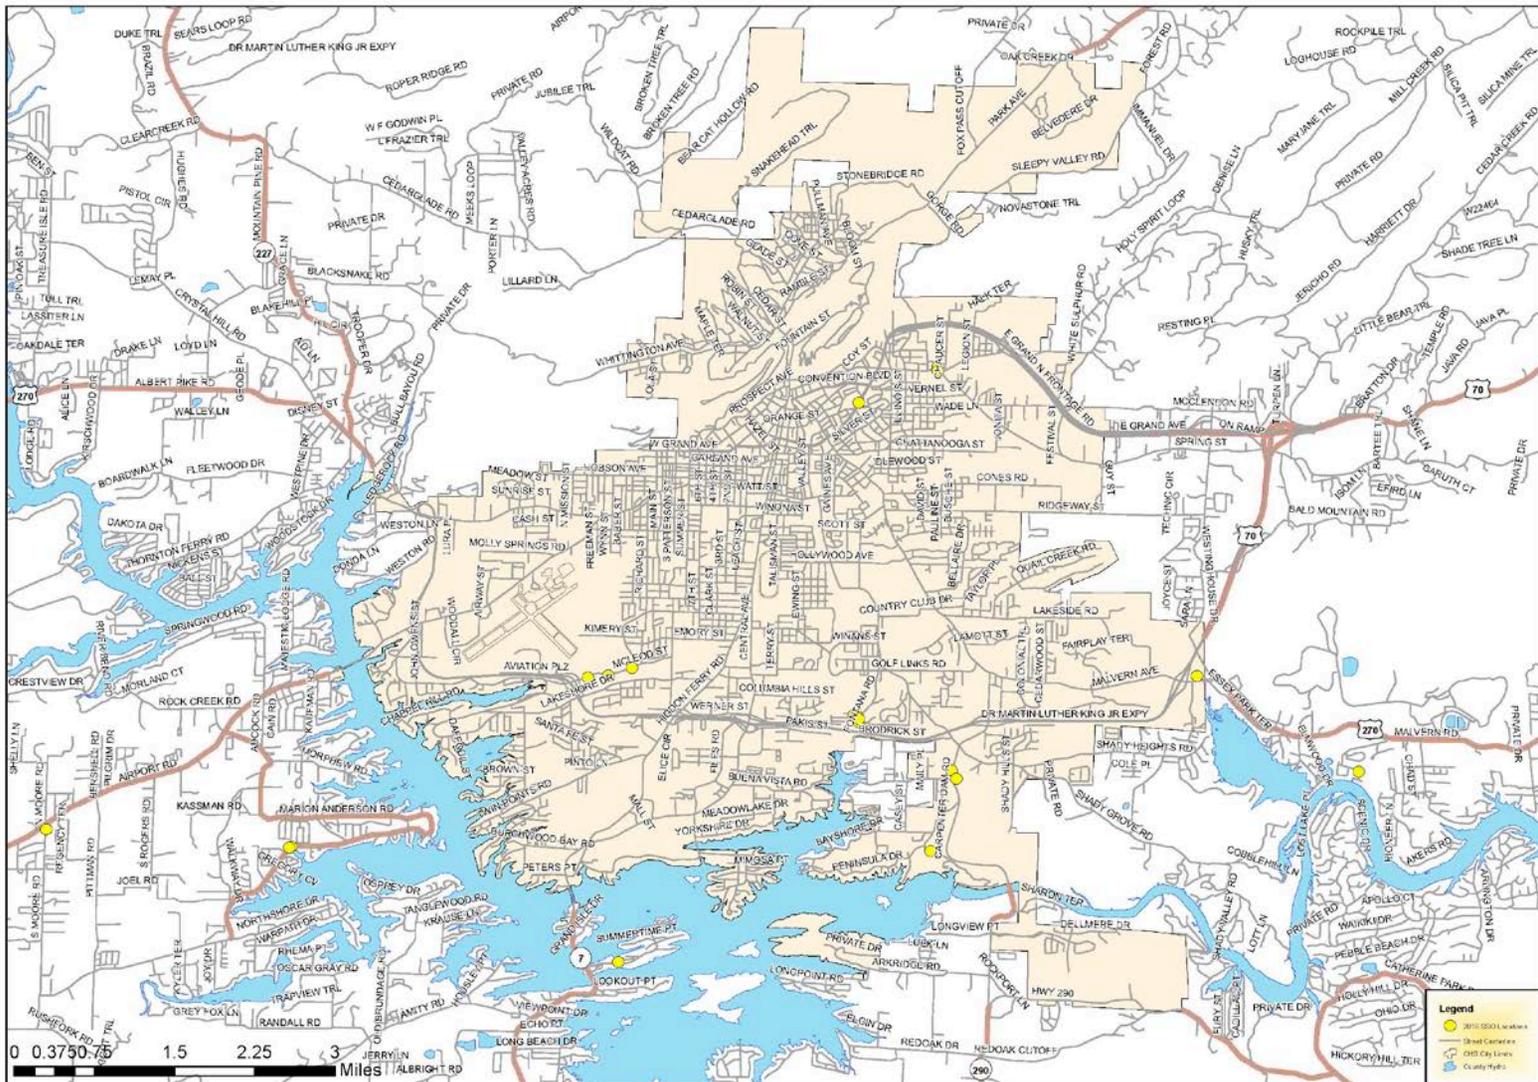
**2016 SSO CAPACITY RELATED EVENT LOCATIONS**

**City of Hot Springs**  
**2016 SSO Capacity Related Event Locations**  
 (86 Each)

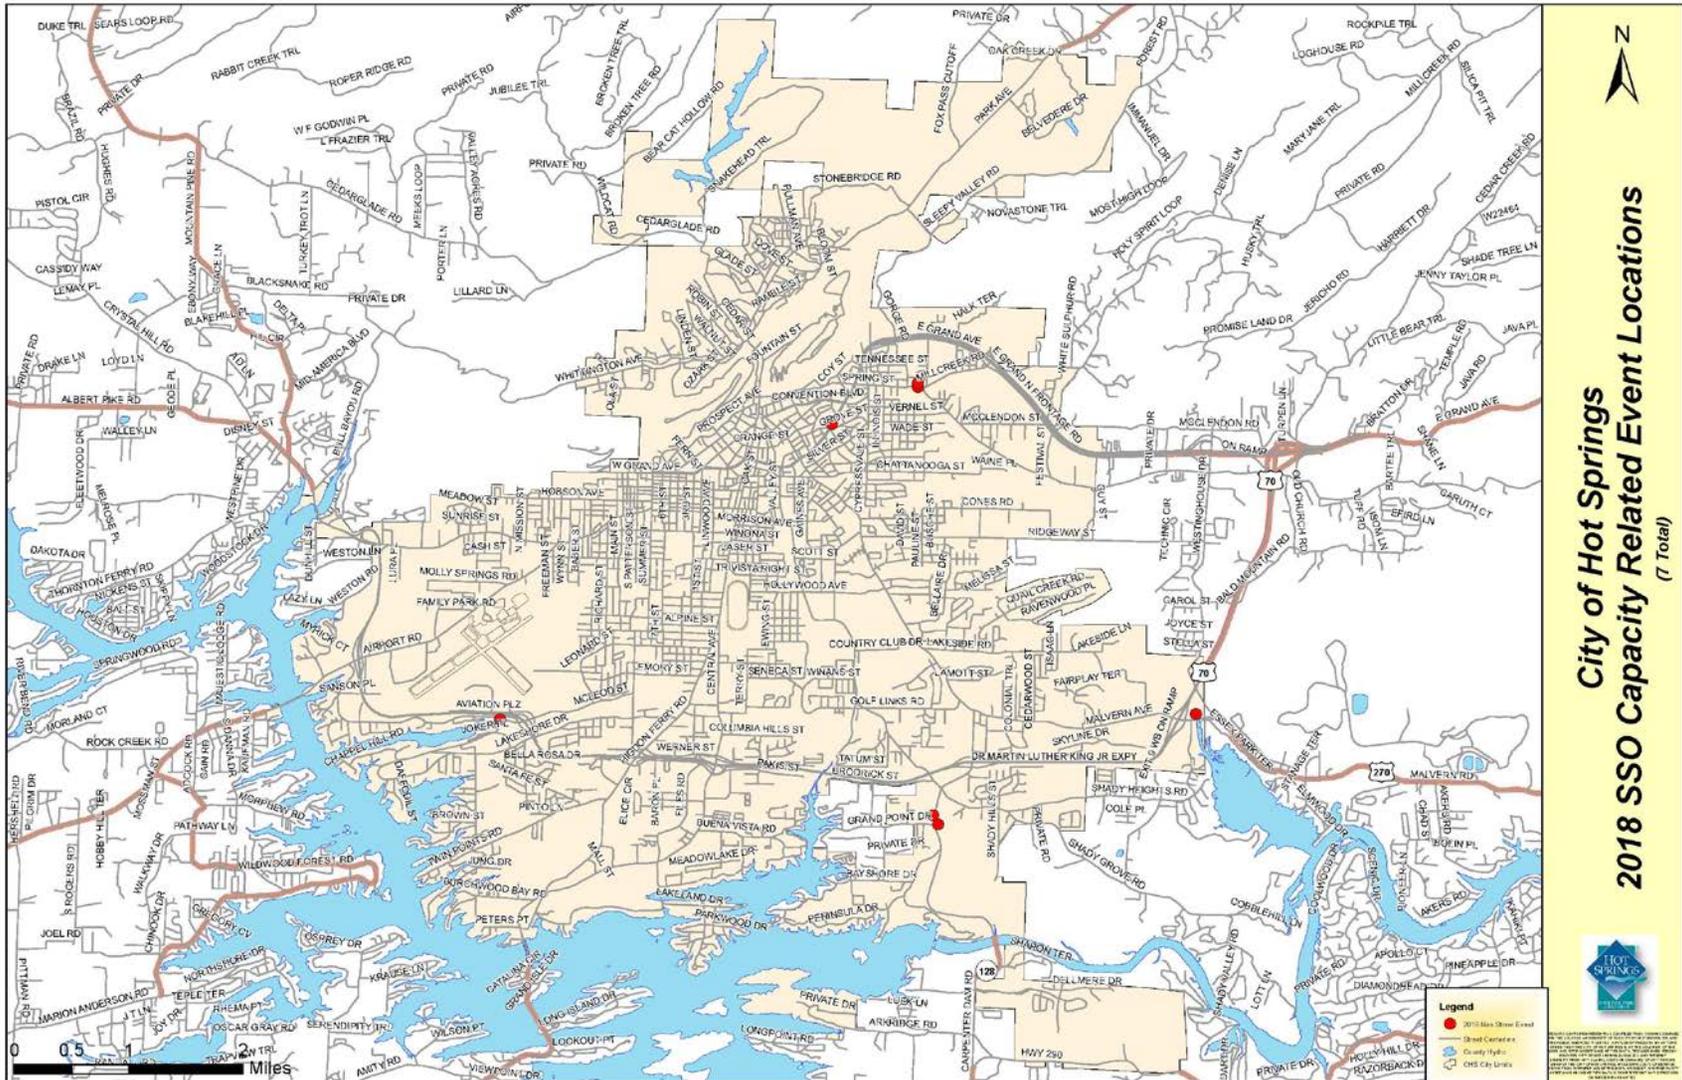
## 2018 SSO CAPACITY RELATED EVENT LOCATIONS

**City of Hot Springs**  
**2018 SSO Capacity Related Event Locations**  
 (7 Total)
