# MENA, AR

# FLOW MONITORING REPORT

## FEBRUARY – MAY 2021

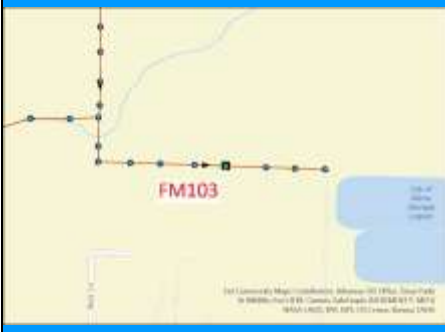
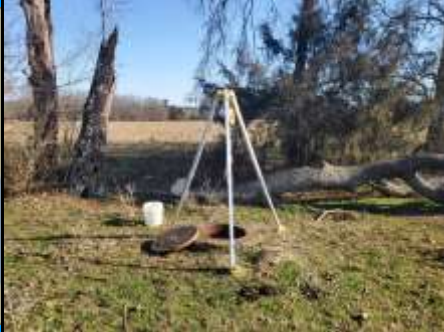
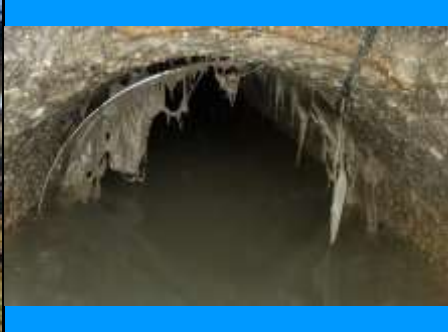
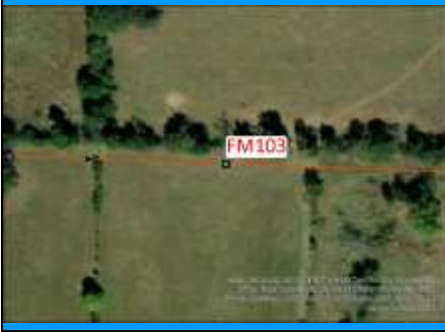
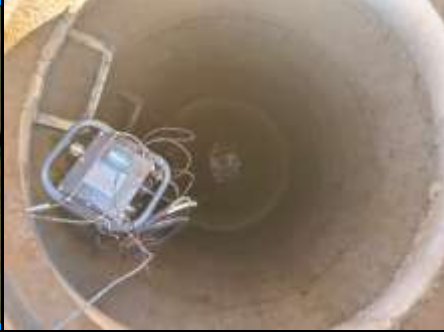
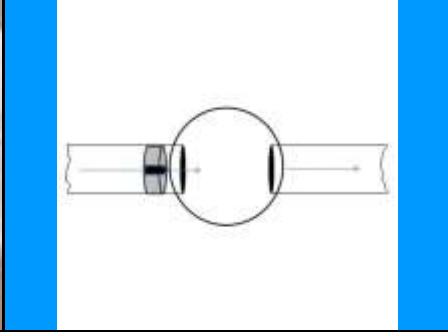
<b>Site ID</b>	<b>Device Type</b>	<b>Installation Date</b>	<b>Installed By</b>
<b>FM103</b>	Flow Meter	2/3/2021	J. Cawthon
<b>Address</b>	<b>Location Details</b>		<b>Traffic Area ?</b>
323 Polk County Rd 53	next to the plant		No
<b>Installation Manhole</b>	<b>Material</b>	<b>Evidence of Surcharge ?</b>	
103	Reinforced Concrete Pipe	No	
<b>Gas Levels</b>			
<b>Oxygen</b>	<b>Carbon Monoxide</b>	<b>Hydrogen Sulfide</b>	<b>Lower Explosive Limit</b>
20.90%	0.00%	0.00%	0
<b>Installation Pipe</b>	<b>Material</b>	<b>Inside Diameter</b>	
incoming	VCP	24

<b>Hydraulic Conditions</b>
Slow and smooth. Evidence of surcharge
<b>General Conditions</b>

Map_FM103	FM103 Area	FM103 Pipe
<b>Downhole Image</b>	<b>Pipe Image</b>	<b>Install Schematic (Top)</b>

Aerial_FM103	FM103 Inner	FM103 Schematic

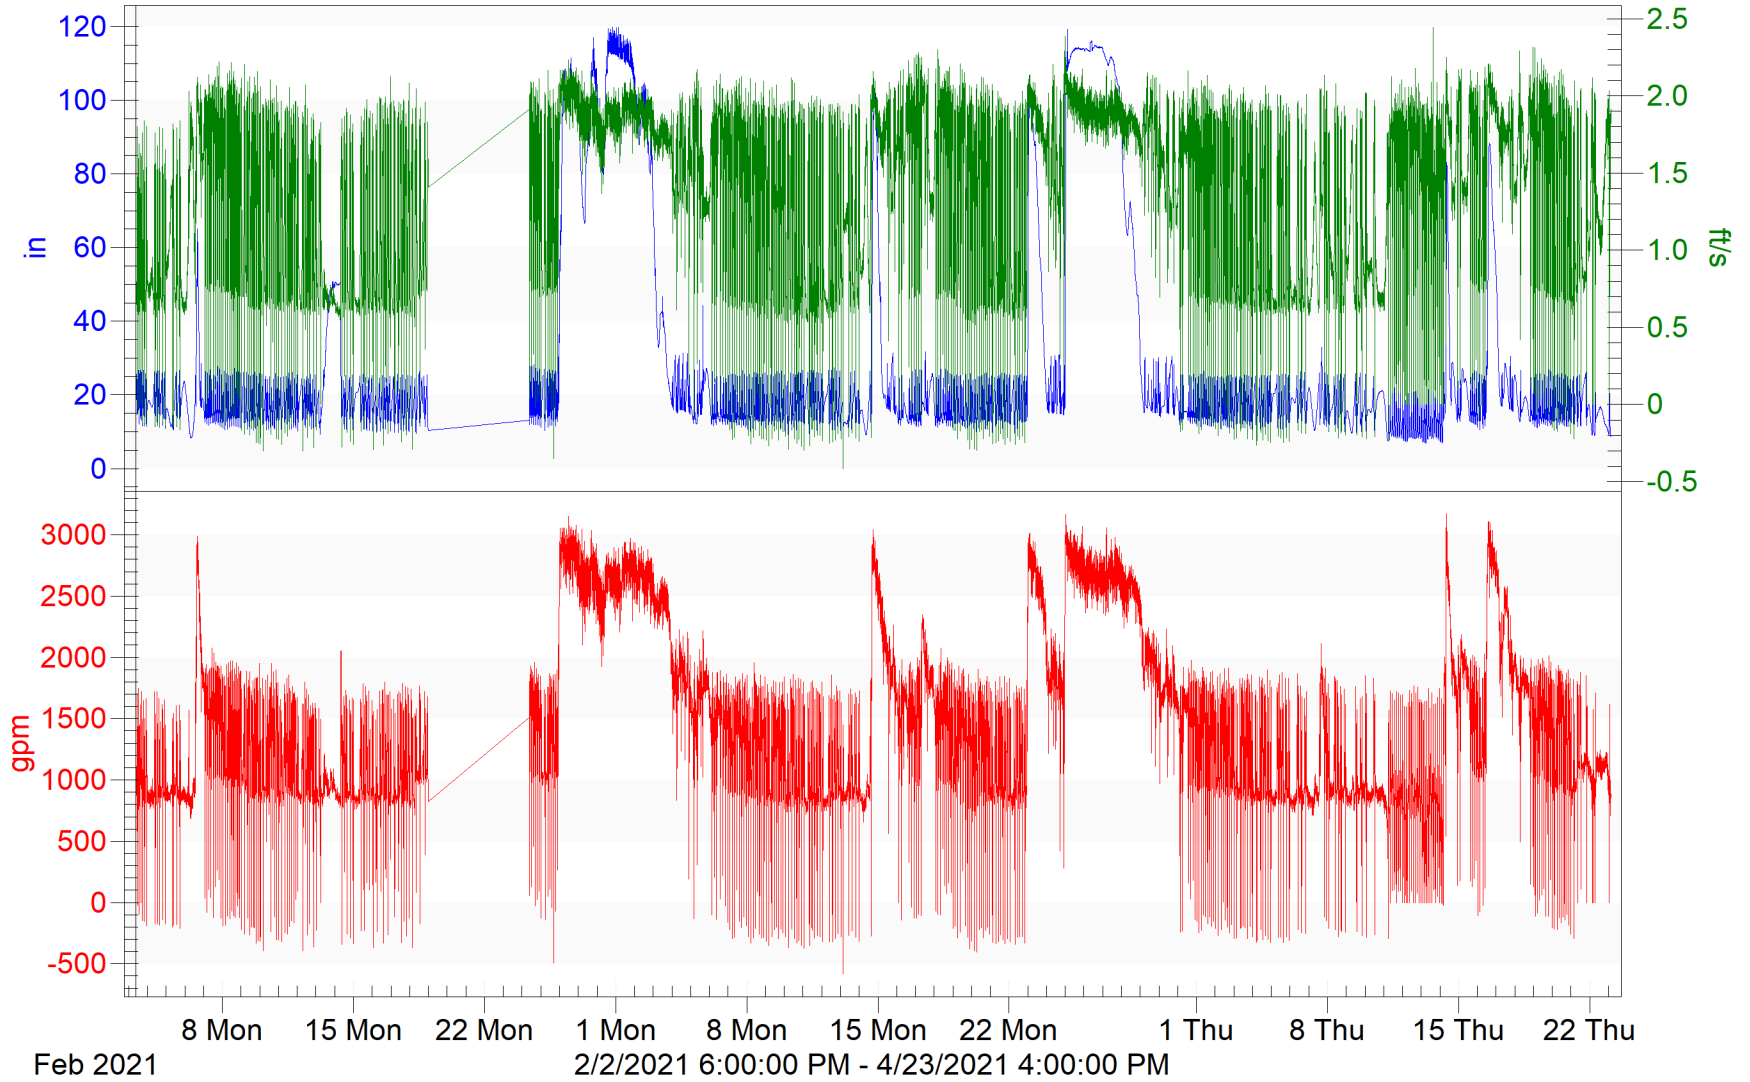
# FM103

Level (30.006 in):-0.08

Velocity (1.407 ft/s):0.00

Flow Rate (168.519 mgal):0.00

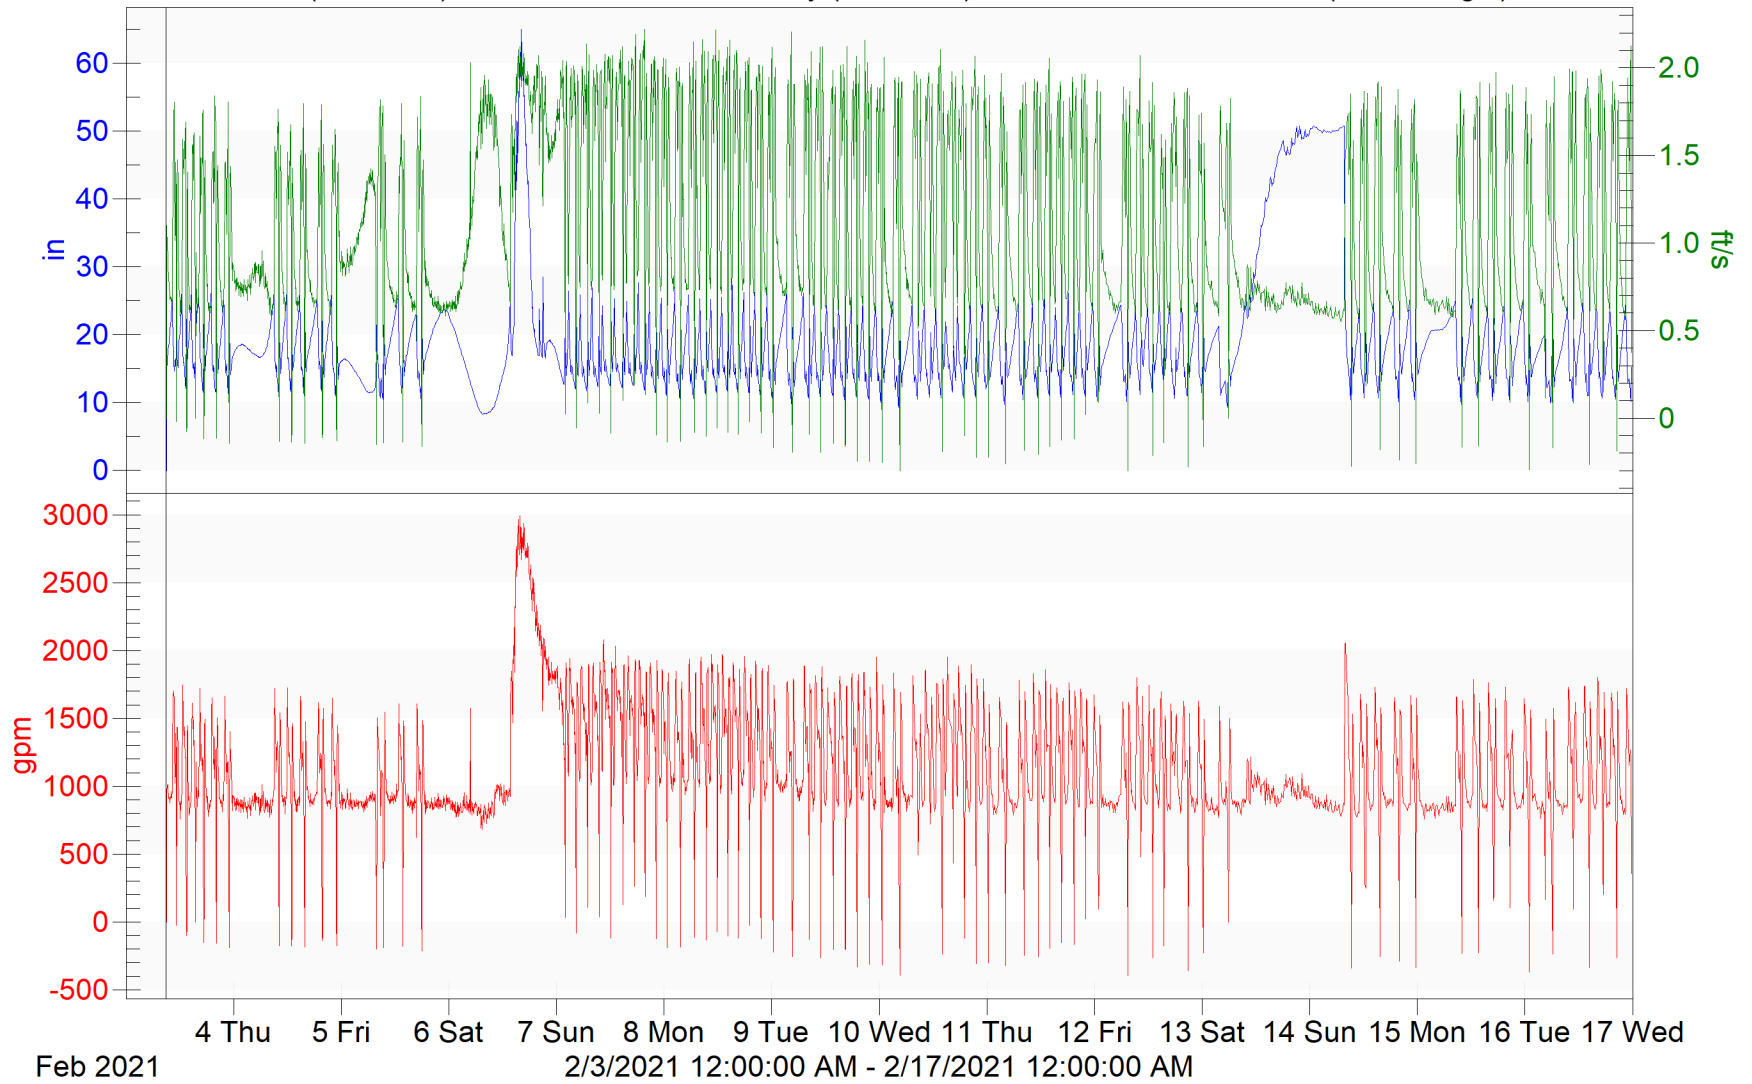
# FM103

Level (18.780 in):-0.08

Velocity (1.161 ft/s):0.00

Flow Rate (21.948 mgal):0.00

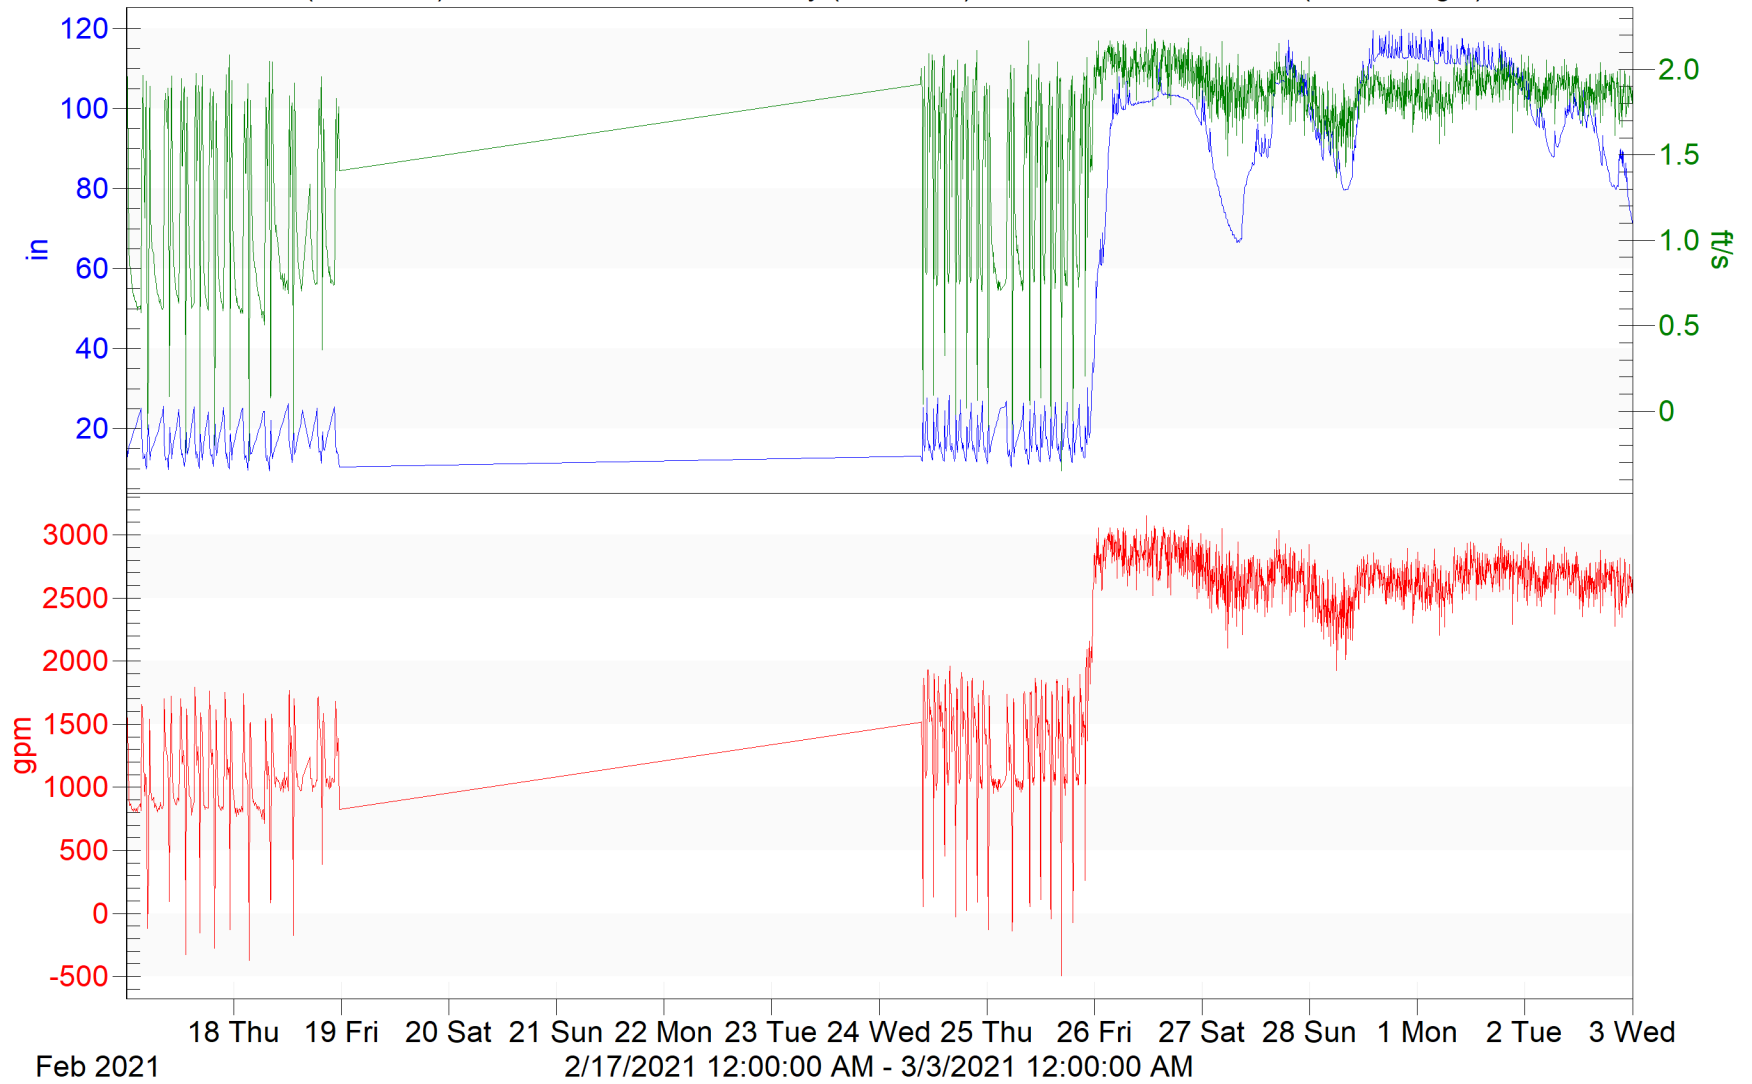
# FM103

Level (71.876 in):16.02

Velocity (1.682 ft/s):1.58

Flow Rate (37.179 mgal):1580.07

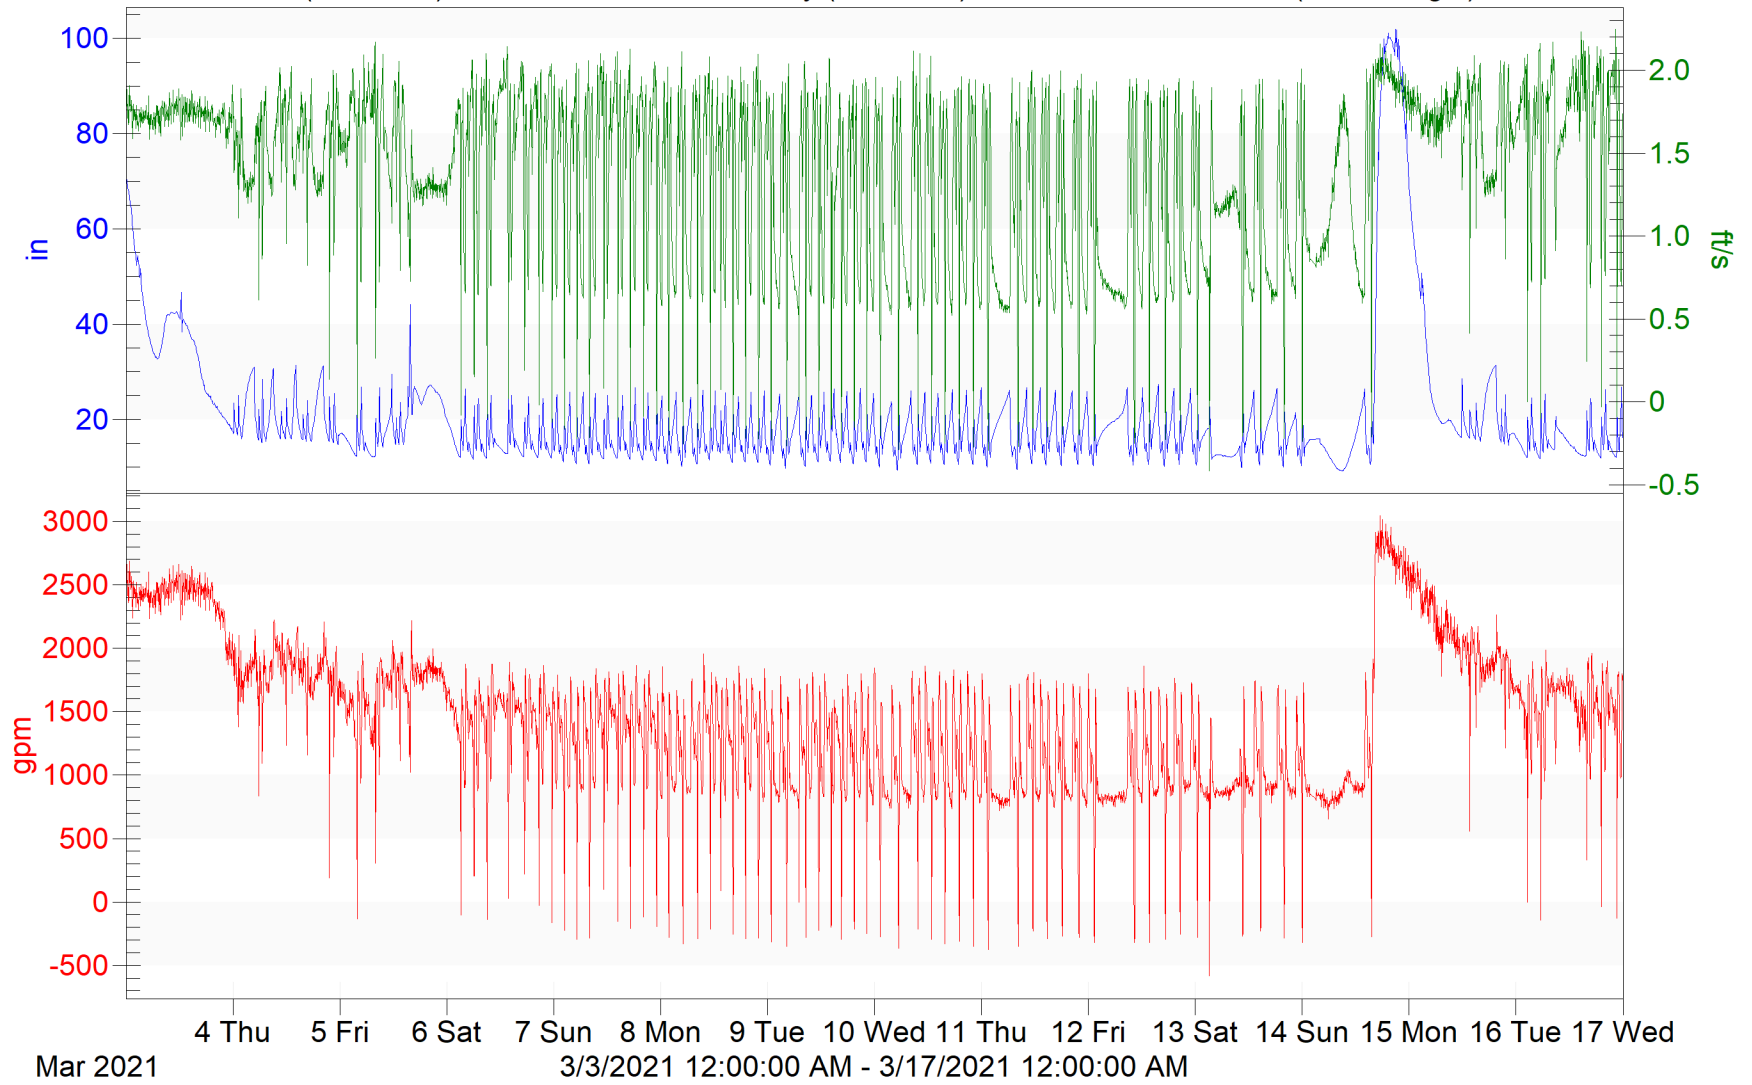
# FM103

Level (20.651 in):71.28

Velocity (1.390 ft/s):1.72

Flow Rate (29.022 mgal):2425.78

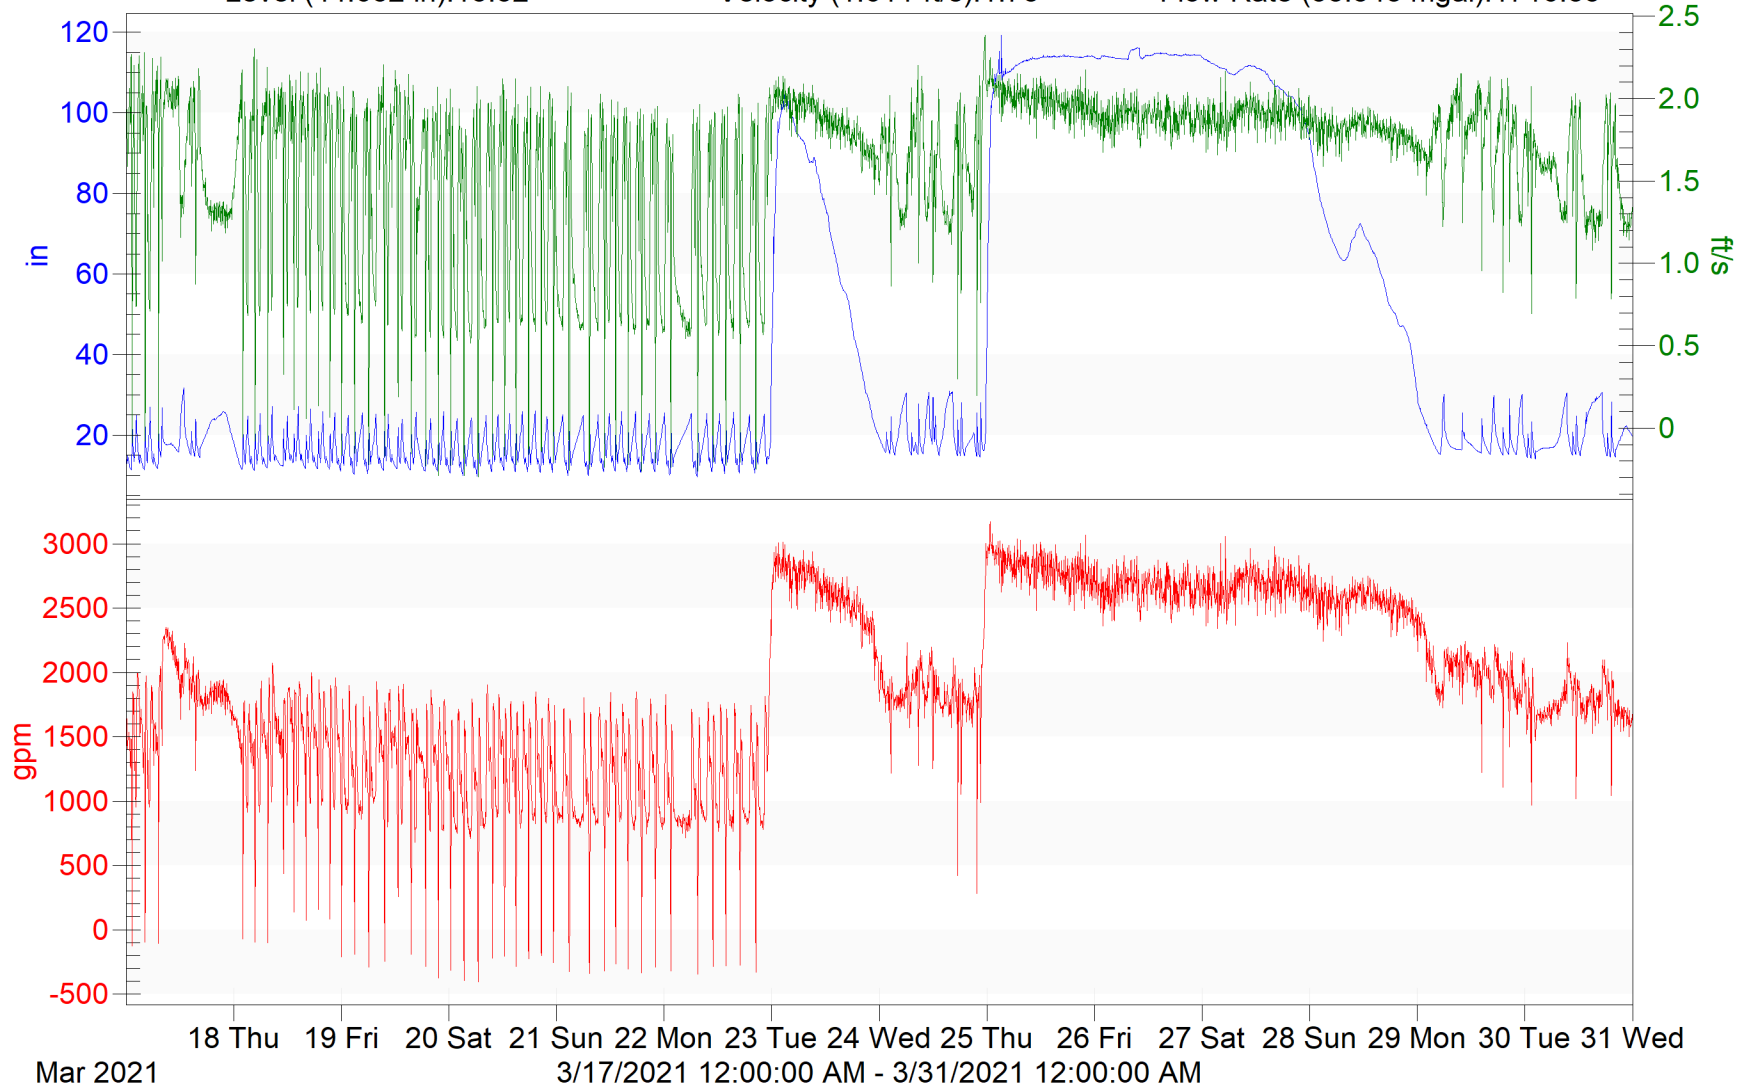
# FM103

Level (44.632 in):15.52

Velocity (1.611 ft/s):1.78

Flow Rate (38.548 mgal):1716.83

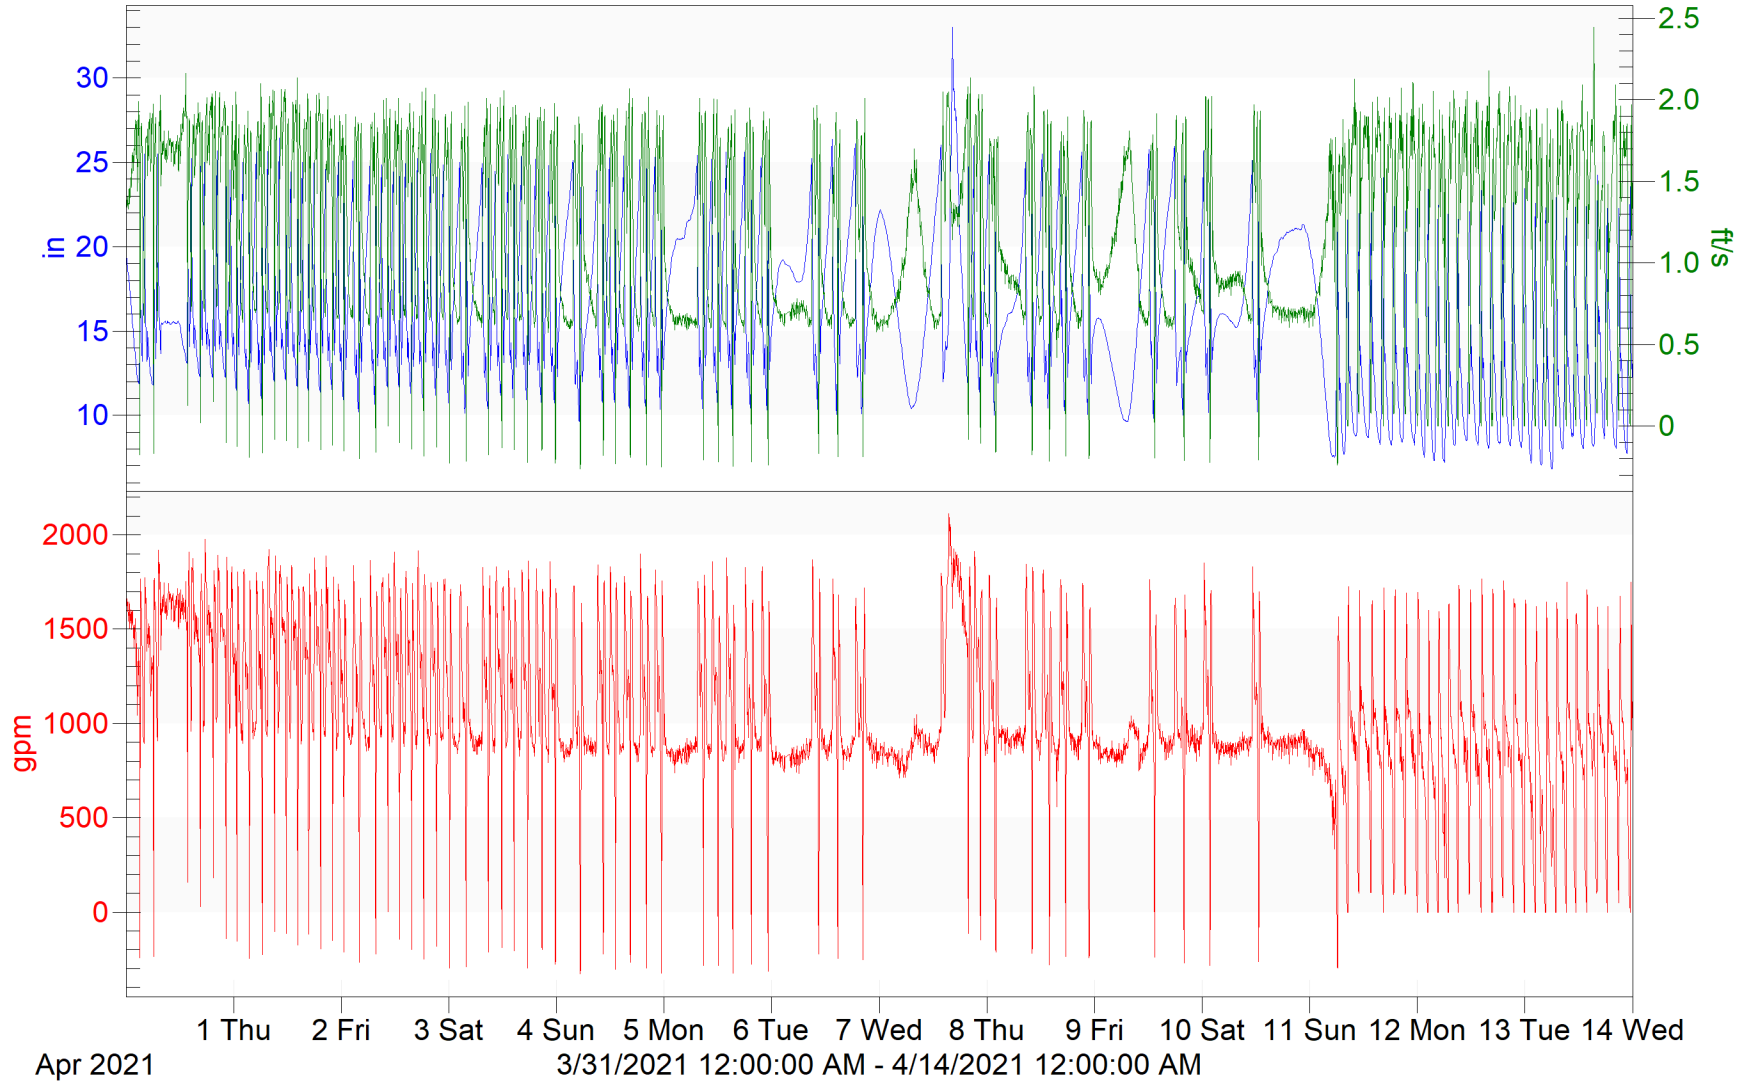
# FM103

Level (15.959 in):19.66

Velocity (1.179 ft/s):1.28

Flow Rate (20.855 mgal):1583.68

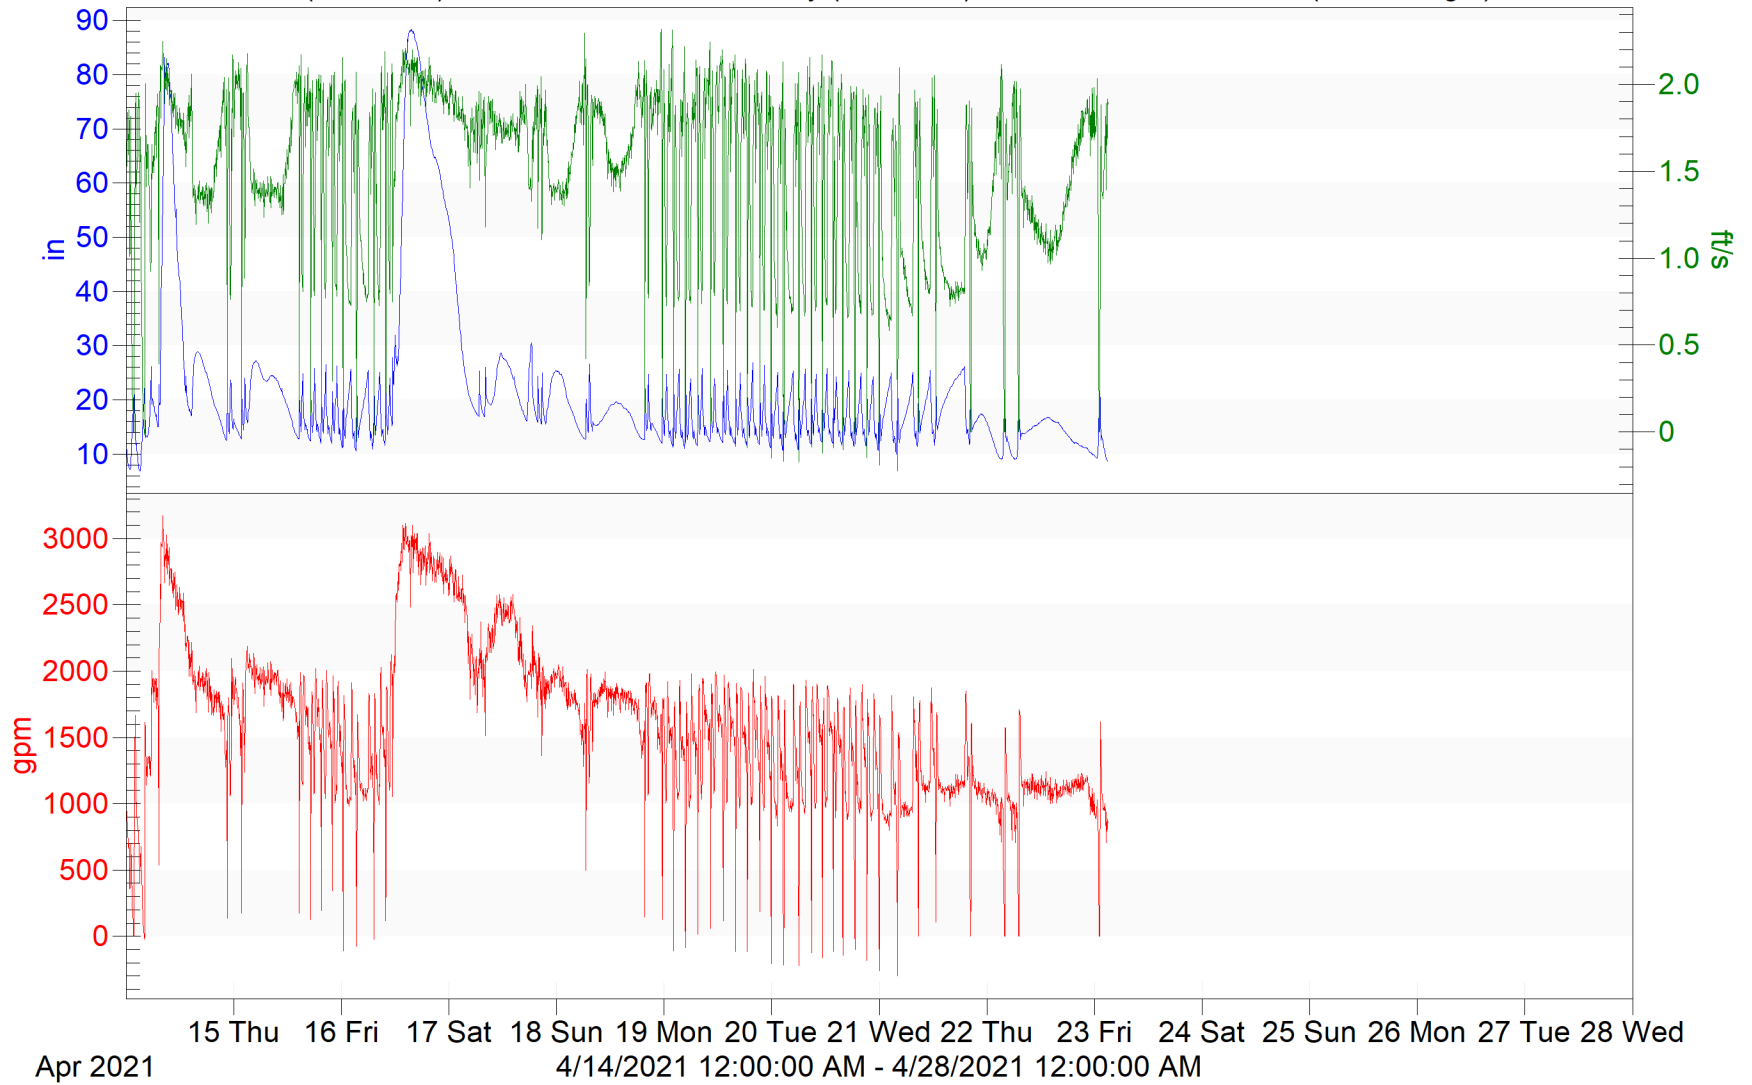
# FM103

Level (21.399 in):11.94

Velocity (1.513 ft/s):1.34

Flow Rate (20.935 mgal):941.01

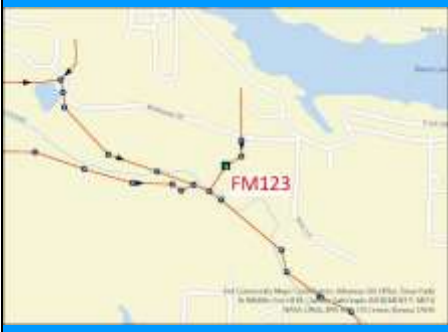
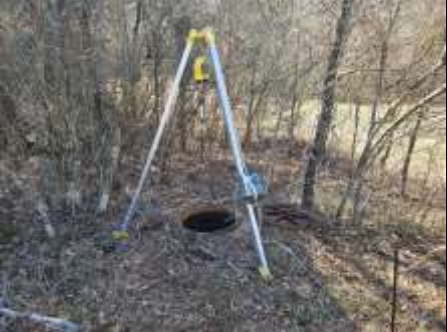
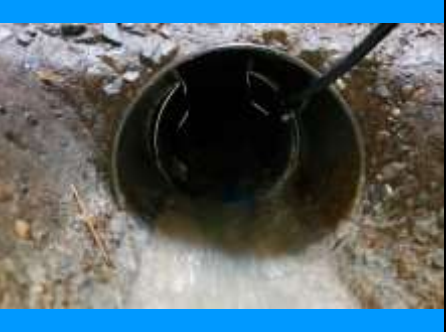
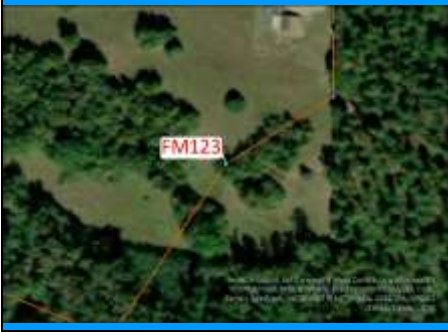
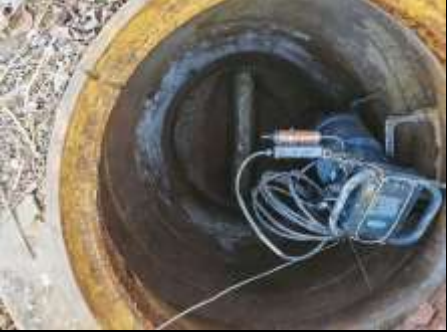
<b>Site ID</b>	<b>Device Type</b>	<b>Installation Date</b>	<b>Installed By</b>
<b>FM123</b>	Flow Meter	2/3/2021	J. Cawthon
<b>Address</b>	<b>Location Details</b>		<b>Traffic Area ?</b>
2805 Midland Rd	Field behind house		No
<b>Installation Manhole</b>	<b>Material</b>	<b>Evidence of Surcharge ?</b>	
123	Reinforced Concrete Pipe	No	
<b>Gas Levels</b>			
<b>Oxygen</b>	<b>Carbon Monoxide</b>	<b>Hydrogen Sulfide</b>	<b>Lower Explosive Limit</b>
20.90%	0.00%	0.00%	0
<b>Installation Pipe</b>	<b>Material</b>	<b>Inside Diameter</b>	
Incoming	PVC	8

<b>Hydraulic Conditions</b>
Normal depth of flow and velocity. Lift station nearby
<b>General Conditions</b>

Map_FM123	FM123 Area	FM123 Pipe
<b>Downhole Image</b>	<b>Pipe Image</b>	<b>Install Schematic (Top)</b>

Aerial_FM123	FM123 Inner	FM123 Schematic

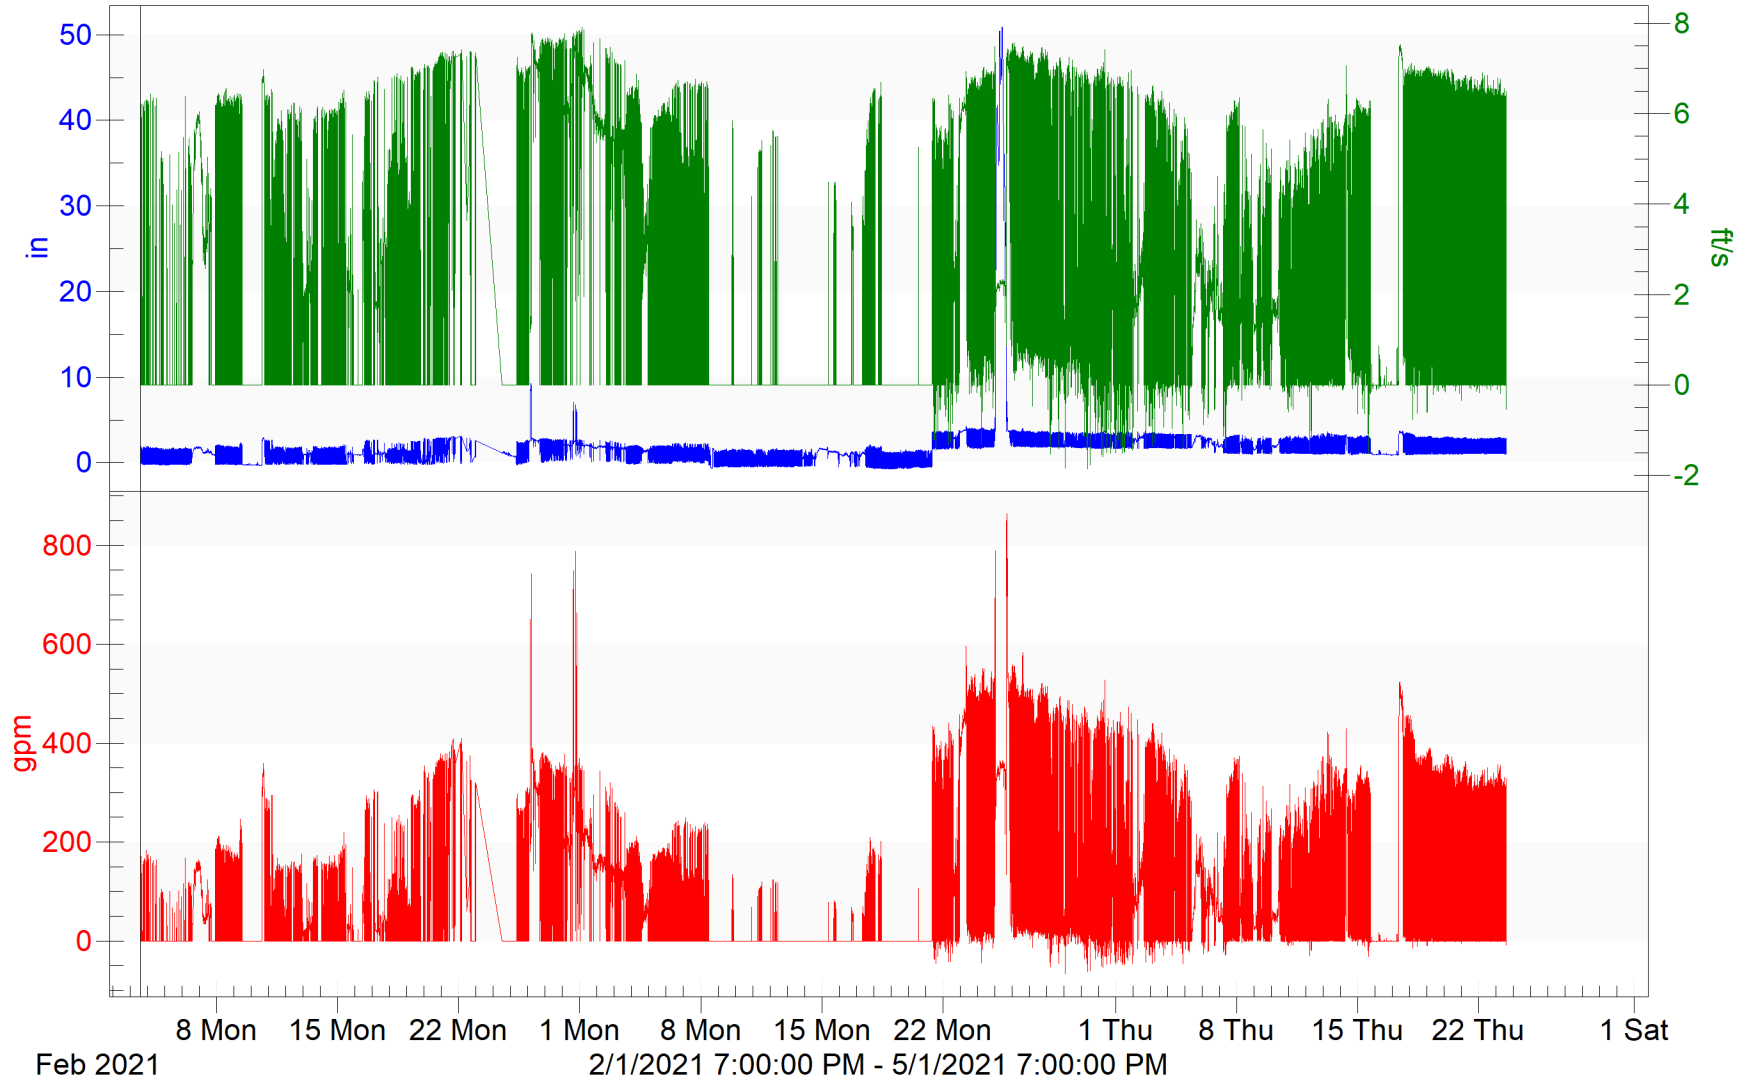
# FM123

Level (1.839 in):-0.06

Velocity (2.125 ft/s):0.00

Flow Rate (10.561 mgal):0.00

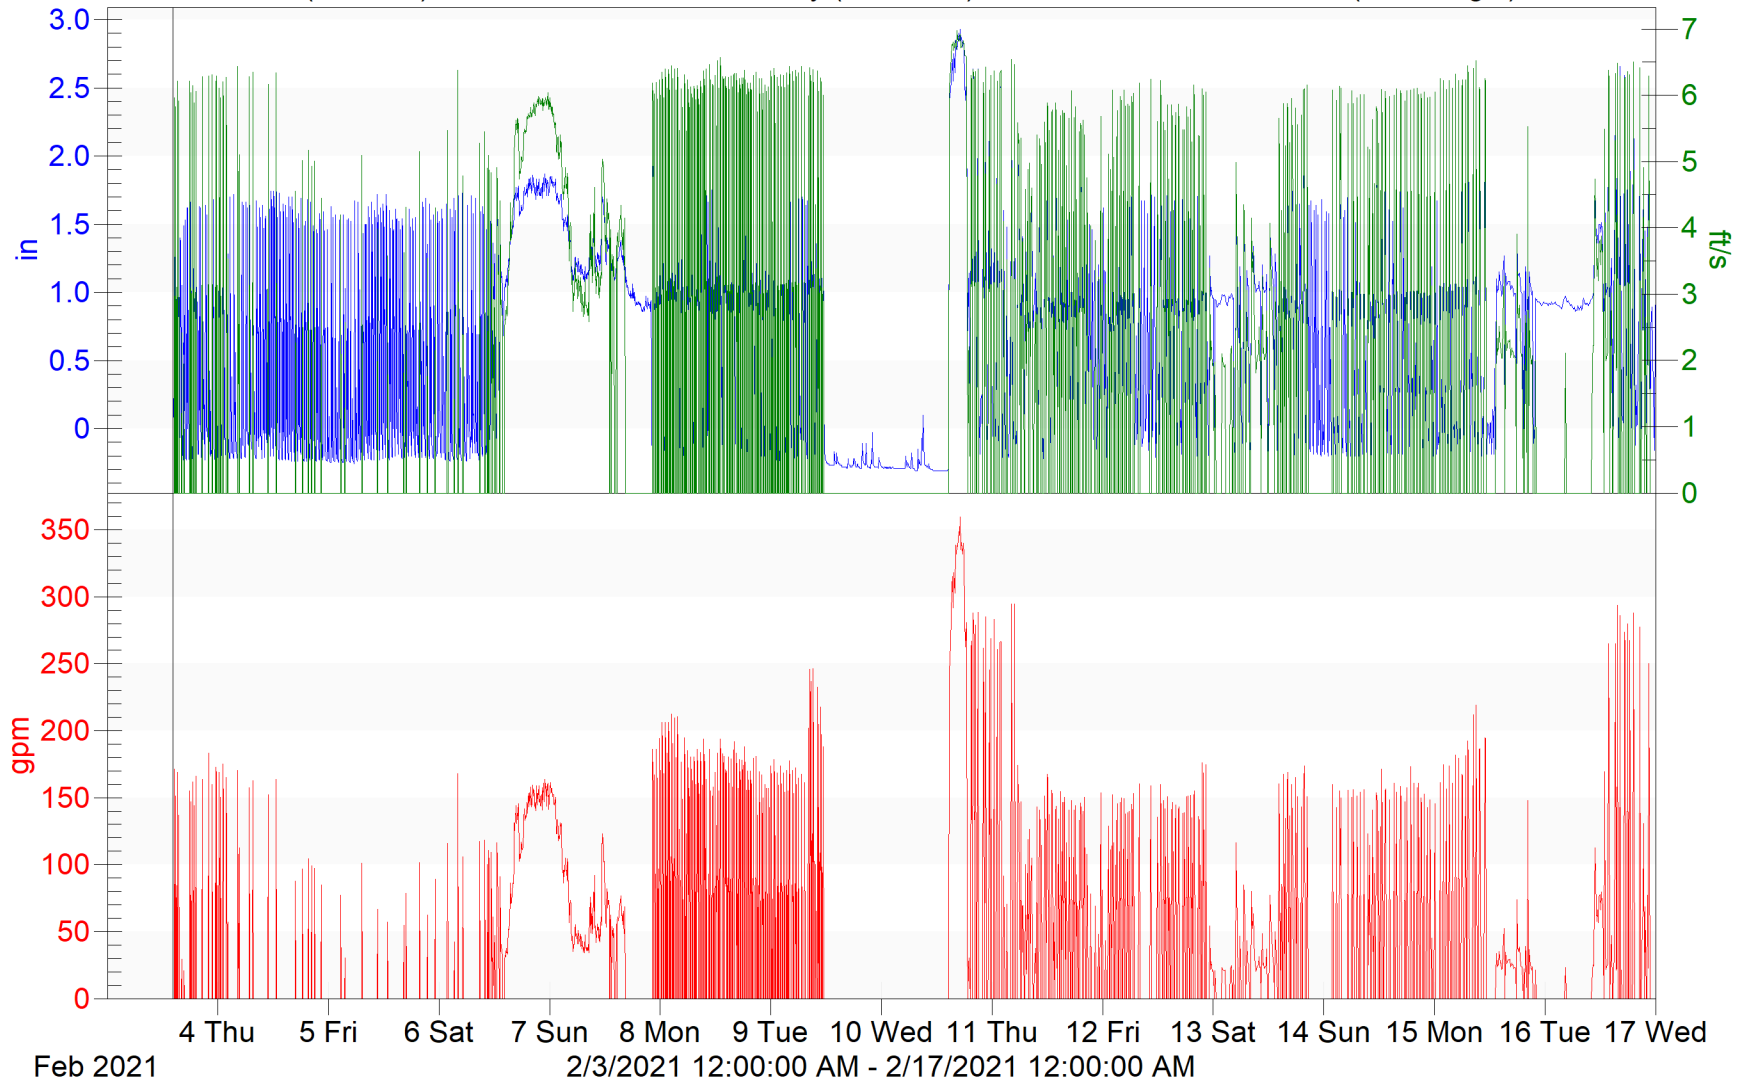
# FM123

Level (0.652 in):-0.06

Velocity (1.511 ft/s):0.00

Flow Rate (0.763 mgal):0.00

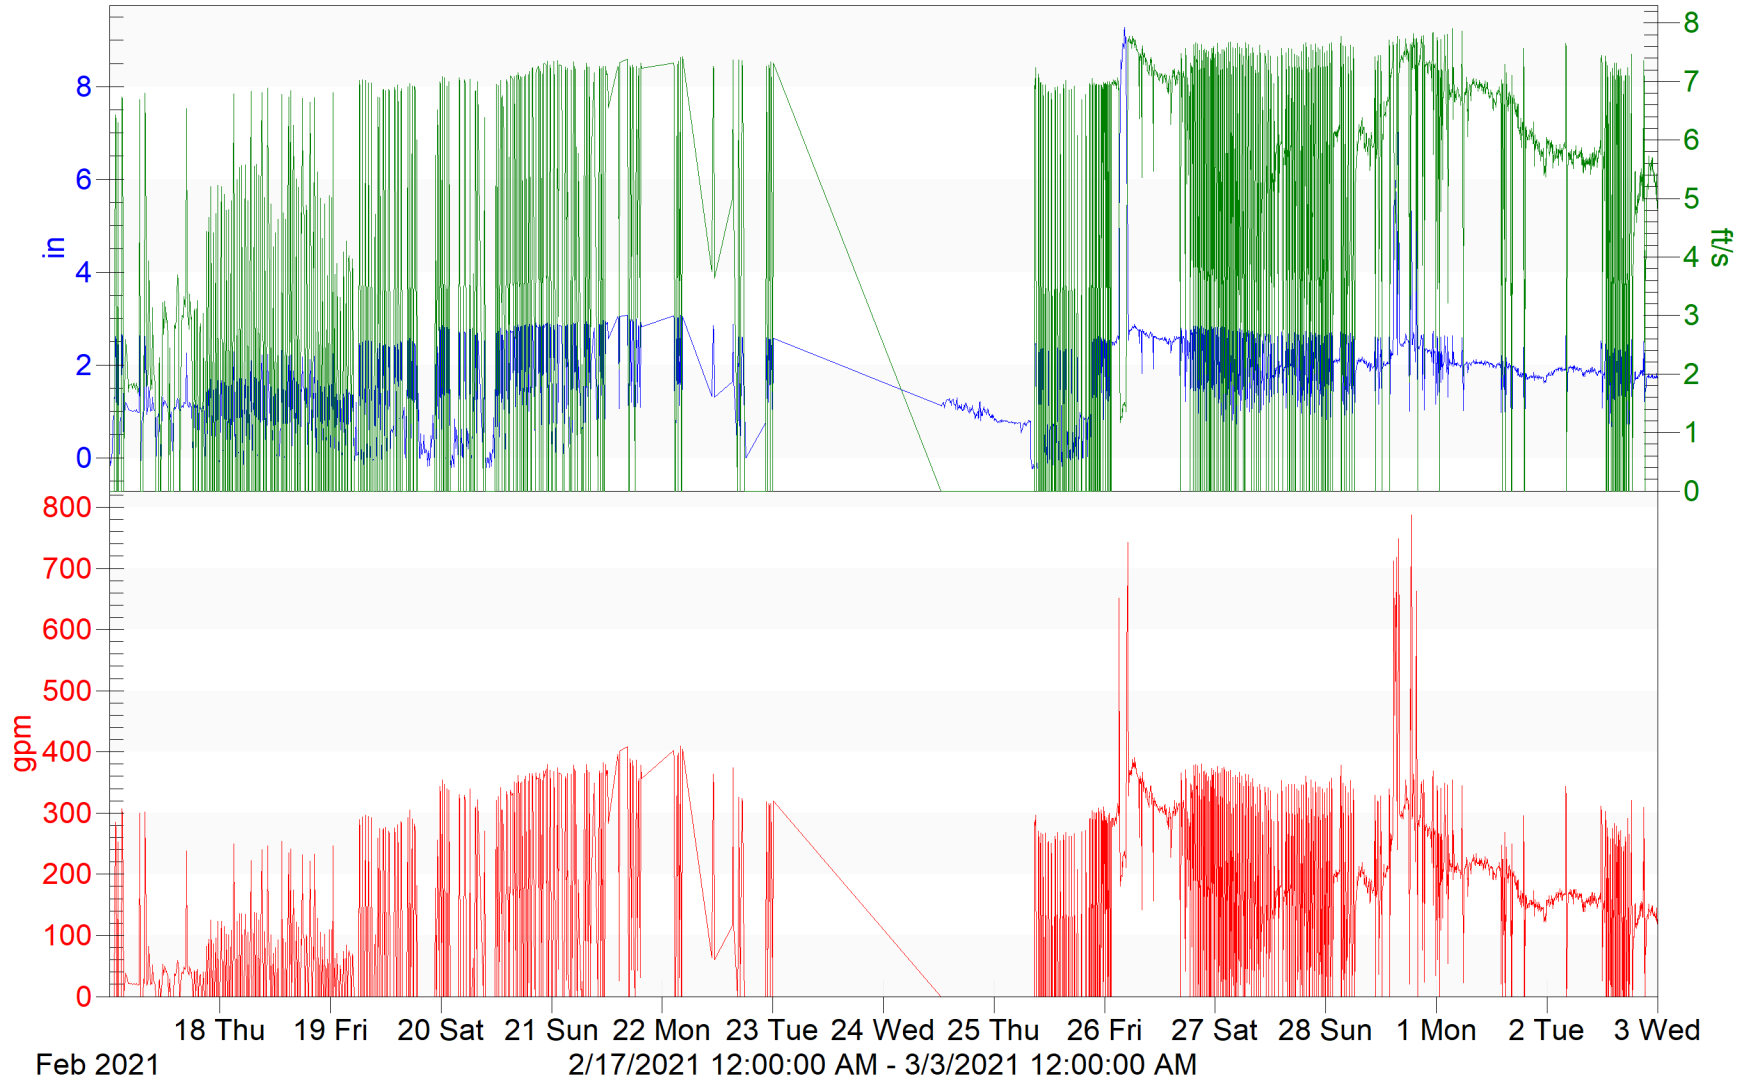
# FM123

Level (1.636 in):0.03

Velocity (4.040 ft/s):0.00

Flow Rate (2.529 mgal):0.00

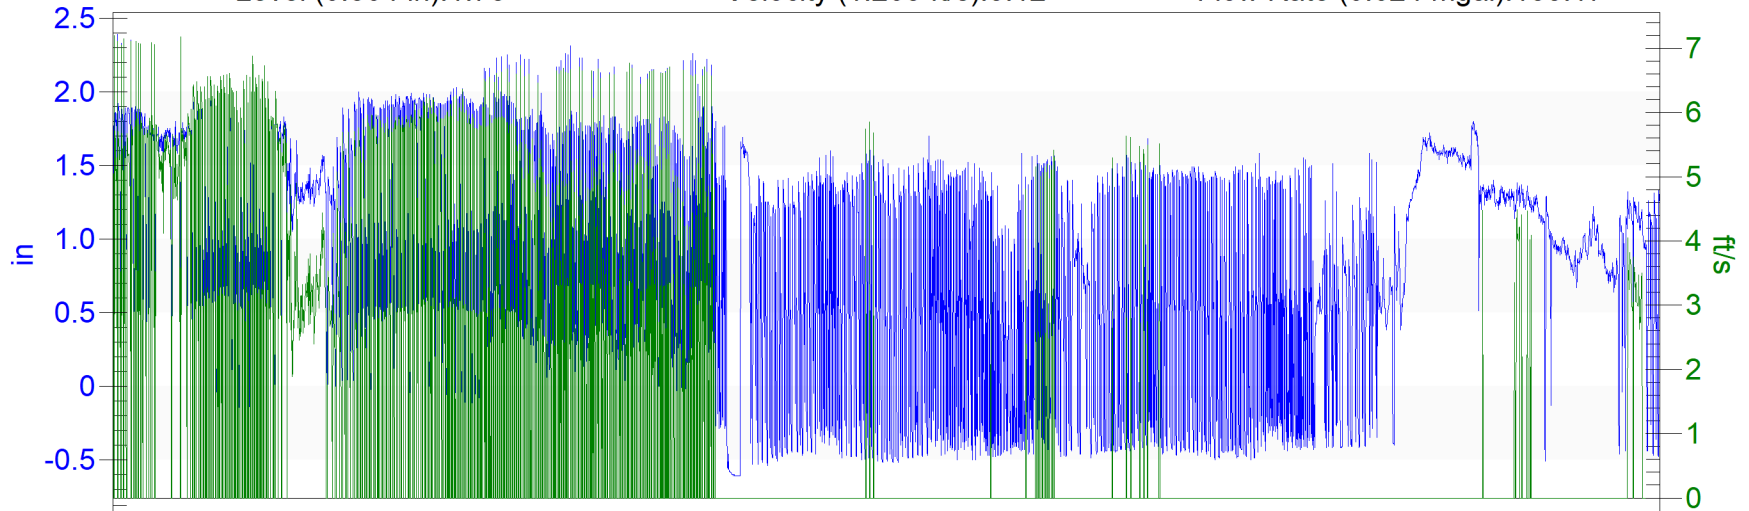
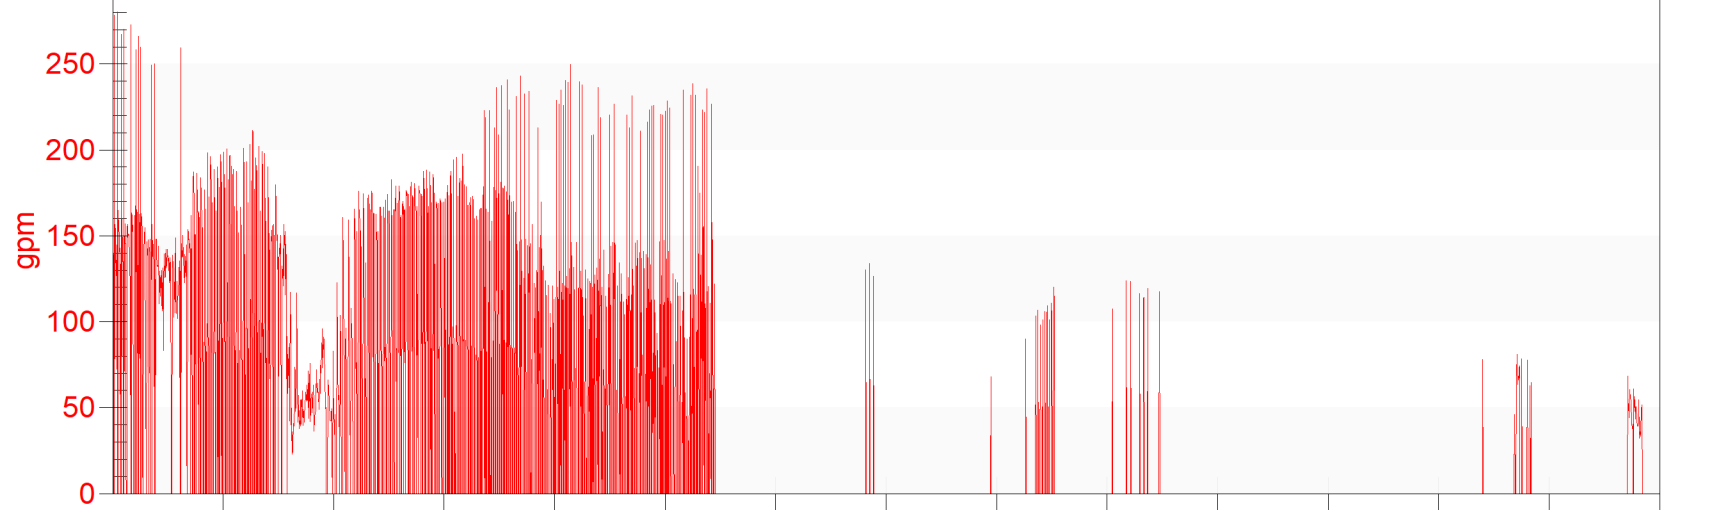
# FM123

Level (0.804 in):1.78

Velocity (1.205 ft/s):5.12

Flow Rate (0.624 mgal):133.17

4 Thu 5 Fri 6 Sat 7 Sun 8 Mon 9 Tue 10 Wed 11 Thu 12 Fri 13 Sat 14 Sun 15 Mon 16 Tue 17 Wed  
Mar 2021  
3/3/2021 12:00:00 AM - 3/17/2021 12:00:00 AM
