# MENA, AR

# FLOW MONITORING REPORT

## FEBRUARY – MAY 2021

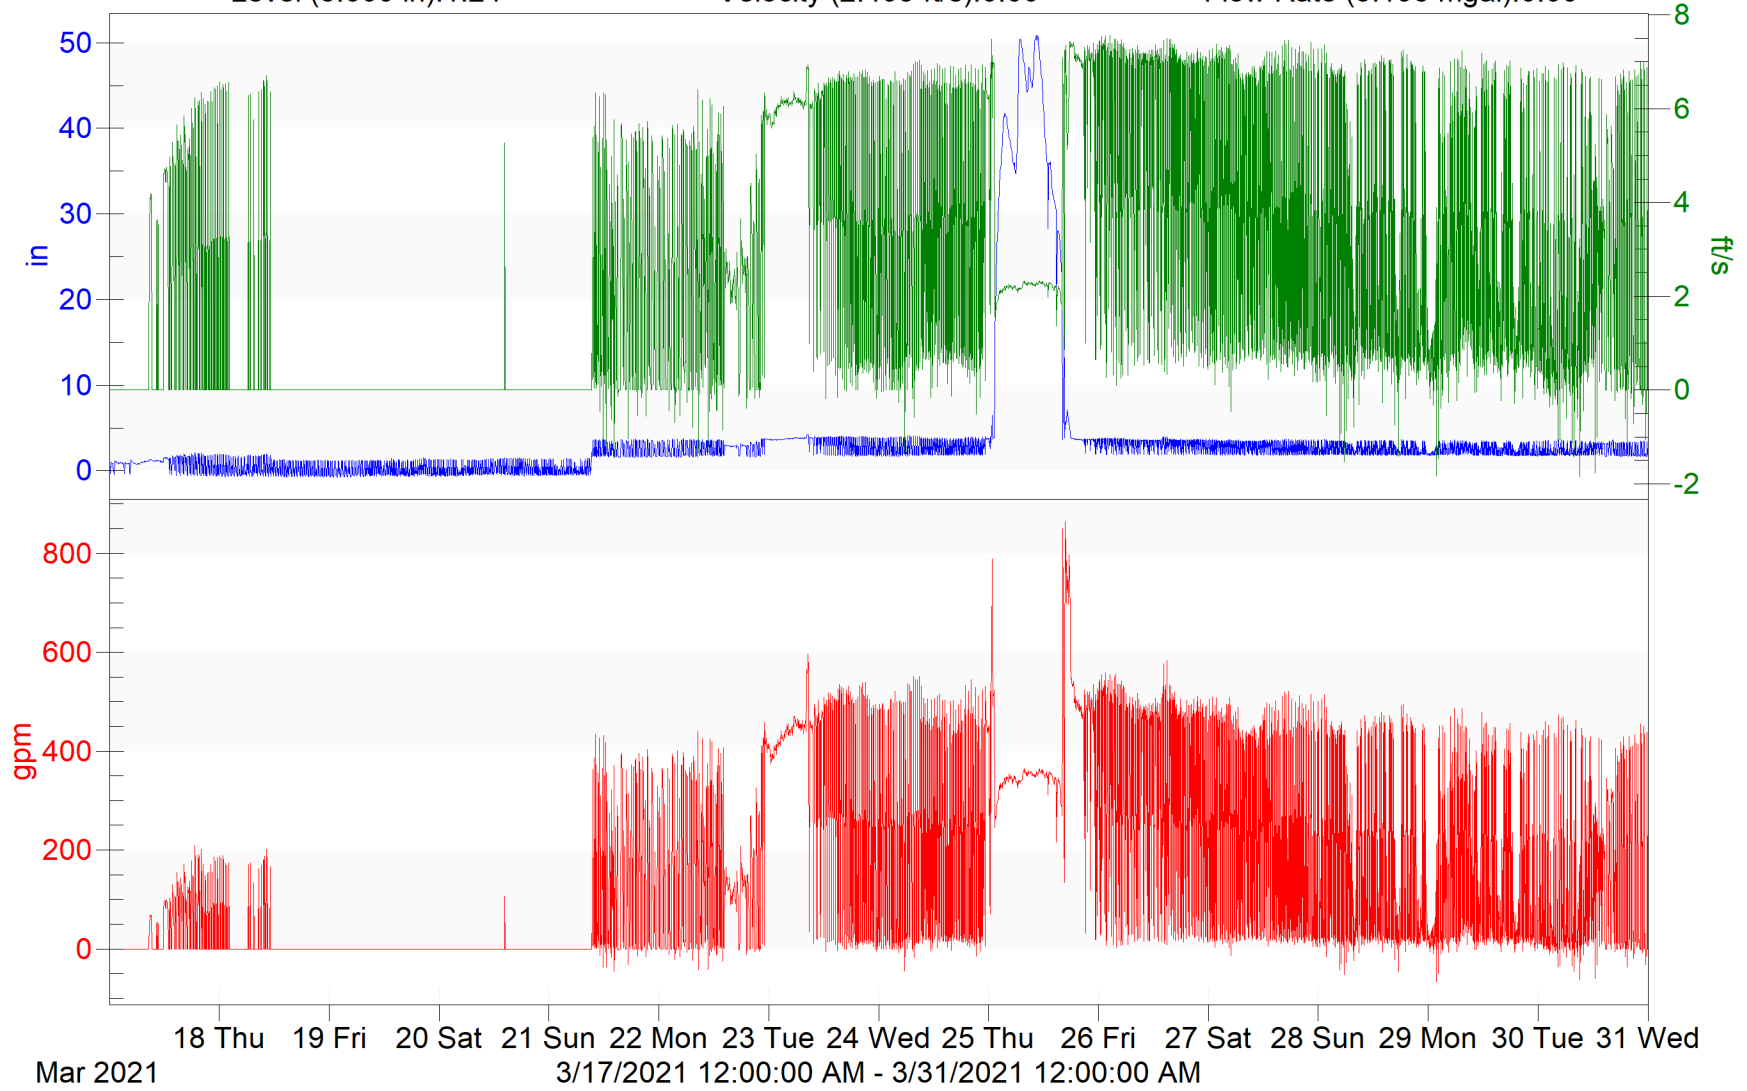
# FM123

Level (3.600 in):1.24

Velocity (2.403 ft/s):0.00

Flow Rate (3.195 mgal):0.00

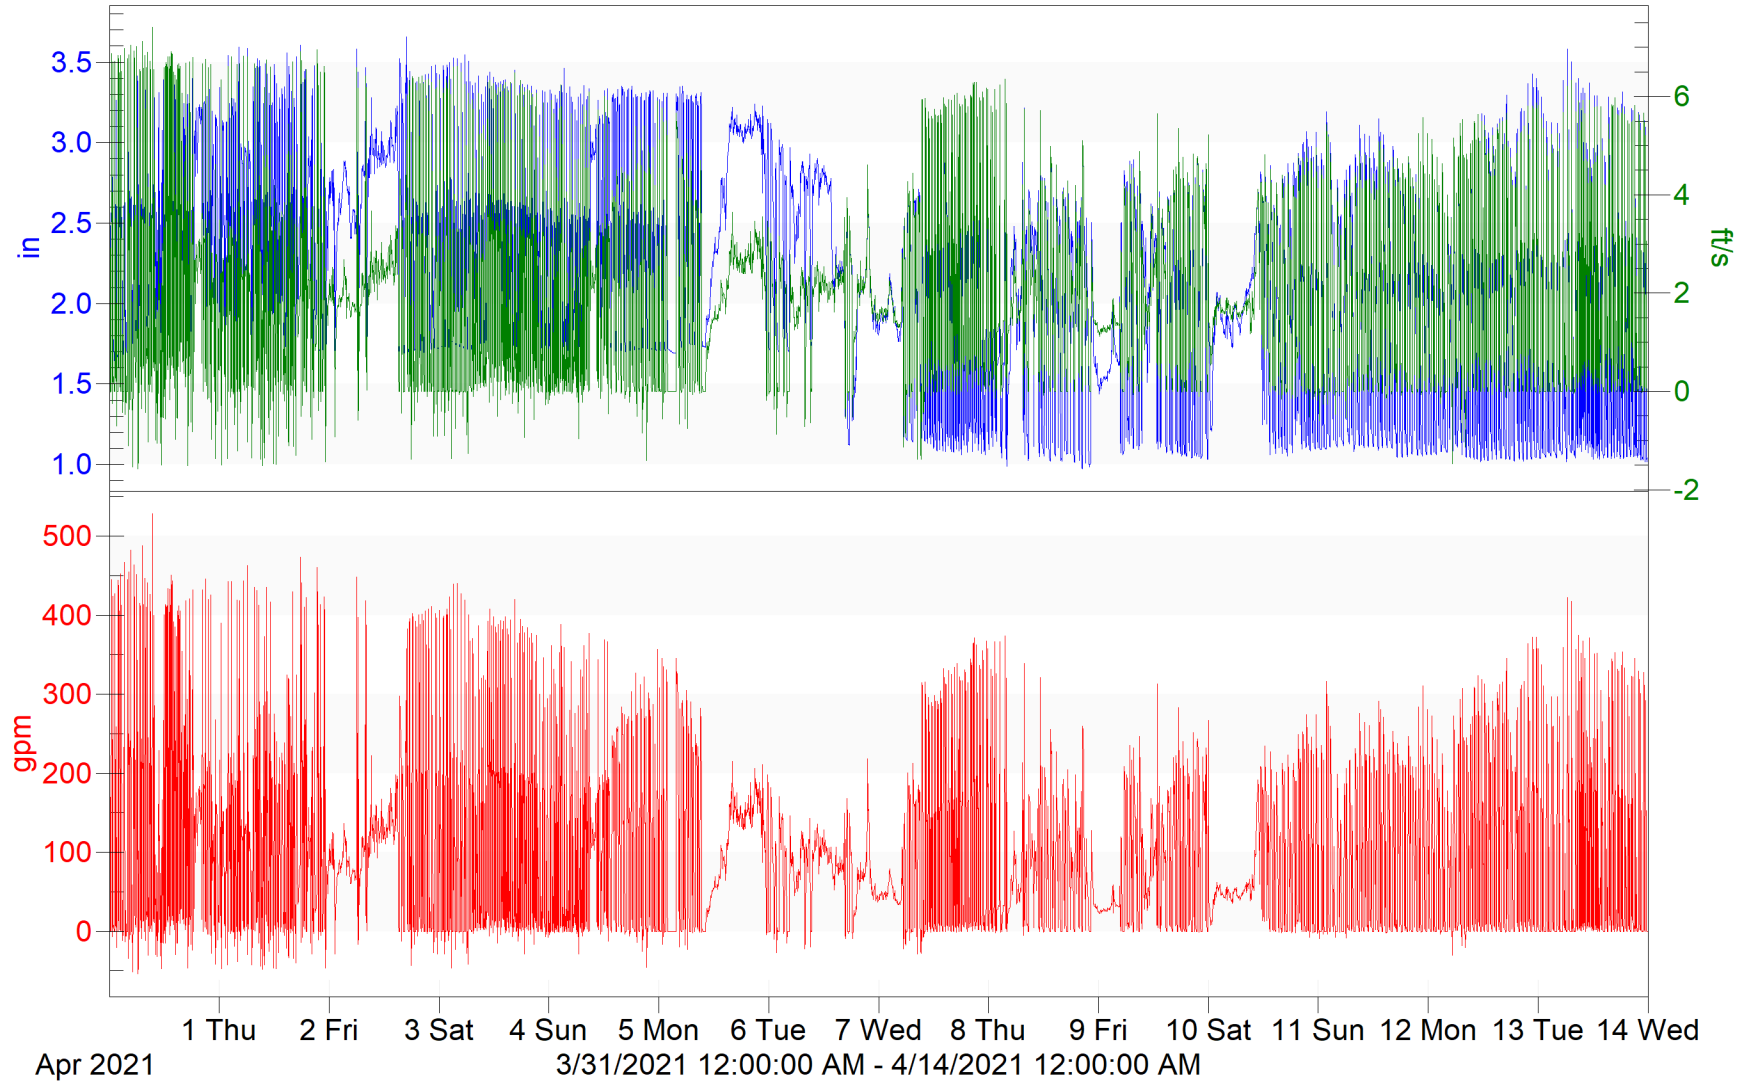
# FM123

Level (2.151 in):1.91

Velocity (1.894 ft/s):-0.82

Flow Rate (1.891 mgal):-23.56

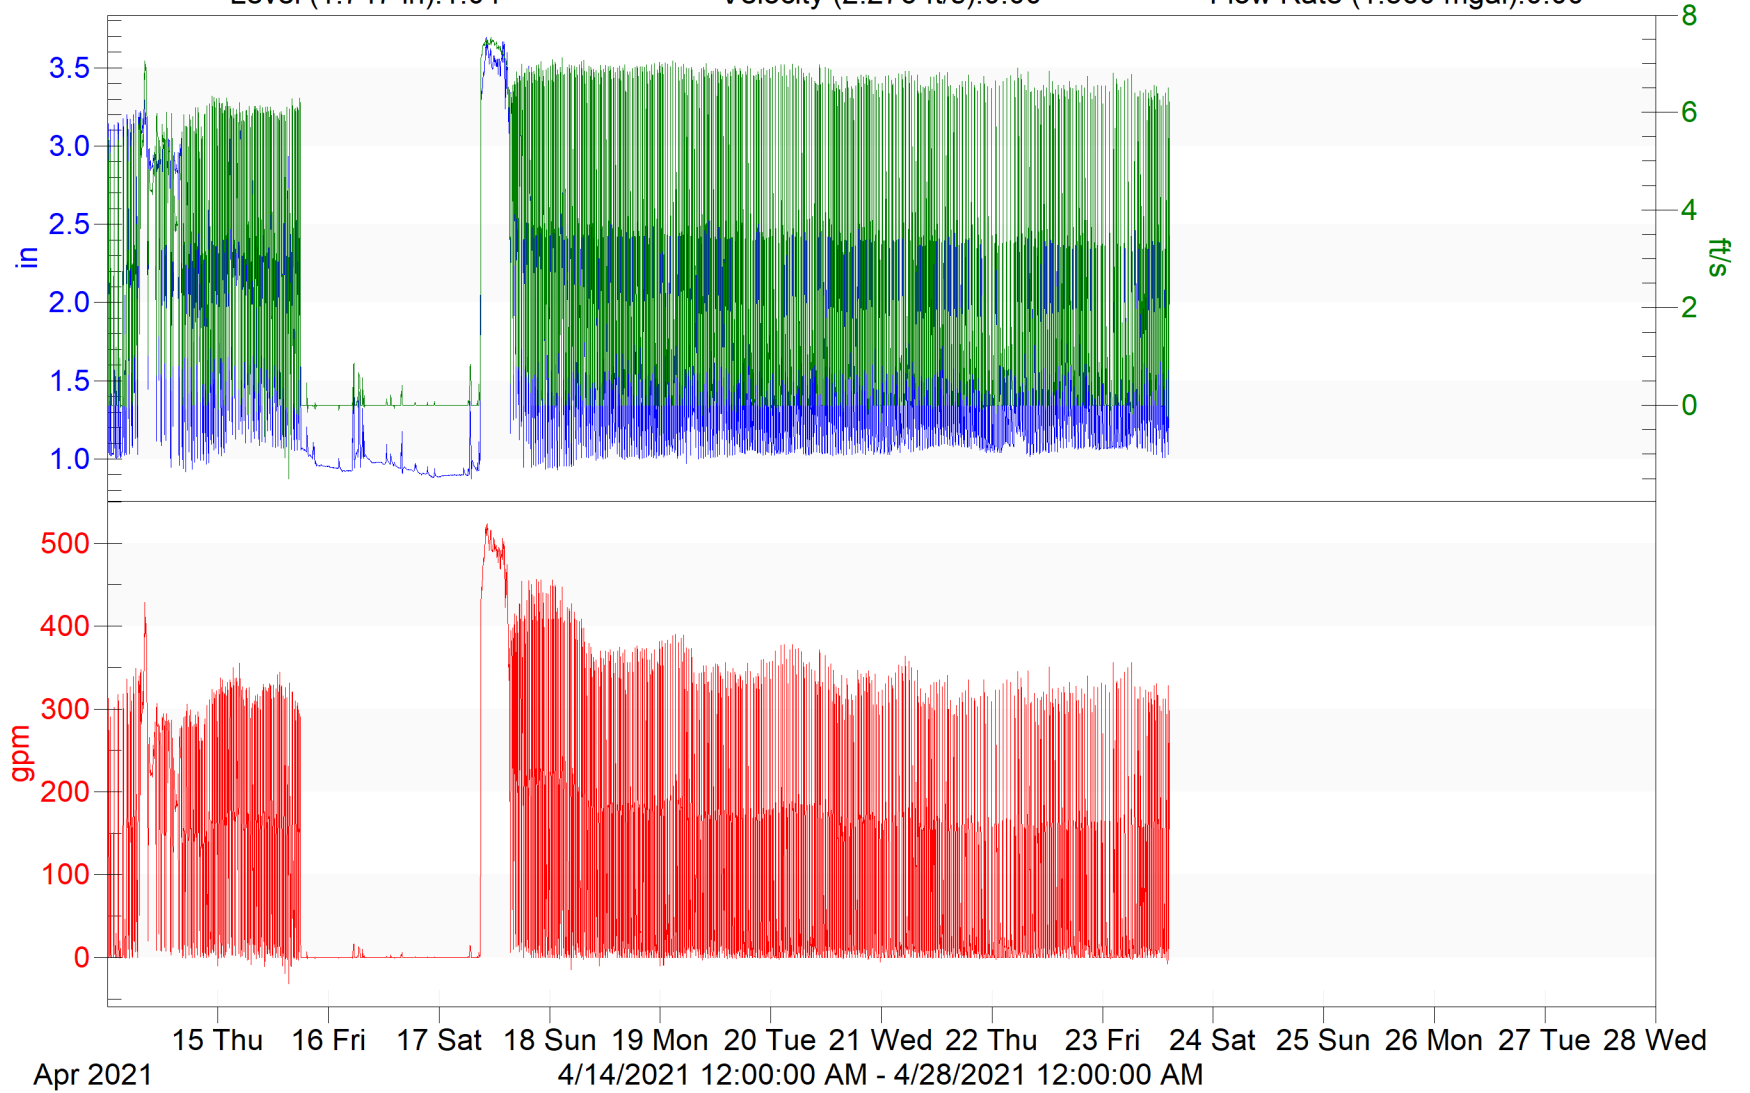
# FM123

Level (1.747 in):1.04

Velocity (2.276 ft/s):0.00

Flow Rate (1.560 mgal):0.00

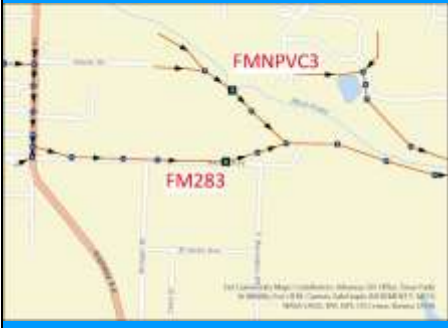
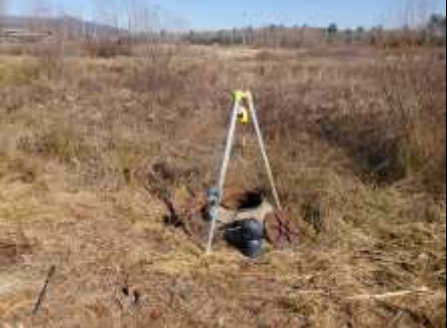
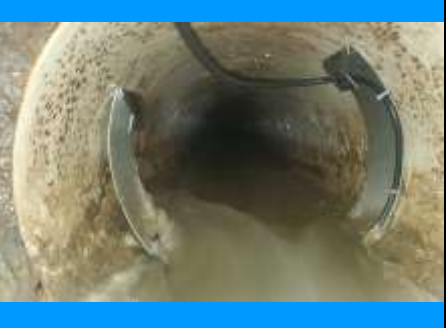
Site ID	Device Type	Installation Date	Installed By
<b>FM283</b>	Flow Meter	2/3/2021	J. Cawthon
Address	Location Details		Traffic Area ?
1200 Dallas Ave	Next to high school parking lot		No
Installation Manhole	Material	Evidence of Surcharge ?	
283	Reinforced Concrete Pipe	No	
Gas Levels			
Oxygen	Carbon Monoxide	Hydrogen Sulfide	Lower Explosive Limit
20.90%	0.00%	0.00%	0
Installation Pipe	Material	Inside Diameter	
incoming	VCP	15

Hydraulic Conditions
Normal level with high velocity
General Conditions

Map_FM283	FM283 Area	FM283 Pipe
Downhole Image	Pipe Image	Install Schematic (Top)

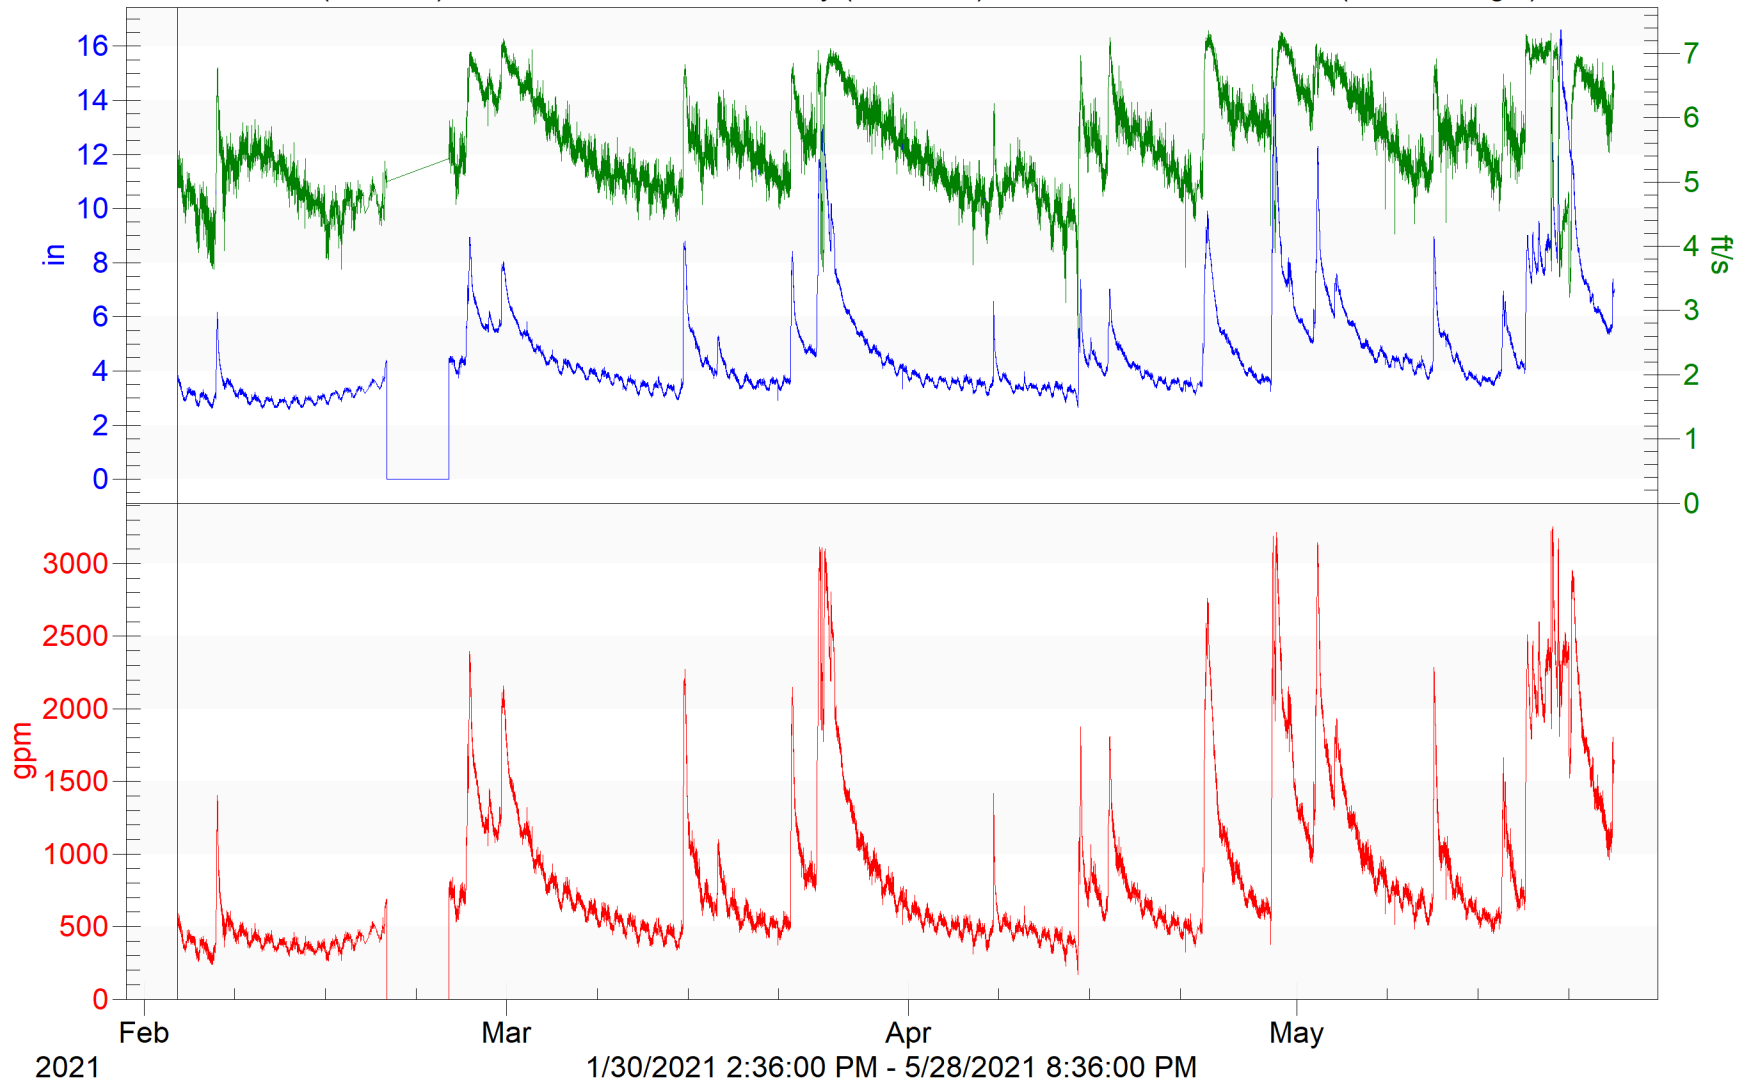
# FM283

Level (4.784 in):-0.05

Velocity (5.641 ft/s):0.00

Flow Rate (133.511 mgal):0.00

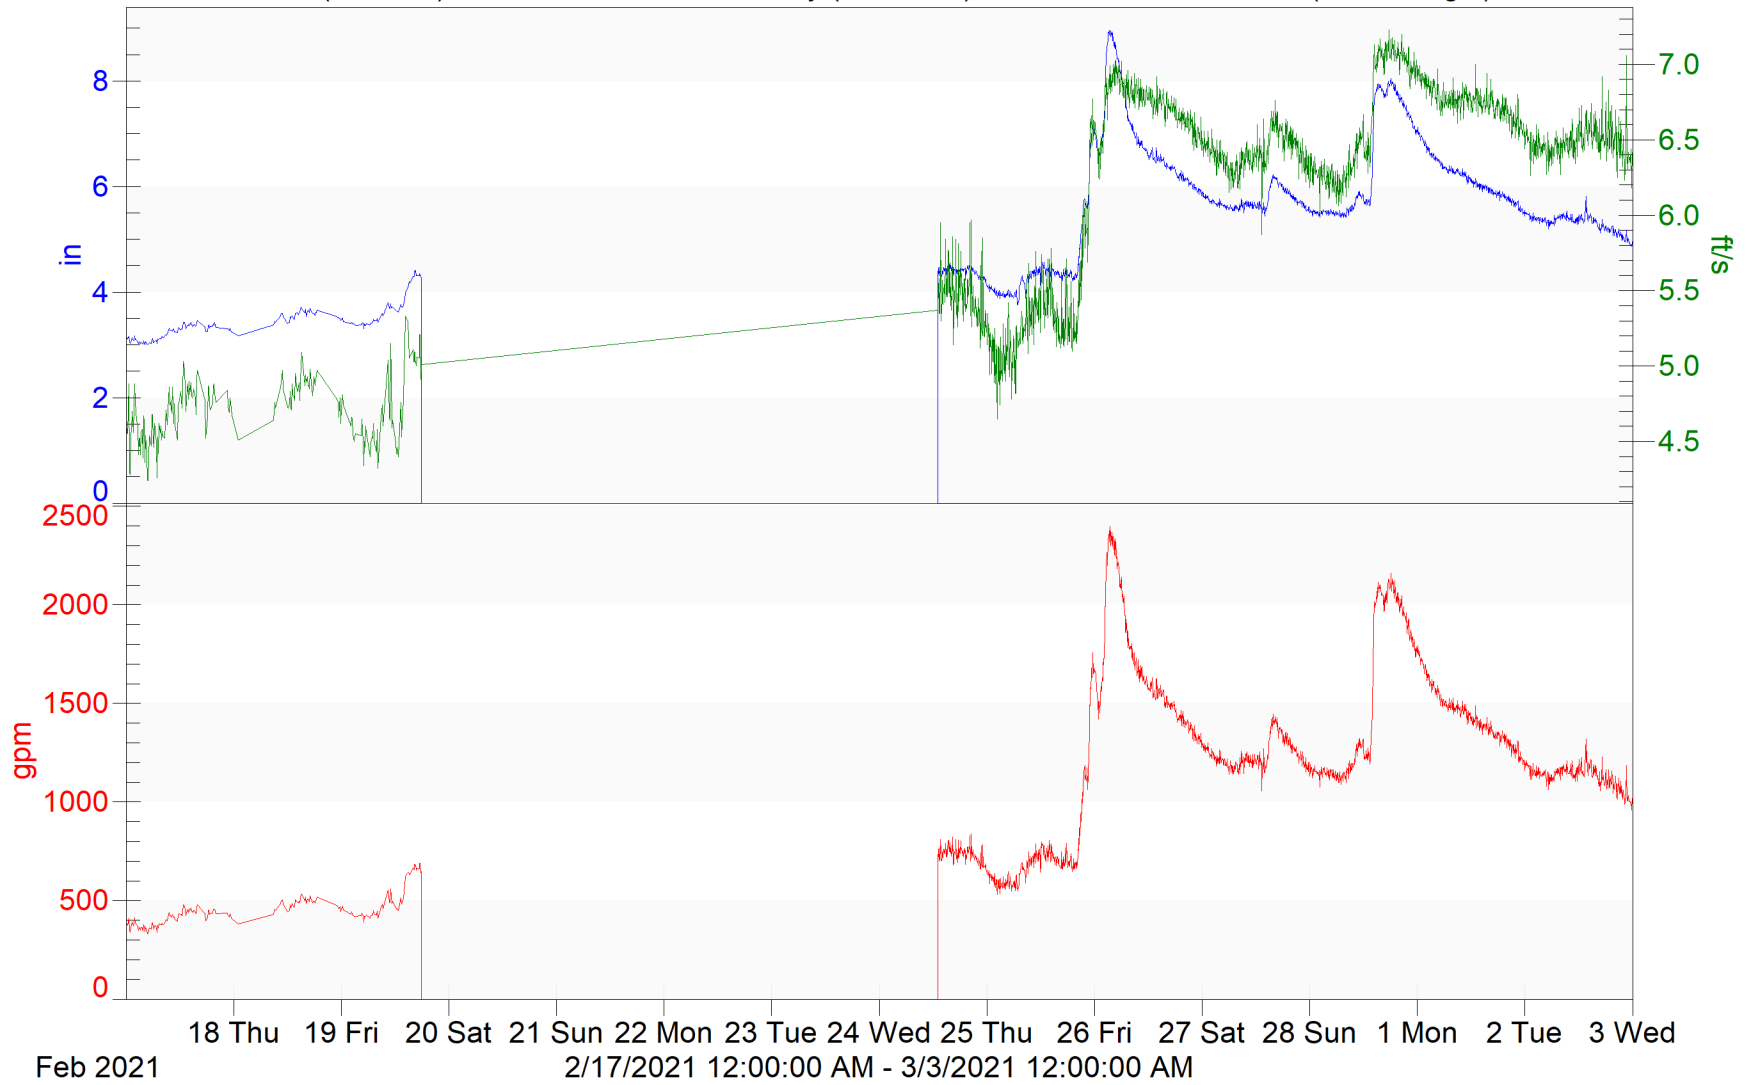
# FM283

Level (5.477 in):3.13

Velocity (6.153 ft/s):4.62

Flow Rate (13.413 mgal):384.95

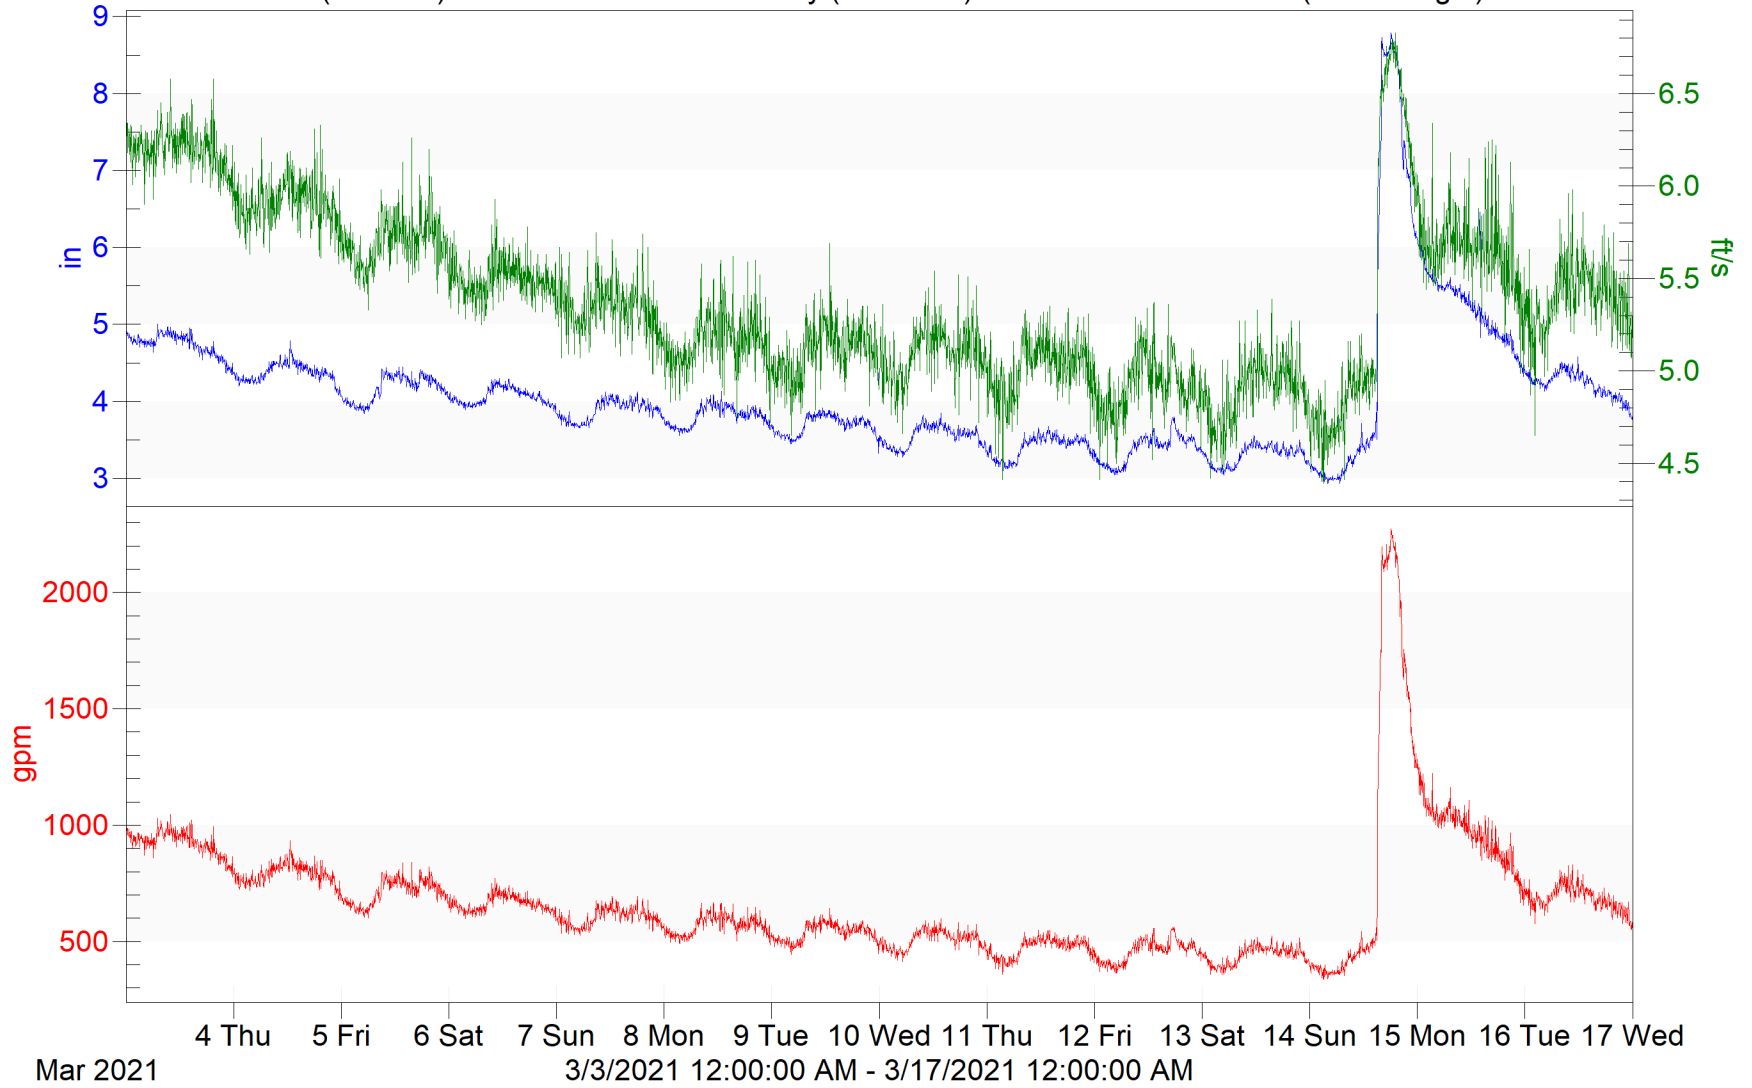
# FM283

Level (4.042 in):4.99

Velocity (5.379 ft/s):6.46

Flow Rate (13.333 mgal):1035.39

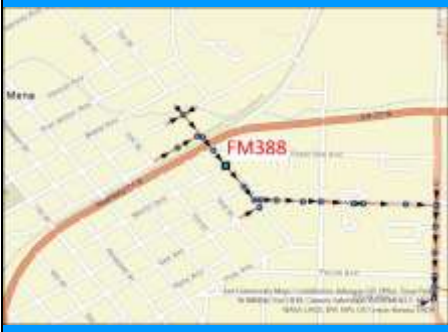
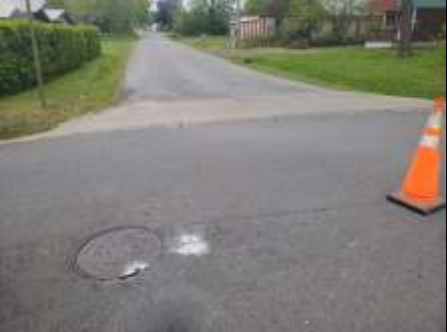
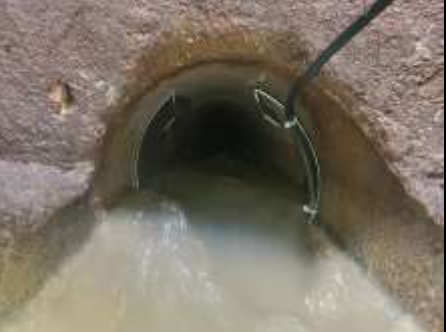
Map Image	Area Image	Sensor Ring Image

Site ID	Device Type	Installation Date	Installed By
<b>FM388</b>	Flow Meter	4/23/2021	J. Cawthon
Address	Location Details		Traffic Area ?
1st and Martin St.	middle of the intersection		Yes
Installation Manhole	Material	Evidence of Surcharge ?	
388	Brick	No	
Gas Levels			
Oxygen	Carbon Monoxide	Hydrogen Sulfide	Lower Explosive Limit
20.70%	10.00%	0.00%	0
Installation Pipe	Material	Inside Diameter	
incoming	VCP	12

Hydraulic Conditions
Normal level with high velocity
General Conditions
light traffic

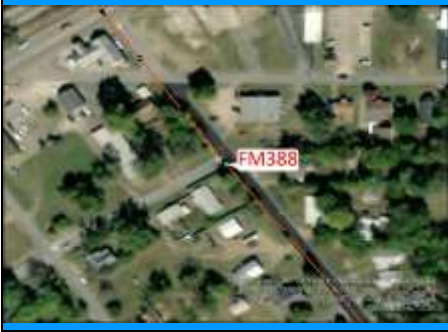
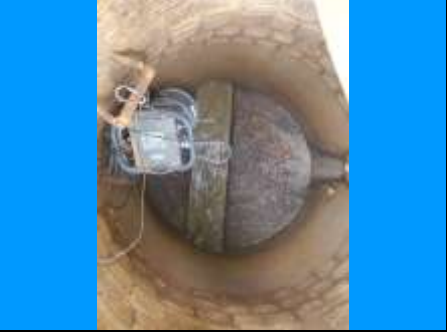
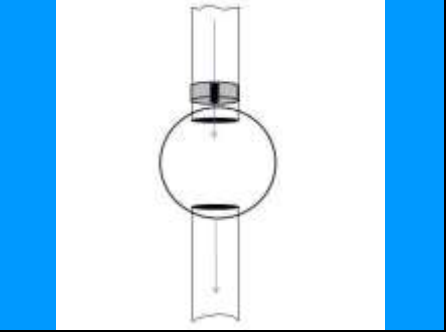
Aerial_FM388	FM388 Inner	FM388 Schematic

Map_FM388	FM388 Area	FM388 Pipe
Downhole Image	Pipe Image	Install Schematic (Top)

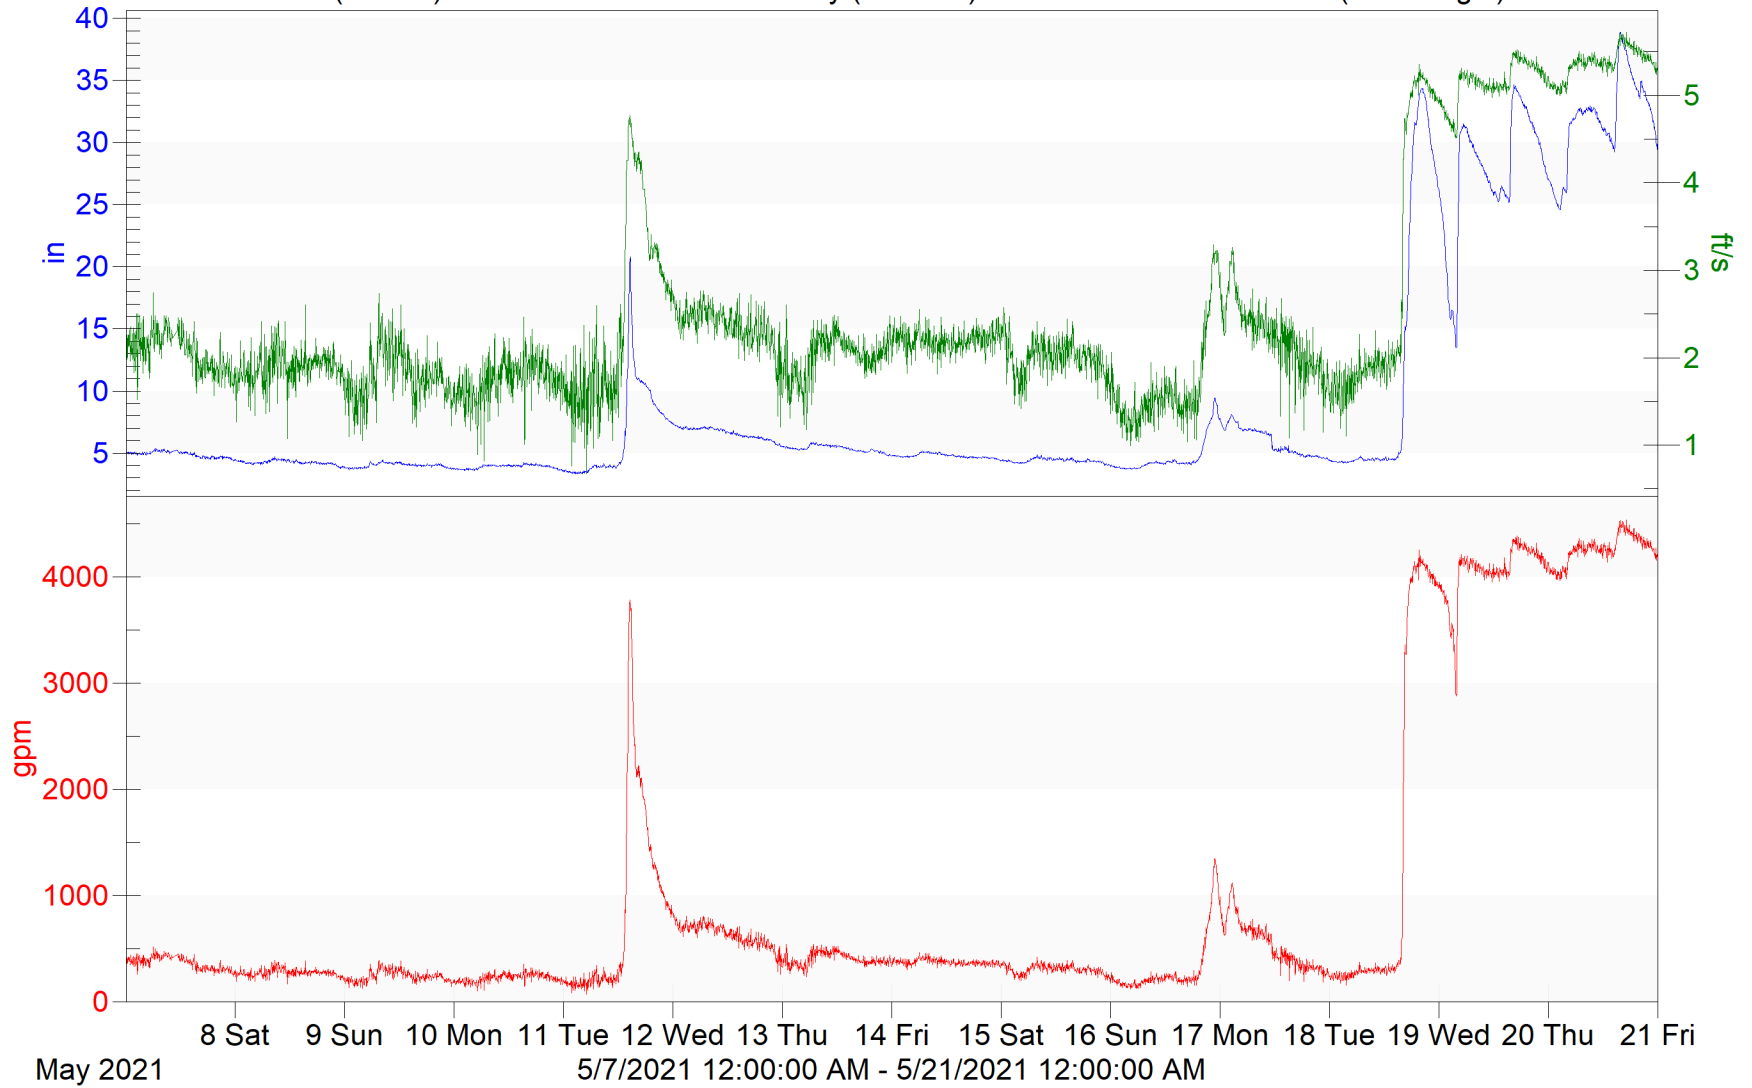
# FM 388

Level (9.09 in):5.02

Velocity (2.57 ft/s):2.27

Flow Rate (20.59 mgal):409.56

There is one issue to note during wet weather flows. FM388 flows into meter FM283. During dry weather flow, FM388 is substantially lower than FM283. But during wet weather events, the peaks are higher at FM388 than FM283. This shows that there is an overflow problem between these two sites. Due to the very high spikes in wet weather flow at FM388, it appears that the issues are mainly caused upstream from this site.

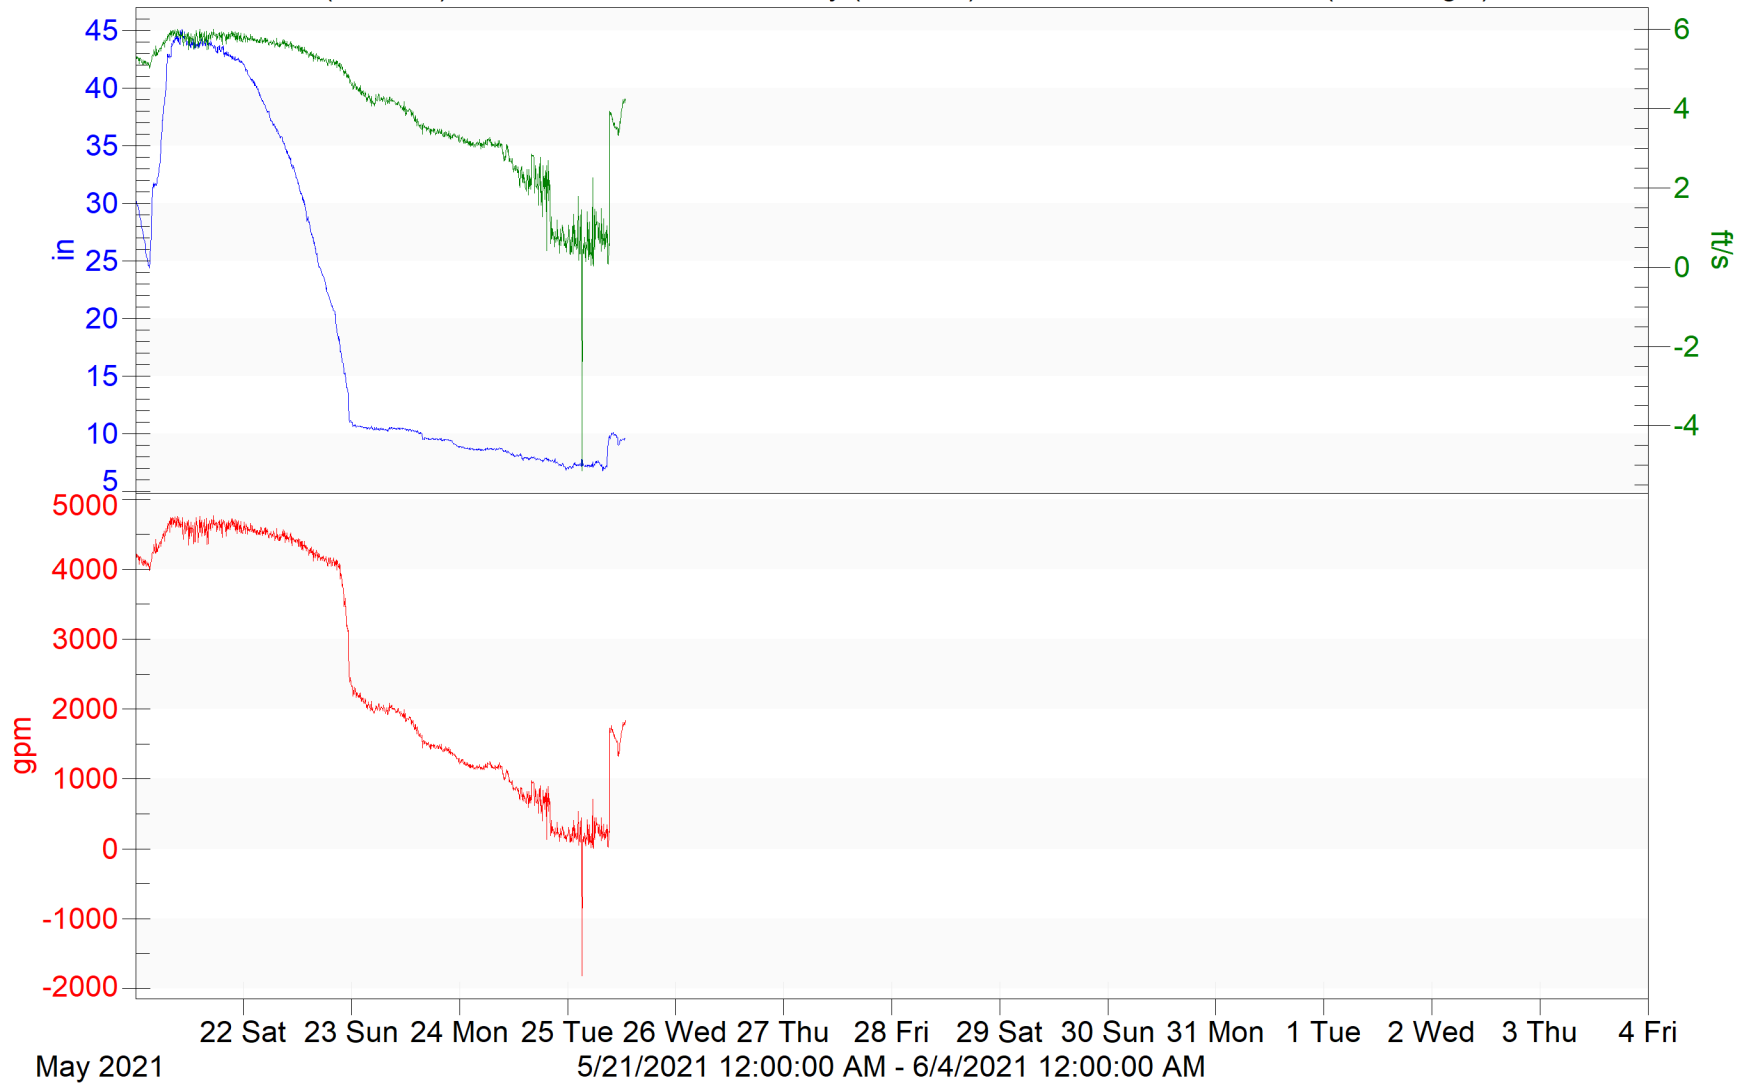
# FM 388

Level (20.37 in):30.27

Velocity (4.02 ft/s):5.26

Flow Rate (16.88 mgal):4171.68

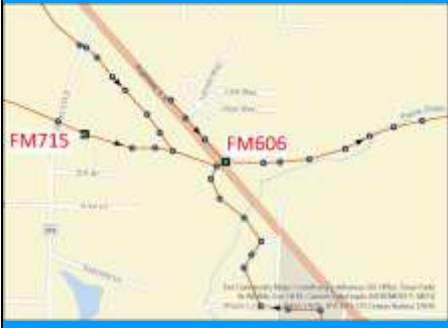
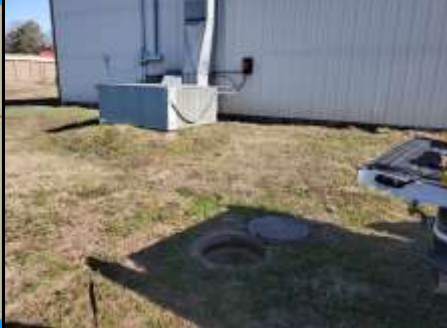
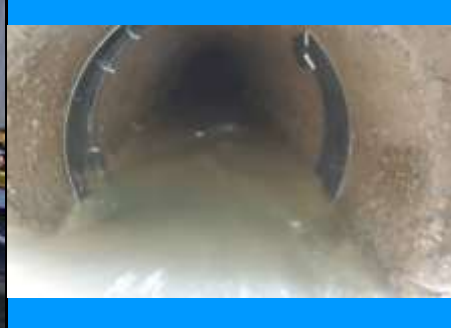
Map Image	Area Image	Sensor Ring Image

Site ID	Device Type	Installation Date	Installed By
<b>FM606</b>	Flow Meter	2/3/2021	J. Cawthon
Address	Location Details		Traffic Area ?
121 Industrial Ln	next to waste company		No
Installation Manhole	Material	Evidence of Surcharge ?	
606	Reinforced Concrete Pipe	No	
Gas Levels			
Oxygen	Carbon Monoxide	Hydrogen Sulfide	Lower Explosive Limit
20.90%	0.00%	0.00%	0
Installation Pipe	Material	Inside Diameter	
	VCP	18

Hydraulic Conditions
Normal Level with high velocity
General Conditions

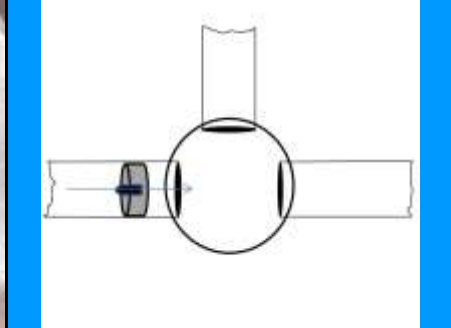
Aerial_FM606	FM606 Inner	FM606 Schematic

Map_FM606	FM606 Area	FM606 Pipe
Downhole Image	Pipe Image	Install Schematic (Top)

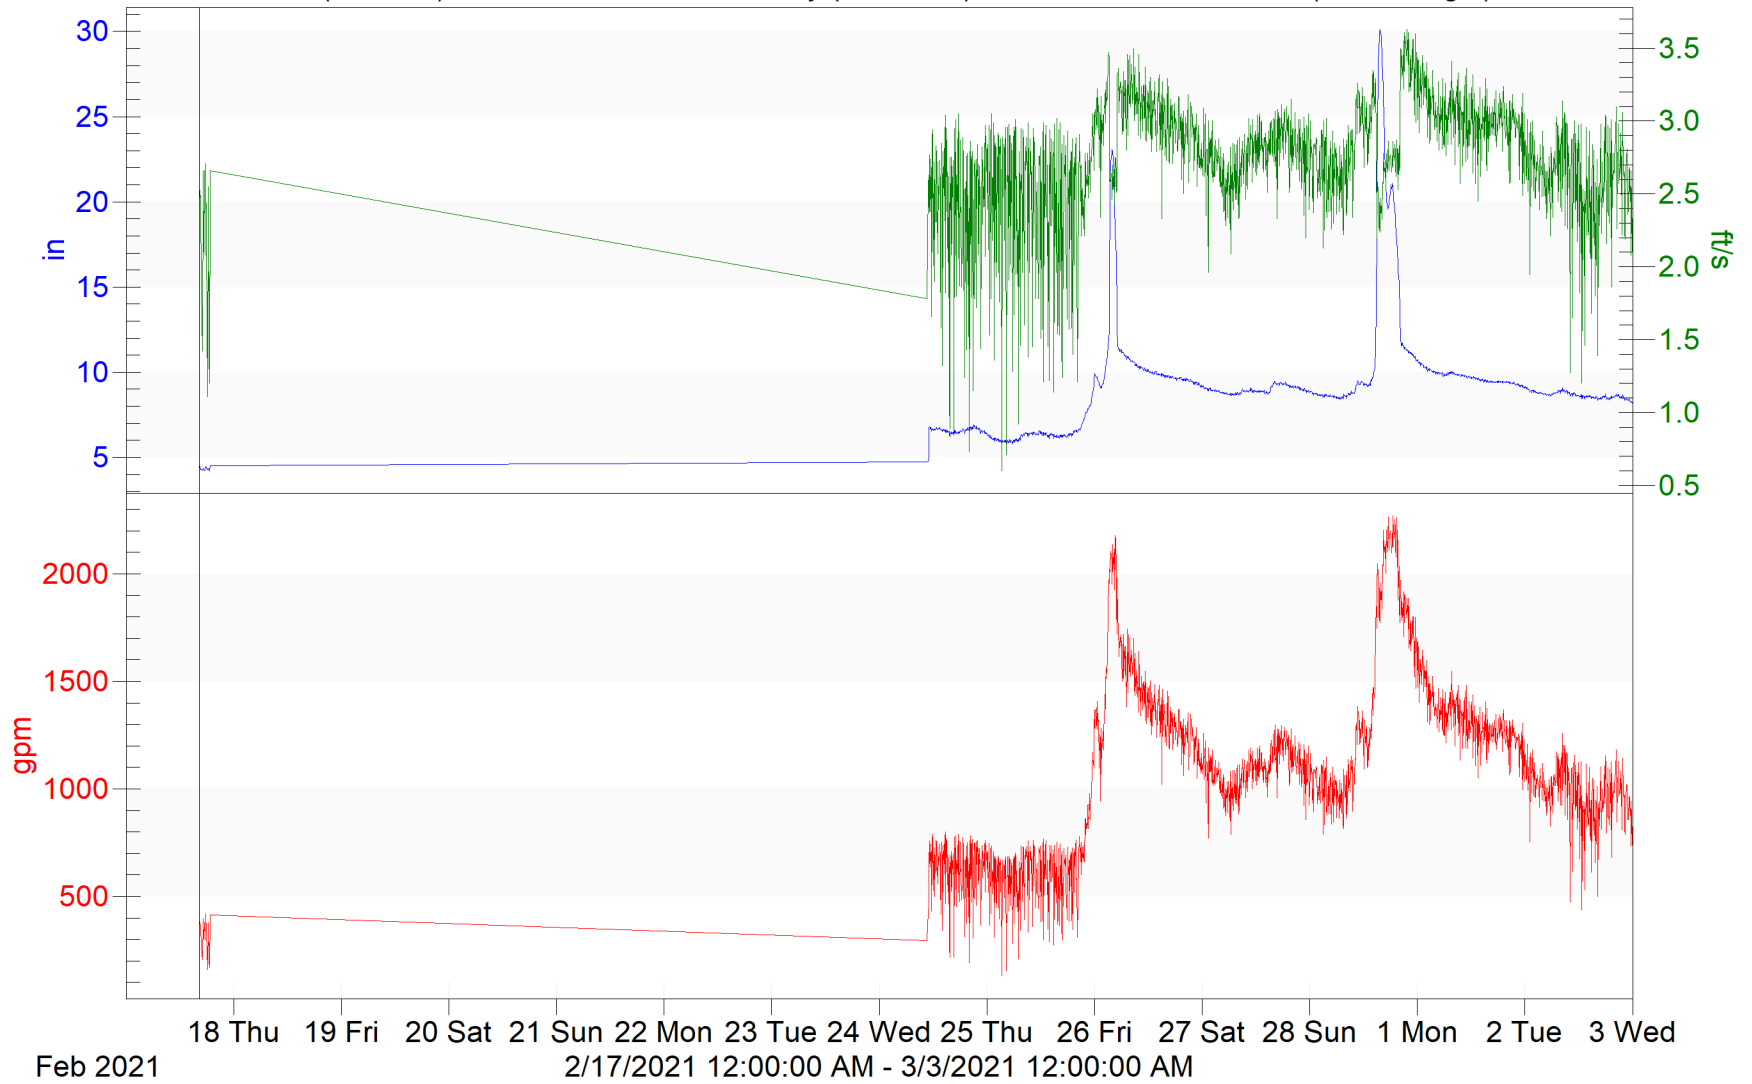
# FM606

Level (9.168 in):4.33

Velocity (2.741 ft/s):2.57

Flow Rate (13.271 mgal):378.55

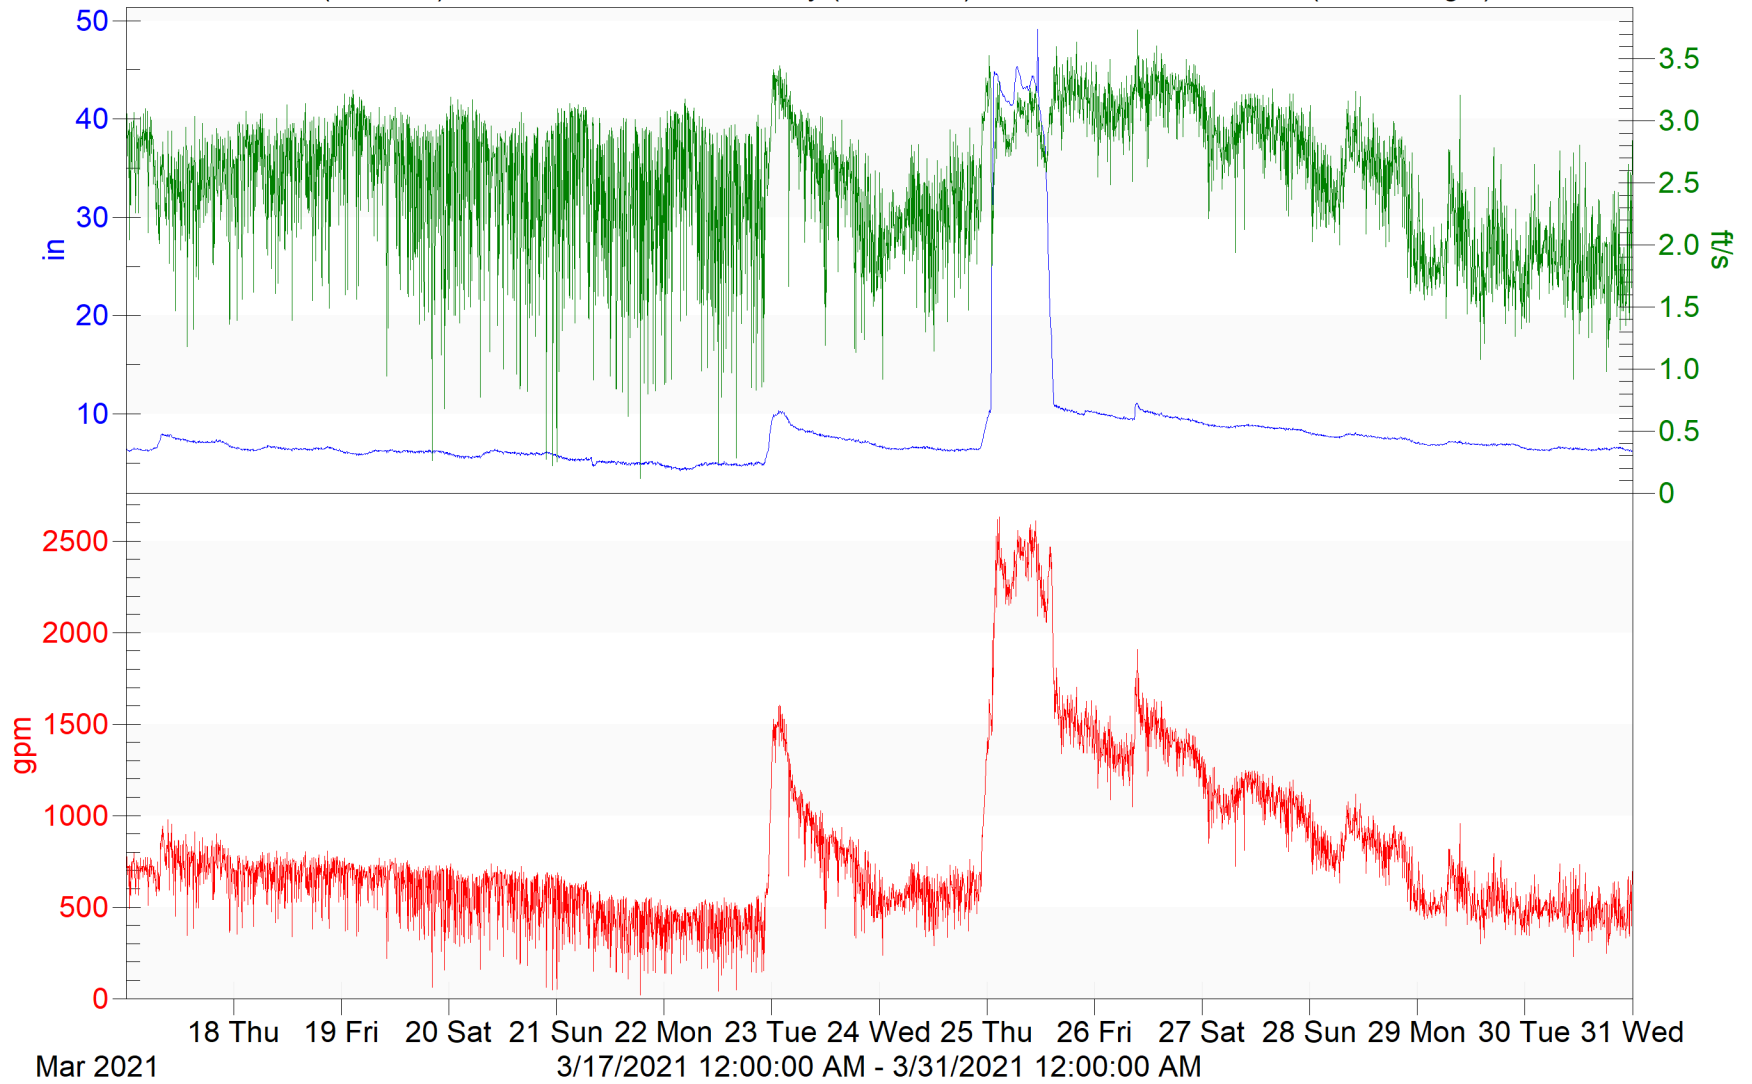
# FM606

Level (8.351 in):6.28

Velocity (2.525 ft/s):2.71

Flow Rate (16.229 mgal):666.11

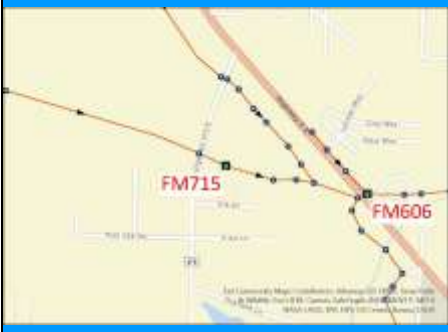
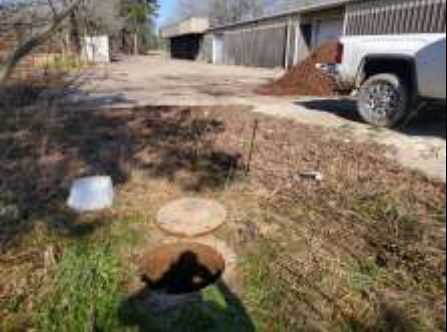
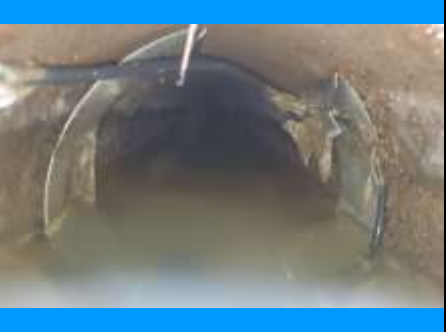
Map Image	Area Image	Sensor Ring Image

Site ID	Device Type	Installation Date	Installed By
<b>FM715</b>	Flow Meter	2/3/2021	J. Cawthon
Address	Location Details		Traffic Area ?
1 Hot Rod Ln	Next to building		No
Installation Manhole	Material	Evidence of Surge ?	
715	Reinforced Concrete Pipe	No	
Gas Levels			
Oxygen	Carbon Monoxide	Hydrogen Sulfide	Lower Explosive Limit
20.90%	0.00%	0.00%	0
Installation Pipe	Material	Inside Diameter	
	VCP	15

Hydraulic Conditions
Normal level and velocity. Evidence of surcharge
General Conditions
S/N for the AV sensor we replaced 200600587565
