# MENA, AR

# FLOW MONITORING REPORT

## FEBRUARY – MAY 2021

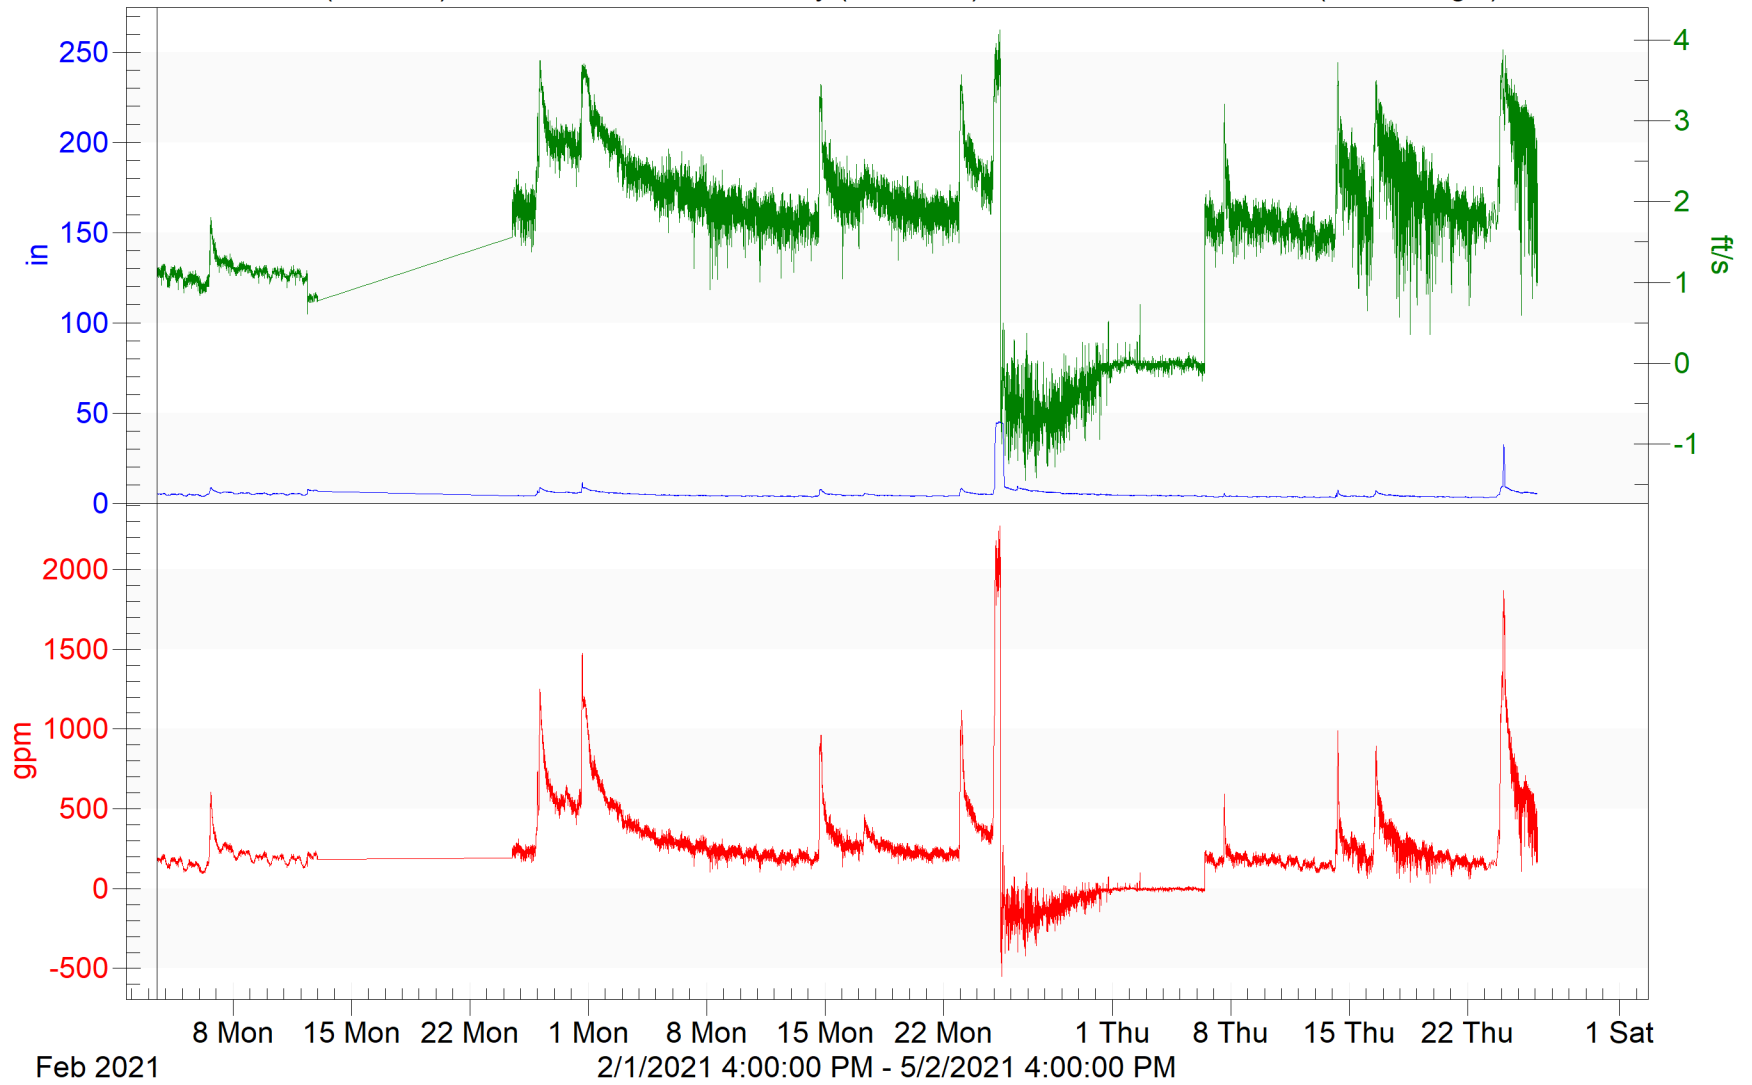
Velocity (1.603 ft/s):1.18

Flow rate (28.009 mgal):199.48

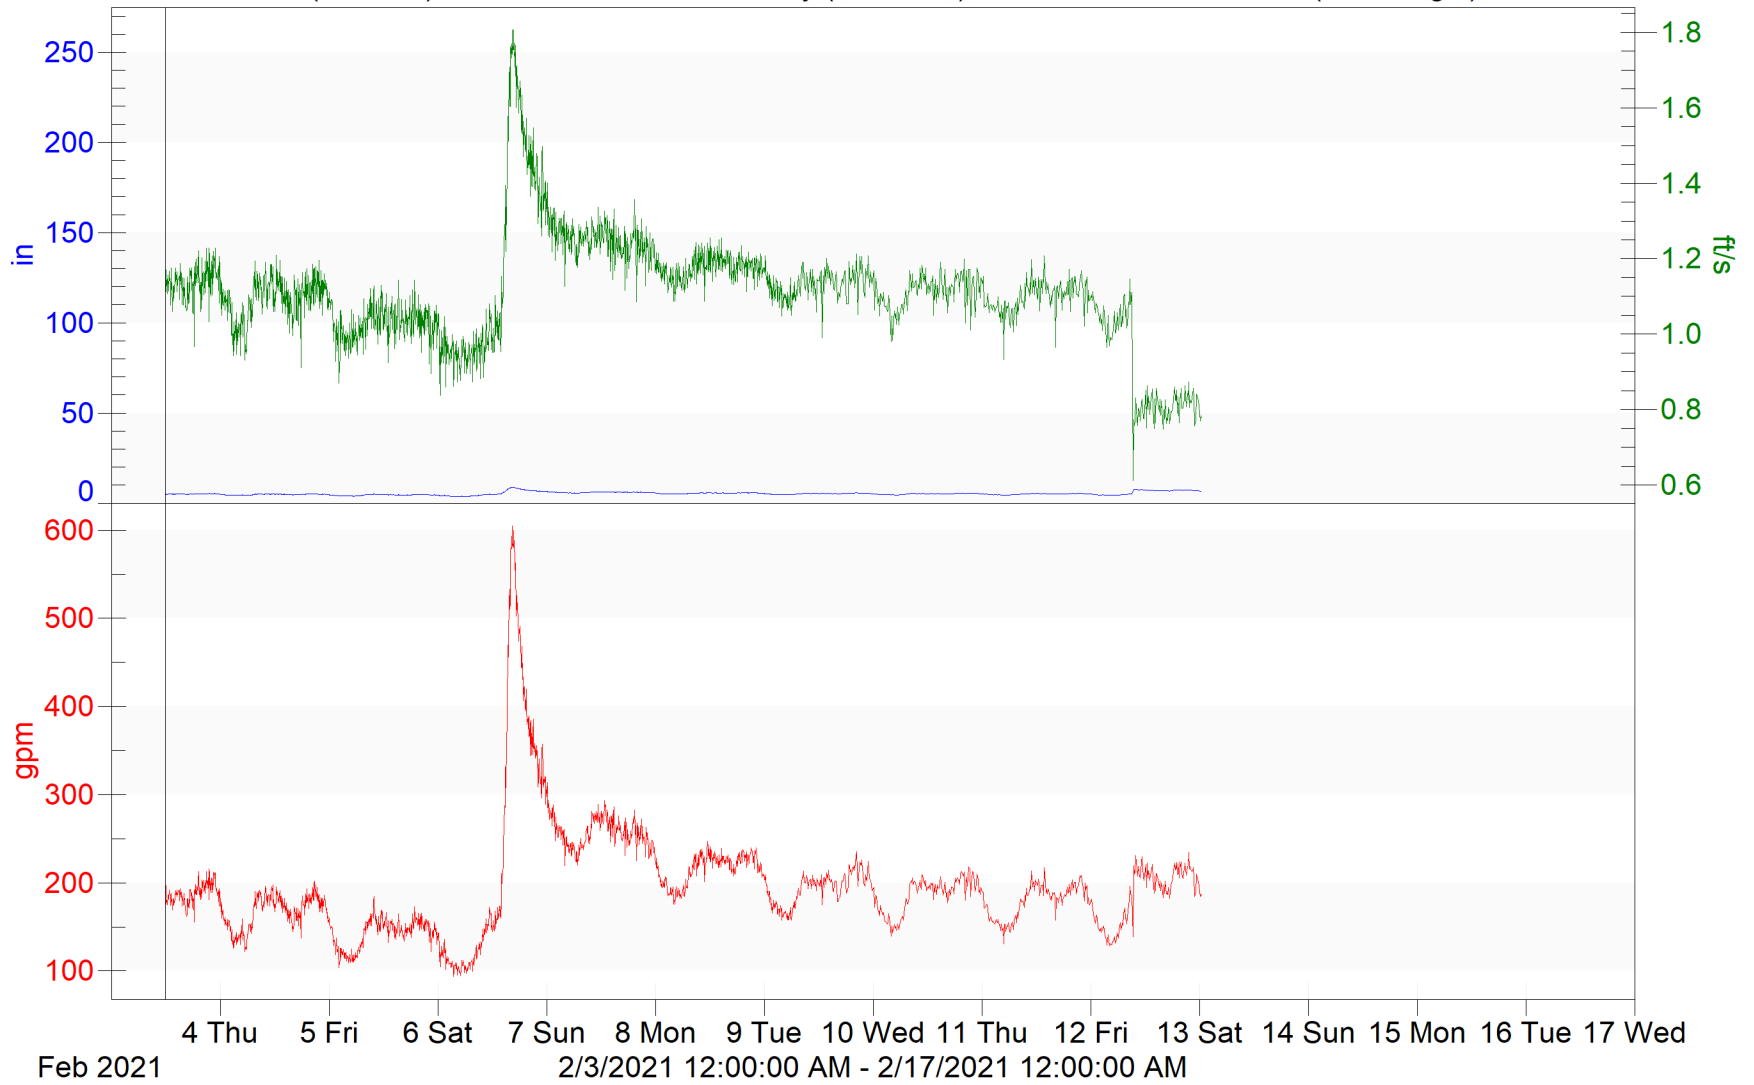
# FM715

Flowlink 5

Level (5.281 in):5.20

Velocity (1.123 ft/s):1.18

Flow rate (2.687 mgal):199.48

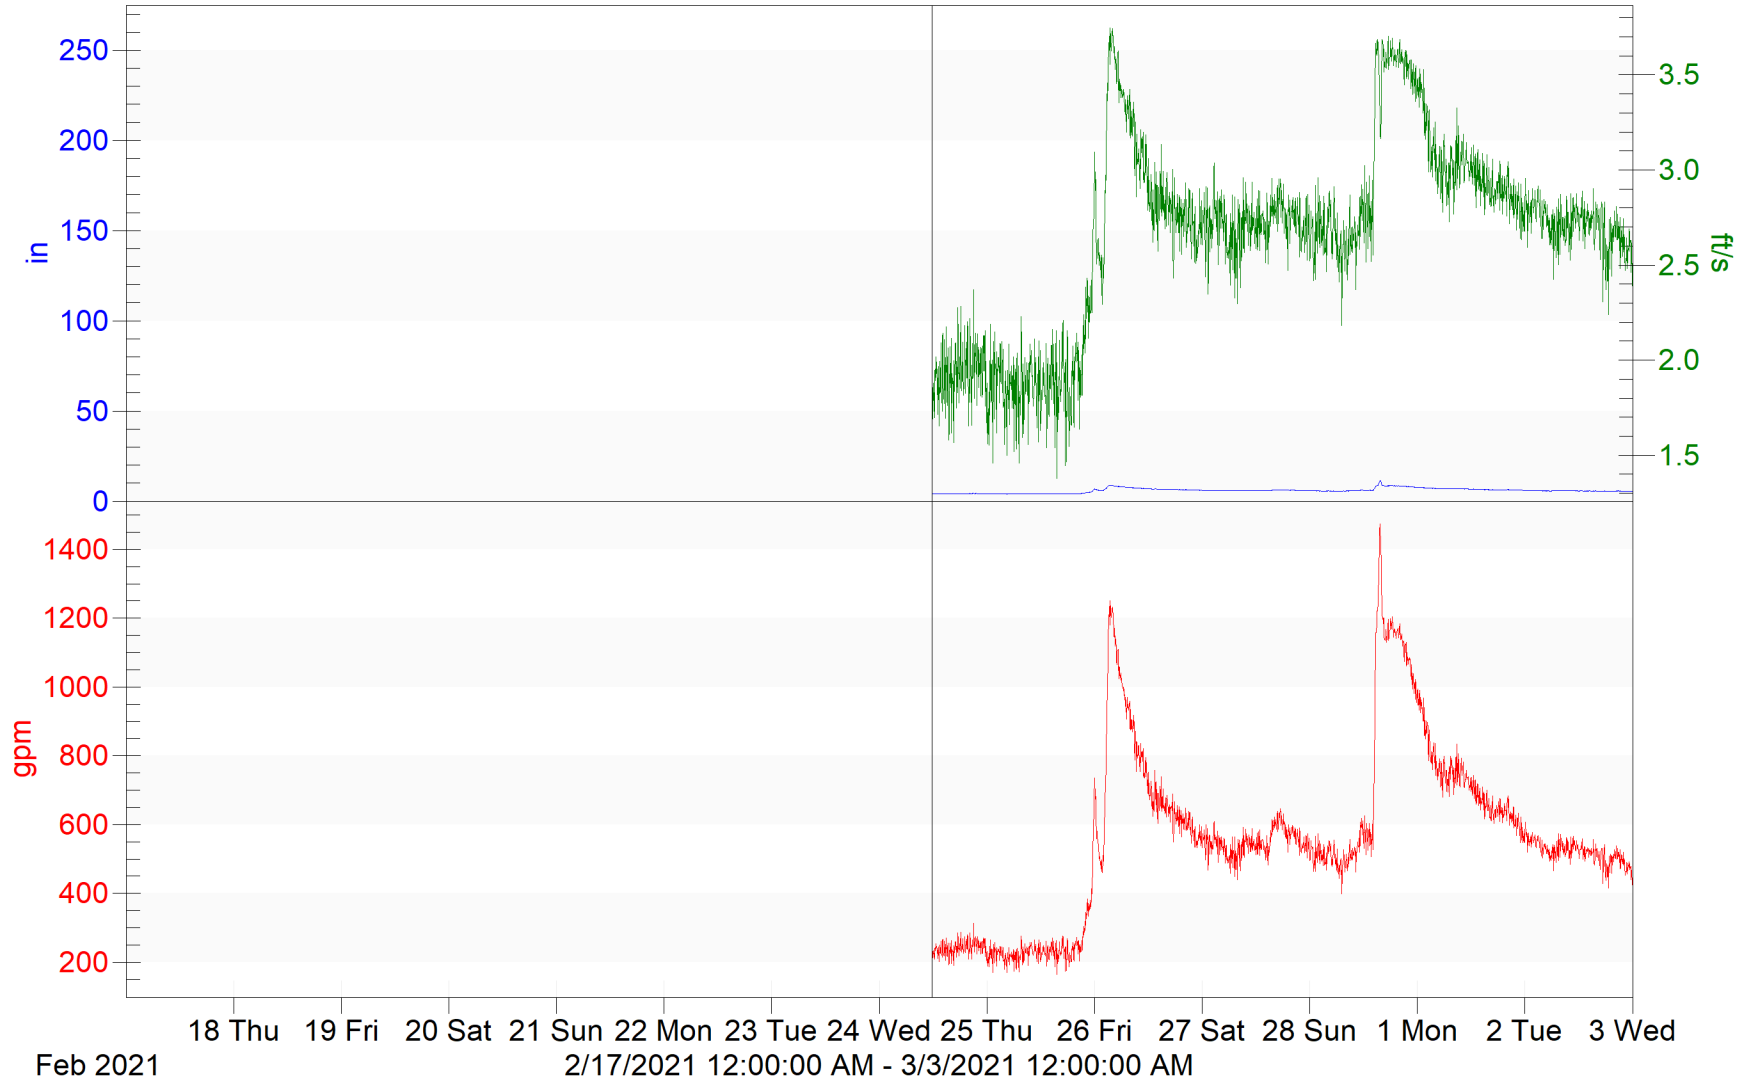
# FM715

Flowlink 5

Level (5.898 in):4.14

Velocity (2.659 ft/s):1.56

Flow rate (5.284 mgal):192.95

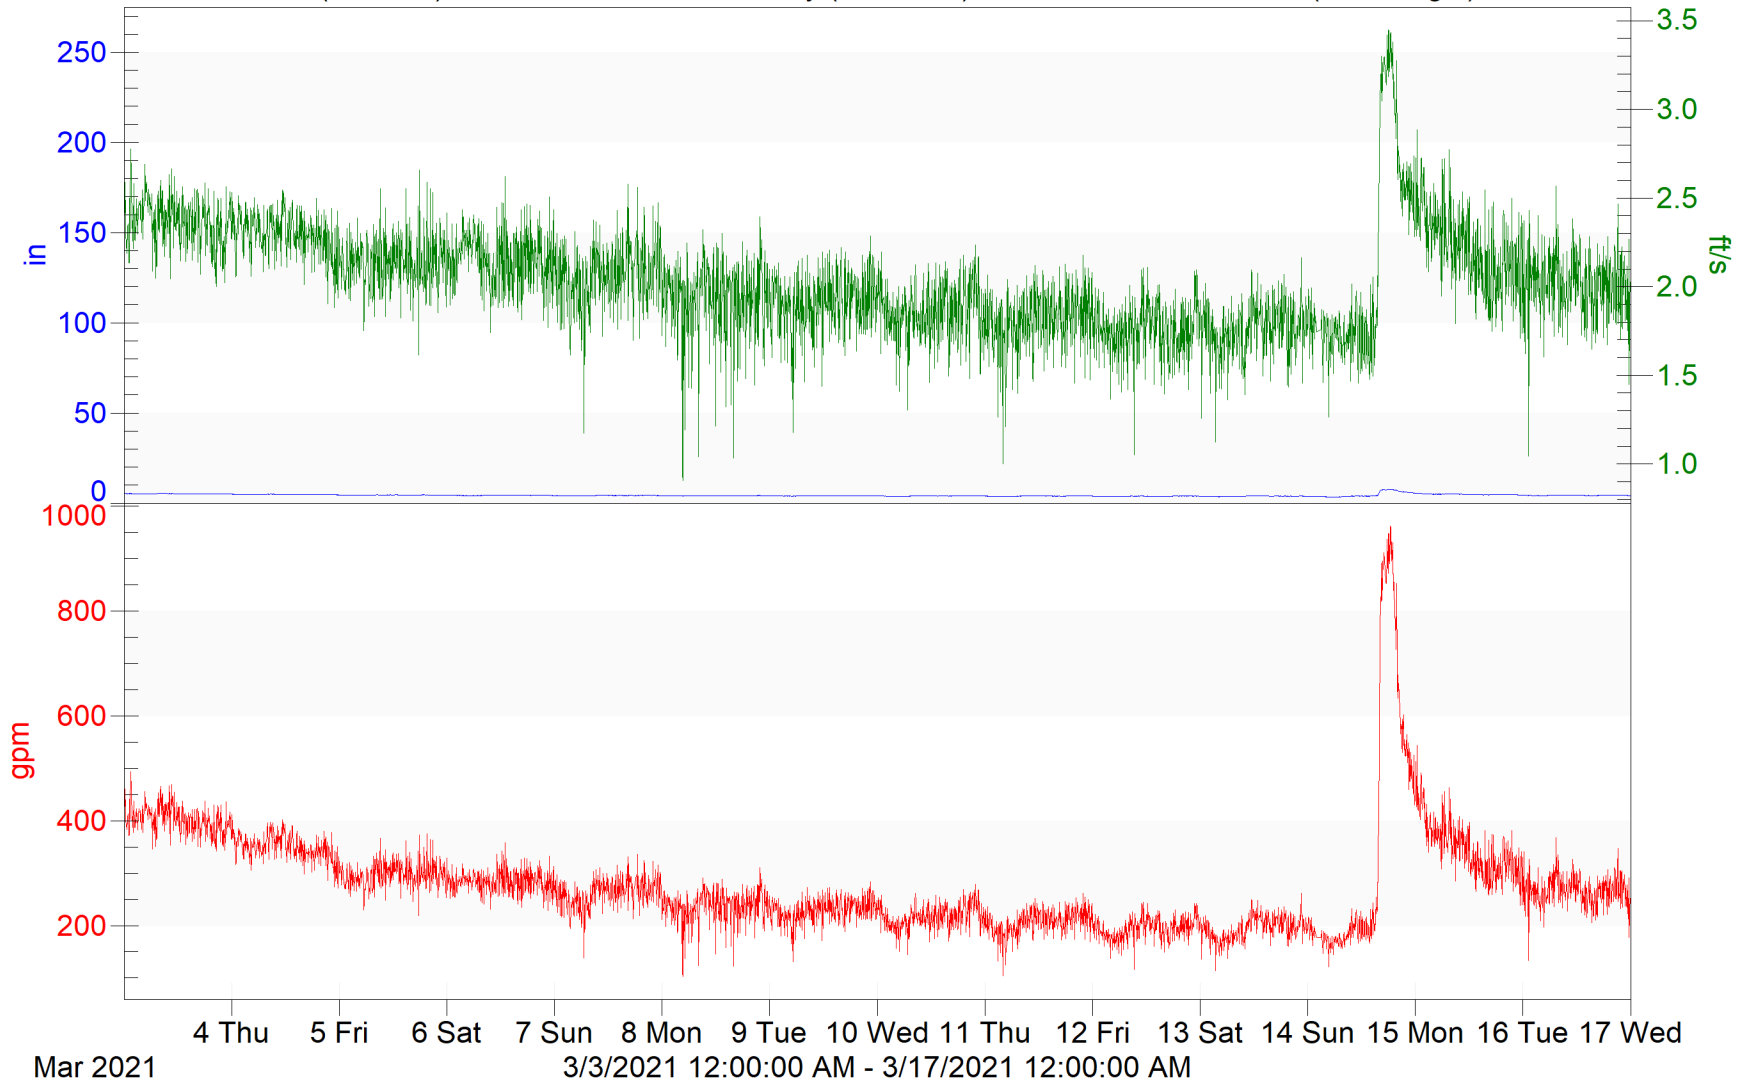
# FM715

Flowlink 5

Level (4.340 in):5.37

Velocity (2.030 ft/s):2.38

Flow rate (5.543 mgal):421.41

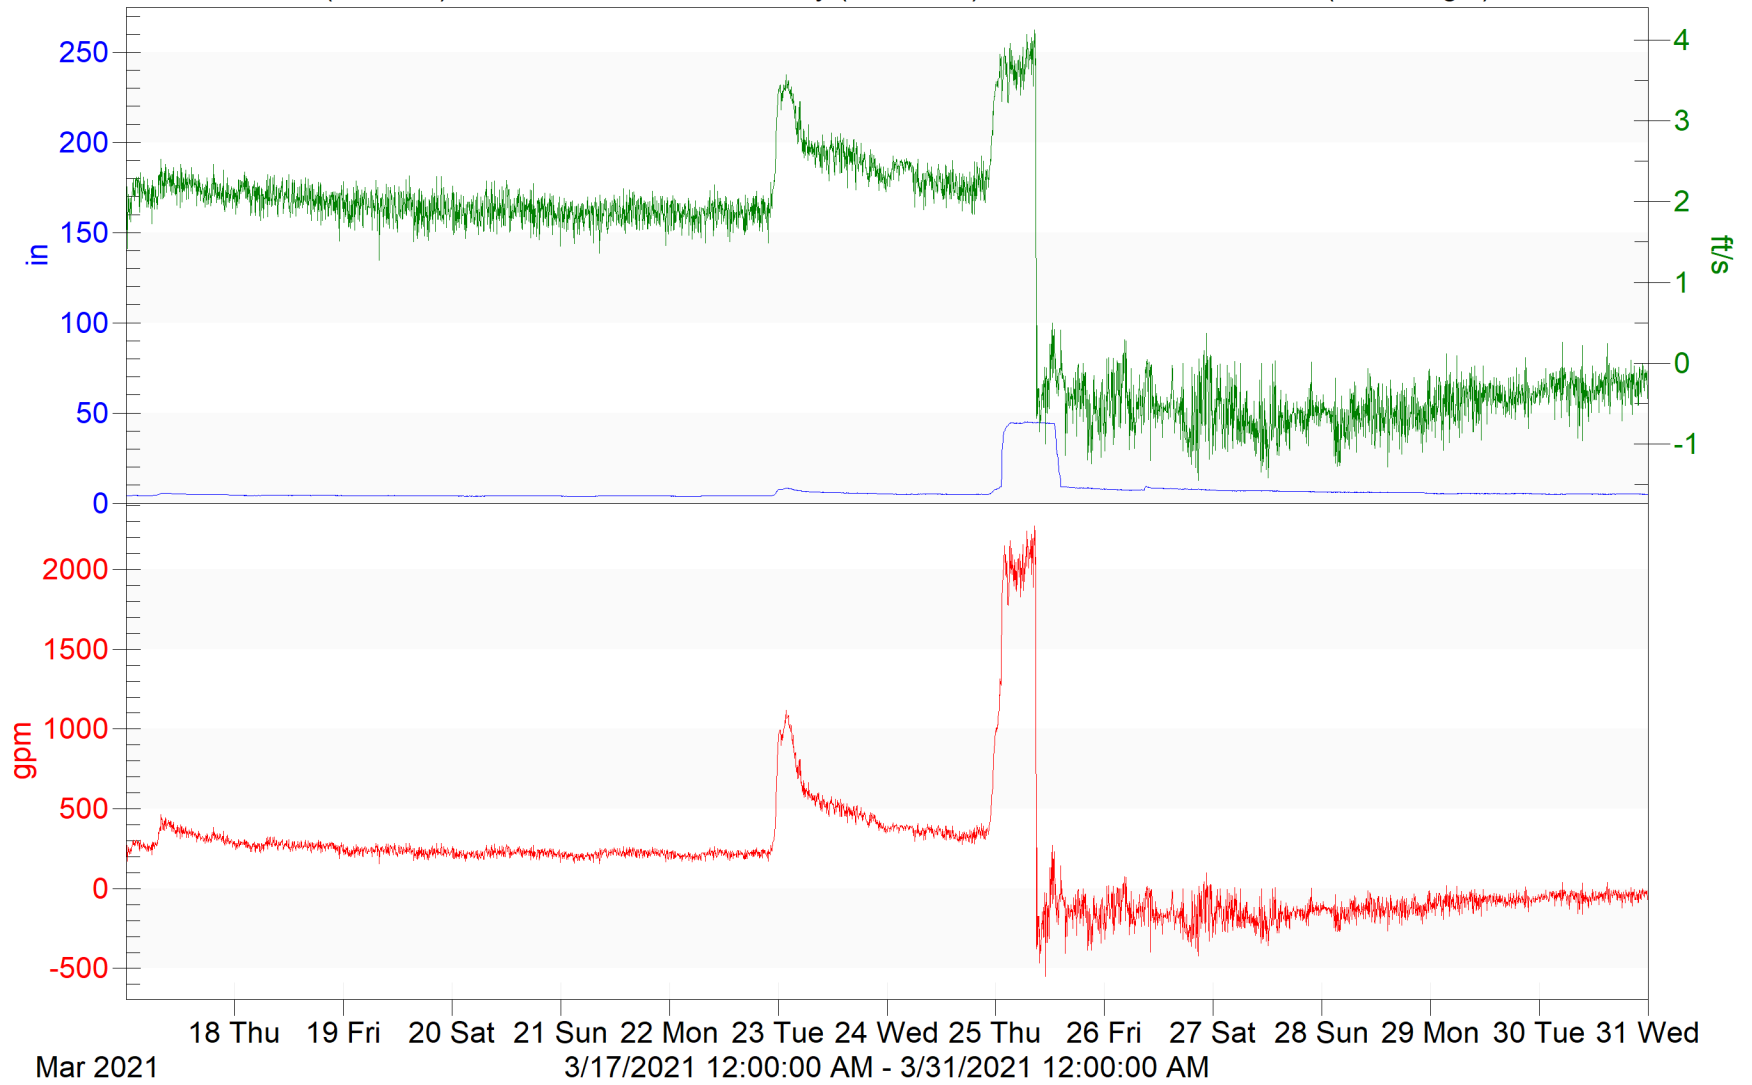
# FM715

Flowlink 5

Level (6.691 in):4.19

Velocity (1.092 ft/s):2.06

Flow rate (3.602 mgal):259.38

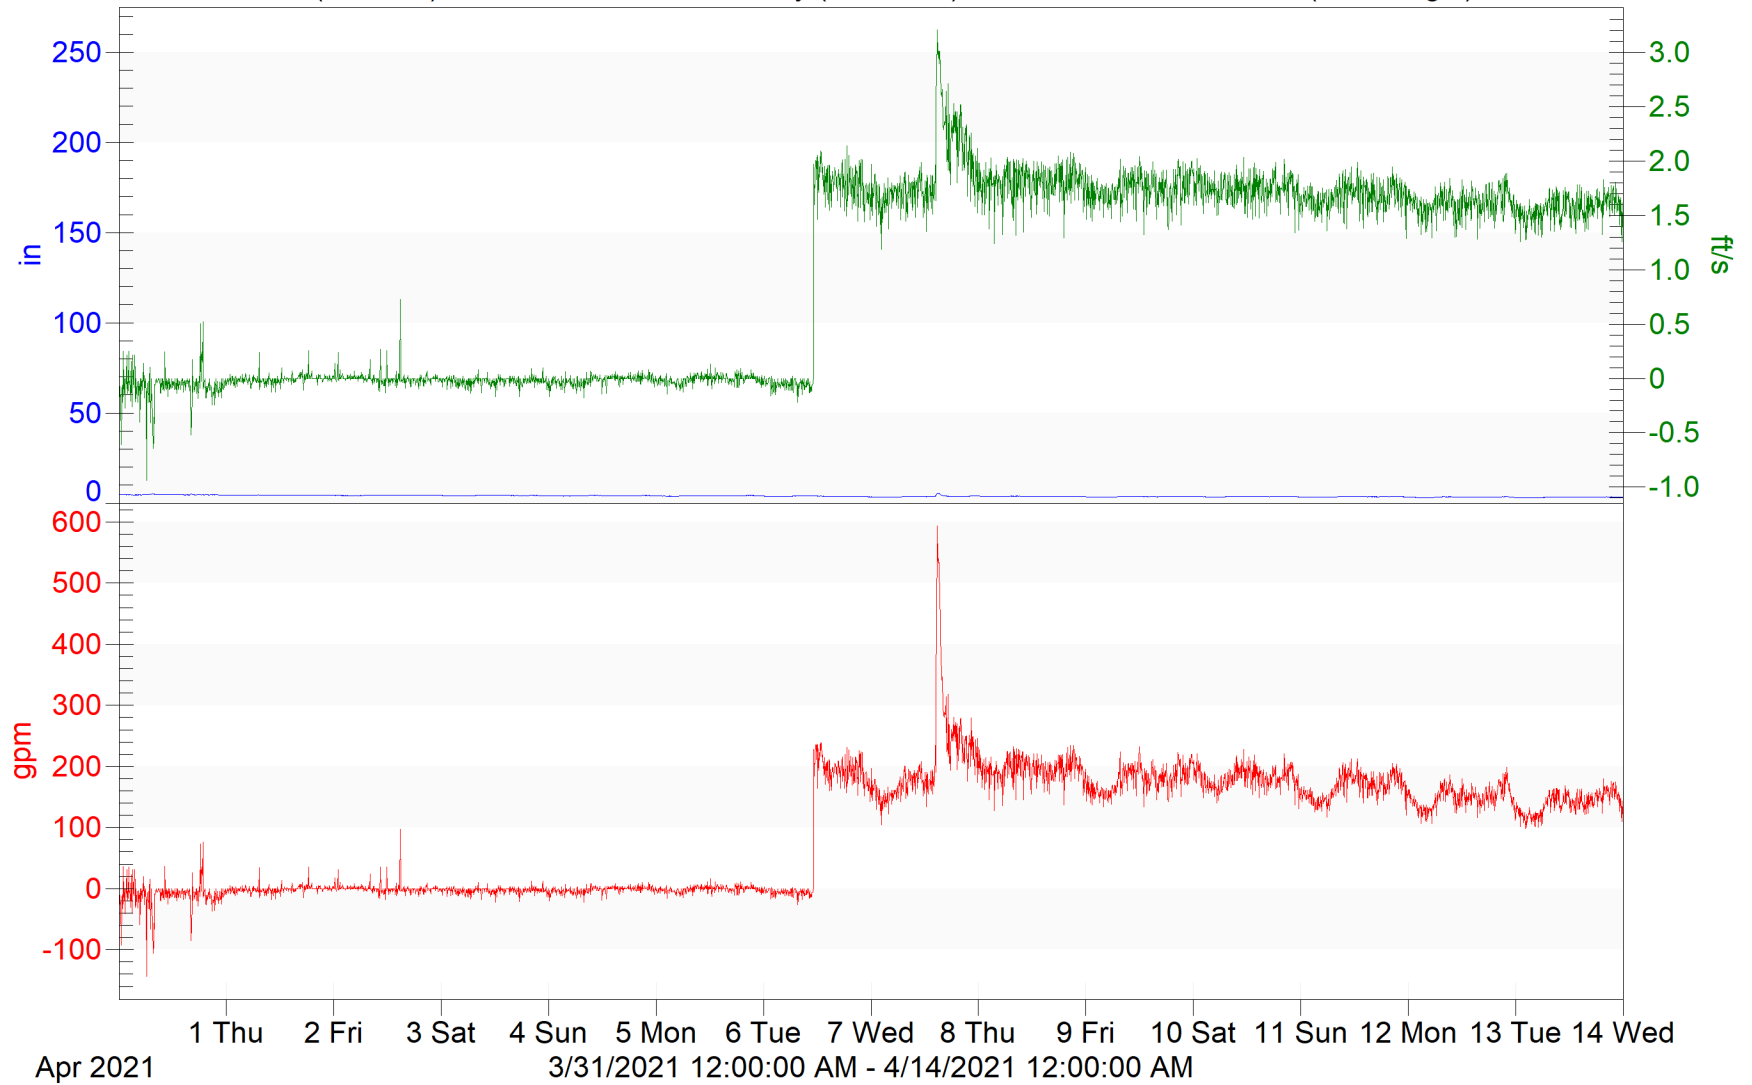
# FM715

Flowlink 5

Level (3.901 in):4.81

Velocity (0.919 ft/s):-0.19

Flow rate (1.875 mgal):-28.41

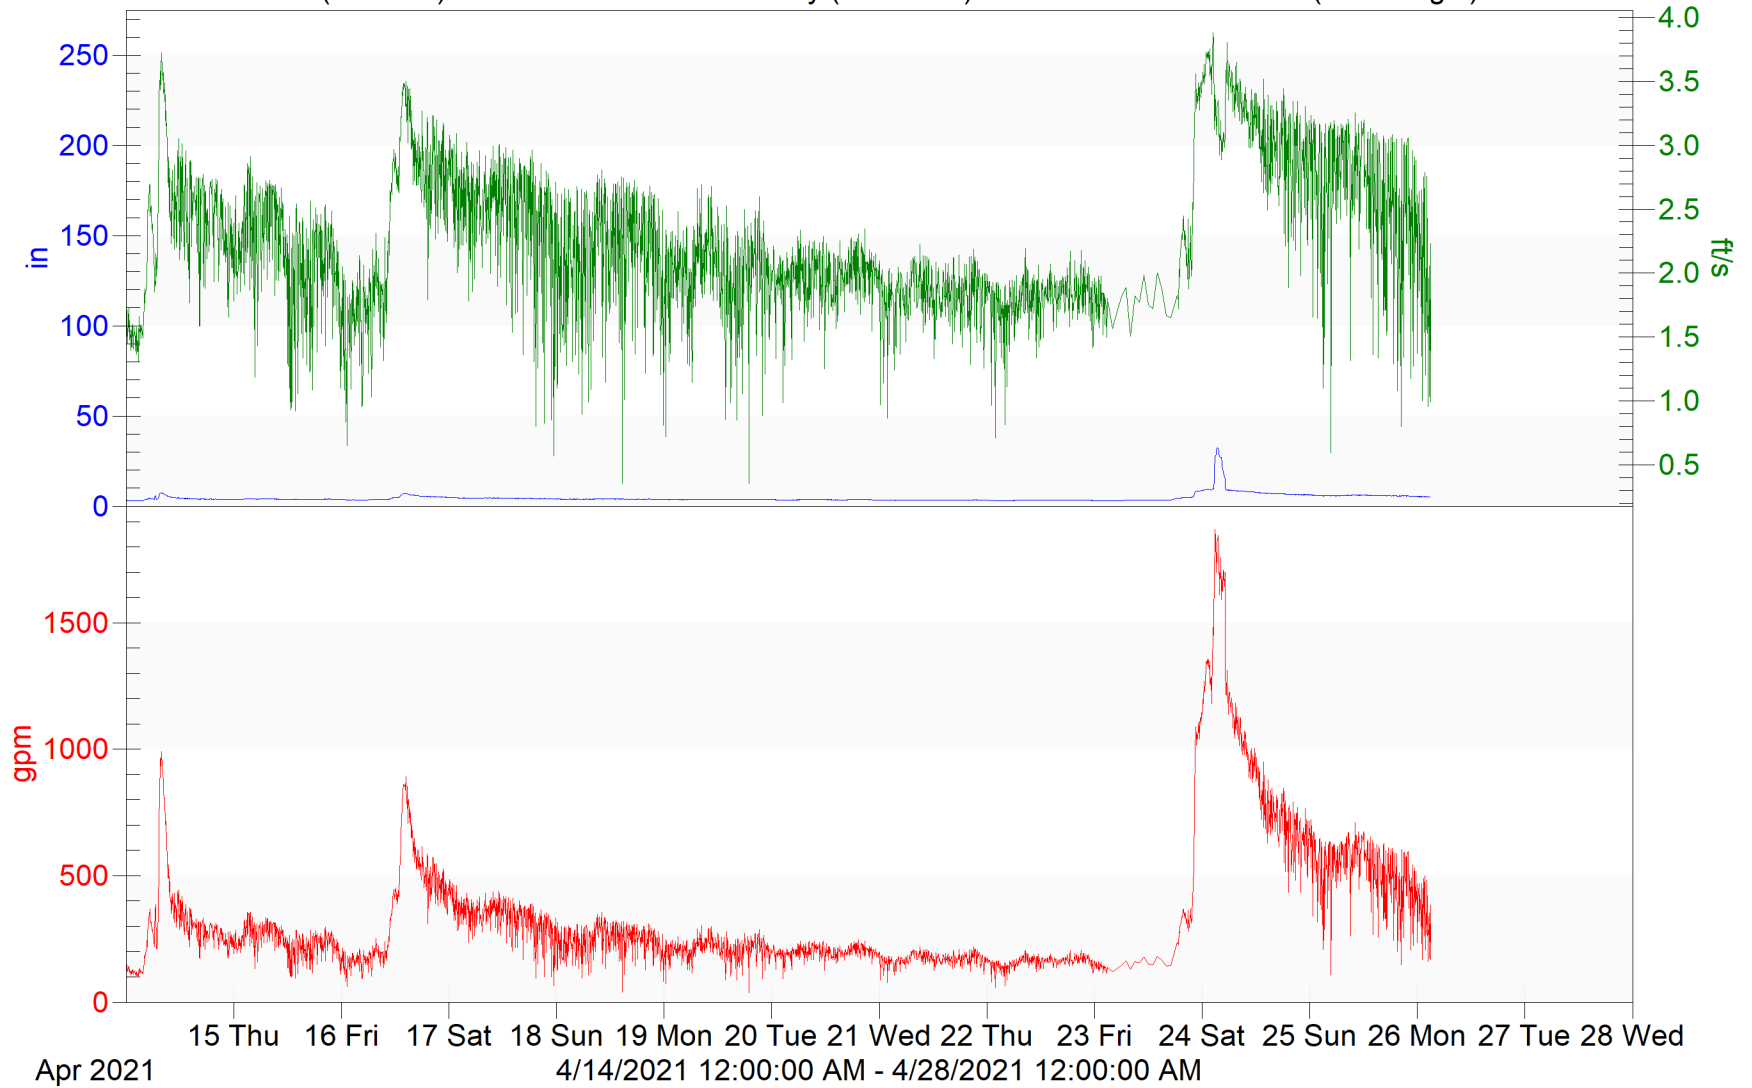
# FM715

Flowlink 5

Level (4.573 in):3.24

Velocity (2.254 ft/s):1.51

Flow rate (5.831 mgal):131.85

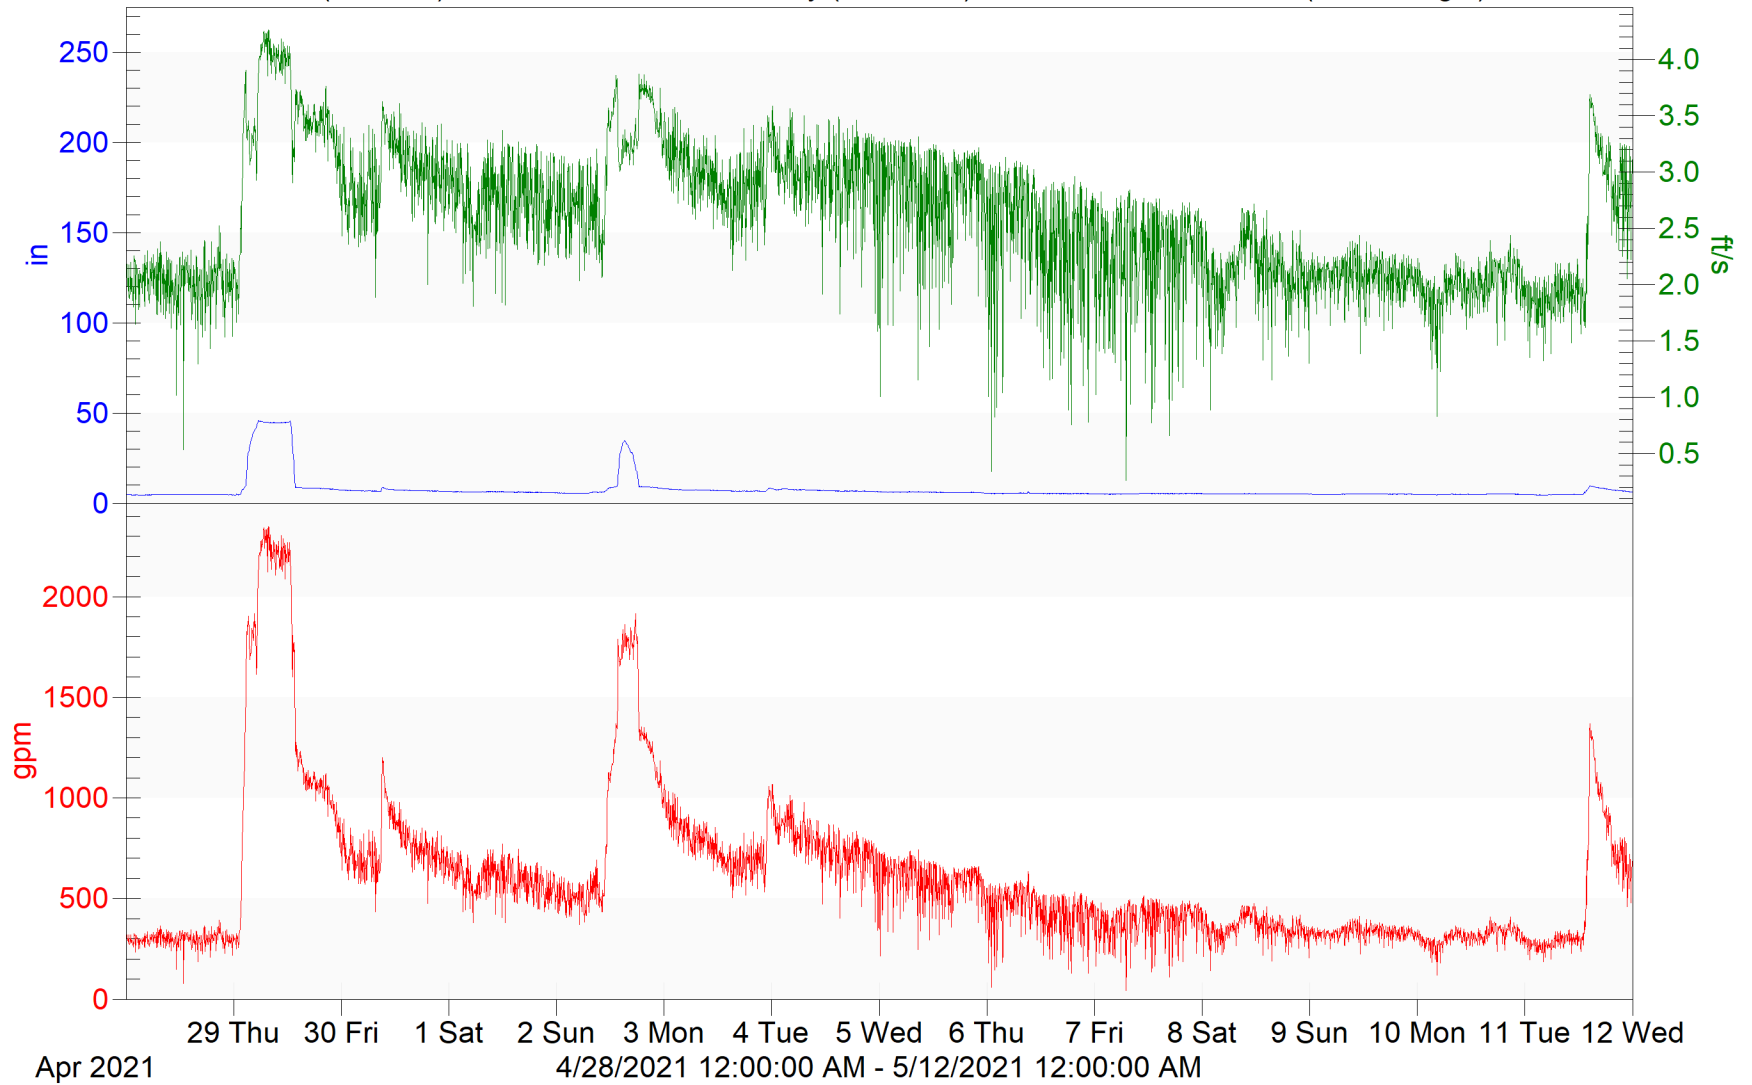
# FM715

Flowlink 5

Level (7.408 in):4.67

Velocity (2.592 ft/s):1.87

Flow rate (12.367 mgal):274.44

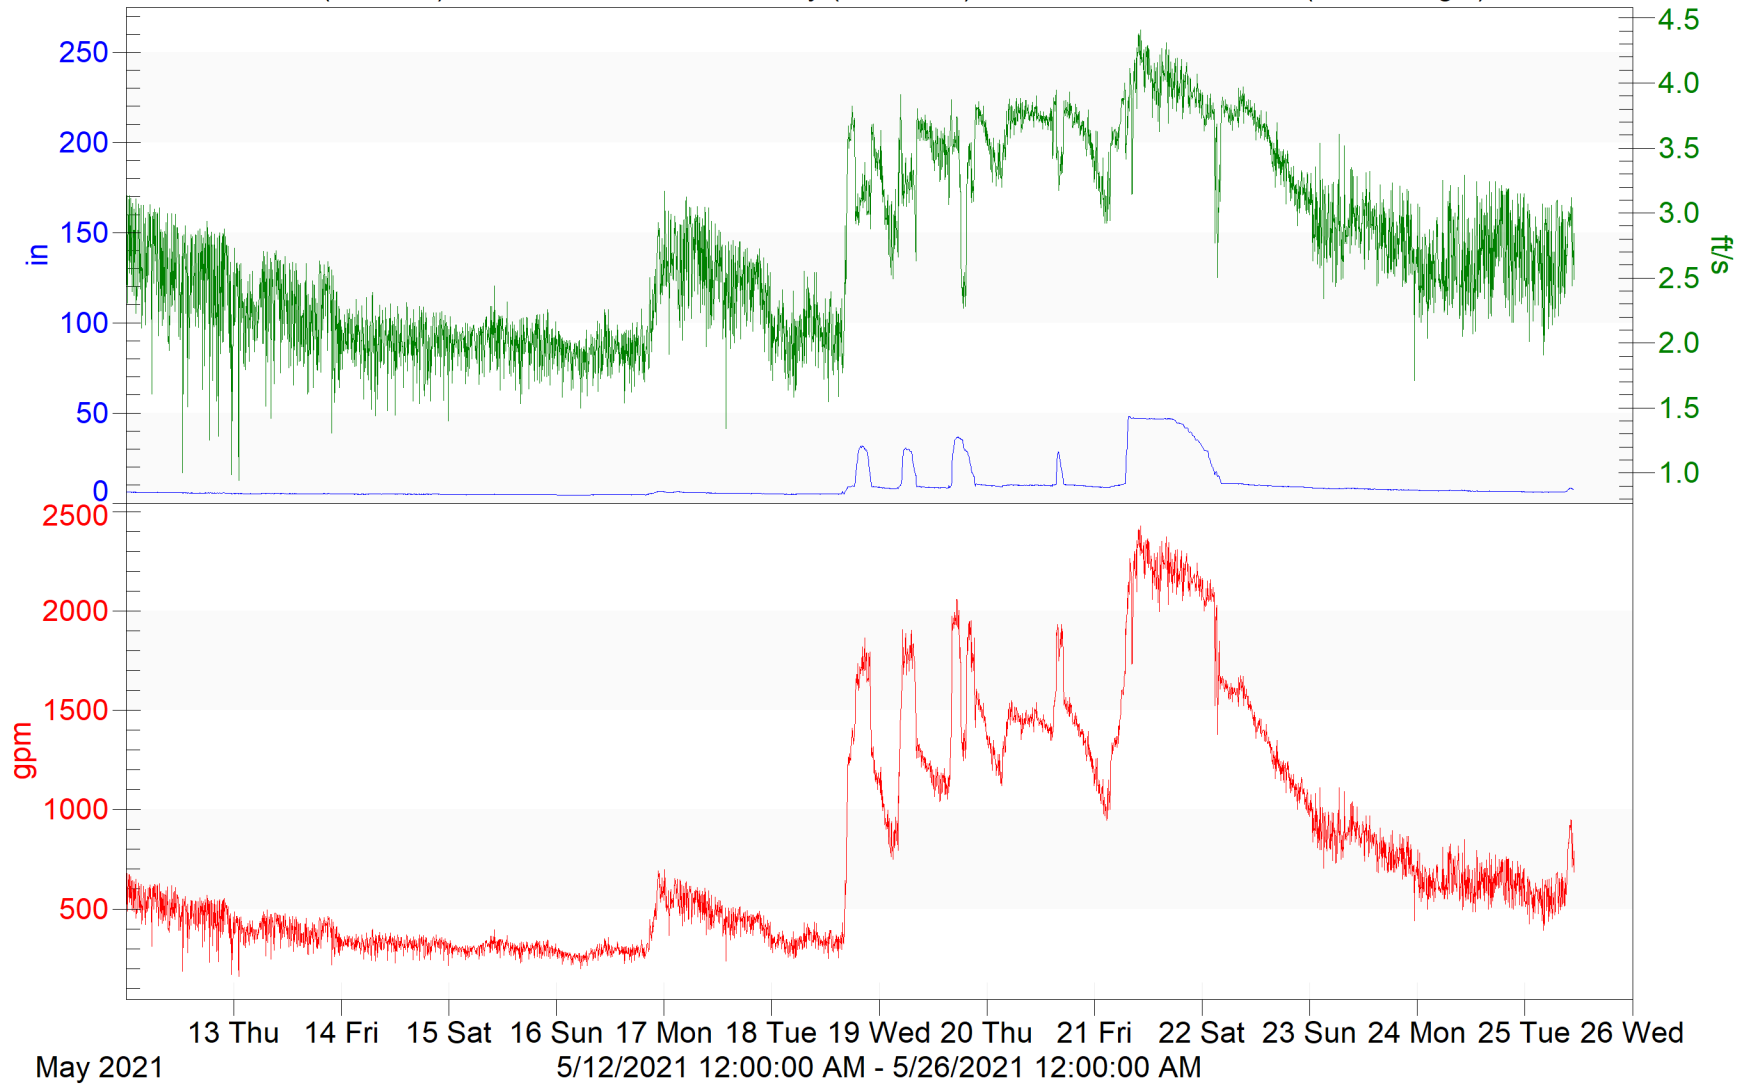
# FM715

Flowlink 5

Level (9.627 in):6.33

Velocity (2.740 ft/s):3.12

Flow rate (15.756 mgal):689.61

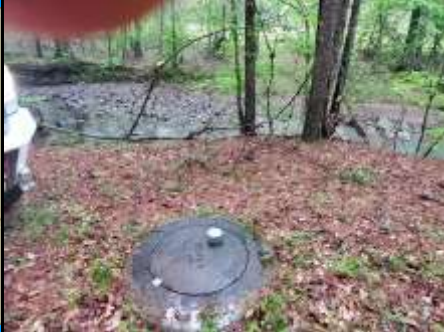
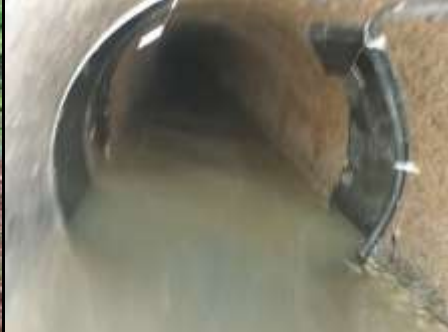
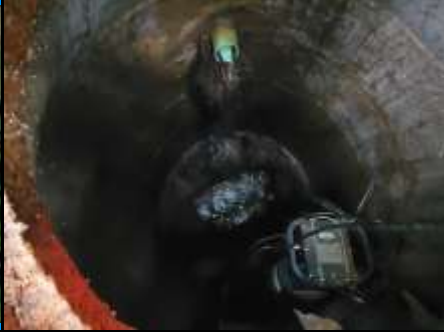
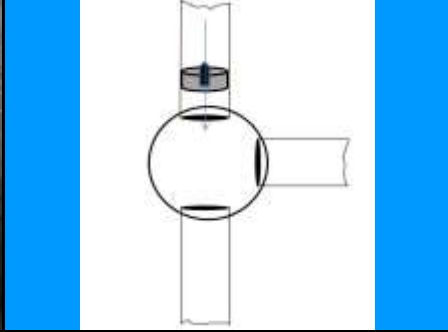
<b>Site ID</b>	<b>Device Type</b>	<b>Installation Date</b>	<b>Installed By</b>
<b>FM760</b>	Flow Meter	4/23/2021	J. Cawthon
<b>Address</b>	<b>Location Details</b>		<b>Traffic Area ?</b>
2109 S Mena St	through a gate and about 100 yards down the right of way.		No
<b>Installation Manhole</b>	<b>Material</b>	<b>Evidence of Surcharge ?</b>	
760	Reinforced Concrete Pipe	No	
<b>Gas Levels</b>			
<b>Oxygen</b>	<b>Carbon Monoxide</b>	<b>Hydrogen Sulfide</b>	<b>Lower Explosive Limit</b>
20.70%	8.00%	0.00%	0
<b>Installation Pipe</b>	<b>Material</b>	<b>Inside Diameter</b>	
incoming	VCP	15.25

<b>Hydraulic Conditions</b>
Normal level and velocity
<b>General Conditions</b>

Map_FM760	FM760 Area	FM760 Pipe
<b>Downhole Image</b>	<b>Pipe Image</b>	<b>Install Schematic (Top)</b>

Aerial_FM760	FM760 Inner	FM760 Schematic

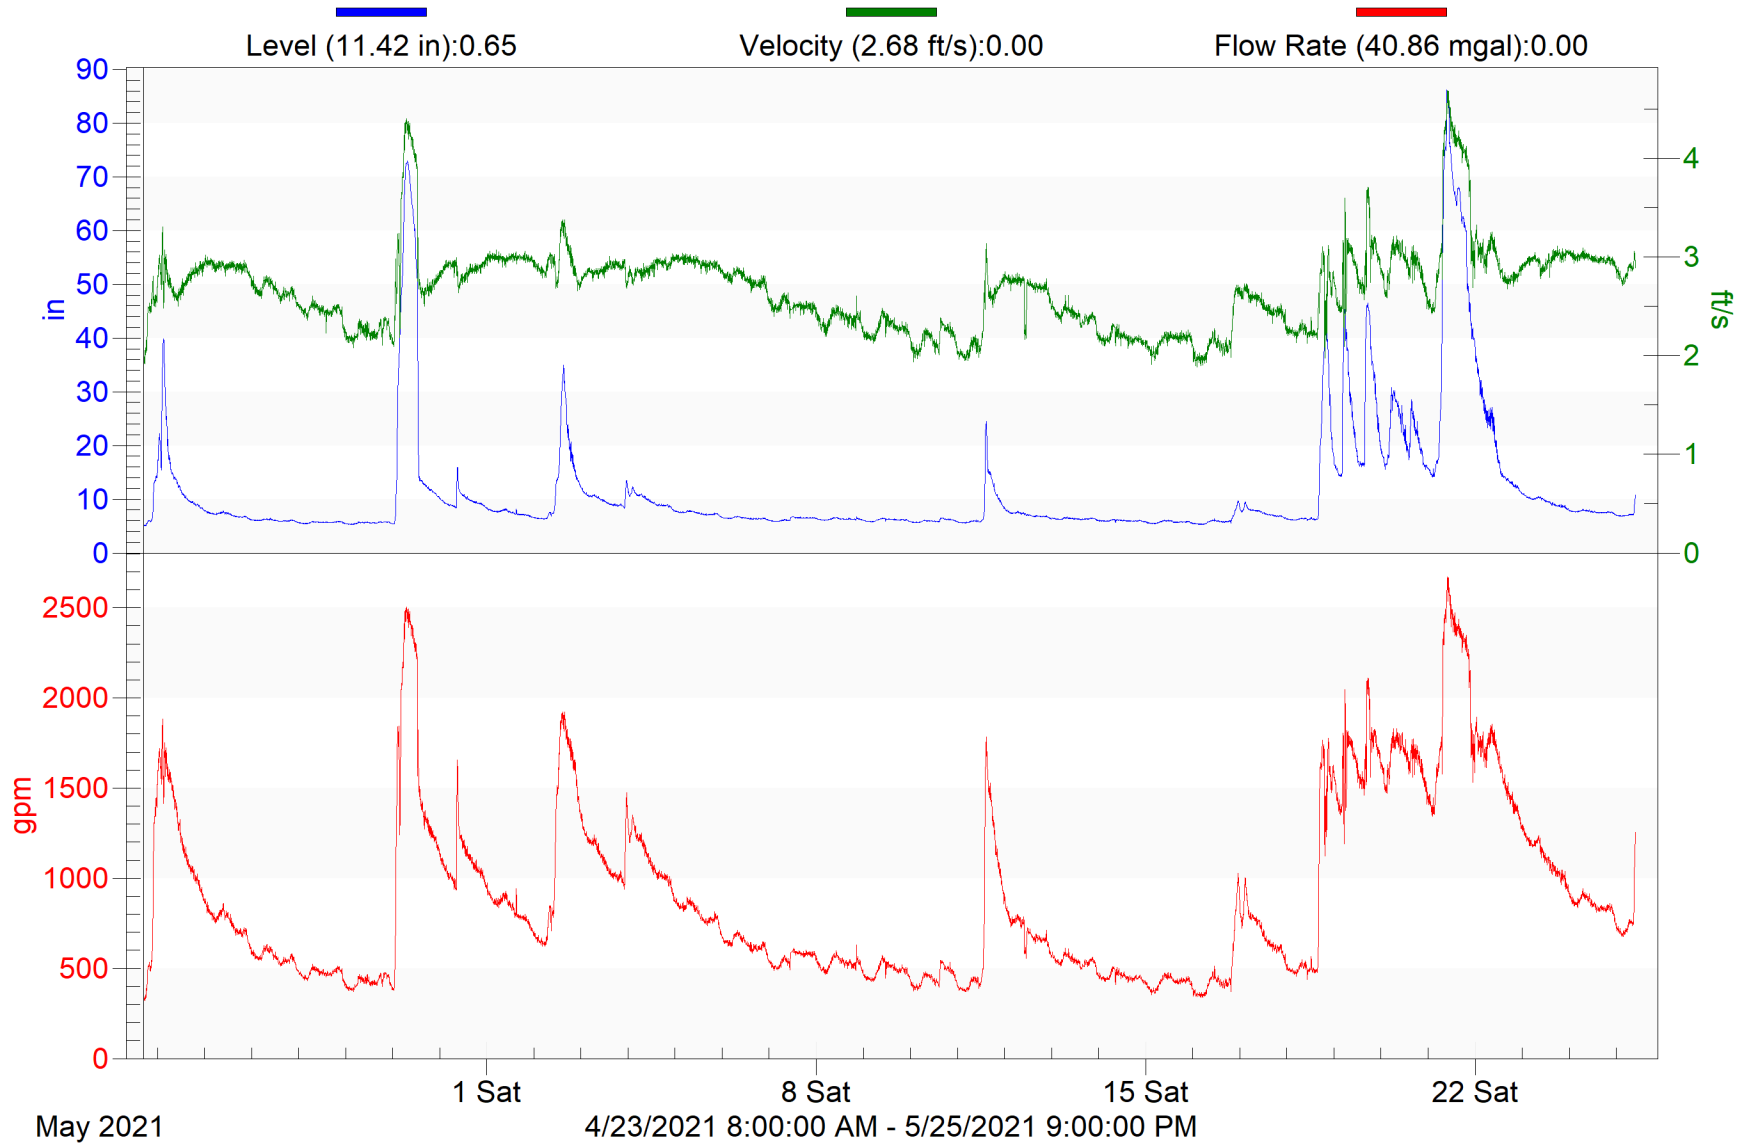
# FM 760

Flowlink 5

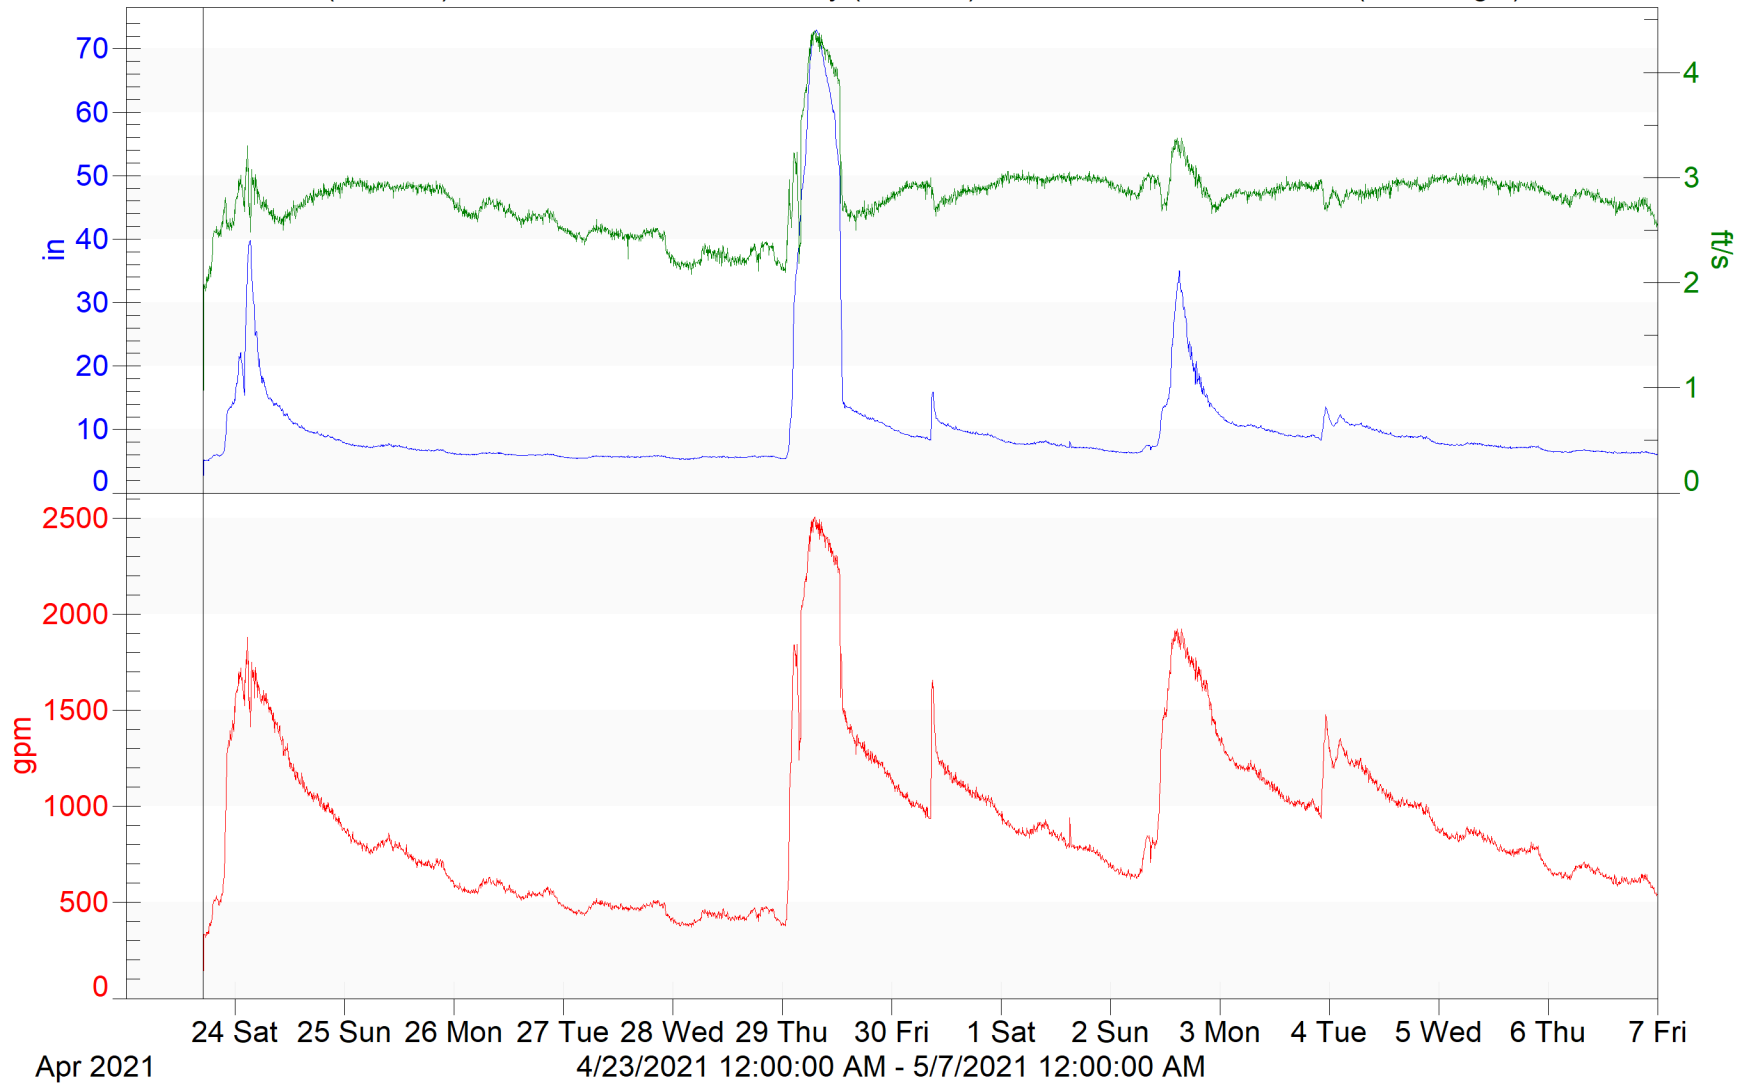
# FM 760

Flowlink 5

Level (10.36 in):0.65

Velocity (2.80 ft/s):0.00

Flow Rate (17.55 mgal):0.00
