# MENA, AR

# FLOW MONITORING REPORT

## FEBRUARY – MAY 2021

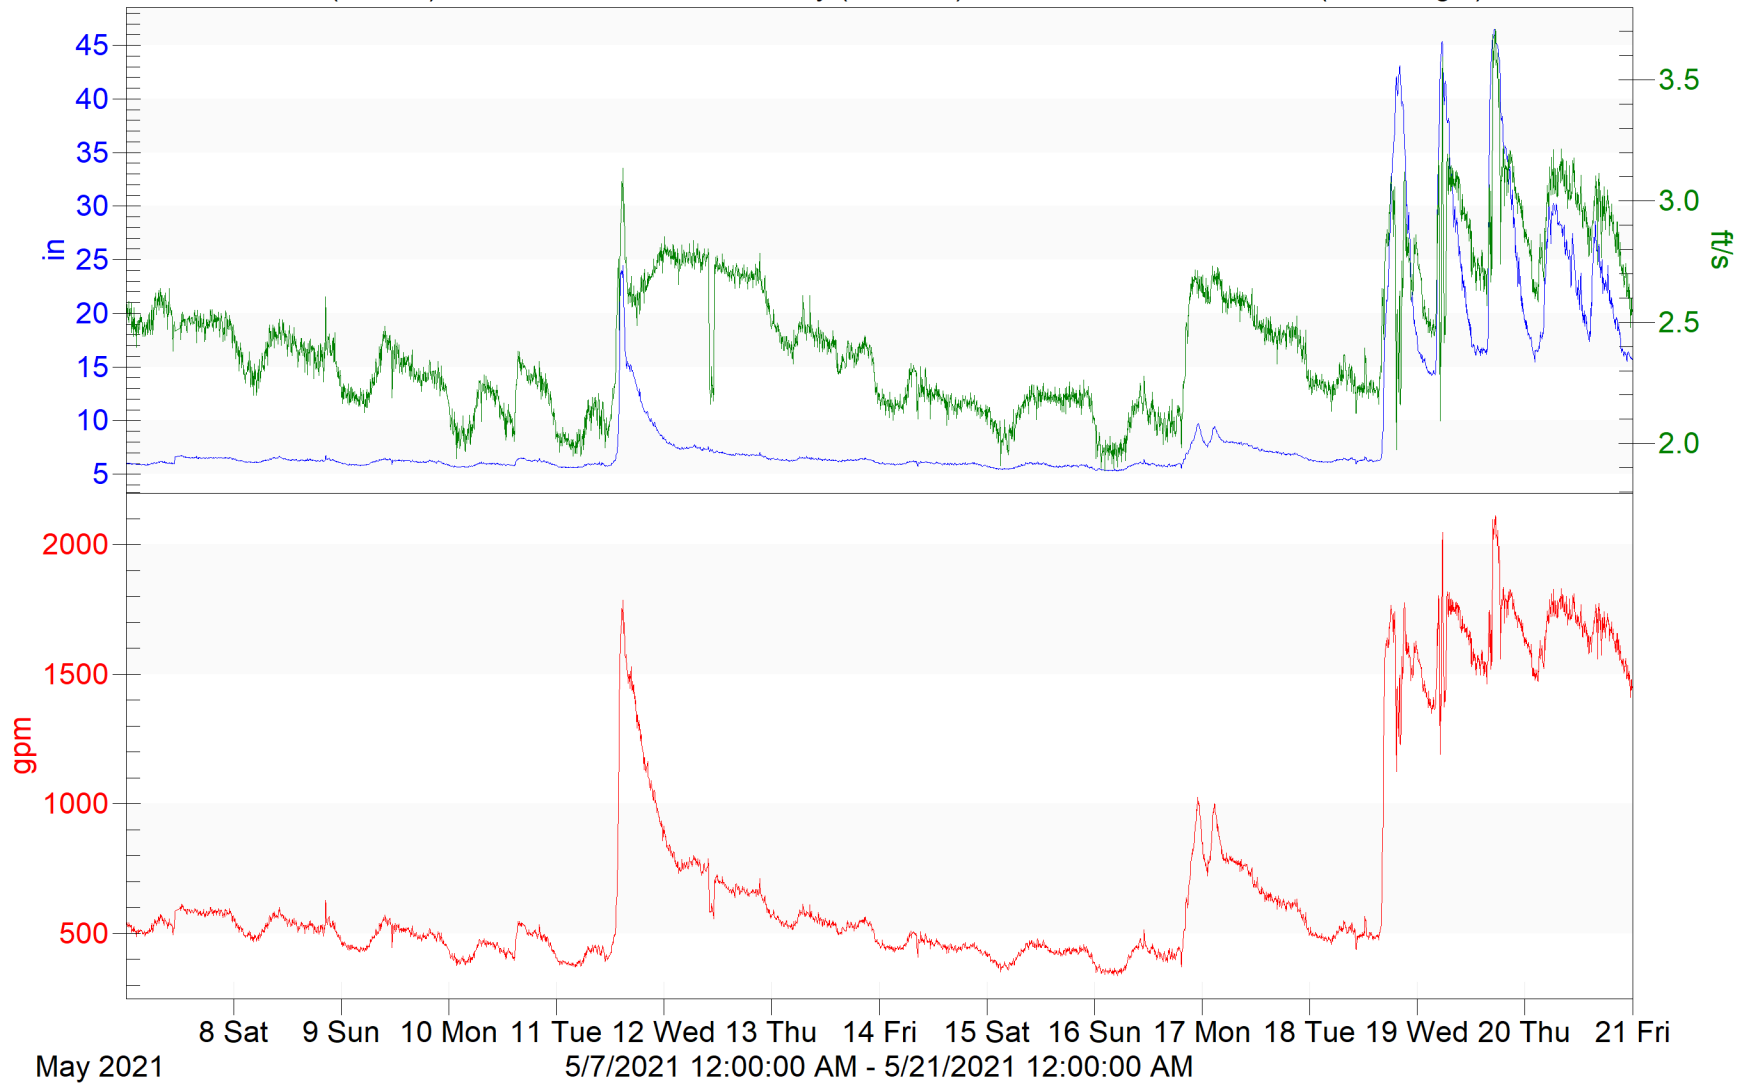
# FM 760

Flowlink 5

Level (9.63 in):6.09

Velocity (2.43 ft/s):2.57

Flow Rate (14.76 mgal):544.33

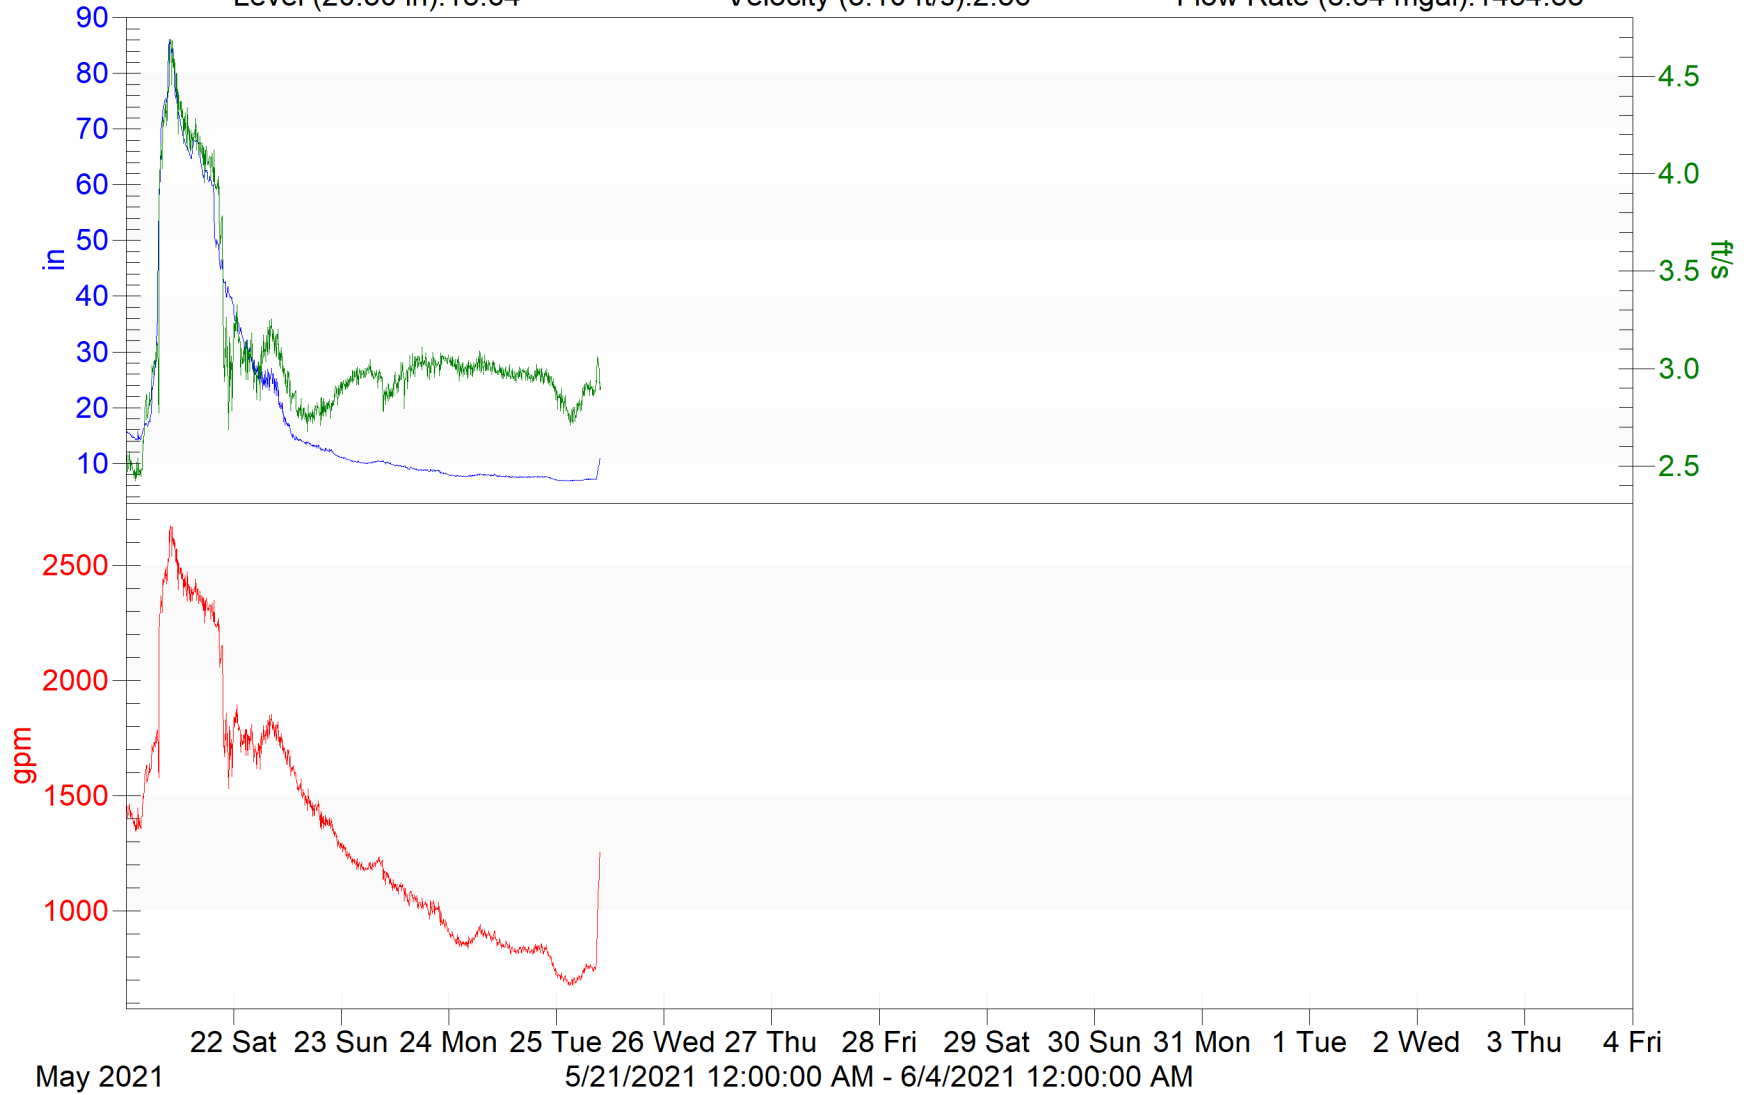
# FM 760

Flowlink 5

Level (20.30 in):15.64

Velocity (3.10 ft/s):2.56

Flow Rate (8.54 mgal):1454.83

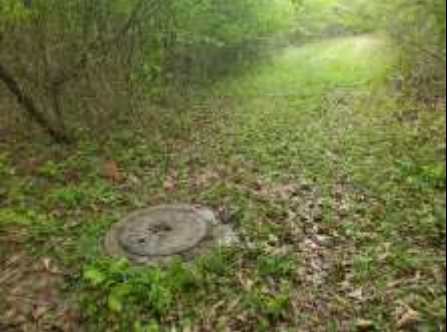
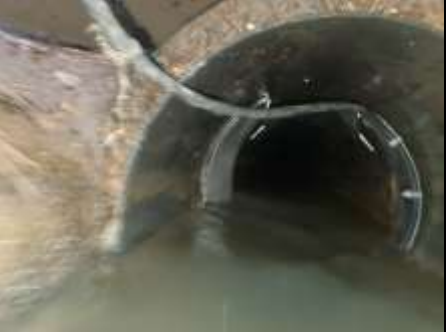
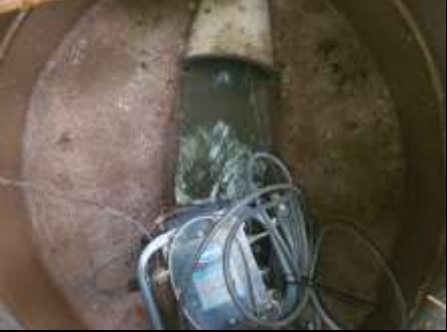
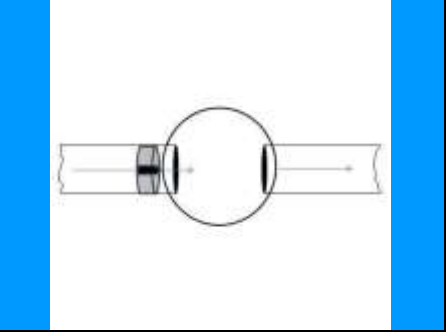
Site ID	Device Type	Installation Date	Installed By
<b>FM852</b>	Flow Meter	4/23/2021	J. Cawthon
Address	Location Details		Traffic Area ?
1108 Parker Dr	right of way behind house being built		No
Installation Manhole	Material	Evidence of Surge ?	
852	Reinforced Concrete Pipe	No	
Gas Levels			
Oxygen	Carbon Monoxide	Hydrogen Sulfide	Lower Explosive Limit
20.90%	0.00%	0.00%	0
Installation Pipe	Material	Inside Diameter	
incoming	CAS	12

Hydraulic Conditions
Normal level and velocity
General Conditions
Meter was moved from MH852 to MH853. Flow Meter name remained the same

Map_FM852	FM852 Area	FM852 Pipe
Downhole Image	Pipe Image	Install Schematic (Top)

Aerial_FM852	FM852 Inner	FM852 Schematic

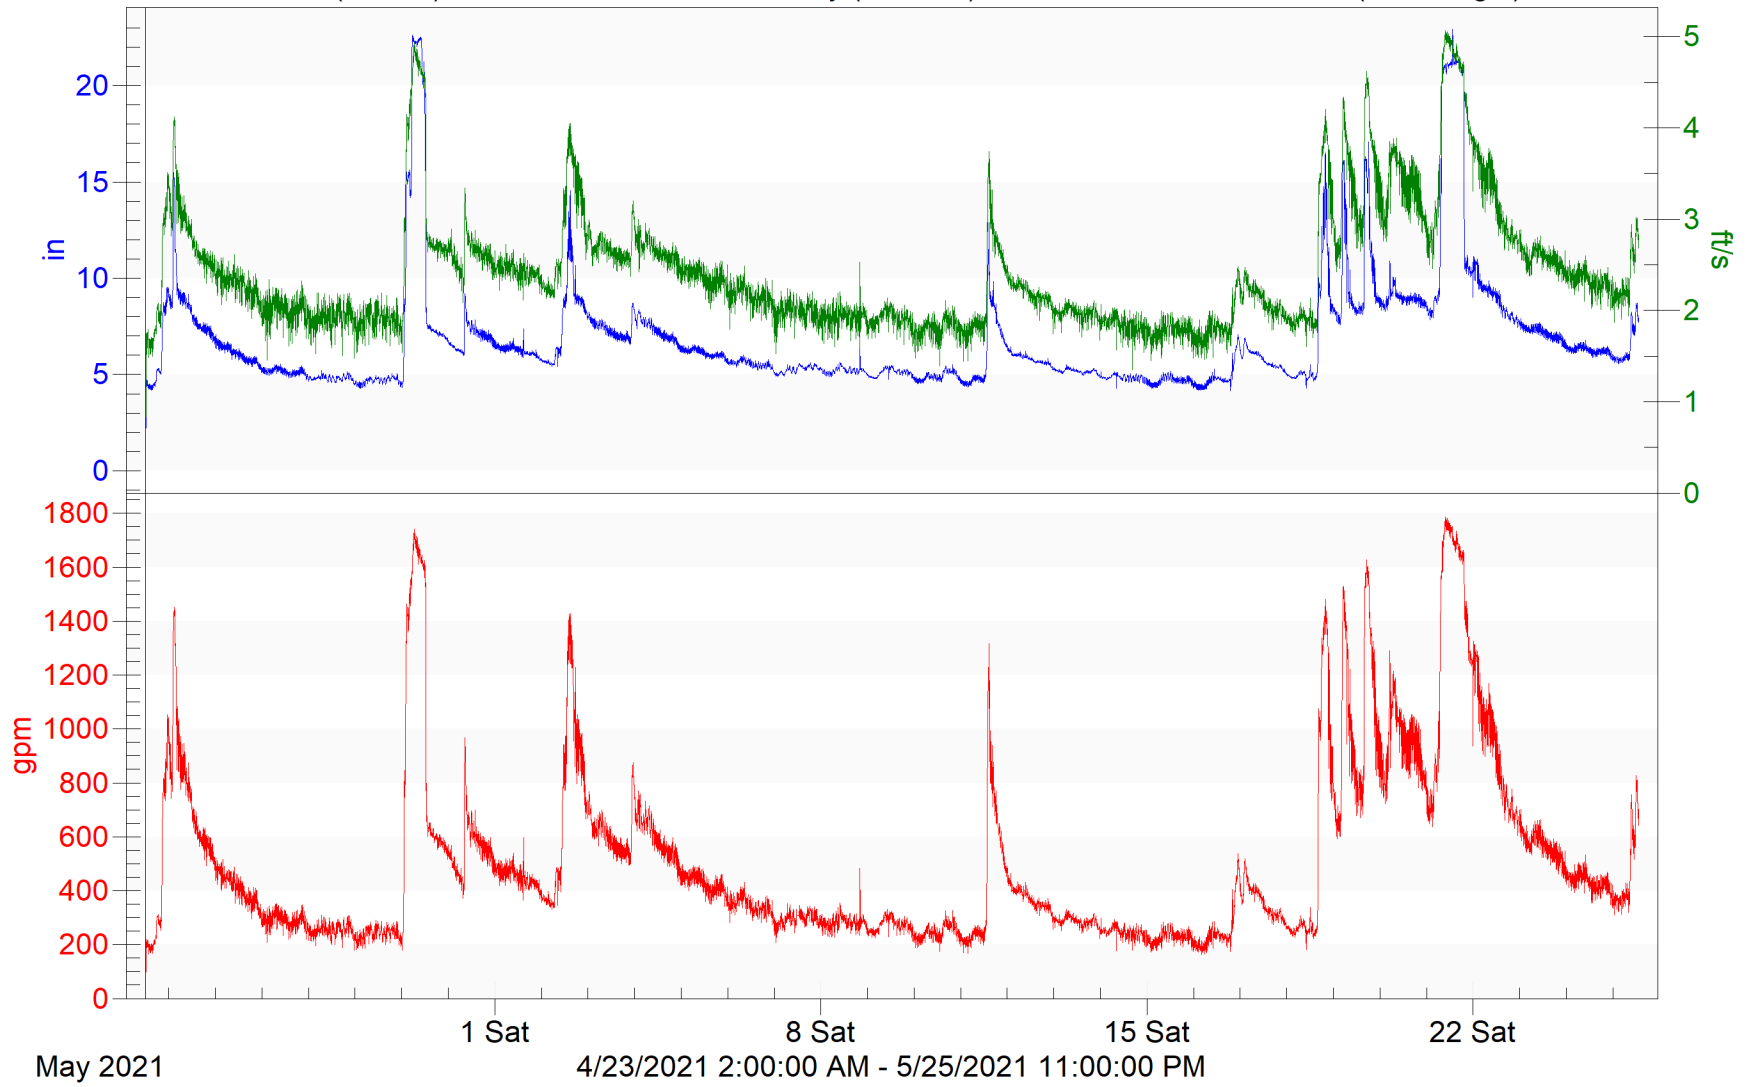
# FM 852

Flowlink 5

Level (6.77 in):1.49

Velocity (2.42 ft/s):0.00

Flow Rate (23.34 mgal):0.00

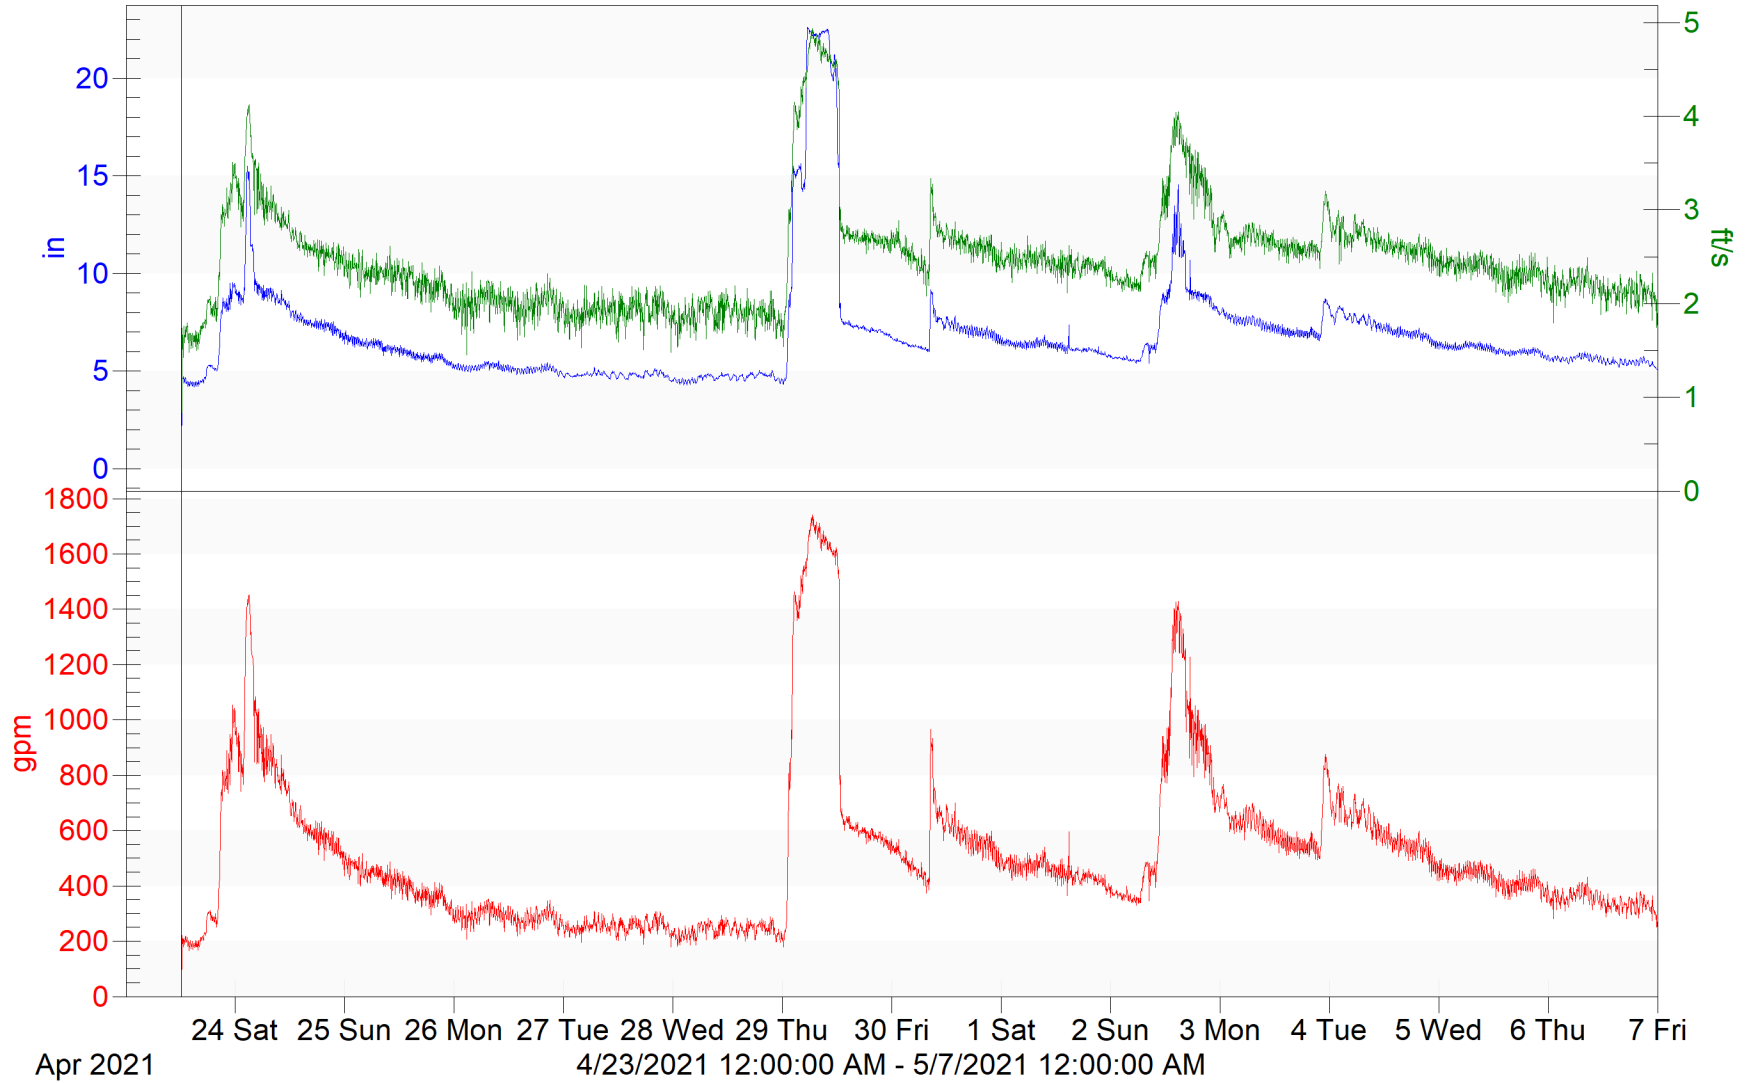
# FM 852

Flowlink 5

Level (6.80 in):1.49

Velocity (2.46 ft/s):0.00

Flow Rate (9.89 mgal):0.00

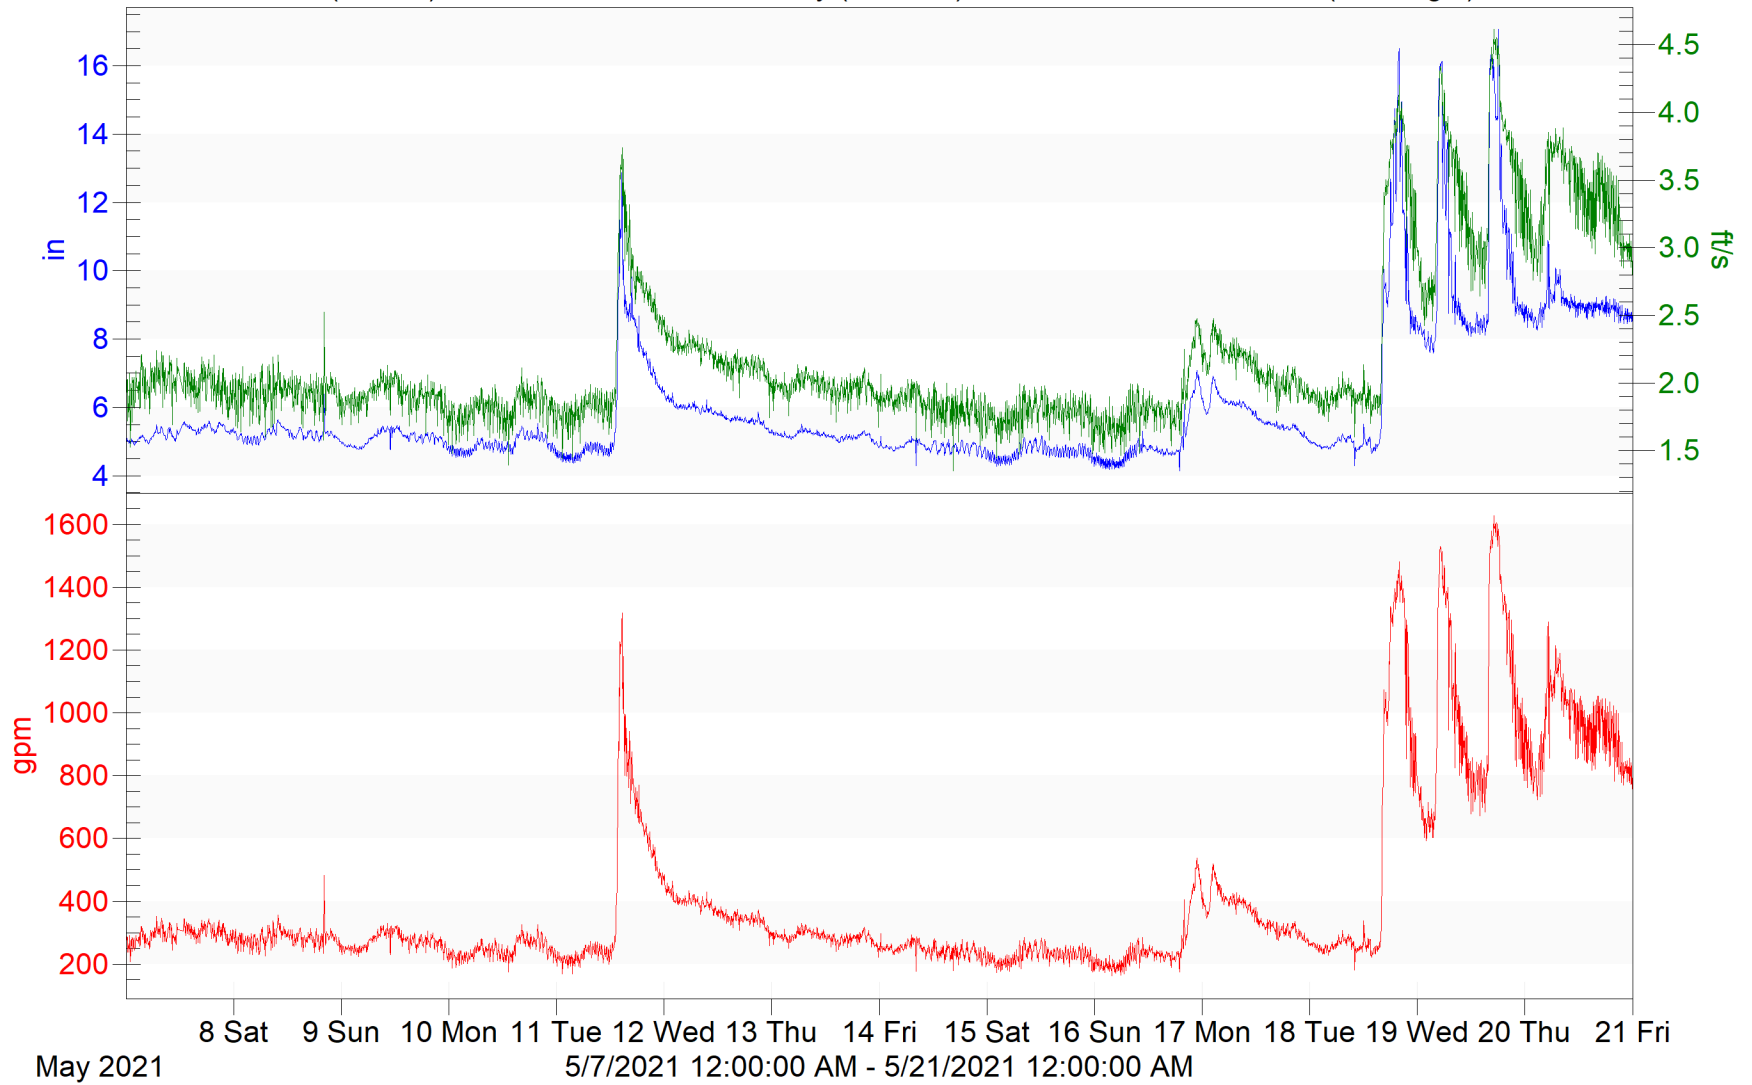
# FM 852

Flowlink 5

Level (5.99 in):5.08

Velocity (2.20 ft/s):1.65

Flow Rate (8.37 mgal):234.46

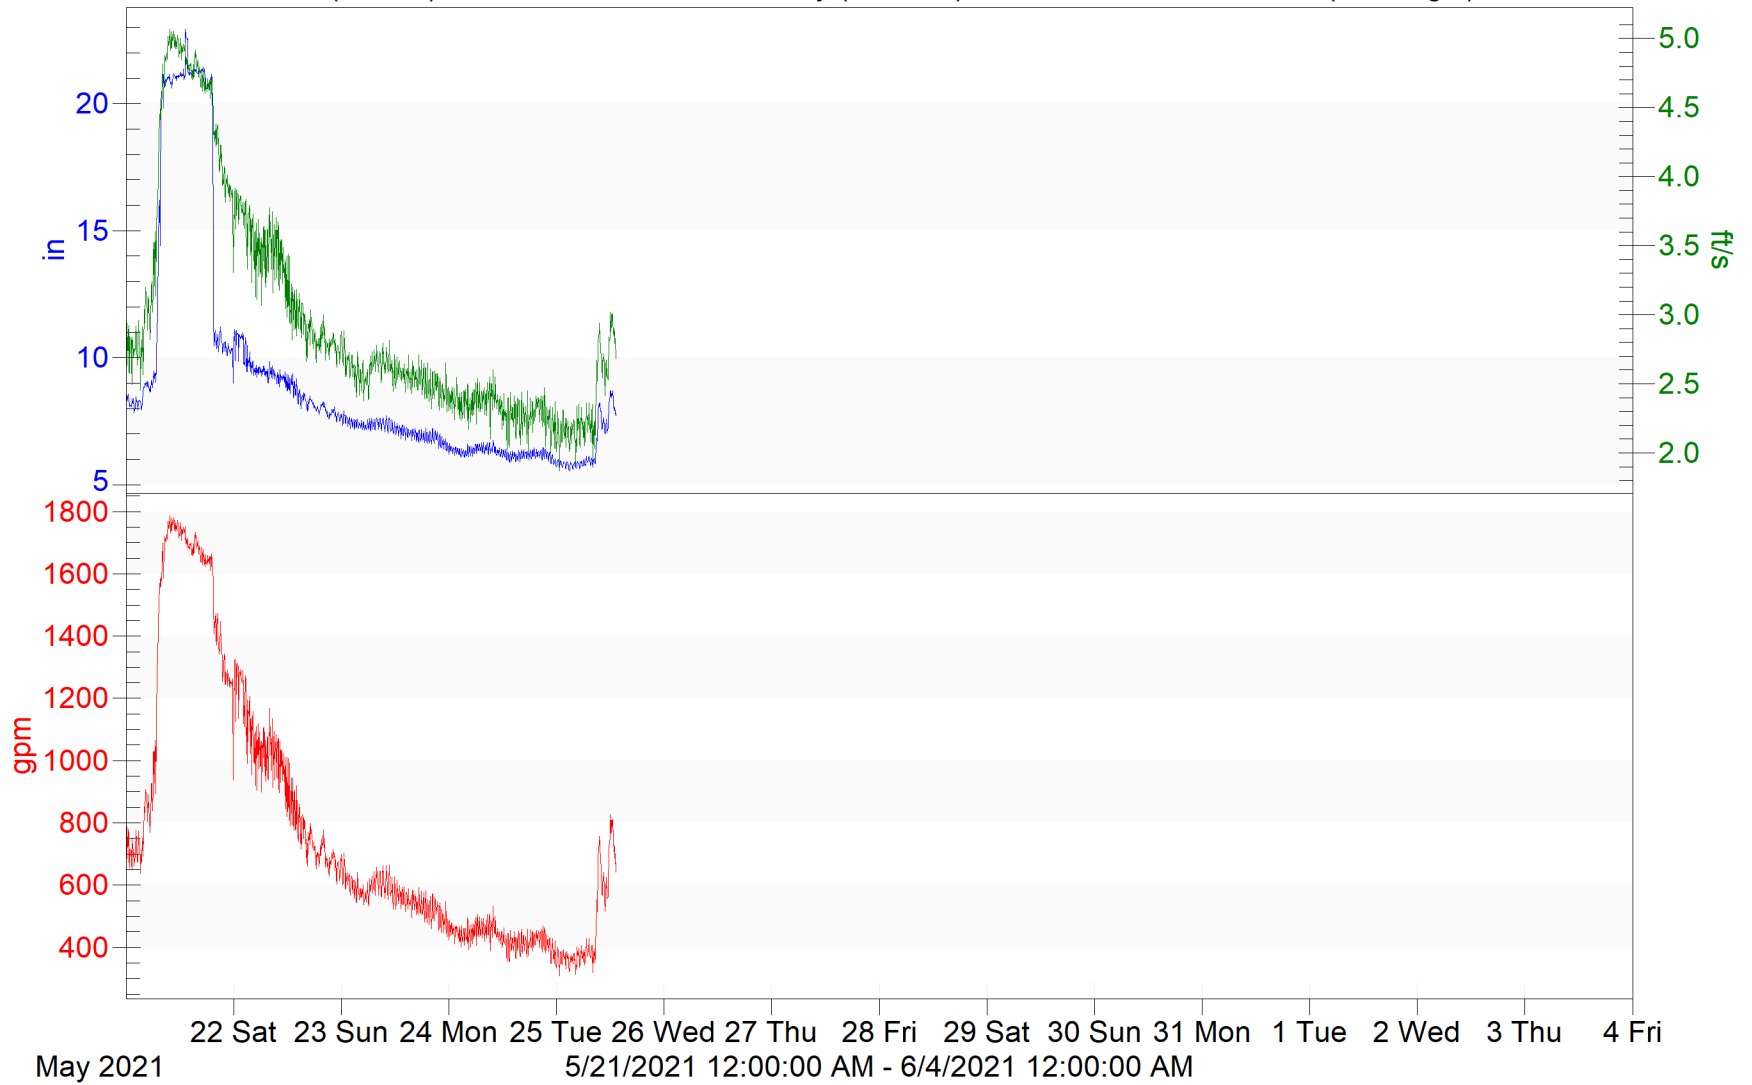
# FM 852

Flowlink 5

Level (9.05 in):8.44

Velocity (2.97 ft/s):2.97

Flow Rate (5.08 mgal):786.52

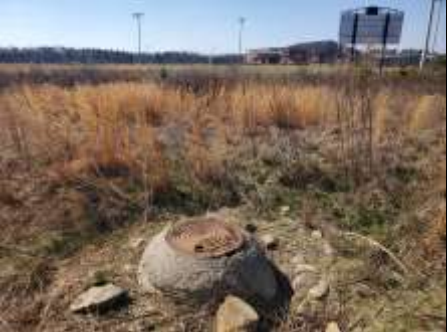
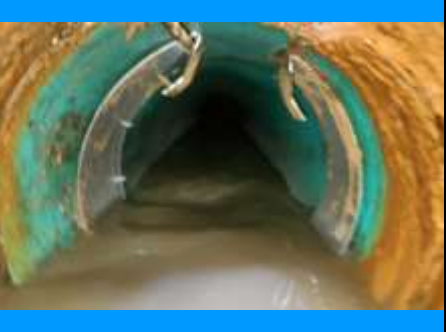
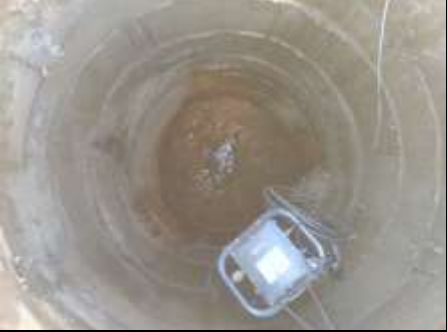
Site ID	Device Type	Installation Date	Installed By
<b>FMNPVC3</b>	Flow Meter	2/3/2021	J. Cawthon
Address	Location Details		Traffic Area ?
1200 Dallas Ave	Next to baseball field		No
Installation Manhole	Material	Evidence of Surge ?	
FMNPVC3	Reinforced Concrete Pipe	No	
Gas Levels			
Oxygen	Carbon Monoxide	Hydrogen Sulfide	Lower Explosive Limit
20.90%	0.00%	0.00%	0
Installation Pipe	Material	Inside Diameter	
	VCP	12

Hydraulic Conditions
Normal level and velocity
General Conditions

Map_FMNPVC3	FMNPVC3 Area	FMNPVC3 Pipe
Downhole Image	Pipe Image	Install Schematic (Top)

Aerial_FMNPVC3	FMNPVC3 Inner	FMNPVC3 Schematic

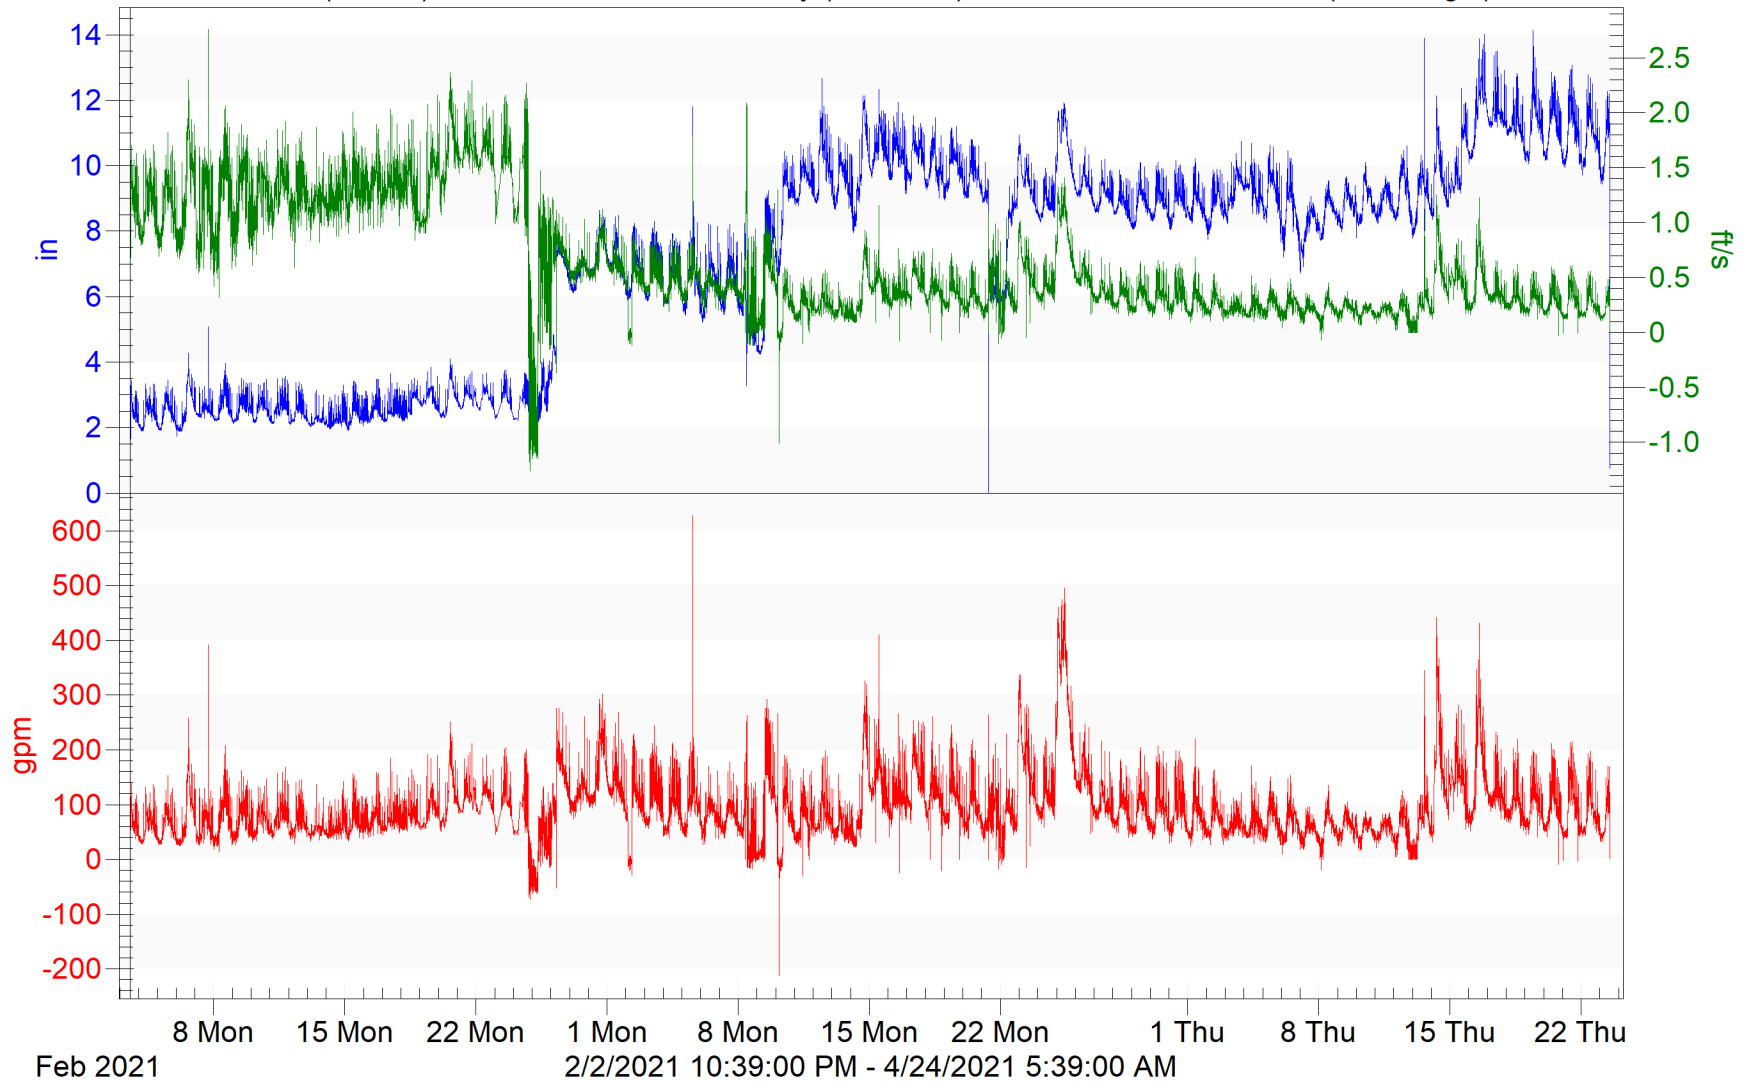
# FMNPVC3

Flowlink 5

Level (7.61 in):0.06

Velocity (0.527 ft/s):0.00

Flow Rate (10.46 mgal):0.00

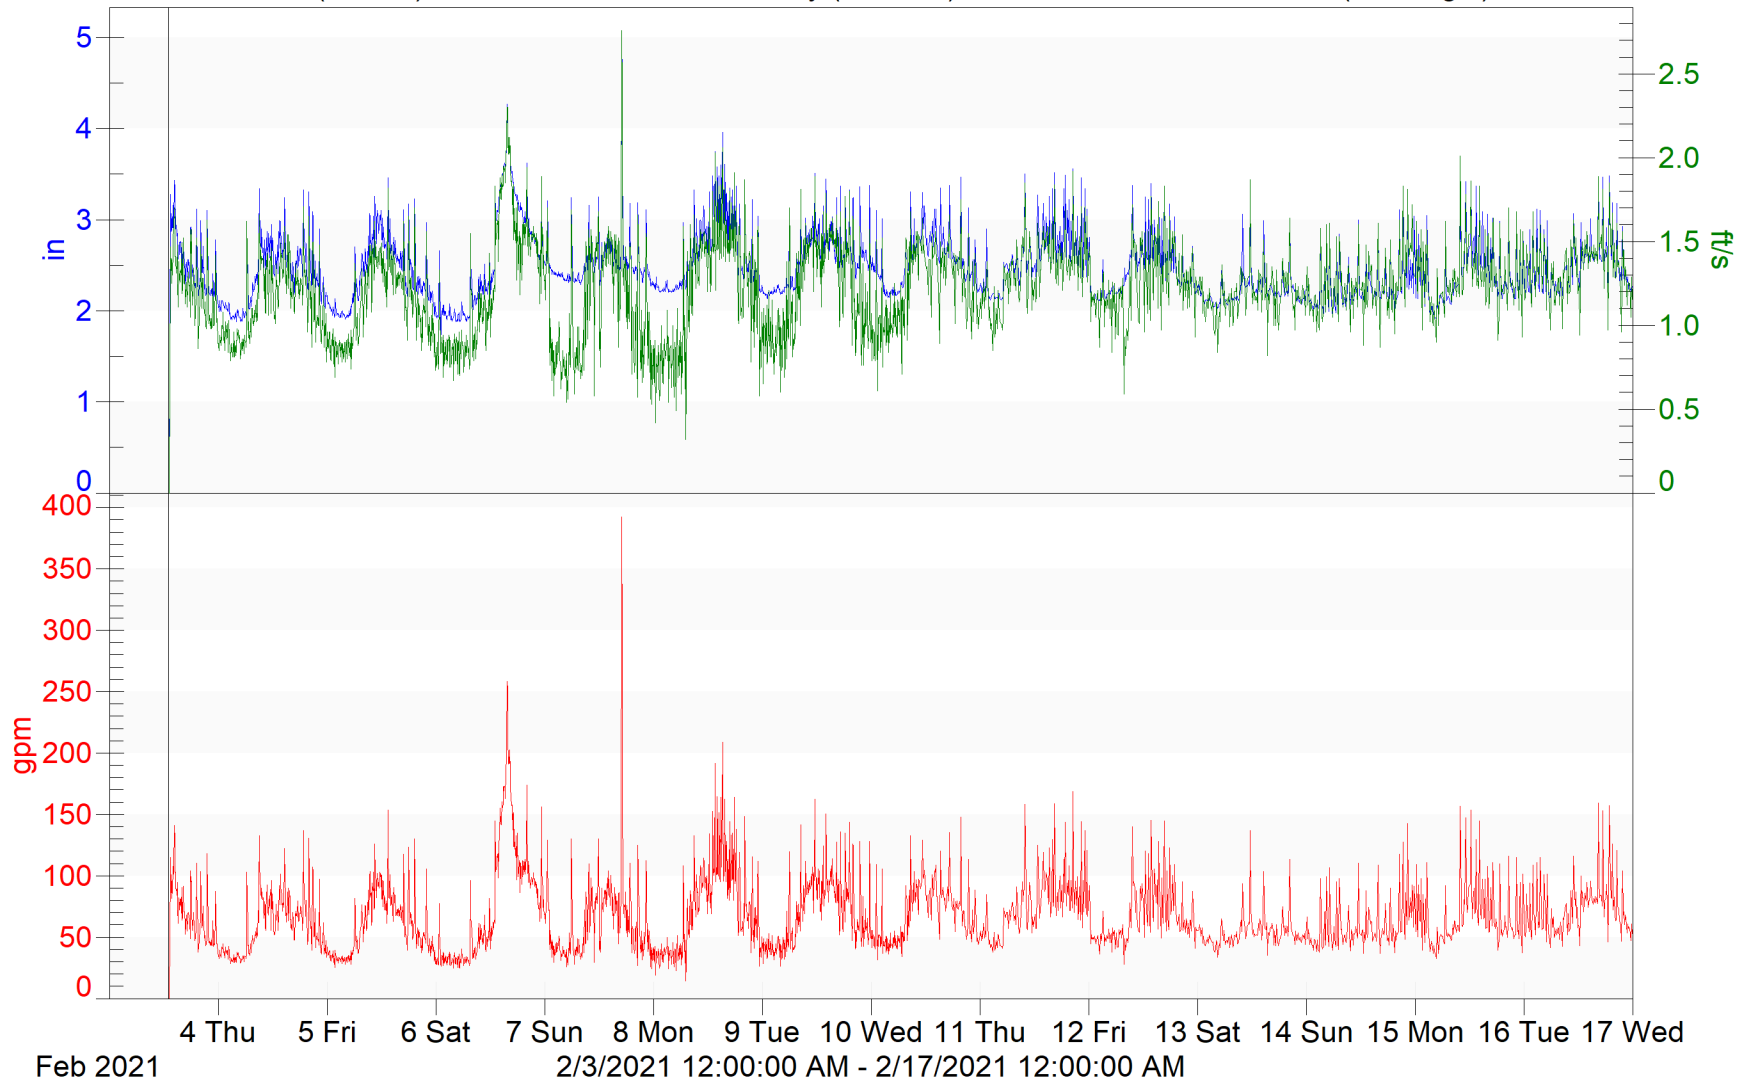
# FMNPVC3

Flowlink 5

Level (2.48 in):0.06

Velocity (1.21 ft/s):0.00

Flow Rate (1.29 mgal):0.00

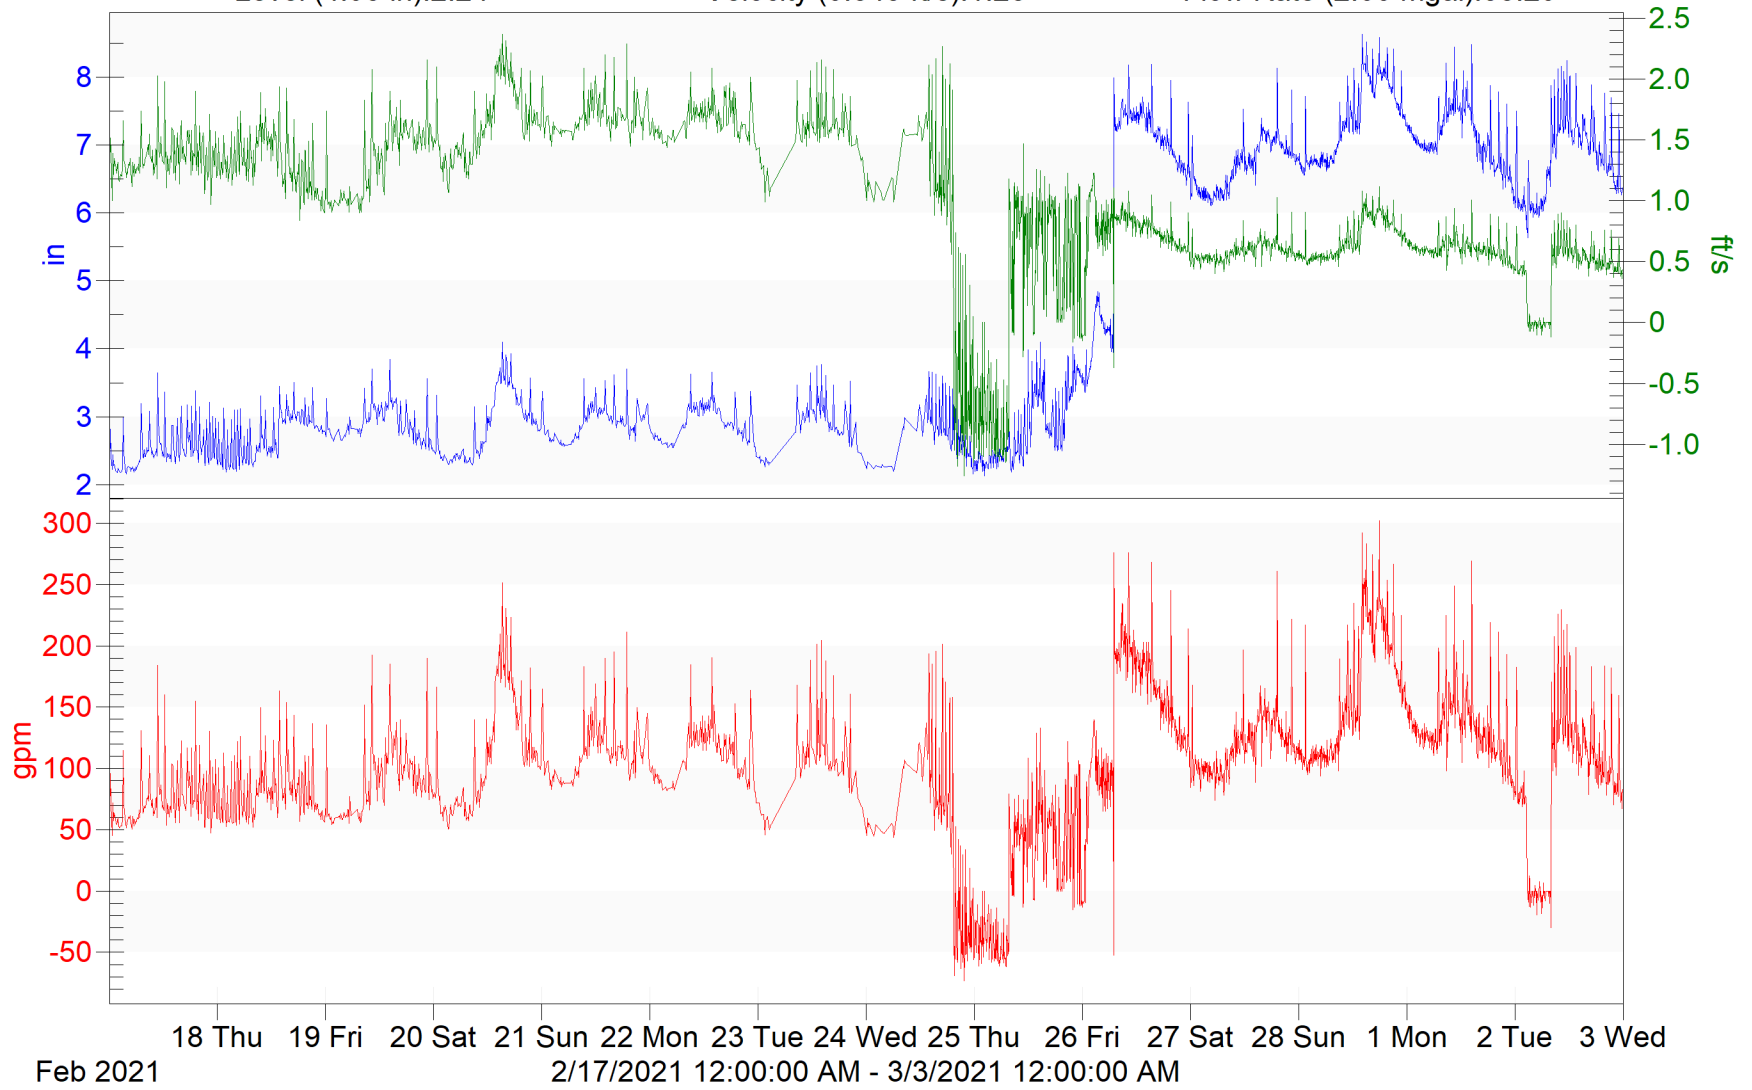
# FMNPVC3

Flowlink 5

Level (4.93 in):2.24

Velocity (0.843 ft/s):1.28

Flow Rate (2.00 mgal):58.29

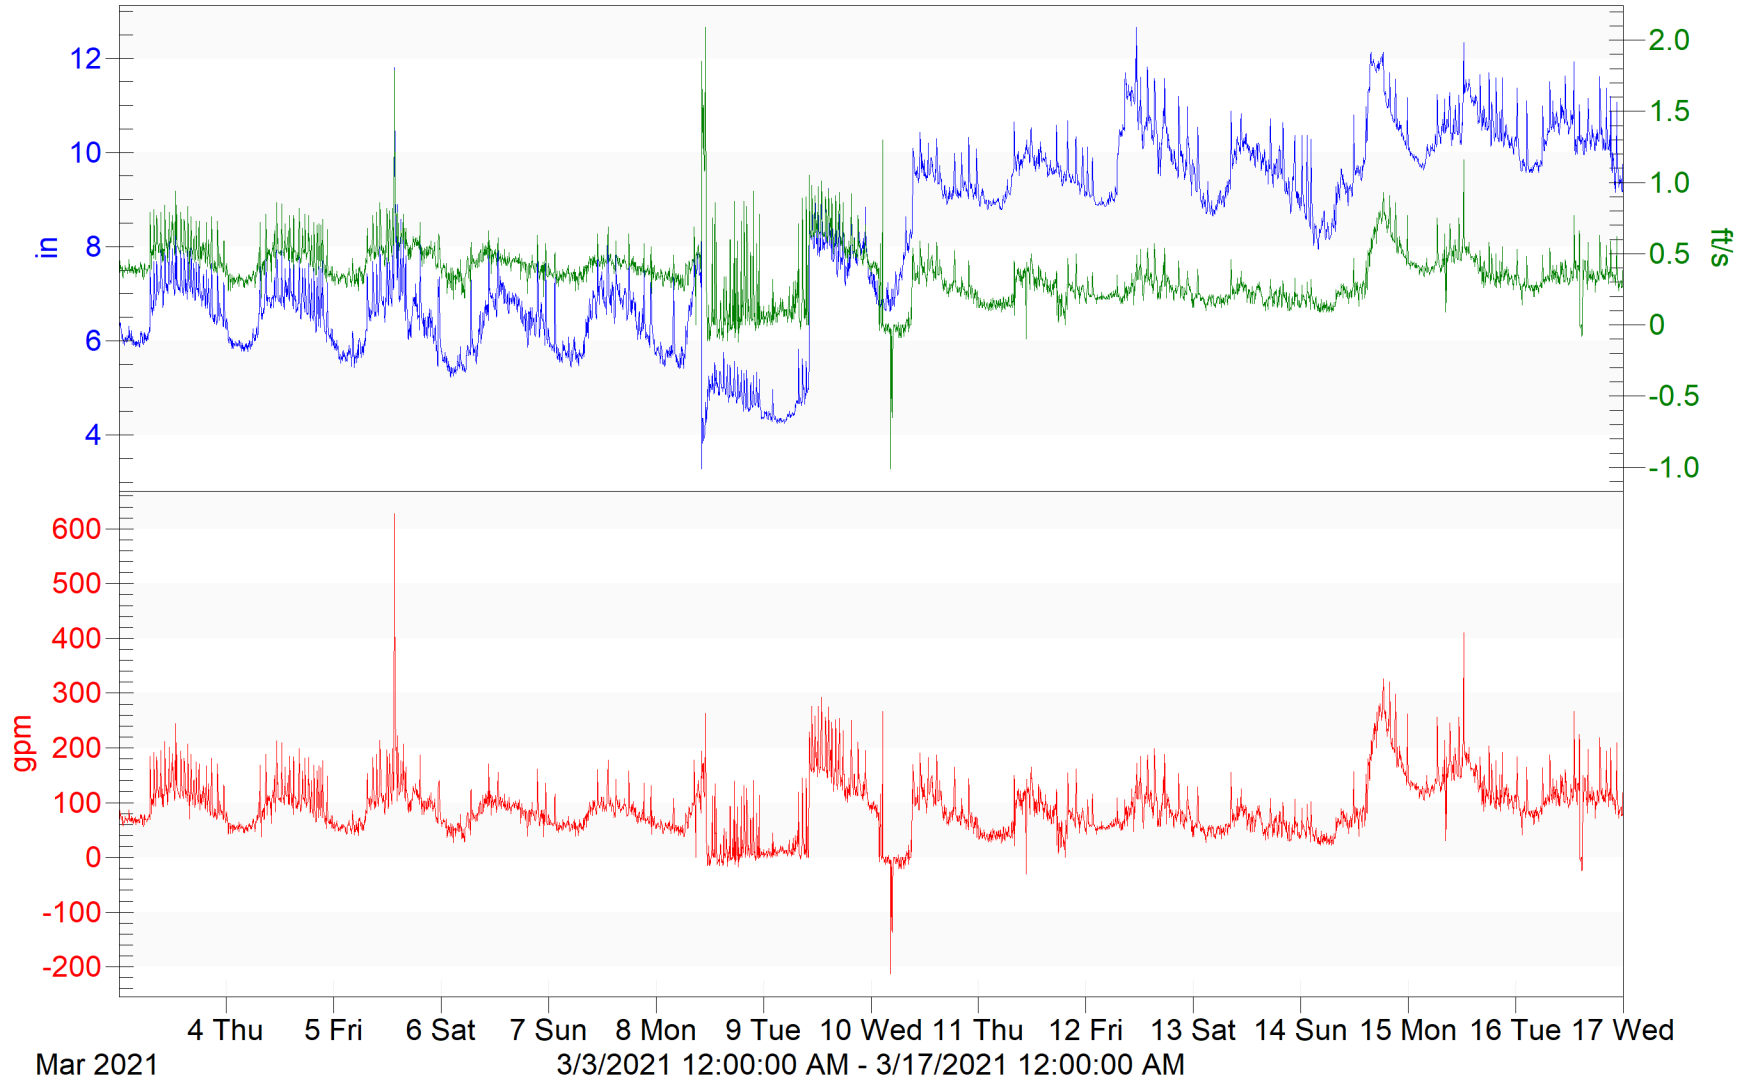
# FMNPVC3

Flowlink 5

Level (8.05 in):6.39

Velocity (0.357 ft/s):0.44

Flow Rate (1.79 mgal):84.23

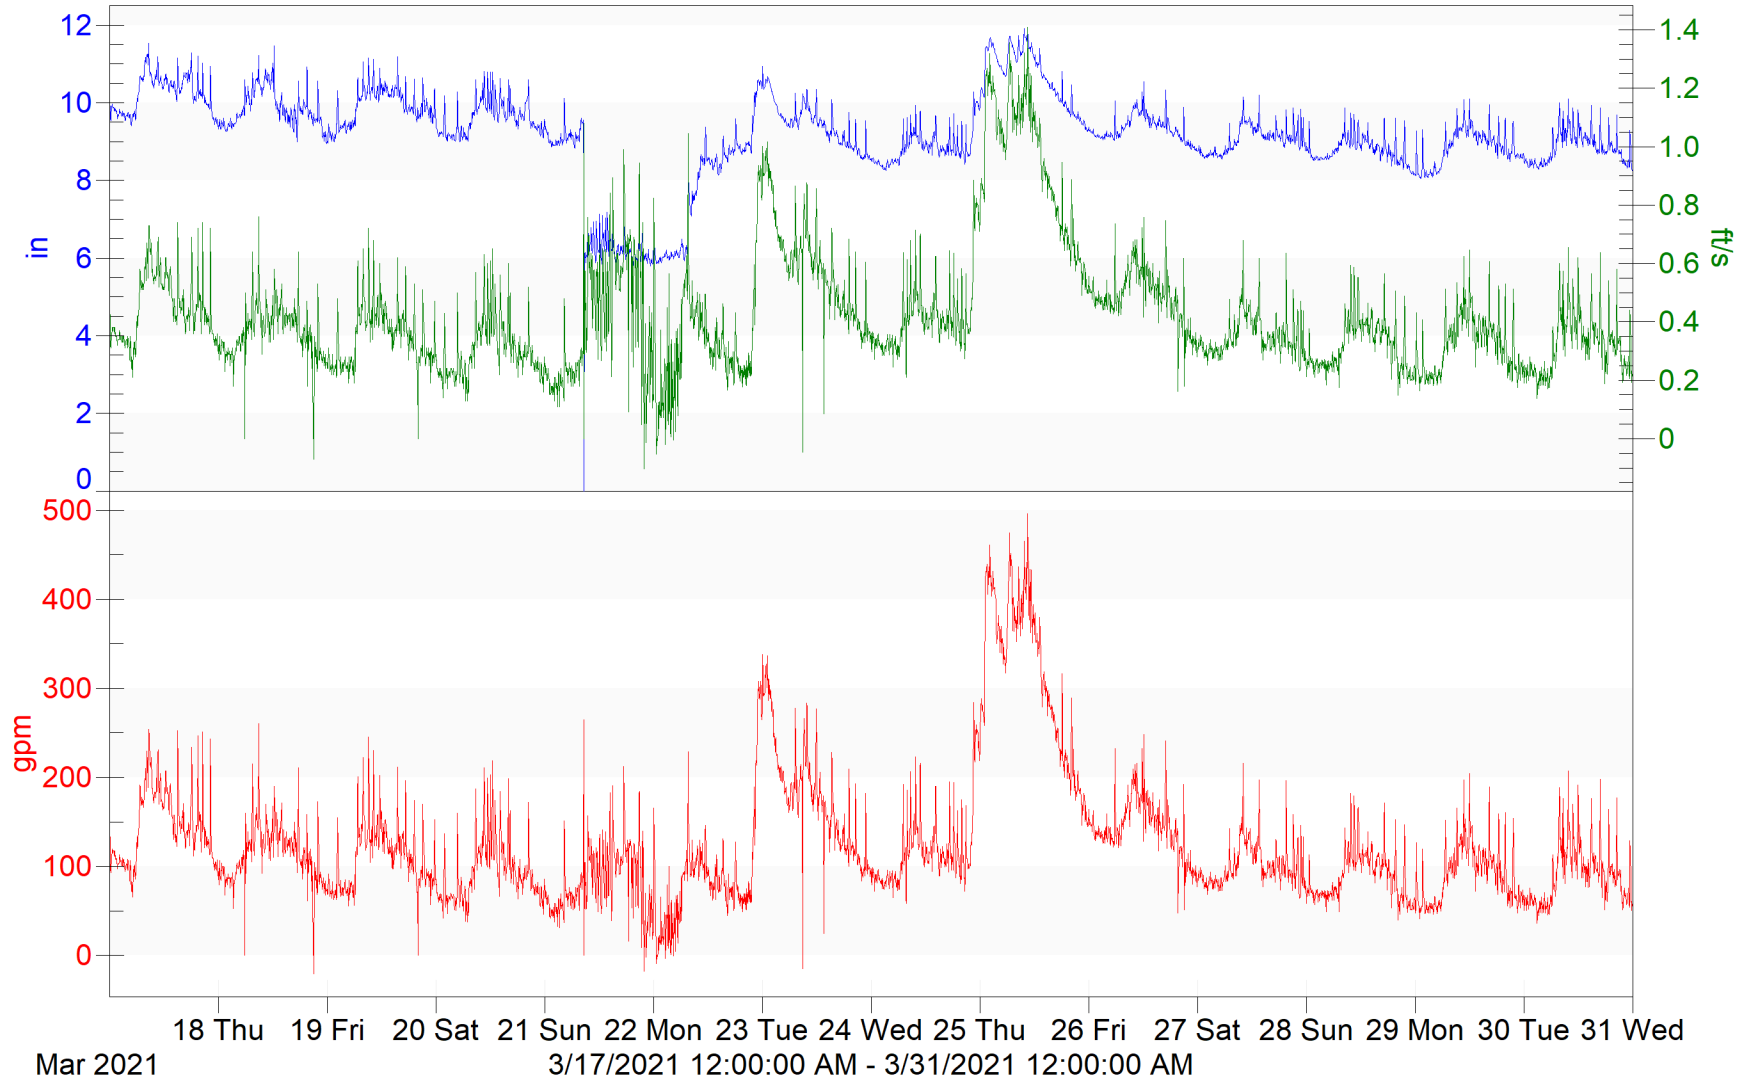
# FMNPVC3

Flowlink 5

Level (9.19 in):10.34

Velocity (0.425 ft/s):0.50

Flow Rate (2.52 mgal):160.03
