# MENA, AR

# FLOW MONITORING REPORT

## FEBRUARY – MAY 2021

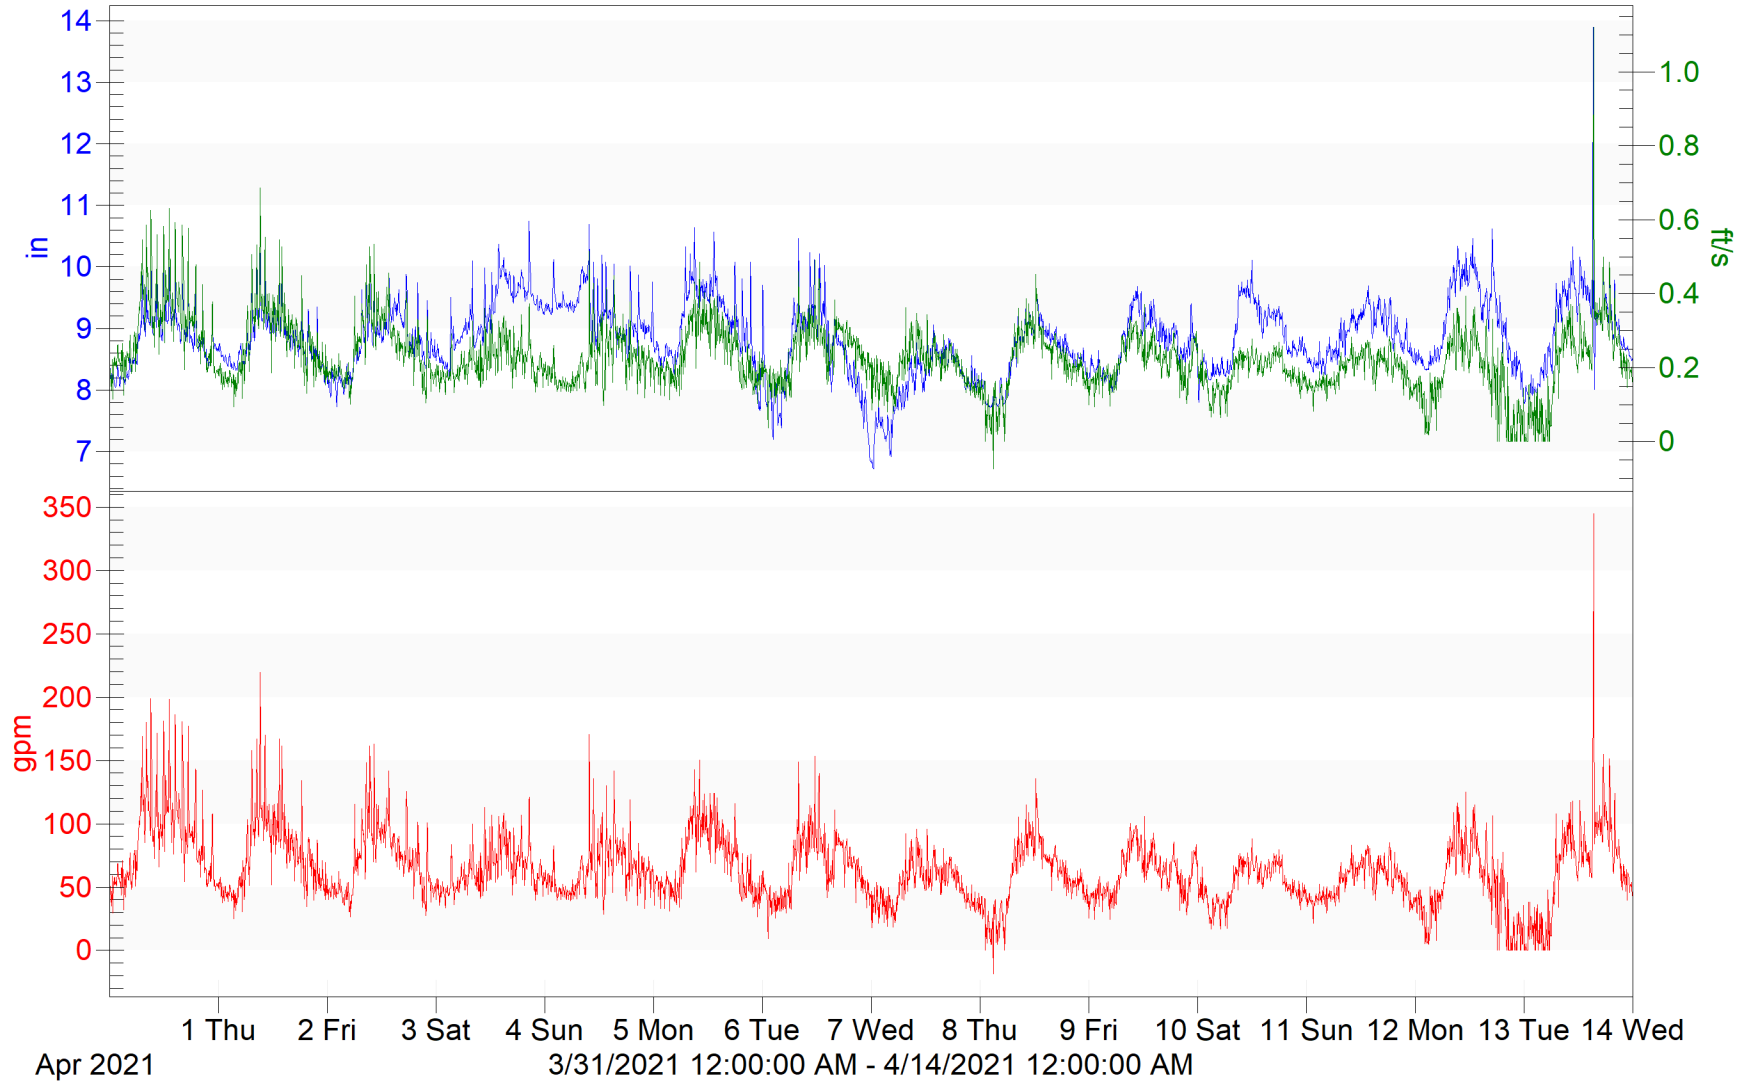
# FMNPVC3

Flowlink 5

Level (8.84 in):8.30

Velocity (0.226 ft/s):0.22

Flow Rate (1.29 mgal):56.04

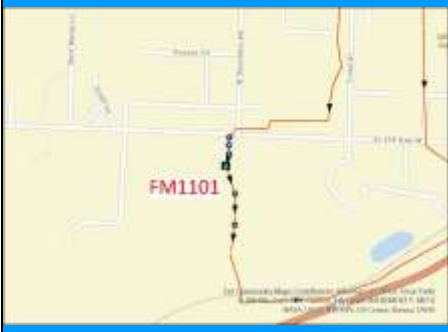
Map_FM1101	FM1101 Area	FM1101 Pipe
Downhole Image	Pipe Image	Install Schematic (Top)

Site ID	Device Type	Installation Date	Installed By
<b>fm1101</b>	Flow Meter	4/23/2021	J. Cawthon
Address	Location Details		Traffic Area ?
3607 HWY 375	back of the property next to a barn		No
Installation Manhole	Material	Evidence of Surge ?	
1100	Reinforced Concrete Pipe	No	
Gas Levels			
Oxygen	Carbon Monoxide	Hydrogen Sulfide	Lower Explosive Limit
20.90%	0.00%	0.00%	0
Installation Pipe	Material	Inside Diameter	
incoming		10

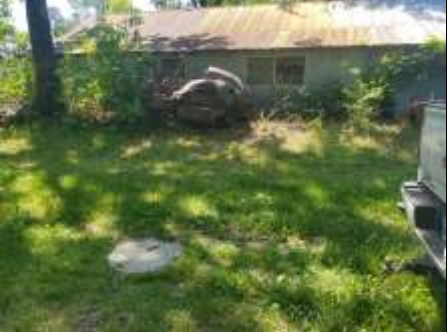
Hydraulic Conditions
Fast moving
General Conditions
Meter was moved from MH1101 to MH1100. Flow meter name remained

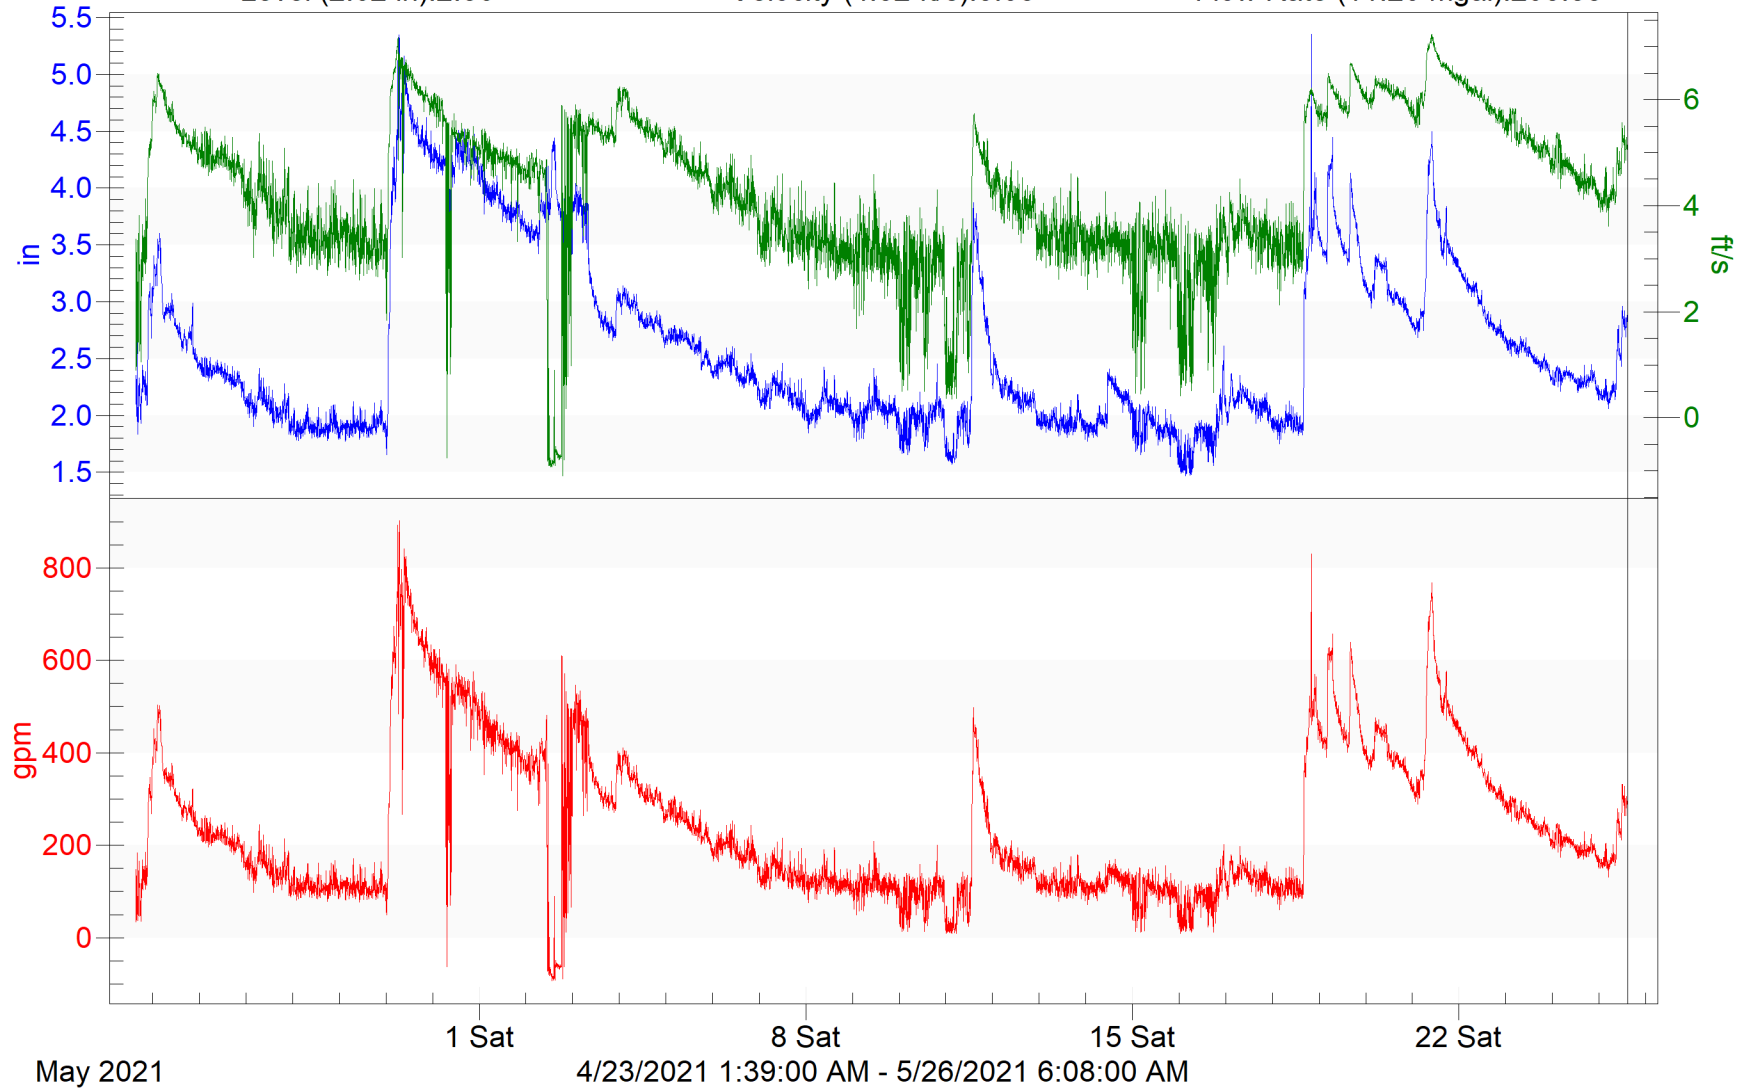
# FM 1101

Flowlink 5

Level (2.62 in):2.86

Velocity (4.32 ft/s):5.08

Flow Rate (11.20 mgal):293.88

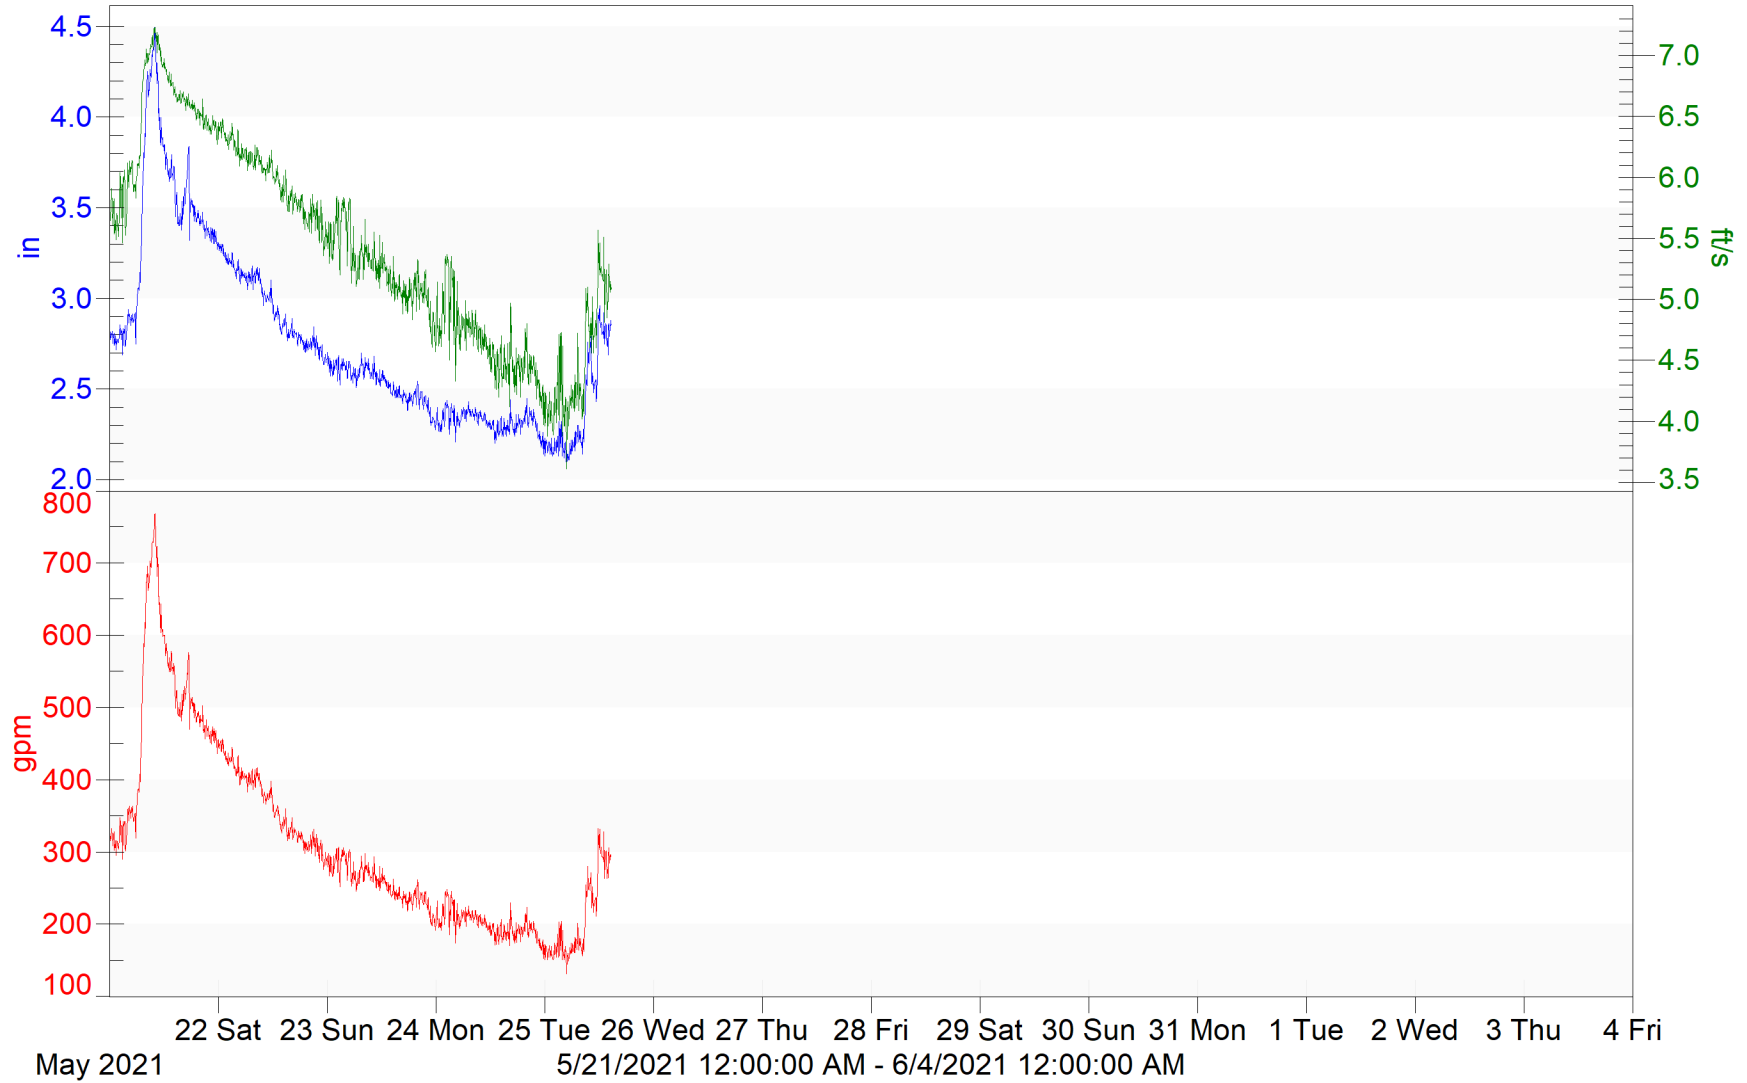
# FM 1101

Flowlink 5

Velocity (5.44 ft/s):5.73

Flow Rate (2.07 mgal):316.92
