**FIGURE 2**  
 PRETREATMENT PROCESS  
 MACLEAN-ESNA  
 POCAHONTAS, ARKANSAS

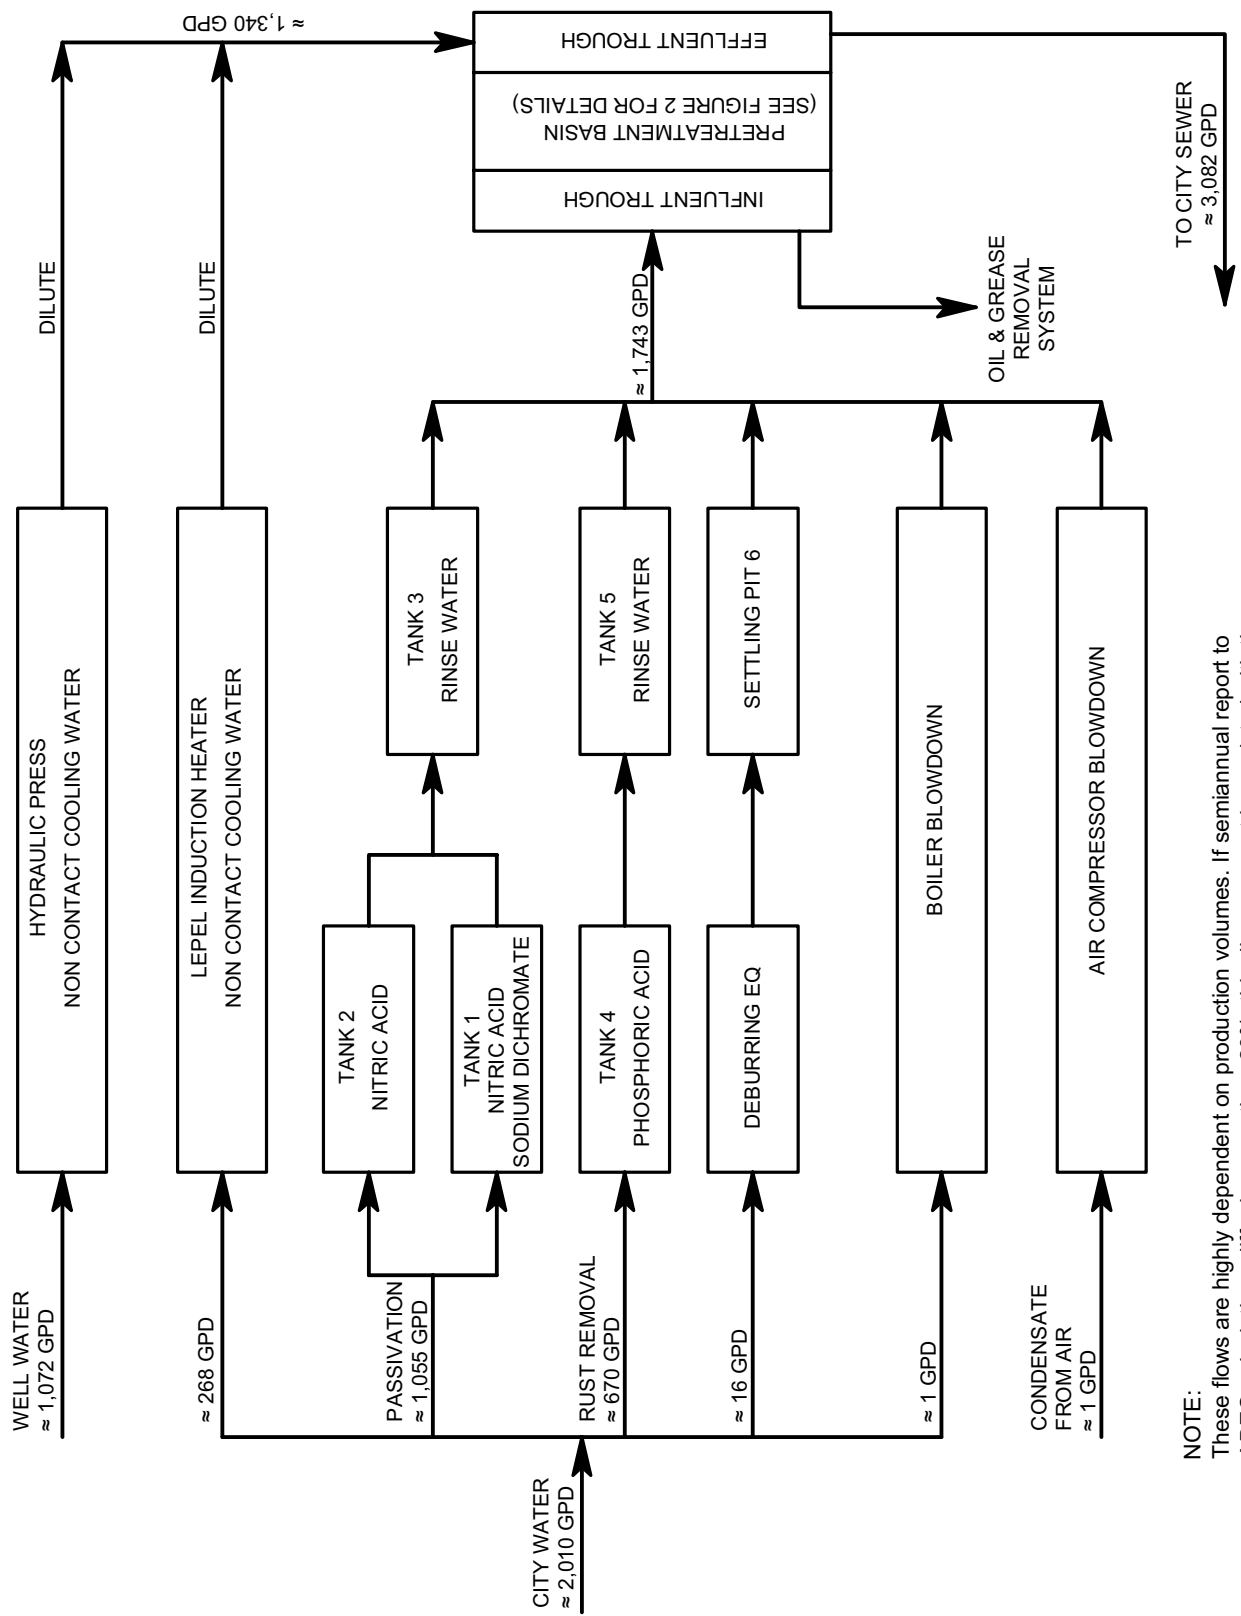
NOTE:  
 These flows are highly dependent on production volumes. If semiannual report to ADEQ calculations differ by more than 20%, this diagram must be updated with the new numbers and submitted to ADEQ.

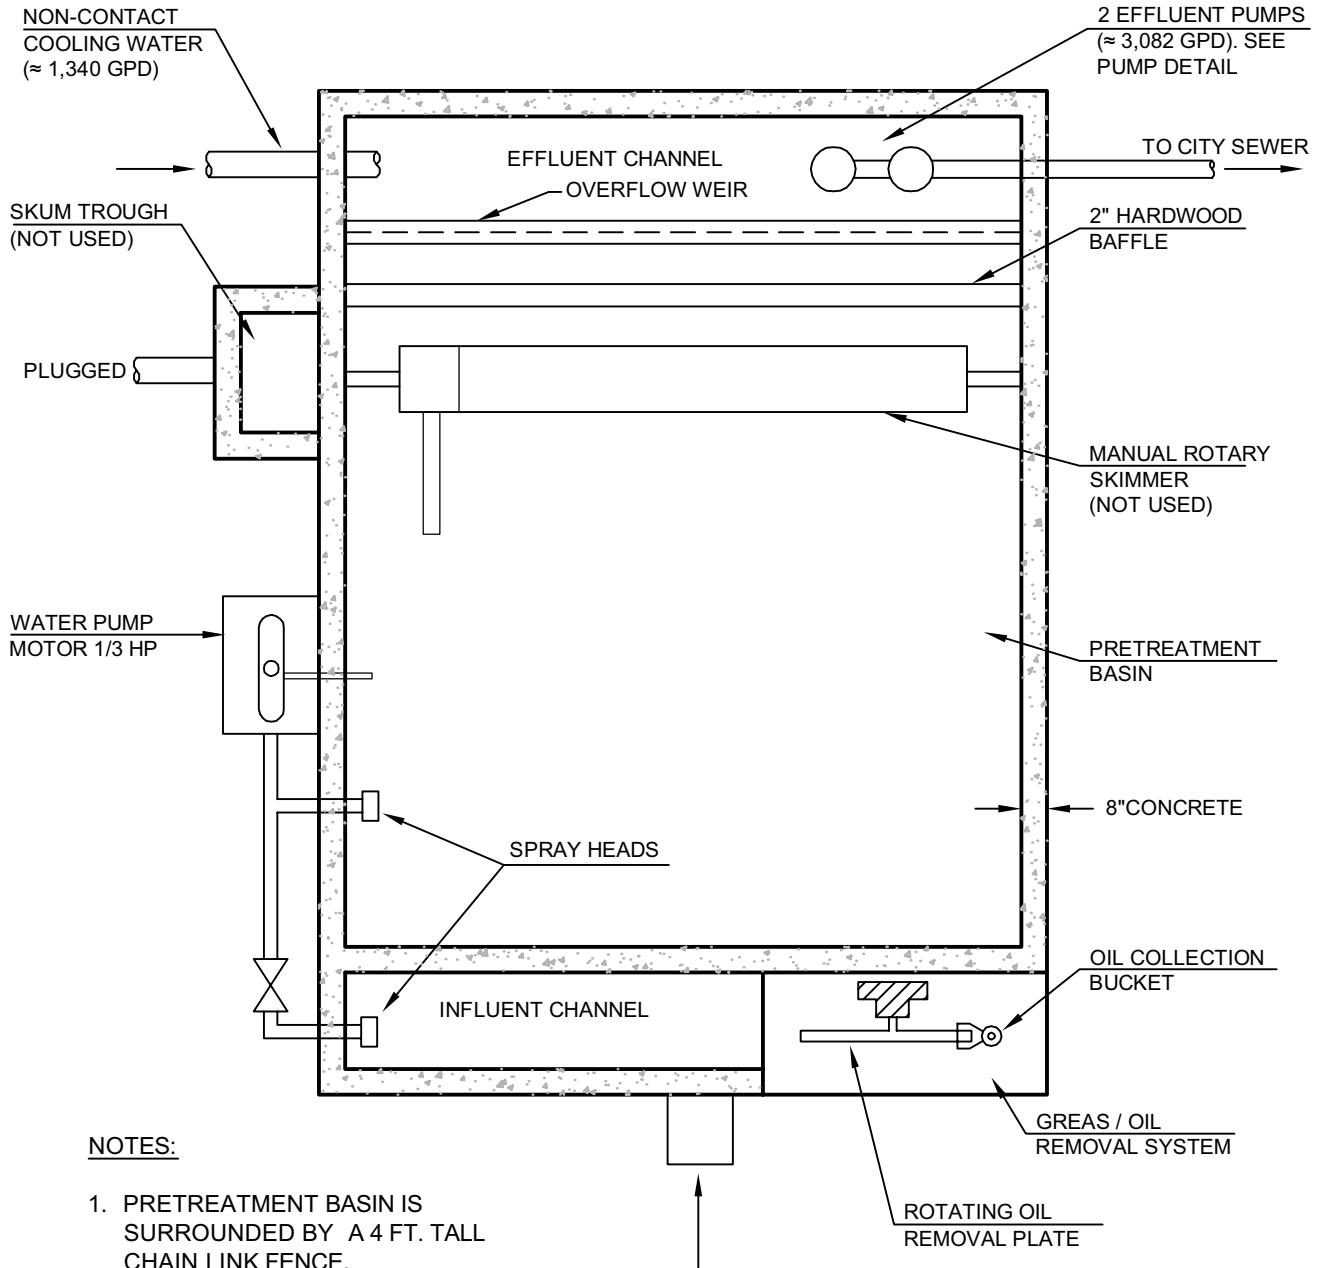
1. PRETREATMENT BASIN IS SURROUNDED BY A 4 FT. TALL CHAIN LINK FENCE.
2. PRETREATMENT BASIN IS COVERED BY A CORRUGATED ROOF.
