BELLA VISTA TRAFALGAR ROAD FIRE – PHASE I REMEDIAL ACTION

Daily Summary

May 20, 2019

Project #111327

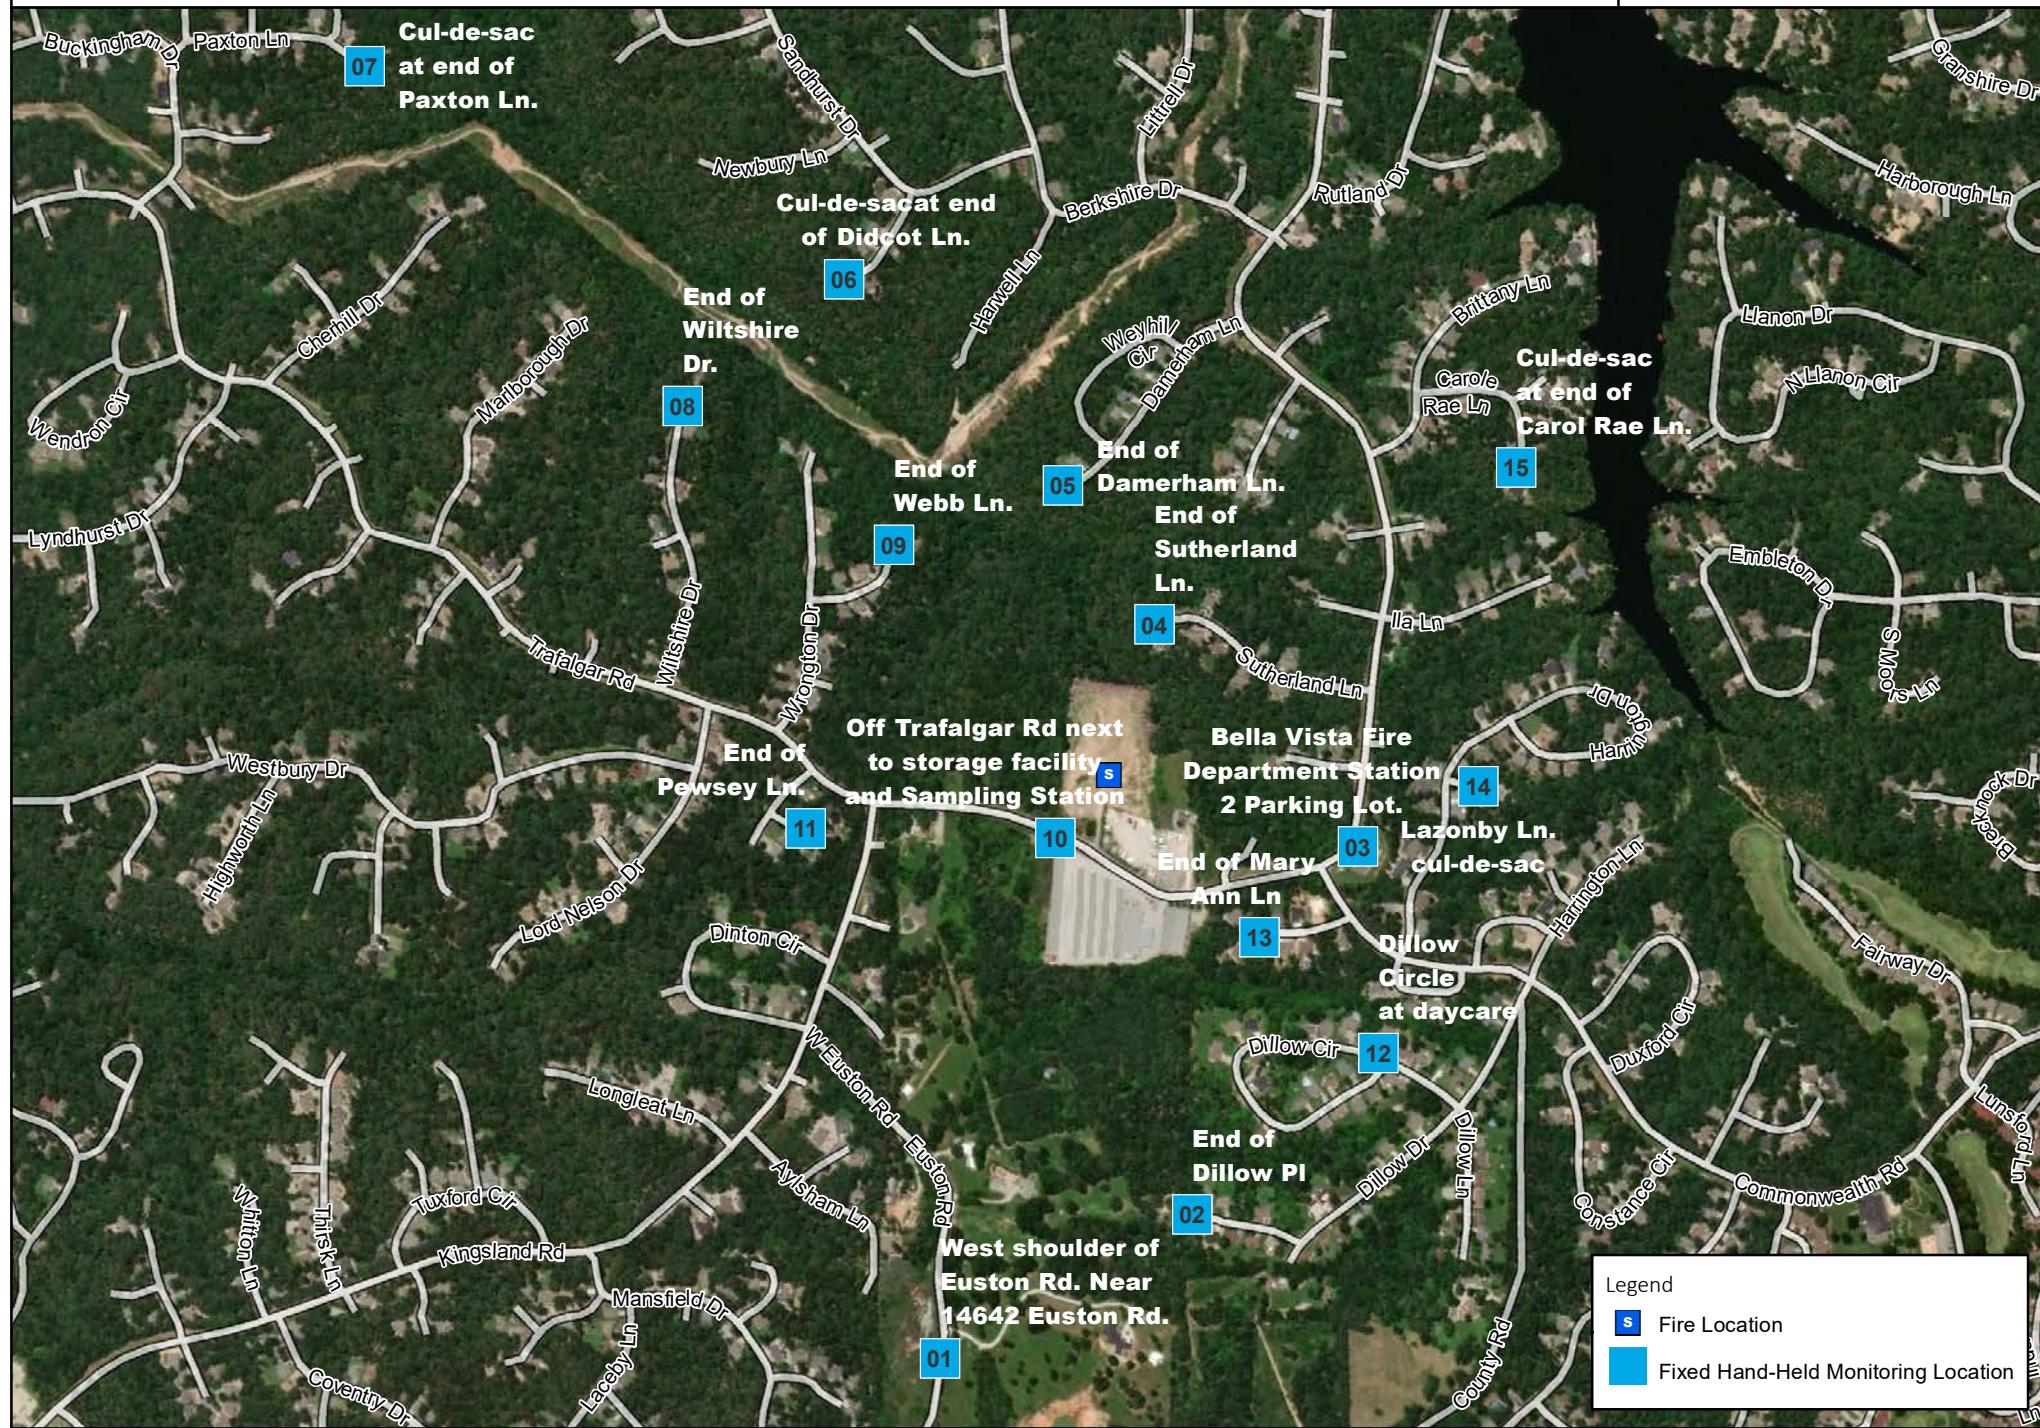
Figure 6: Fixed Hand-Held Real-Time Air Monitoring Locations

Table 1 summarizes the results for hand-held air monitoring readings and **Table 2** summarizes hand-held air monitoring results by their respecting fixed real-time location (FRT).

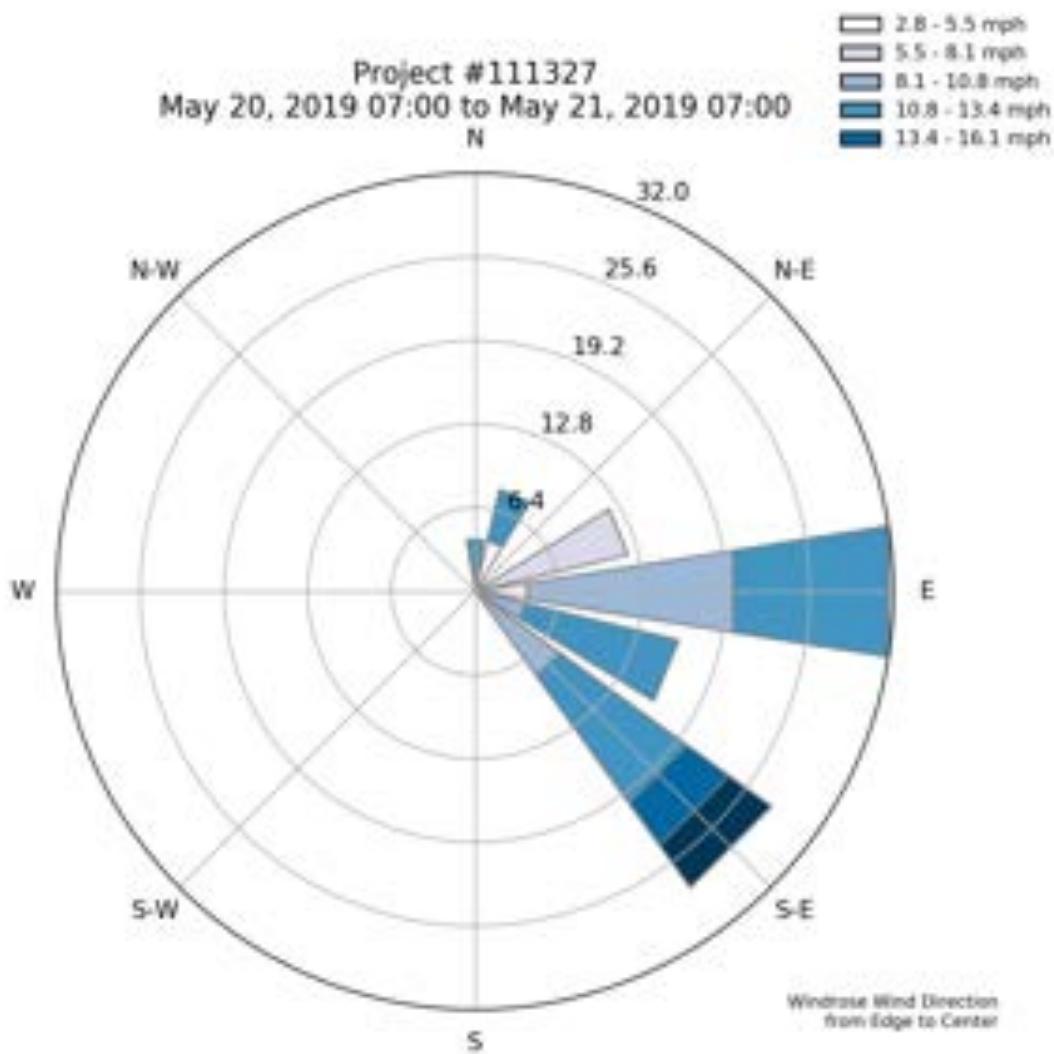
Meteorological Conditions

Attachment B contains a wind rose depicting wind speed and direction for this reporting period.
