NPDES Compliance Inspection Report

Name and Location of Facility Inspected (For industrial users discharging to POTW, also include POTW name and NPDES permit number) Russellville City Corporation Wastewater collection system transmission line near Prairie Creek pump station	Entry Time /Date 1430 / 5-14-2007	Permit Effective Date April 1, 2005
	Exit Time/Date 1245 / 5-18-2007	Permit Expiration Date March 31, 2010
Name(s) of On-Site Representative(s)/Title(s)/Phone and Fax Number(s) Craig Noble / General Manager Larry Collins / WWTP Operations Manager Keith Gray / Maintenance Supervisor		Other Facility Data N35° 17' 06.96" W93° 08' 16.79" Discharge location
Name, Address of Responsible Official/Title/Phone and Fax Number Craig Nobel, General Manager Russellville City Corporation P.O. Box 3186 Russellville, AR 72811 479-968-2080 ext. 113		
		Contacted Yes <input checked="" type="checkbox"/> No <input type="checkbox"/>

SUBJECT: Sewer line break, Russellville City Corporation

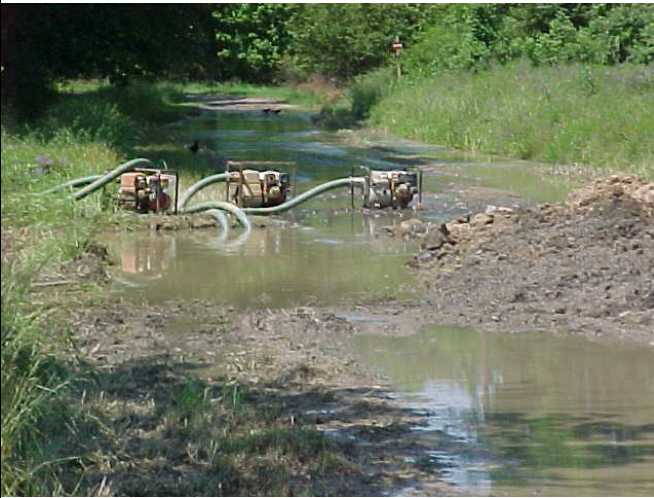
Location:		Russellville City Corp line break, west of N. El Paso Ave.					
Photographer:		Greg Kremers			Witness:		
Photo #	1	Of	8		Date:	5-14-2007	Time: 1438
Description:							
<p>Origin of the wastewater line break. The three pumps could not empty water from the excavated hole fast enough to allow crews to find the line.</p>

Upon arrival, I found the maintenance crew on site along with other representatives of City Corp. Maintenance Supervisor, Keith Gray, explained to me the plan of action he would take to stop the leak. The line was a 24 inch force main. They currently were not able to locate the line due to the amount of water that was leaking. The three pumps at the site could not keep up with the volume of water in the pipe. A 2000 gpm pump from TRS was in route to the site. While waiting, I verified that water from the line was traveling down the road and then entering Prairie Creek. I then left the site and observed Prairie Creek at two separate locations. The first was at West "K" Street, approximately ¼ mile downstream from where the waste was entering the stream. The stream was turbid and there was a strong wastewater smell. The second site was at the Corp of Engineers pump station on Lake Front Drive. This pump station is approximately 2 miles downstream and directly across the road from Lake Dardanelle. Since Prairie Creek is the major storm water collection system for the city, the COE will periodically discharge water from the creek into Lake Dardanelle. I could not tell that the waste stream had made it to this point at that time. I met with COE Environmental Specialist, Ron Hudson while there. He asked if they should hold the water until further notice. That was when I called you and you stated that we were not in a position to keep them from pumping due to flooding issues.

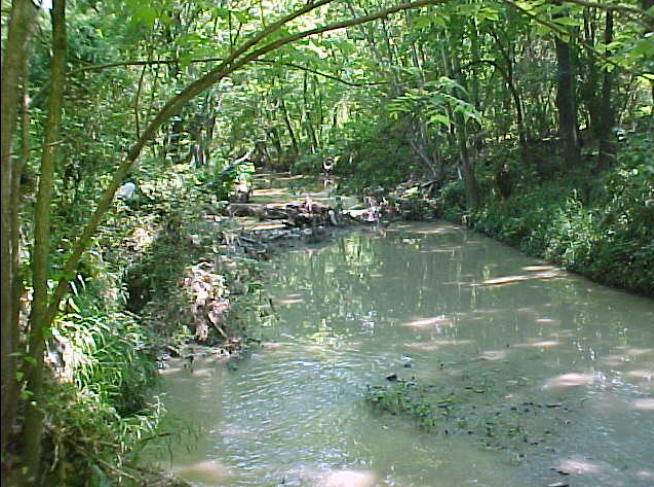
Photographer:		Greg Kremers			Witness:		None
Photo #	2	Of	8		Date:	5-14-2007	Time: 1502
Description:							
<p>Observation of Prairie Creek on West "K" Street. This is approximately ¼ mile downstream of where the waste was entering the stream.</p>

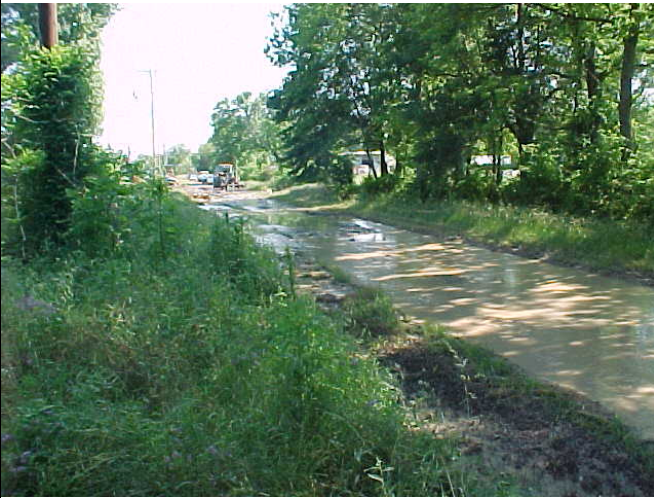
Location:		Russellville City Corp line break, west of N. El Paso Ave.						
Photographer:		Greg Kremers			Witness:		None	
Photo #	3	Of	8	Date:		5-14-2007	Time:	1609
Description:								
Path of wastewater as it traveled down the road towards Prairie Creek.

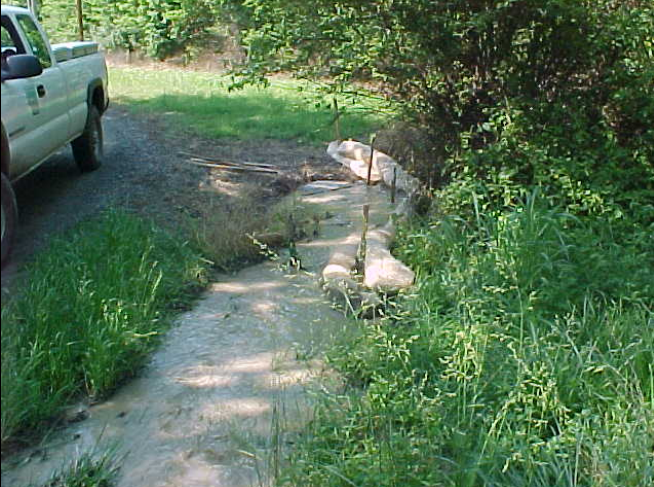
Photographer:		Greg Kremers			Witness:		None	
Photo #	4	Of	8	Date:		5-14-2007	Time:	1612
Description:								
Wastewater entering Prairie Creek to the right.

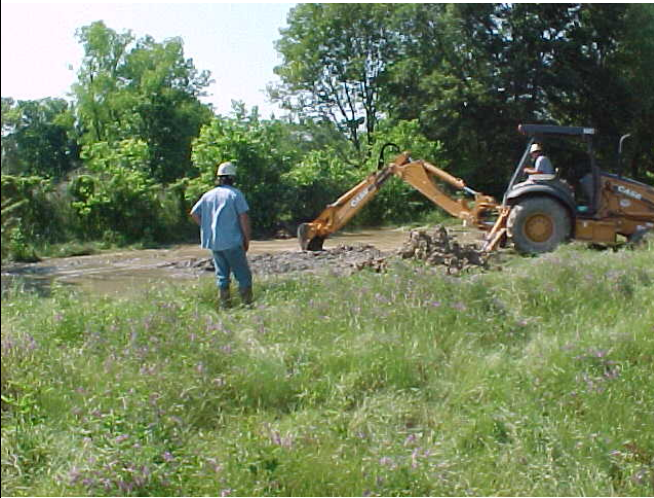
Location:		Russellville City Corp line break, west of N. El Paso Ave.						
Photographer:		Greg Kremers			Witness:			
Photo #	5	Of	8		Date:	5-14-2007	Time:	1607
Description:								
Excavation of the hole above the line.

When I arrived back at the site, the pump from TRS had arrived. A hole above the line had been excavated to allow the pump to be backed into it. At this point, water at City Corp's Prairie Creek station was held back for a short period while the TRS pump was allowed to empty the hole of water to allow for further excavation. Once the well at the station was filled to capacity, water was then allowed to flow through, filling the hole again. This process would be repeated numerous times throughout the evening until the pipe was located. Larry Collins stated that they had pulled samples from three locations on Prairie Creek. I stated to Mr. Collins that City Corp should continue to pull samples the following day as well. I left the site at around 1700 hours.

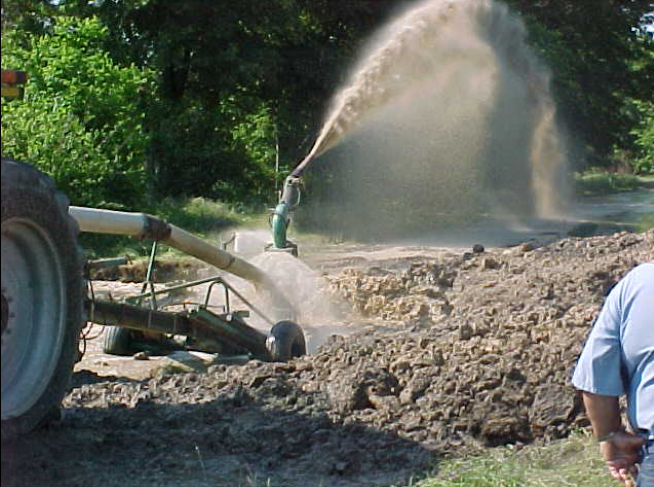
Photographer:		Greg Kremers			Witness:			
Photo #	6	Of	8		Date:	5-14-2007	Time:	1641
Description:								
Water being pumped down the road to help aid in the finding of the pipe. Pump was brought in by TRS.

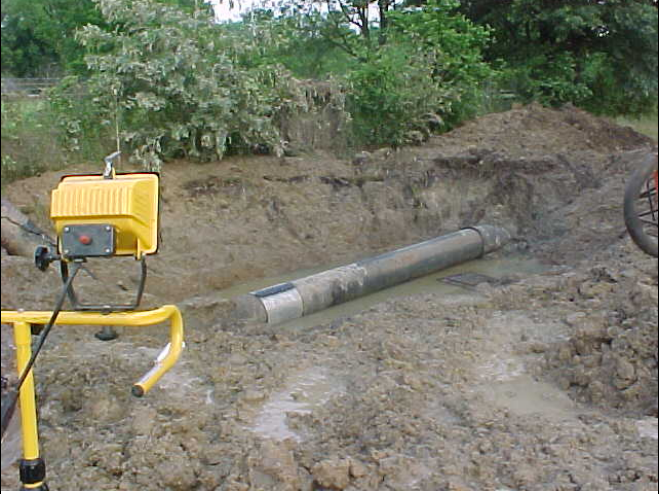
Location:		Russellville City Corp line break, west of N. El Paso Ave.						
Photographer:		Greg Kremers			Witness:		Rickey Biffle	
Photo #	7	Of	8		Date:	5-15-2007	Time:	0800
Description:								
Completion of the newly installed segment of line.

I arrived back on location at 0800 on May 15. I spoke to Rickey Biffle of City Corp. He informed me that the pipe was replaced that morning at around 0445 hours. Approximately 20 feet of the ductile-iron pipe had been replaced. A gash along the length of the old pipe was observed. After verifying that no more wastewater was being discharged from the line, I left for prior commitments over the next few days.
