NPDES Compliance Inspection Report

Name and Location of Facility Inspected (For industrial users discharging to POTW, also include POTW name and NPDES permit number) Cabot Water & Wastewater Commission – Pump station just east of North 2nd street – from North Little Rock, go north on Highway 67/167 toward Cabot. Take the Highway 89 exit and go east toward downtown. Turn left at 2nd street and go north approximately 4 blocks. Pump station is at back of vacant lot across from W. Cherry Street.		Entry Time/Date 11:15 AM/ 05/14/08		Permit Effective Date 11/01/07	
		Exit Time/Date 12:03 PM/ 05/14/08		Permit Expiration Date 10/31/12	
Name(s) of On-Site Representative(s)/Title(s)/Phone and Fax Number(s) none				Other Facility Data	
Name, Address of Responsible Official/Title/Phone and Fax Number Tim Joyner P.E. – General Manager / 501-605-1740 208 North 1st St. Cabot, AR 72023				Contacted Yes <input type="checkbox"/> No <input checked="" type="checkbox"/>

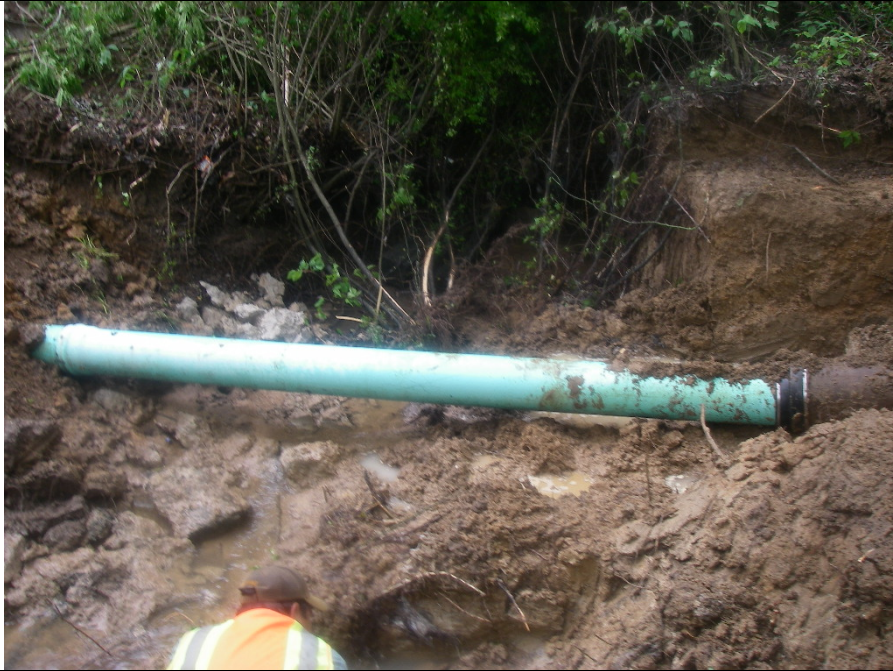
Location:	Cabot Water and Sewer						
Photographer:	Dennis Benson			Witness:	None		
Photo #	1	Of	2	Date:	05/14/08	Time:	11:17 am
Description:	Repaired gravity line which goes to pump station to the left

Investigated SSO referral from emergency response group. Spot where gravity line to pumping station and force main from pumping station cross small storm drain had failed due to storm flows. When I arrived, the Cabot work crews had already repaired the gravity line and were working on replacing force main. Pump station wet well was holding wastewater, so discharge to stream had stopped. Walked portion of creek. No visible solids, although water was gray and smelled of sewage. Drove to where stream crossed North Polk Street, water still smelled of sewage but was not septic and no visible solids were noted. Followed stream to railroad tracks. No dead fish, no paper, water gray.

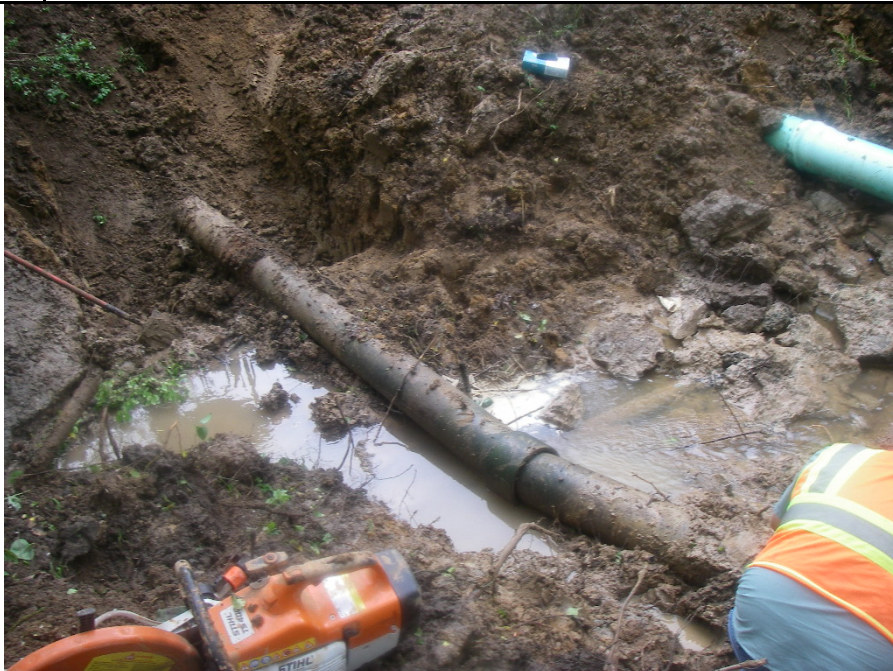
Photographer:	Dennis Benson			Witness:	None		
Photo #	2	Of	2	Date:	05/14/08	Time:	11:17 am
Description:	Force main from pumping station being repaired
