ARKANSAS
Department of Environmental Quality

RE: Compliance Inspection

NPDES Permit No.: AR0022381

NPDES Compliance Inspection Report

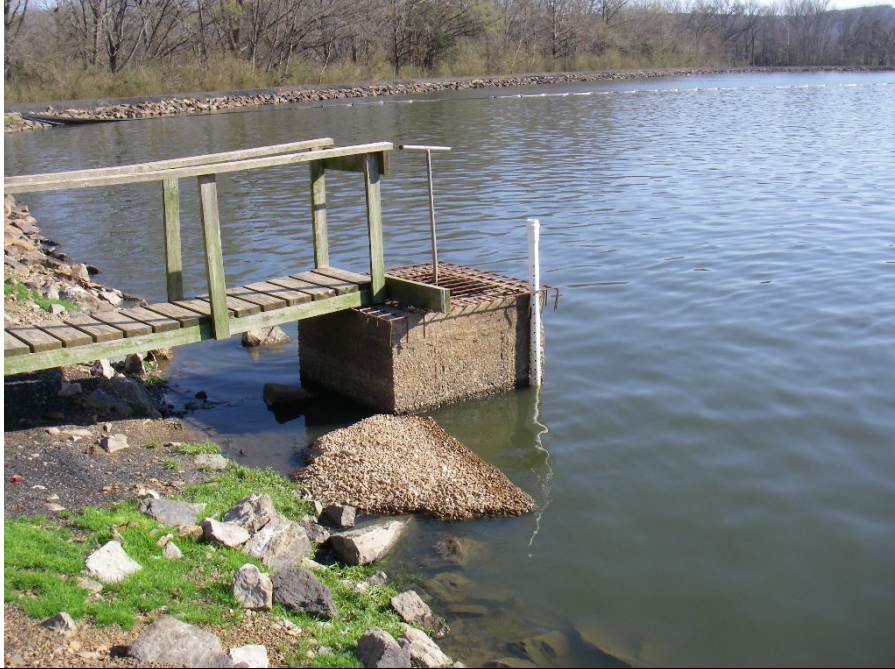
Photo # 1 **Of** 7 **Date:** 3-10-11 **Time:** 1528

Description: This is a view of the Potential Unpermitted Discharge, which is an old outfall structure located on the northeast side of Cell #2. This structure known as Outfall 001 has been capped off at the outfall at Sulfur Creek.

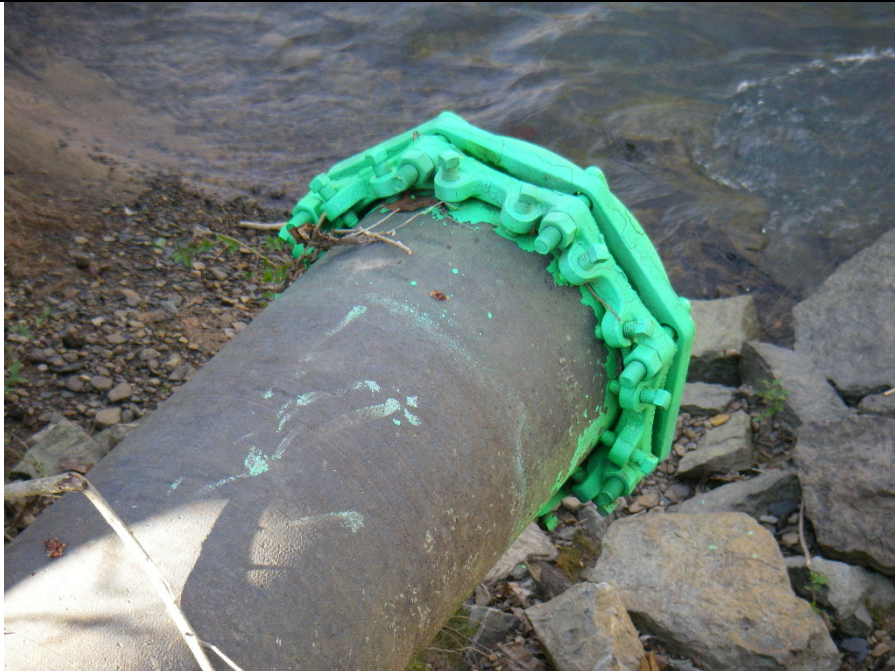
Photo # 2 **Of** 7 **Date:** 3-10-11 **Time:** 1528

Description: This view shows the structure permanently capped off at the outfall.

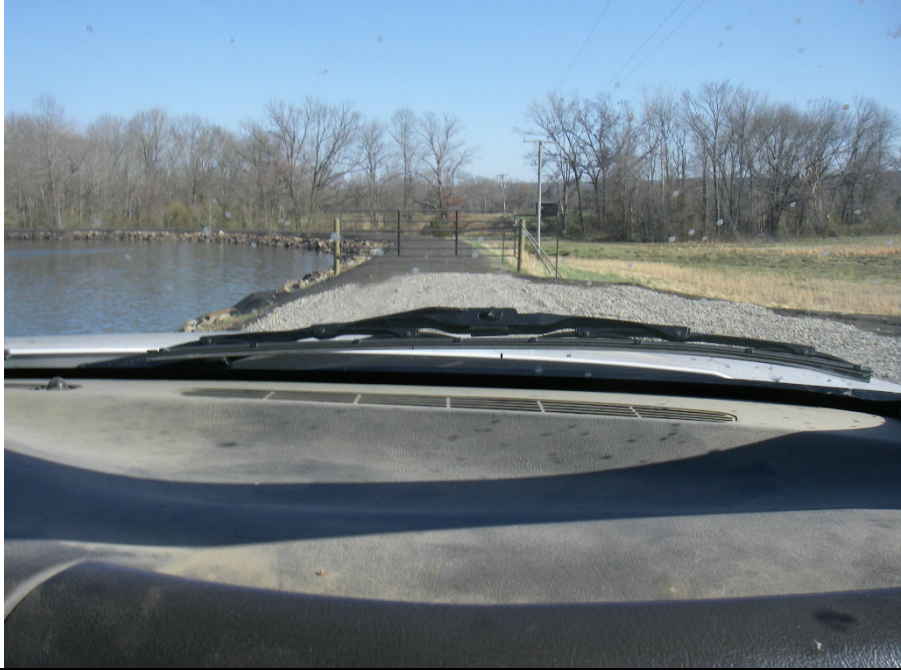
Photo # 3 **Of** 7 **Date:** 3-10-11 **Time:** 1521

Description: This is a view of the side of Cell #1 showing where the levee roads/tops have been graveled and fenced.

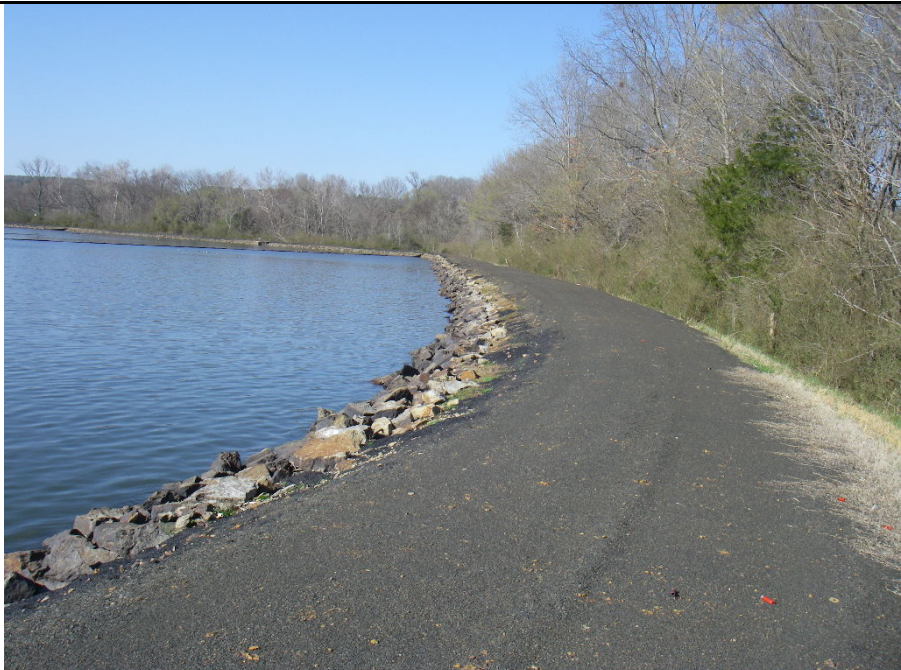
Photo # 4 **Of** 7 **Date:** 3-10-11 **Time:** 1524

Description: This view shows the southeast corner of the Settlement Pond showing the repaired and graveled top of the levee.

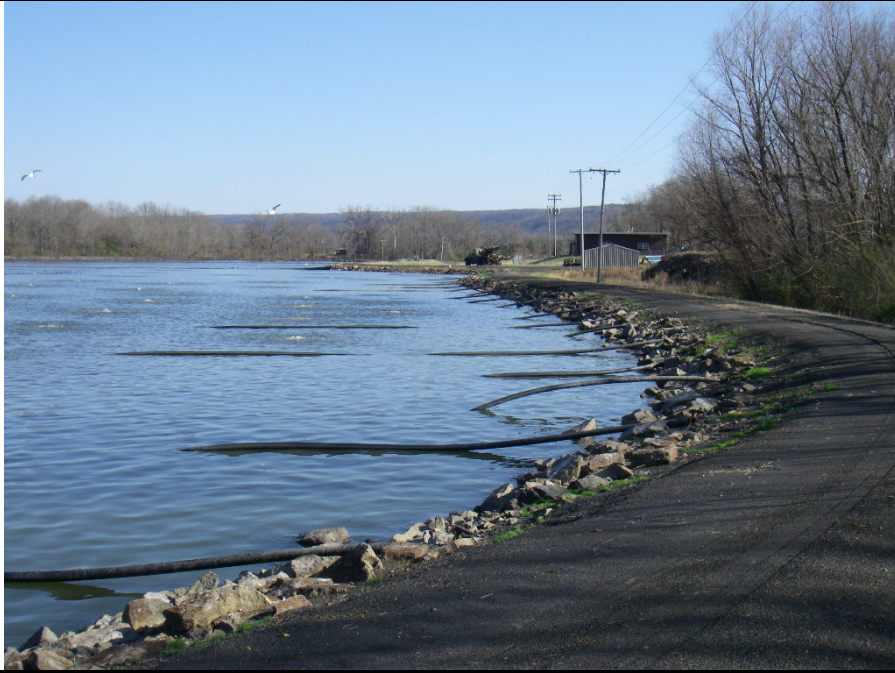
Photo # 5 **Of** 7 **Date:** 3-10-11 **Time:** 1532

Description: This view at the northwest corner of the Settlement Pond shows that the levee all around the Settlement Pond has been repaired and graveled.

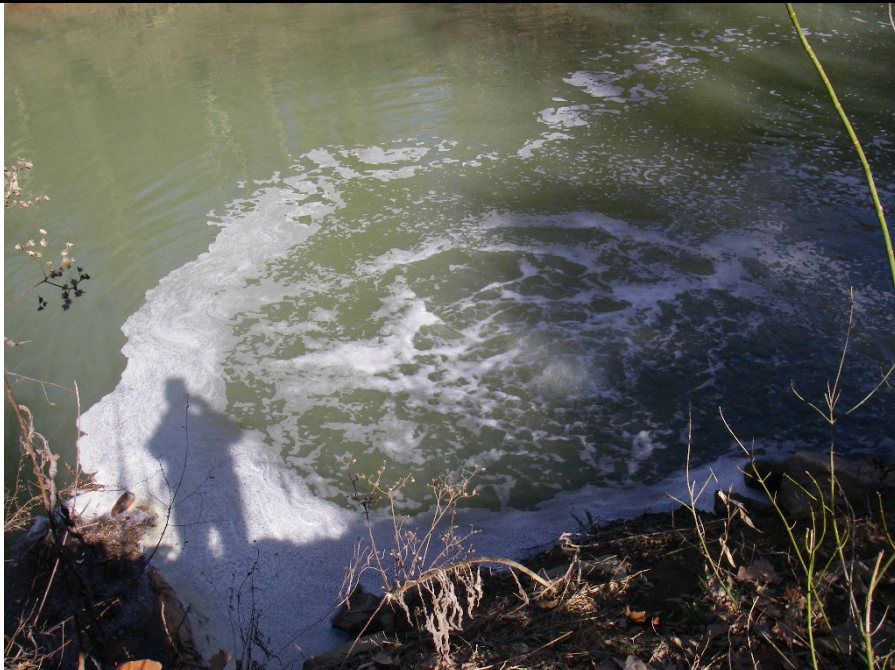
Photo # 6 **Of** 7 **Date:** 3-10-11 **Time:** 1512

DETAILS: (Small amount of visible foam at outfall, but not persistent)

On the date of the inspection, a small amount of visible foam was observed on the surface of the water at Outfall #2. This outfall flows into Sulfur Creek, which then flows into Little Red River located approximately 50 yards southeast. The Inspector observed at the mouth of Sulfur Creek where the creek enters Little Red River that the foam was not reaching Little Red River.

Description: View at the outfall into Sulfur Creek showing foam on the water at this point, the foam was not reaching Little Red River approximately 50 yards away.

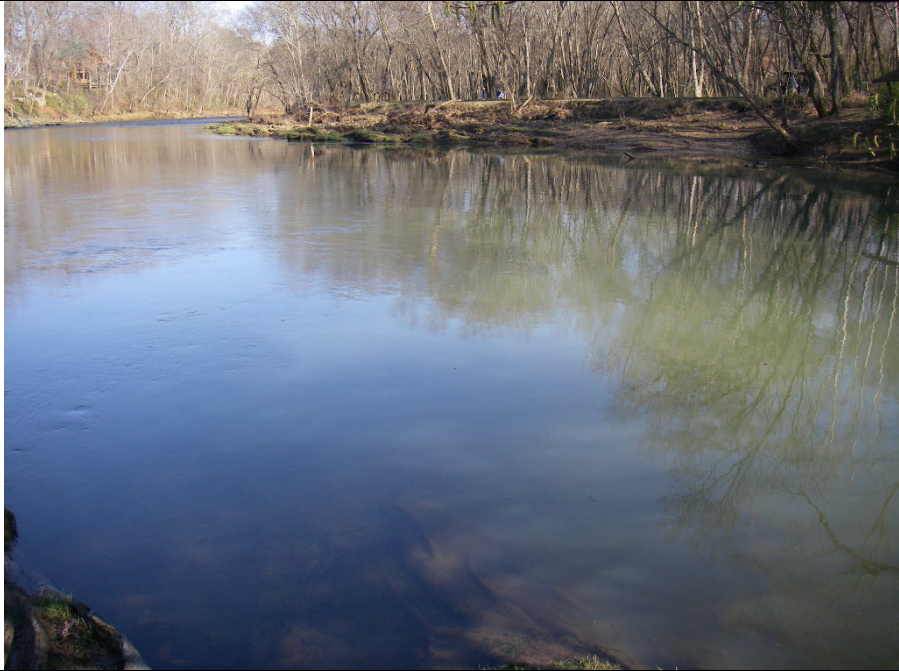
Photo # 7 **Of** 7 **Date:** 3-10-11 **Time:** 1600

Description: This view at the mouth of Sulfur Creek where the creek enters Little Red River shows no foam entering the river. The river is located approximately 50 yards southeast of Outfall 002.
