Subject: City of Stuttgart WWTP (Arkansas Co)  
AFIN: 01-00214 NPDES Permit No.: AR0034380

**Water Division Photographic Evidence Sheet**

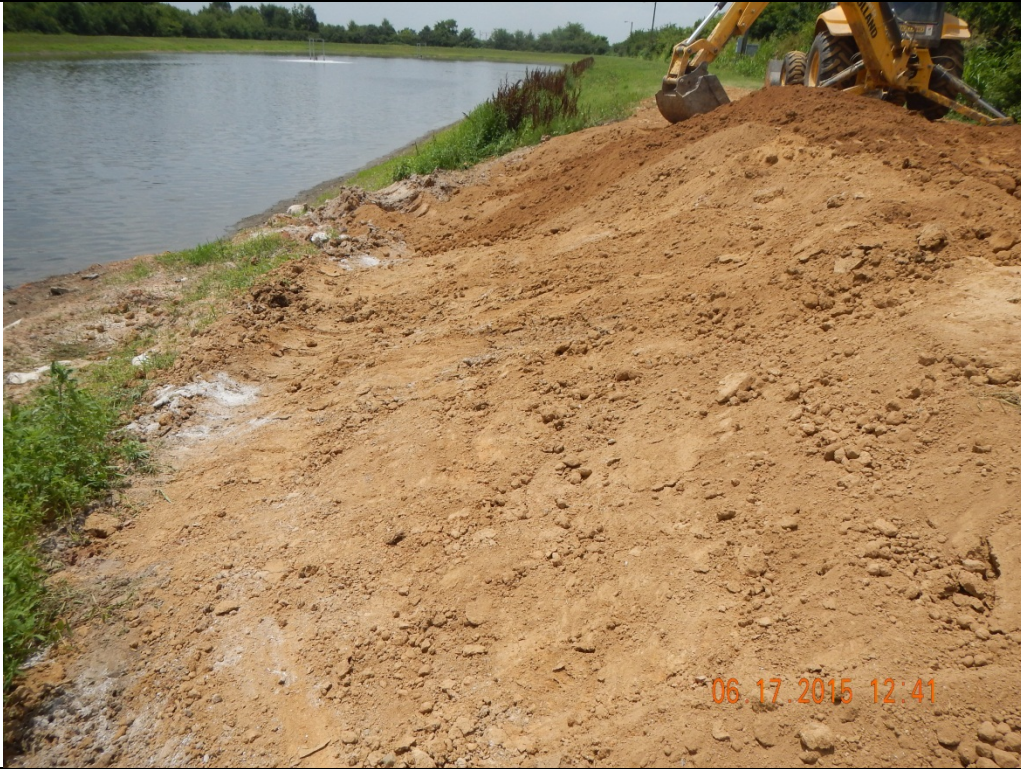
Location:	<b>City of Stuttgart WWTP-EQ Basin</b>		
Photographer:	<b>Steven L. Henderson</b>	Date:	<b>6/17/2015</b>
Time:	<b>12:41</b>	Witness:	<b>N/A</b>
Photo #:	<b>1</b>	Description:	<b>Inside of EQ basin levee.</b>

On June 17, 2015, a Reconnaissance Inspection was conducted to determine the status of the levee breach on the west-side of the EQ basin located at the City's wastewater treatment facility. At the time of inspection, the discharge of wastewater from the EQ Basin had been stopped. The levee appeared to be approximately eighty-five percent complete. According to Tommy Lawson, Manager, Stuttgart Municipal Waterworks, a little more dirt and compacting of the levee should finish the project.

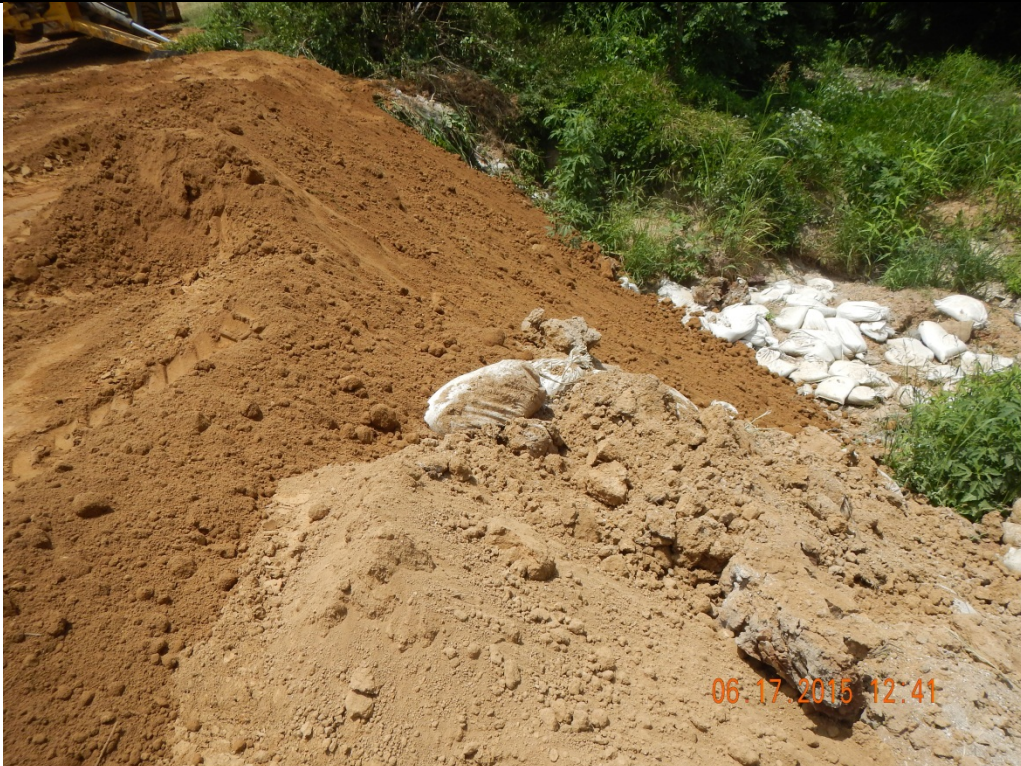
Photographer:	<b>Steven L. Henderson</b>	Date:	<b>6/17/2015</b>
Time:	<b>12:41</b>	Witness:	<b>N/A</b>
Photo #:	<b>2</b>	Description:	<b>Outside of EQ basin levee.</b>

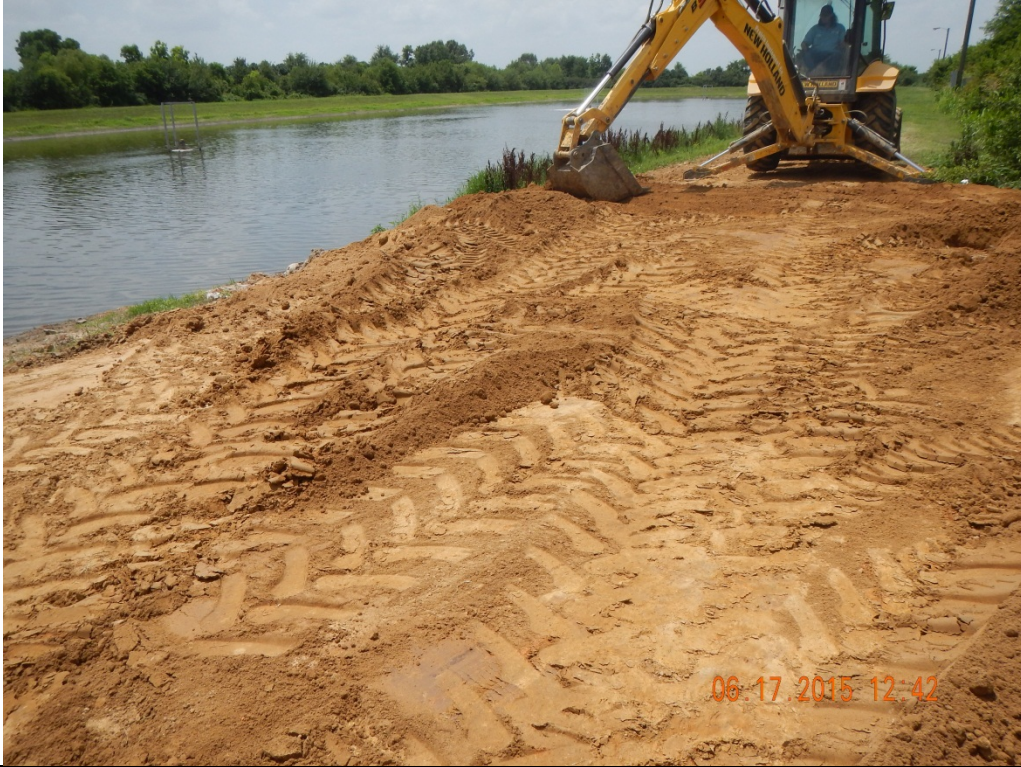
Location:	<b>City of Stuttgart WWTP-EQ Basin</b>		
Photographer:	<b>Steven L. Henderson</b>	Date:	<b>6/17/2015</b>
Time:	<b>12:42</b>	Witness:	<b>N/A</b>
Photo #:	<b>3</b>	Description:	<b>Top of EQ basin levee.</b>

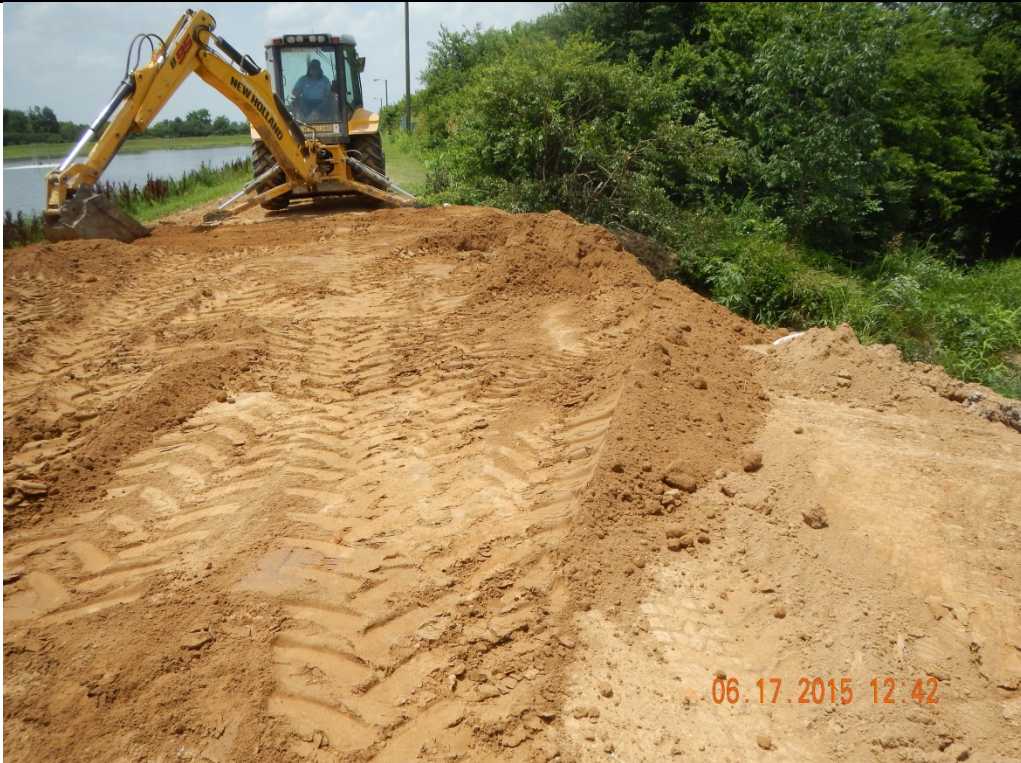
Photographer:	<b>Steven L. Henderson</b>	Date:	<b>6/17/2015</b>
Time:	<b>12:42</b>	Witness:	<b>N/A</b>
Photo #:	<b>4</b>	Description:	<b>Top of EQ basin levee.</b>
