**OFFICE OF WATER INSPECTION REPORT**

Inspection Report: **Twin Rivers Foods, Inc.**, AFIN: **66-01652**, Permit #: **AR0021750**  
**POTW Pretreatment Program**

**Industrial Site Visit**

**Office of Water Photographic Evidence Sheet**

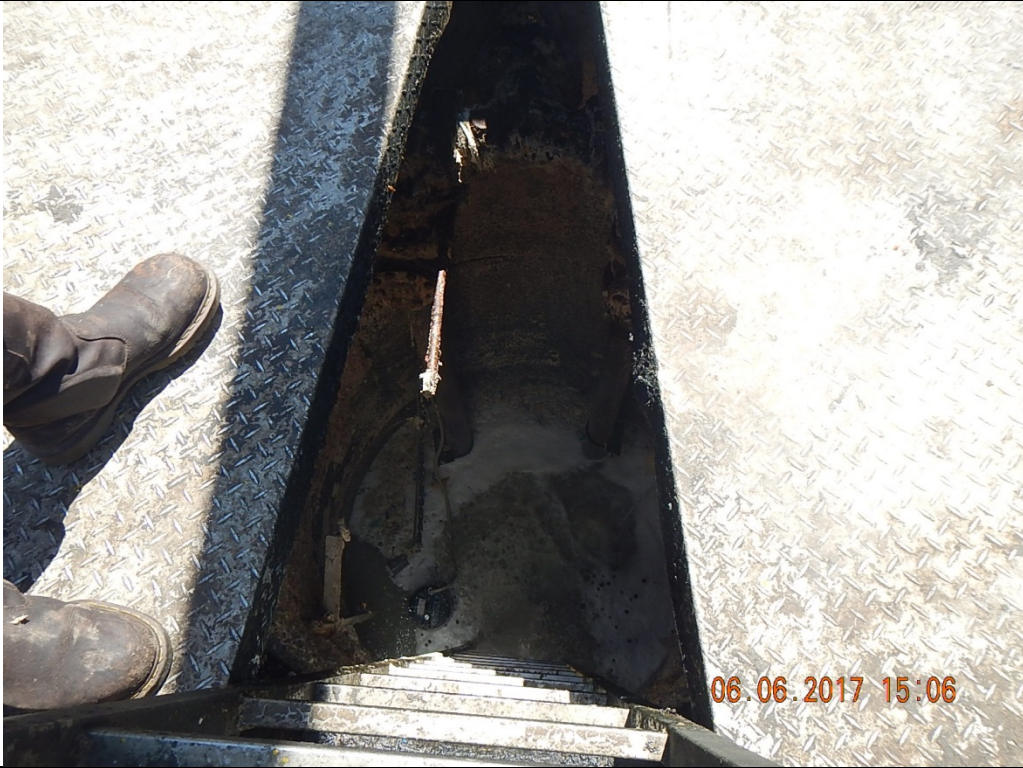
Location:	<b>Twin Rivers Foods, Inc.</b>				
Photographer:	<b>Dannielle Gray</b>	Date:	<b>6/6/2017</b>	Time:	<b>1506</b>
Witness:	<b>Kerri McCabe, John Hancock, Don Glover, Chris Cooper, Ernesto Mendoza</b>			Photo #:	<b>1</b>
Description:	<b>Process water influent</b>

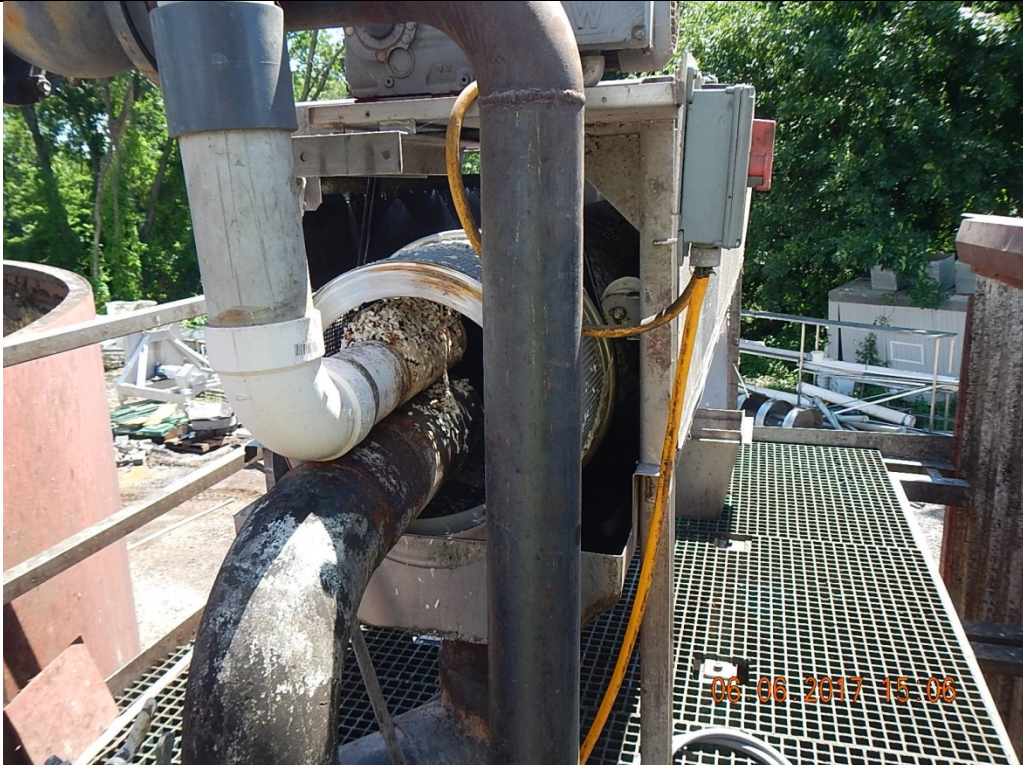
Photographer:	<b>Dannielle Gray</b>	Date:	<b>6/6/2017</b>	Time:	<b>1506</b>
Witness:	<b>Kerri McCabe, John Hancock, Don Glover, Chris Cooper, Ernesto Mendoza</b>			Photo #:	<b>2</b>
Description:	<b>Influent screening</b>

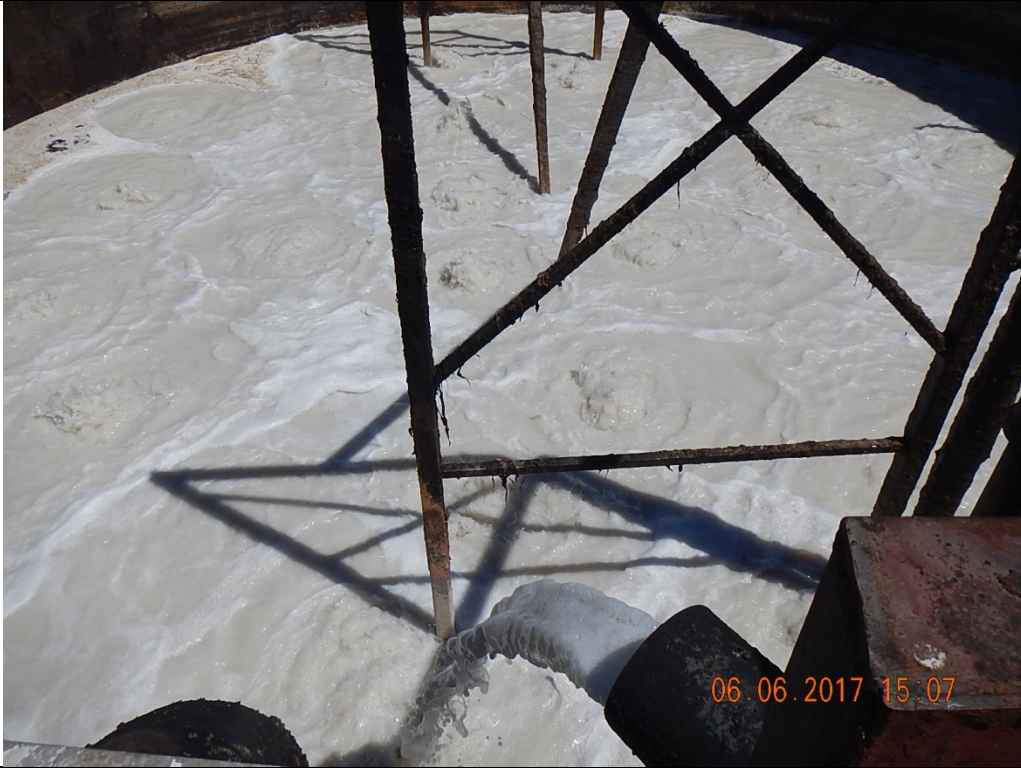
Location:	<b>Twin Rivers Foods, Inc.</b>		
Photographer:	<b>Dannielle Gray</b>	Date:	<b>6/6/2017</b>
Witness:	<b>Kerri McCabe, John Hancock, Don Glover, Chris Cooper, Ernesto Mendoza</b>	Time:	<b>1507</b>
Description:	<b>Combined equalization tank and aeration tank; lime injection occurs here as well.</b>

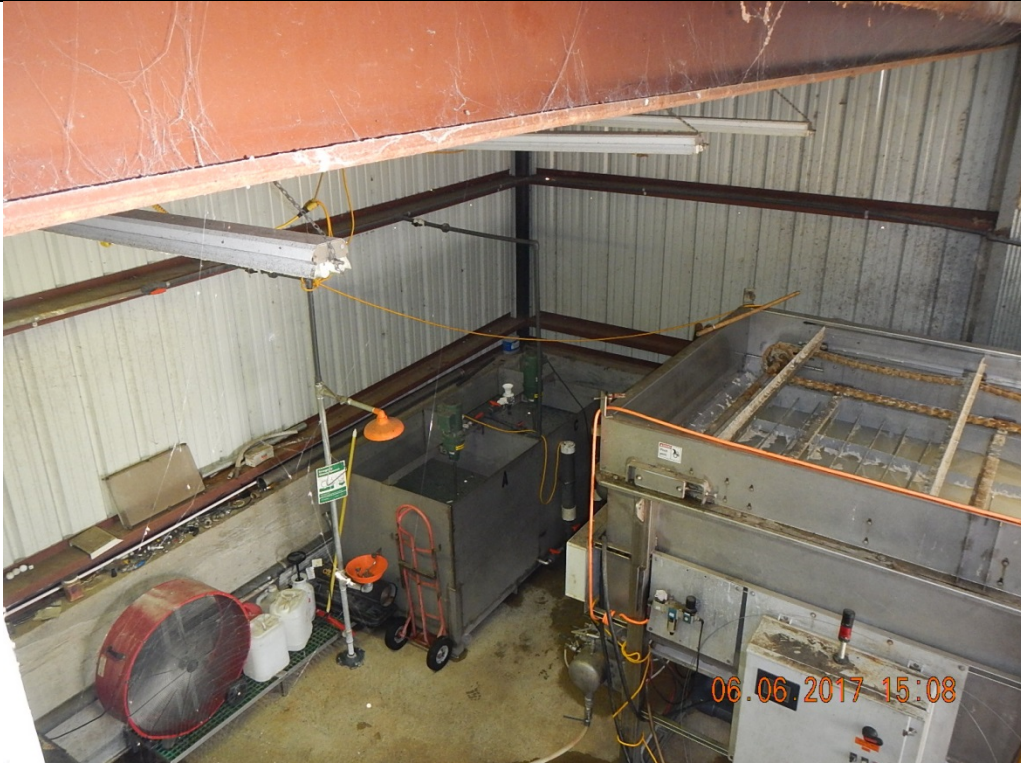
Photographer:	<b>Dannielle Gray</b>	Date:	<b>6/6/2017</b>
Witness:	<b>Kerri McCabe, John Hancock, Don Glover, Chris Cooper, Ernesto Mendoza</b>	Time:	<b>1508</b>
Description:	<b>Ionic and cationic mixing tank (photo center; silver tank by eye wash station).</b>

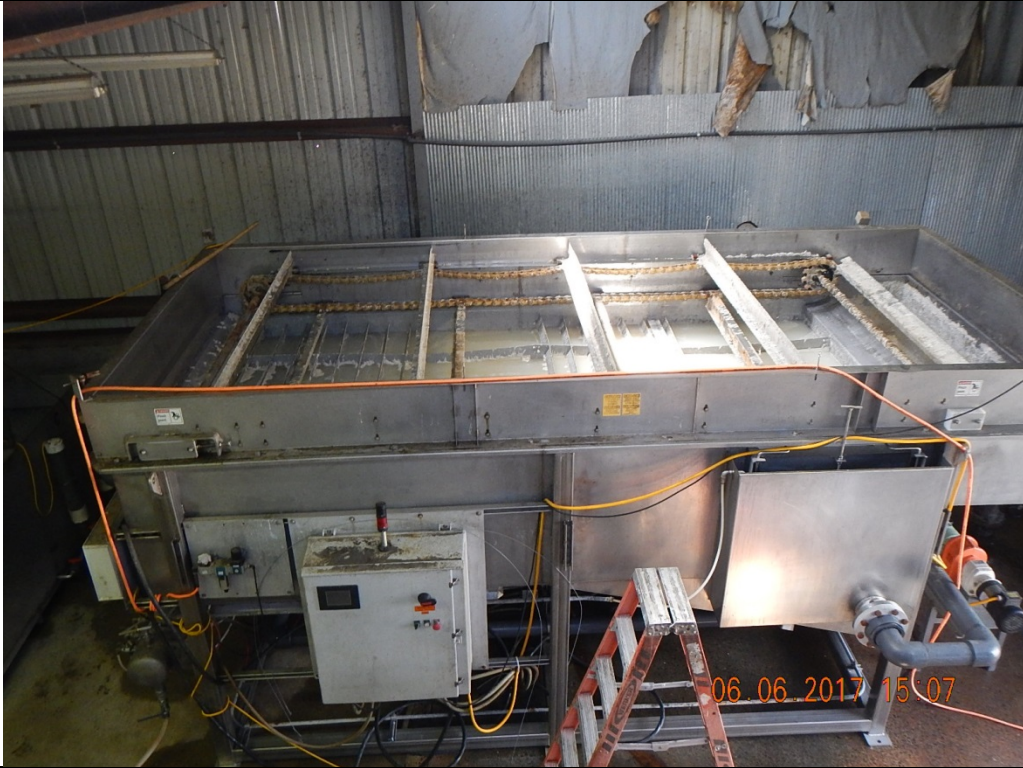
Location:	<b>Twin Rivers Foods, Inc.</b>		
Photographer:	<b>Dannielle Gray</b>	Date:	<b>6/6/2017</b>
Witness:	<b>Kerri McCabe, John Hancock, Don Glover, Chris Cooper, Ernesto Mendoza</b>	Time:	<b>1507</b>
Description:	<b>DAF Unit</b>	Photo #:	<b>5</b>

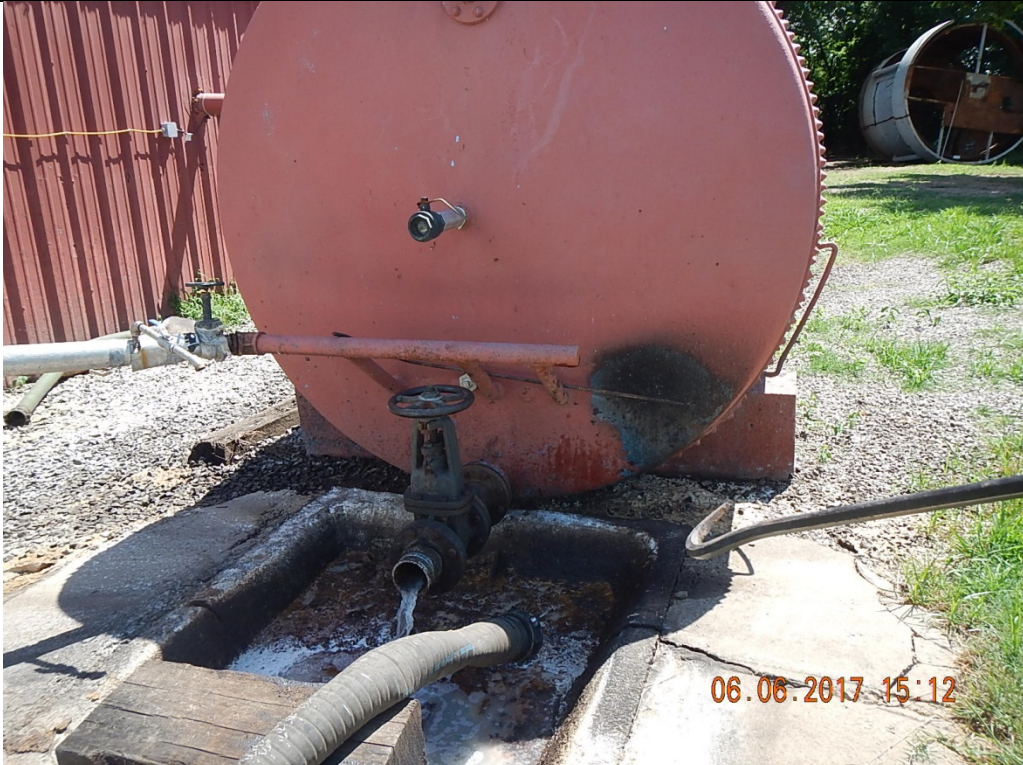
Photographer:	<b>Dannielle Gray</b>	Date:	<b>6/6/2017</b>
Witness:	<b>Kerri McCabe, John Hancock, Don Glover, Chris Cooper, Ernesto Mendoza</b>	Time:	<b>1512</b>
Description:	<b>Sludge collection tank; sludge is hauled away and land applied by contractor.</b>

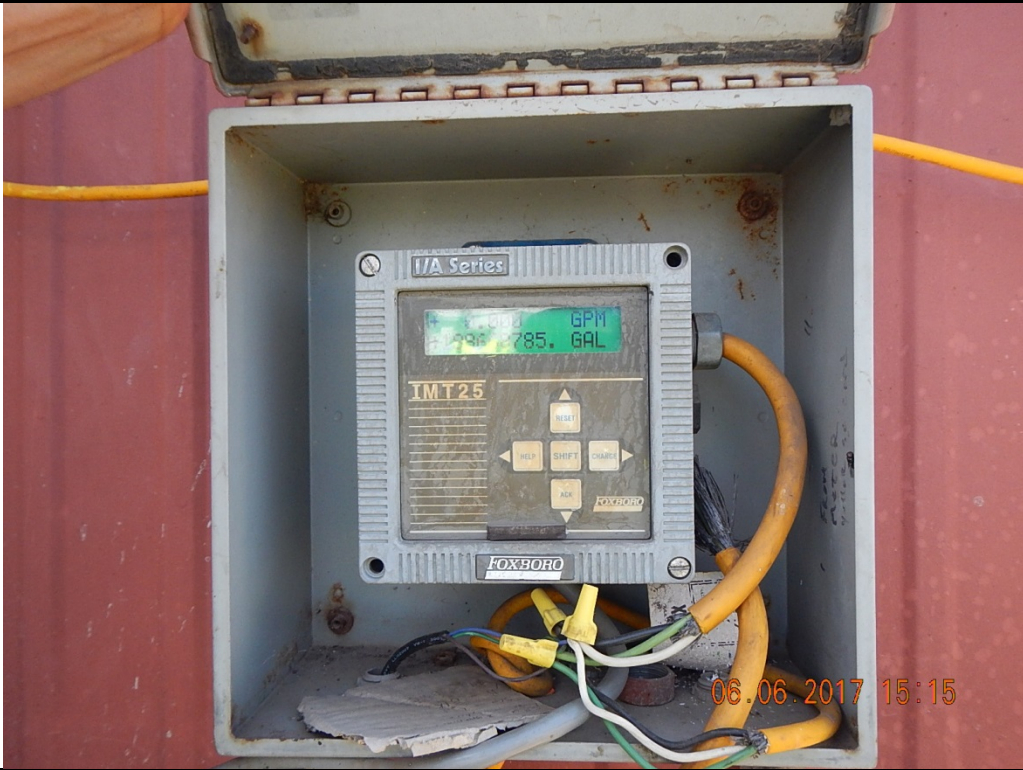
Location:	<b>Twin Rivers Foods, Inc.</b>		
Photographer:	<b>Dannielle Gray</b>	Date:	<b>6/6/2017</b>
Witness:	<b>Kerri McCabe, John Hancock, Don Glover, Chris Cooper, Ernesto Mendoza</b>	Time:	<b>1515</b>
Description:	<b>Flowmeter</b>	Photo #:	<b>7</b>

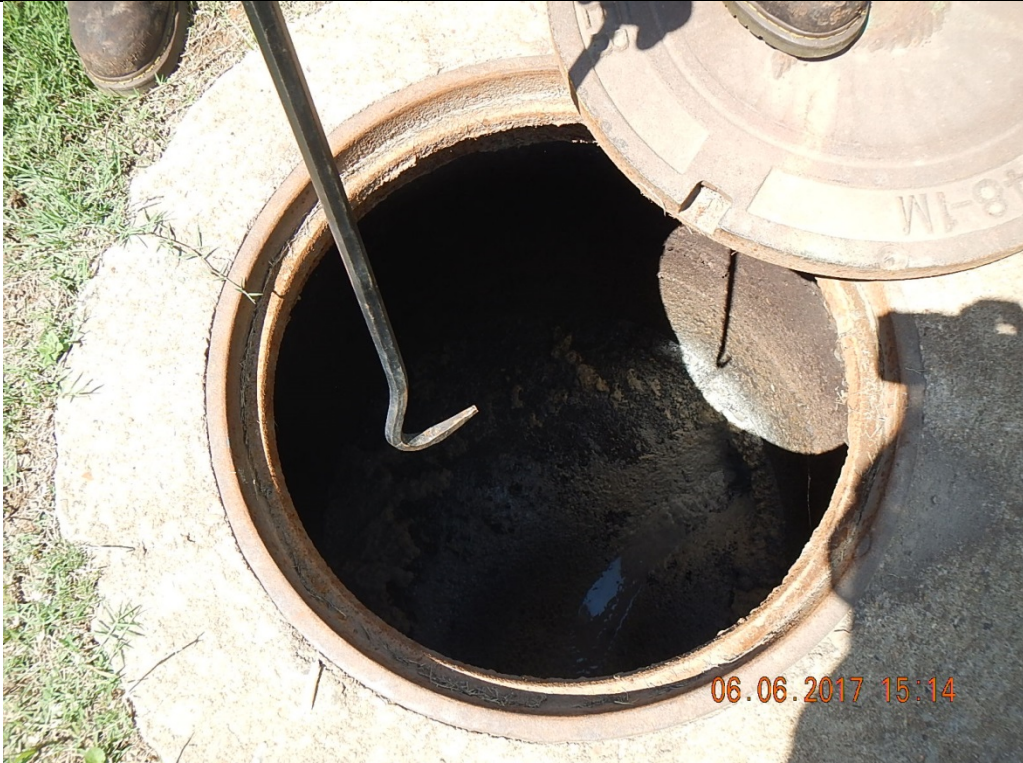
**Additional Comments:** The treatment plant is in disrepair. Further, a lime coating was noted in the outfall surrounding the flow channel. The Operator informed that this is the result of lime injected into the wastewater at headworks that is not being adequately removed prior to discharge. This facility is in "Non-Compliant" status with the POTW. The City has issued an AO and has given them a three year compliance schedule for completion of a corrective action plan. This compliance schedule is outlined in the IU's current permit and was reviewed during inspection.

Photographer:	<b>Dannielle Gray</b>	Date:	<b>6/6/2017</b>
Witness:	<b>Kerri McCabe, John Hancock, Don Glover, Chris Cooper, Ernesto Mendoza</b>	Time:	<b>1514</b>
Description:	<b>Outfall and monitoring location. Note lime buildup on flow channel.</b>

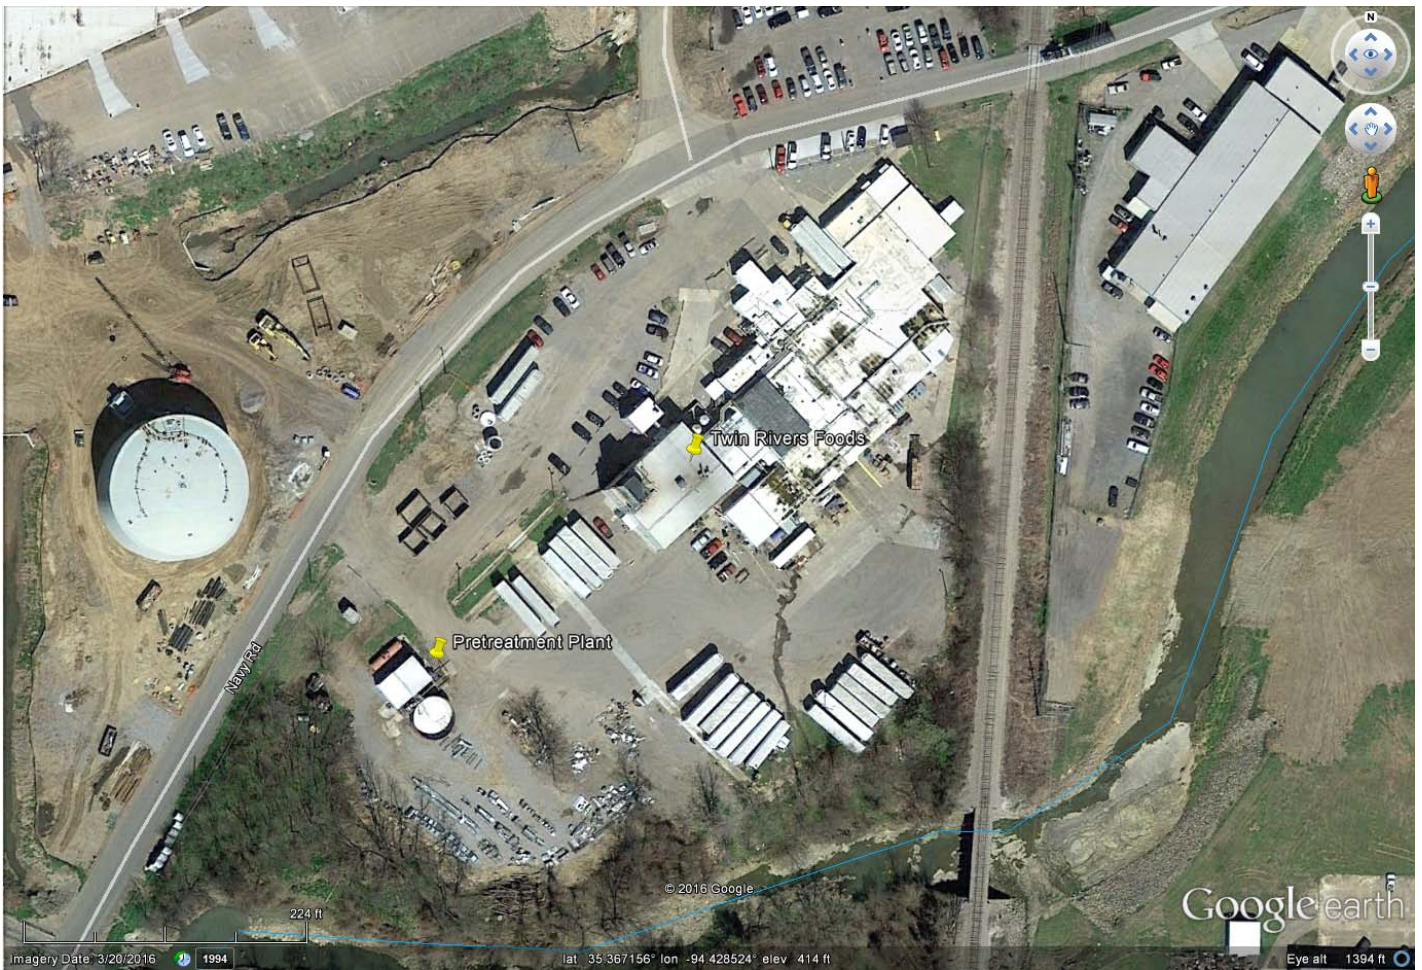
Figure 1. Google Earth image dated March 20, 2016 showing facility overview and pretreatment plant location.
