**RE: City of Stuttgart WWTP Inspections (Arkansas Co.)**  
**AFIN: 01-00214** **NPDES Permit No.: AR0034380**  
**ARR000670**

## WATER DIVISION INSPECTION REPORT

FACILITY INFORMATION	INSPECTION INFORMATION
NAME: <b>City of Stuttgart WWTP</b> LOCATION: <b>10<sup>th</sup> Street Extension West</b> CITY: <b>Stuttgart, AR 72160</b>	FACILITY TYPE: <b>1 - Municipal</b> INSPECTOR ID#: <b>26075 S - State</b> FACILITY EVALUATION RATING: <b>1 - Unsatisfactory</b> INSPECTION TYPE: <b>Reconnaissance</b>
	DATE(S): <b>2/1/2018</b> ENTRY TIME: <b>10:00</b> EXIT TIME: <b>11:00</b> PERMIT EFFECTIVE DATE: <b>2/1/2015</b> PERMIT EXPIRATION DATE: <b>1/31/2020</b>
RESPONSIBLE OFFICIAL	
NAME / TITLE: <b>Tommy Lawson, / Water Utilities Manager</b> COMPANY: <b>City of Stuttgart</b> MAILING ADDRESS: <b>P.O. Box 130</b> CITY, STATE, ZIP: <b>Stuttgart, AR 72160</b> PHONE & EXT. / FAX: <b>870-673- 3246 / 870-674-7115</b> EMAIL: <b>stuttgartarwater@centurytel.net</b>	FAYETTEVILLE SHALE RELATED: <b>N</b> FAYETTEVILLE SHALE VIOLATIONS: <b>N</b>
CONTACTED DURING INSPECTION: <b>Yes</b>	INSPECTION PARTICIPANTS

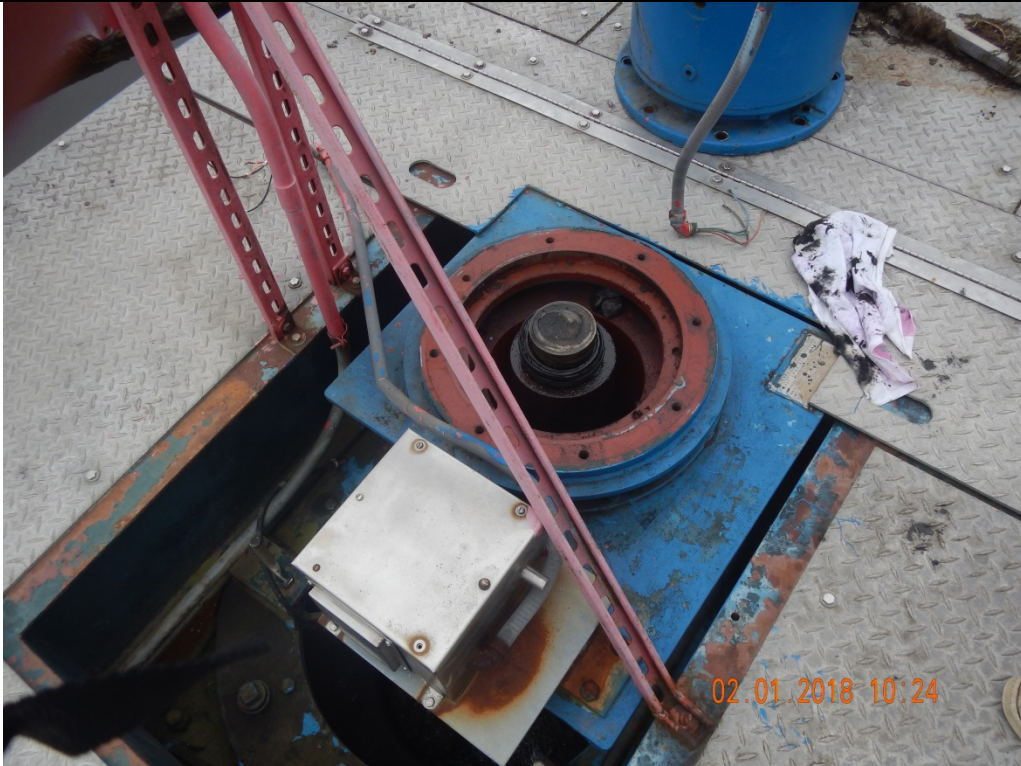
Location:	<b>City of Stuttgart WWTP (Arkansas Co.)</b>		
Photographer:	<b>Steven L. Henderson</b>	Date:	<b>2/1/2018</b>
Witness:	<b>N/A</b>	Time:	<b>10:24</b>
		Photo #:	<b>1</b>
Description:	<b>Final Clarifier with broken shaft.</b>

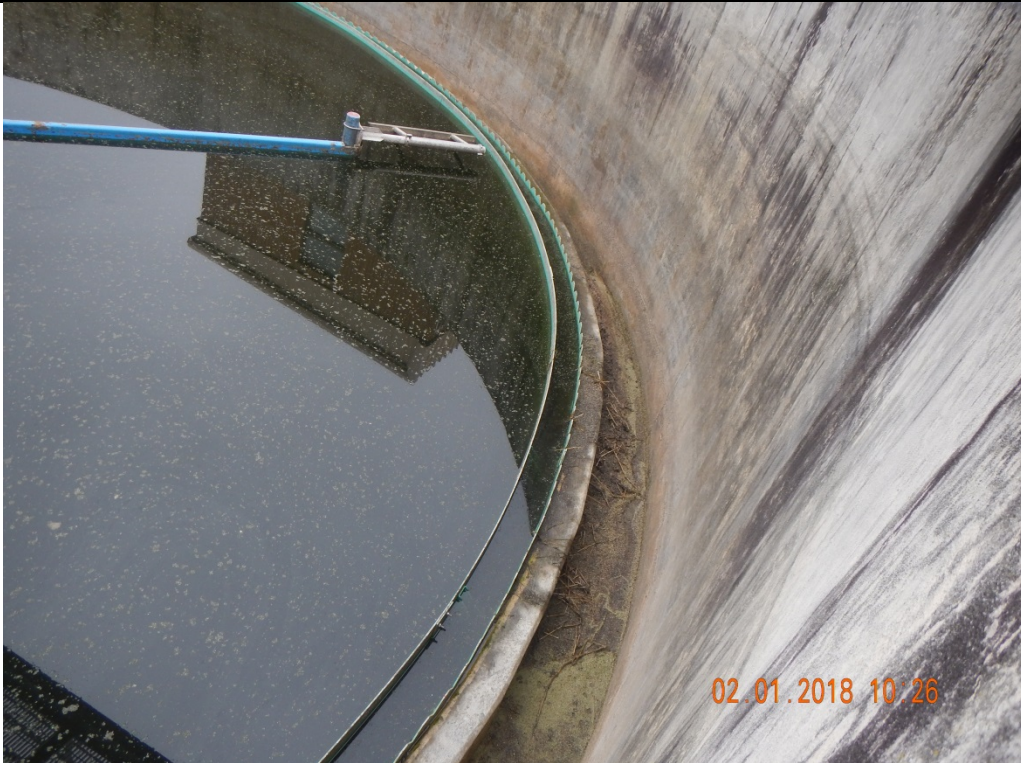
- 2. Part III, Section B, 1, A; Inadequate Operation and Maintenance.** Specifically, the facility has two pumps down at the head of the plant causing the diversion of influent to the EQ Basin. Two Intermittent Clarifiers and two Final Clarifiers are still not in operation and are in need of cleaning. This is a REPEAT violation.

Photographer:	<b>Steven L. Henderson</b>	Date:	<b>2/1/2018</b>
Witness:	<b>N/A</b>	Time:	<b>10:26</b>
		Photo #:	<b>2</b>
Description:	<b>Intermittent Clarifier not in operation; needs cleaning.</b>

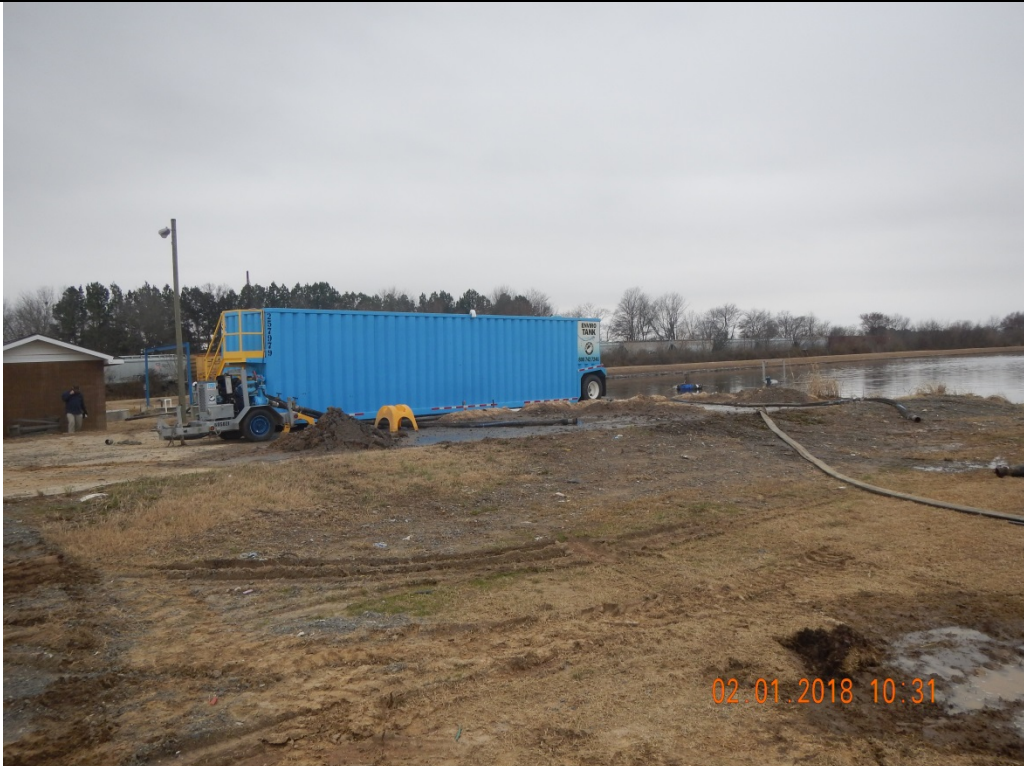
- 1. Part I, Section A: Unauthorized Discharge.** The facility is only permitted to discharge from Outfall 001. According to management, the facility discharged from the EQ Basin from Jan 22, 2018 until Feb 1, 2018. This is a REPEAT violation.

According to facility management, equipment failure has caused the diversion of a large amount of influent to the EQ Basin. The EQ Basin filled to capacity and there were concerns of levee failure. The facility began discharging from the EQ Basin directly into the adjacent drainage ditch (downstream of the permitted outfall) on Jan 22, 2018 until Feb 1, 2018. The facility has no timeframe for equipment repairs.

Location:	<b>City of Stuttgart WWTP (Arkansas Co.)</b>		
Photographer:	<b>Steven L. Henderson</b>	Date:	<b>2/1/2018</b>
Time:	<b>10:31</b>	Witness:	<b>N/A</b>
Photo #:	<b>3</b>	Description:	<b>Evidence of unpermitted discharge from the EQ Basin.</b>

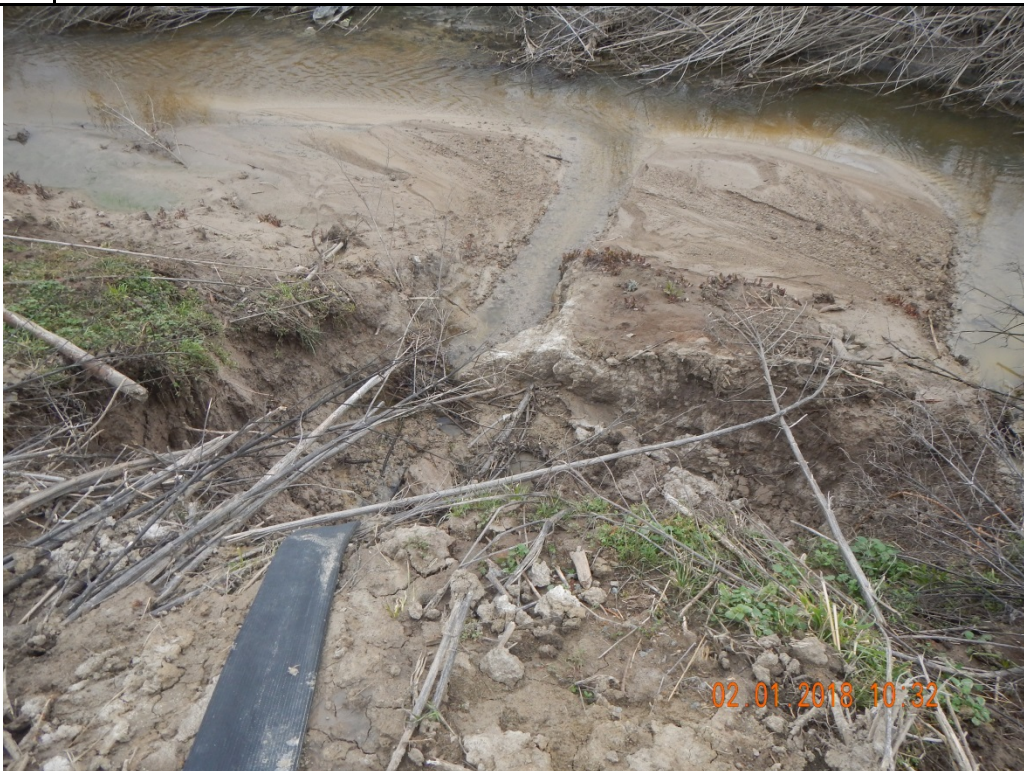
Photographer:	<b>Steven L. Henderson</b>	Date:	<b>2/1/2018</b>
Time:	<b>10:32</b>	Witness:	<b>N/A</b>
Photo #:	<b>4</b>	Description:	<b>Evidence of an unpermitted discharge from EQ Basin into the adjacent drainage ditch.</b>
