RE: Springdale POTW Inspection
AFIN: 72-00003 Permit No.: AR0022063

OFFICE OF WATER QUALITY INSPECTION REPORT

RE: Inspection Report: Springdale Collection System, AFIN: 72-00003, Permit #: AR0022063

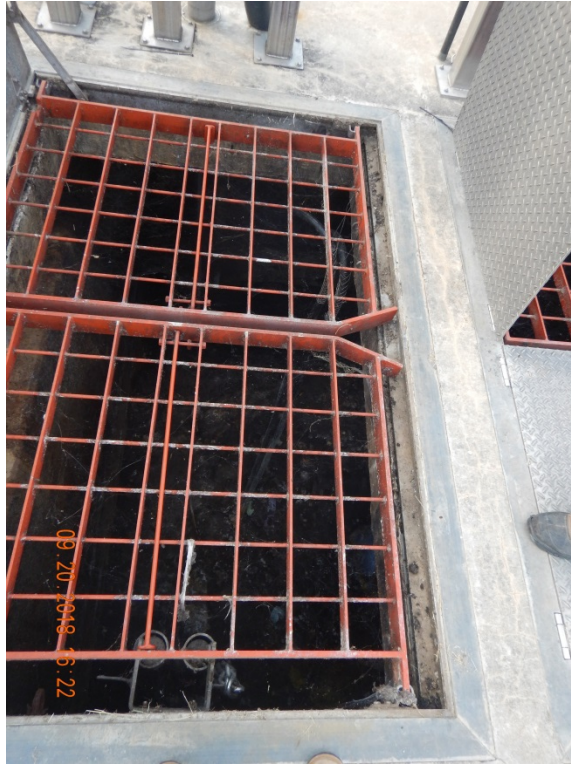
- The north wet well at the Robinson Lift Station contained large amounts of grease and solids (Photo #1). This is a violation of Part II, Section B.1.a of the permit. Mr. Selby and Mr. Dorman stated that this lift station is cleaned several times a year to remove grease build-up.

Location:	Springdale POTW				
Photographer:	Garrett Grimes, District 1 Inspector	Date:	9/20/2018	Time:	16:22
Witness:				Photo #:	1
Description:	Robinson Lift Station wet well with grease build up and solids.

1. The utility maintains a contract with Environmental Works, Inc. to perform regular lift station wet well cleaning. Wet well cleaning is performed on an as-needed basis as identified by field staff. The cleaning of this wet well was previously scheduled as field staff identified the need to clean the wet well prior to your inspection. Environmental Works, Inc. cleaned the wet well on 10/09/2018. Photos, taken on 10/23/2018, are attached to this letter that indicate the wet well was recently cleaned.

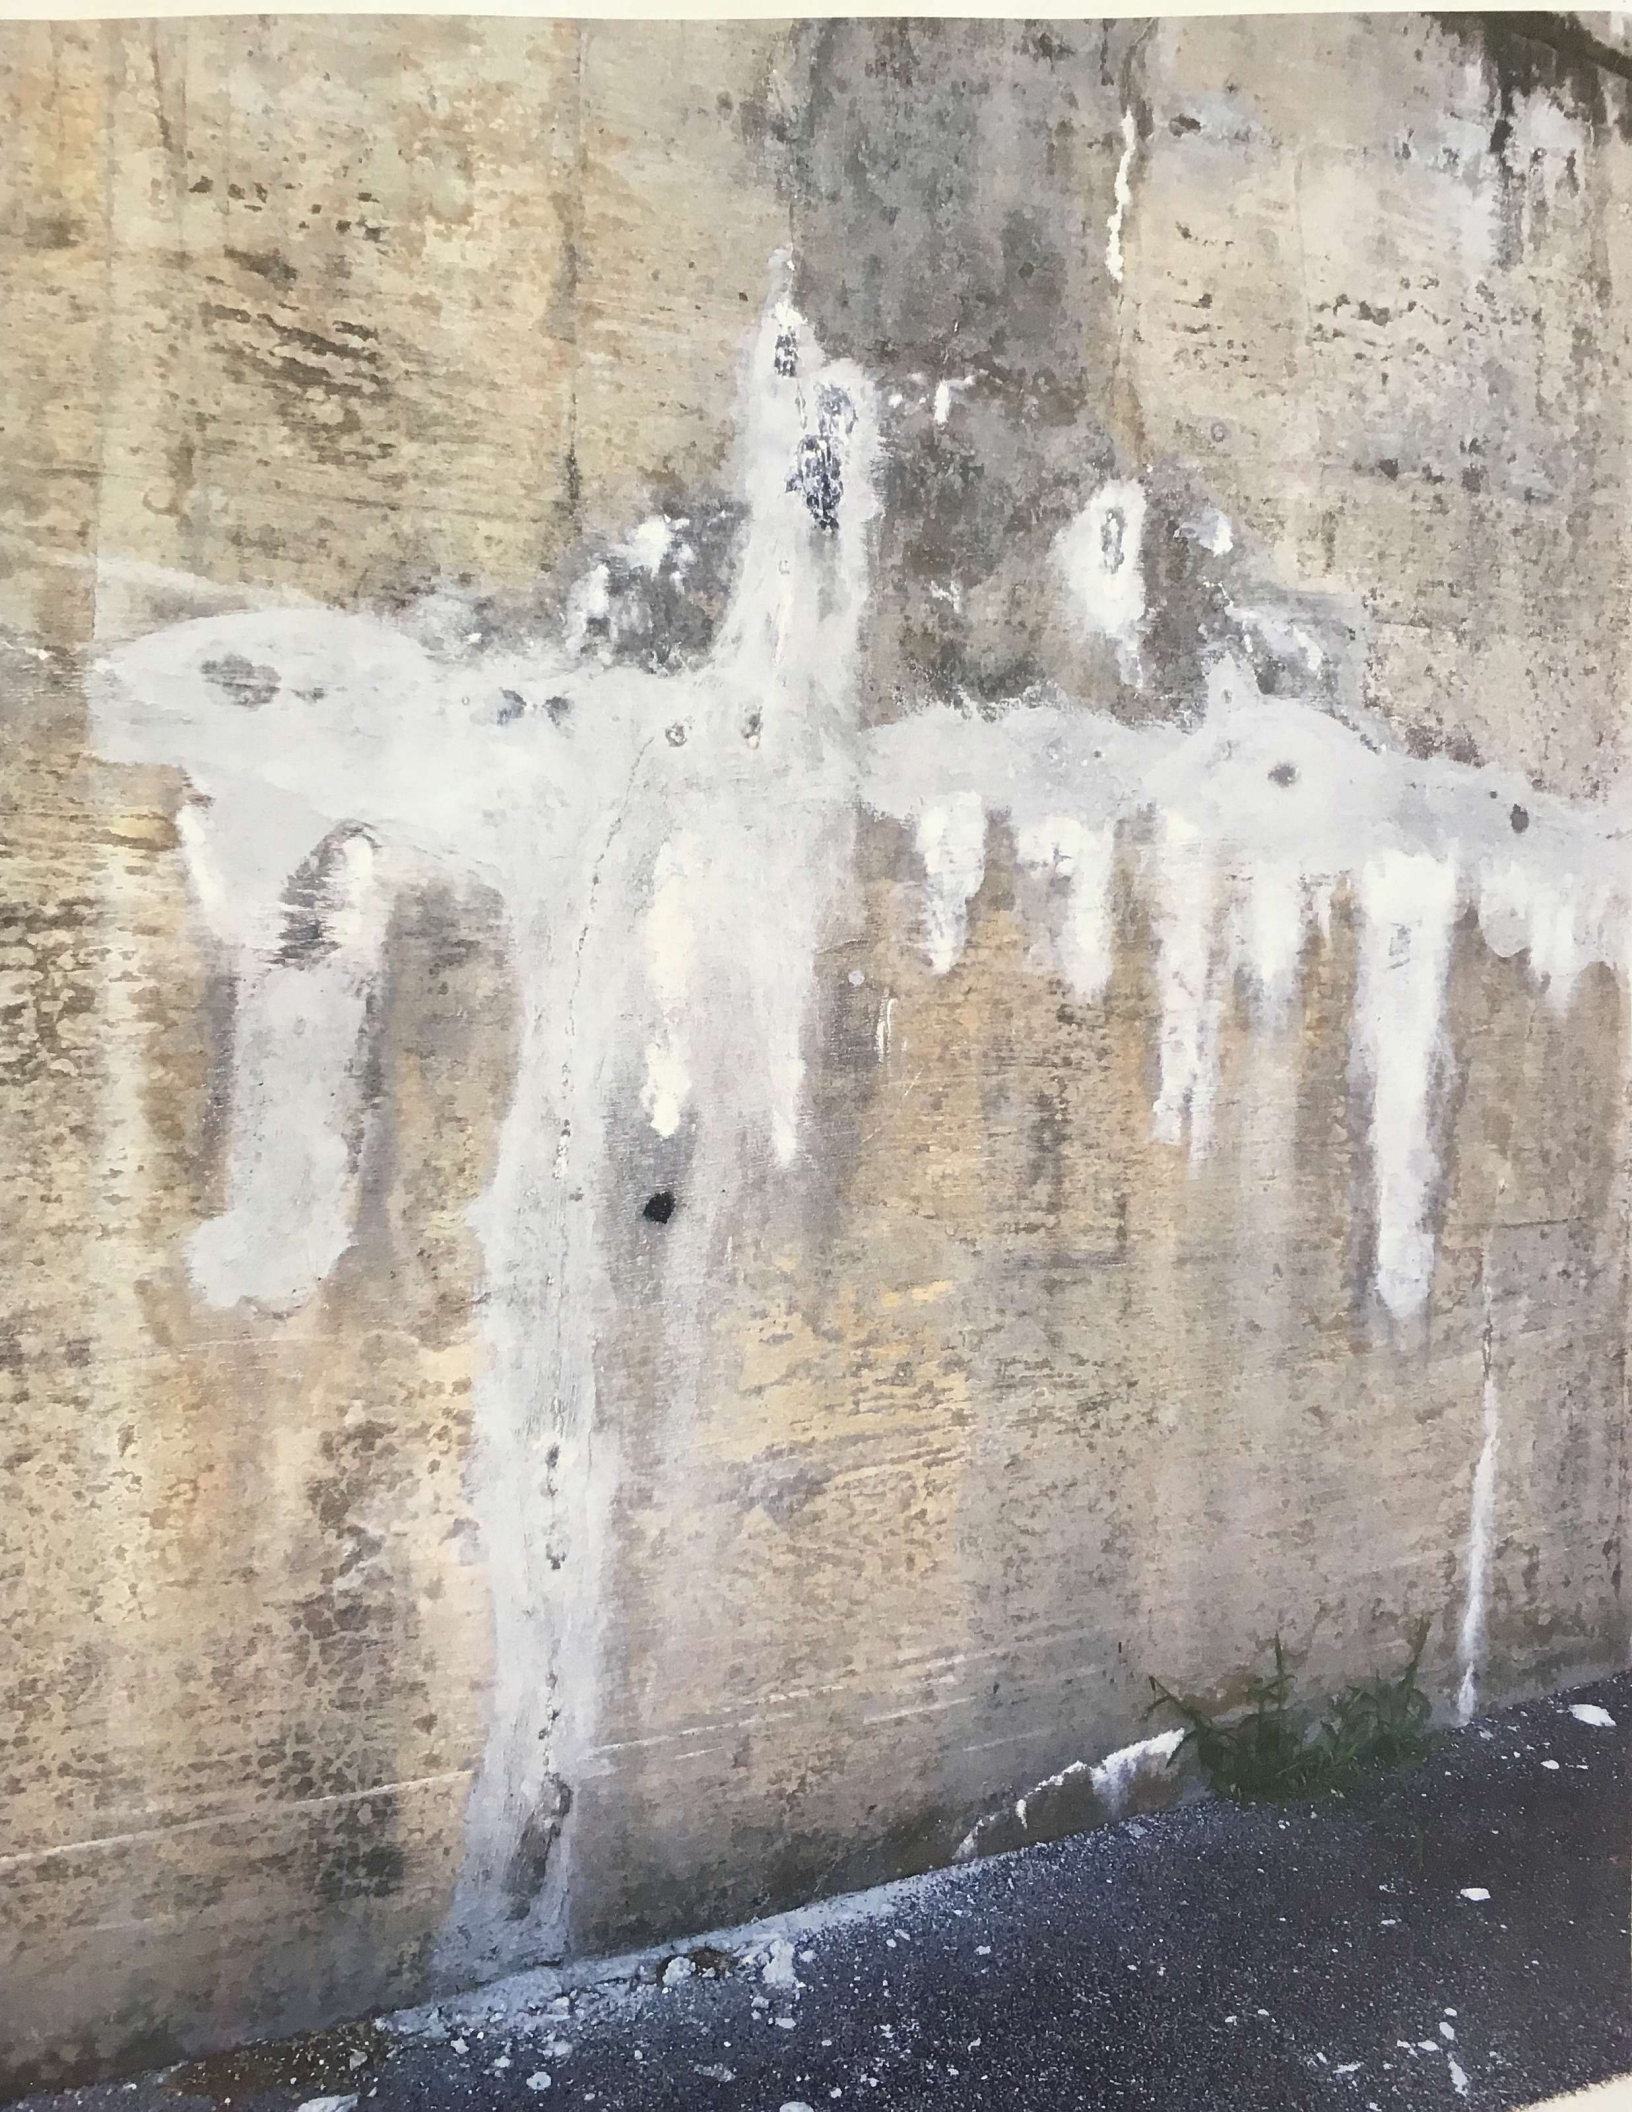
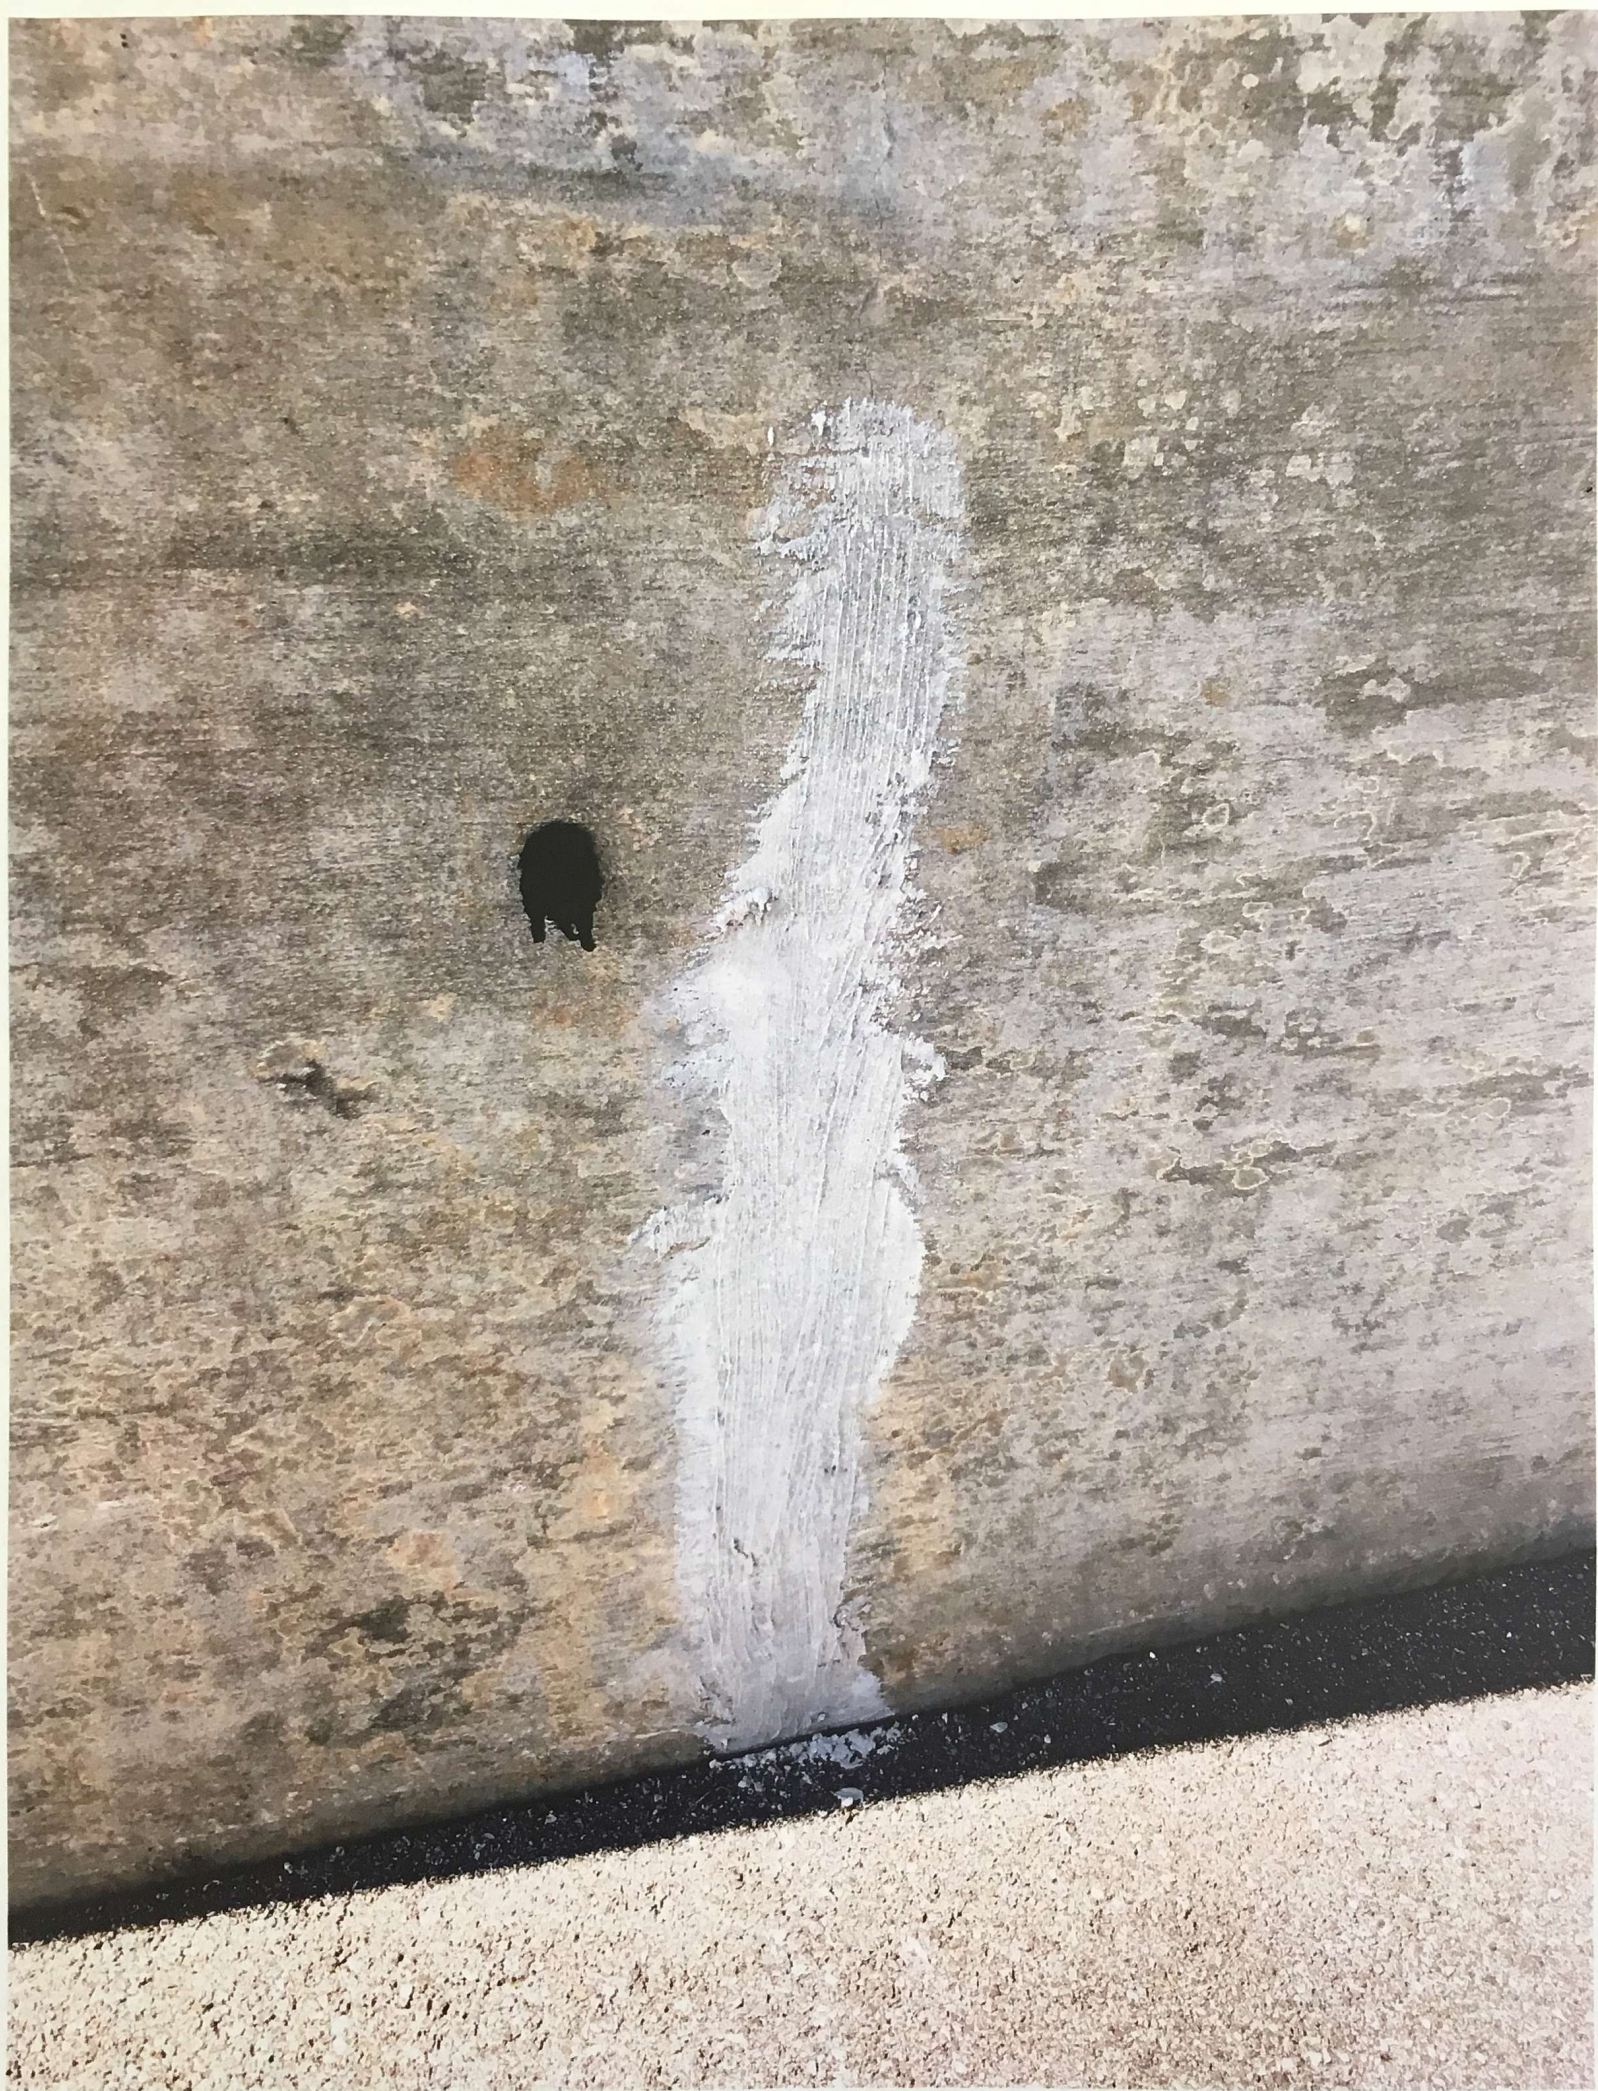
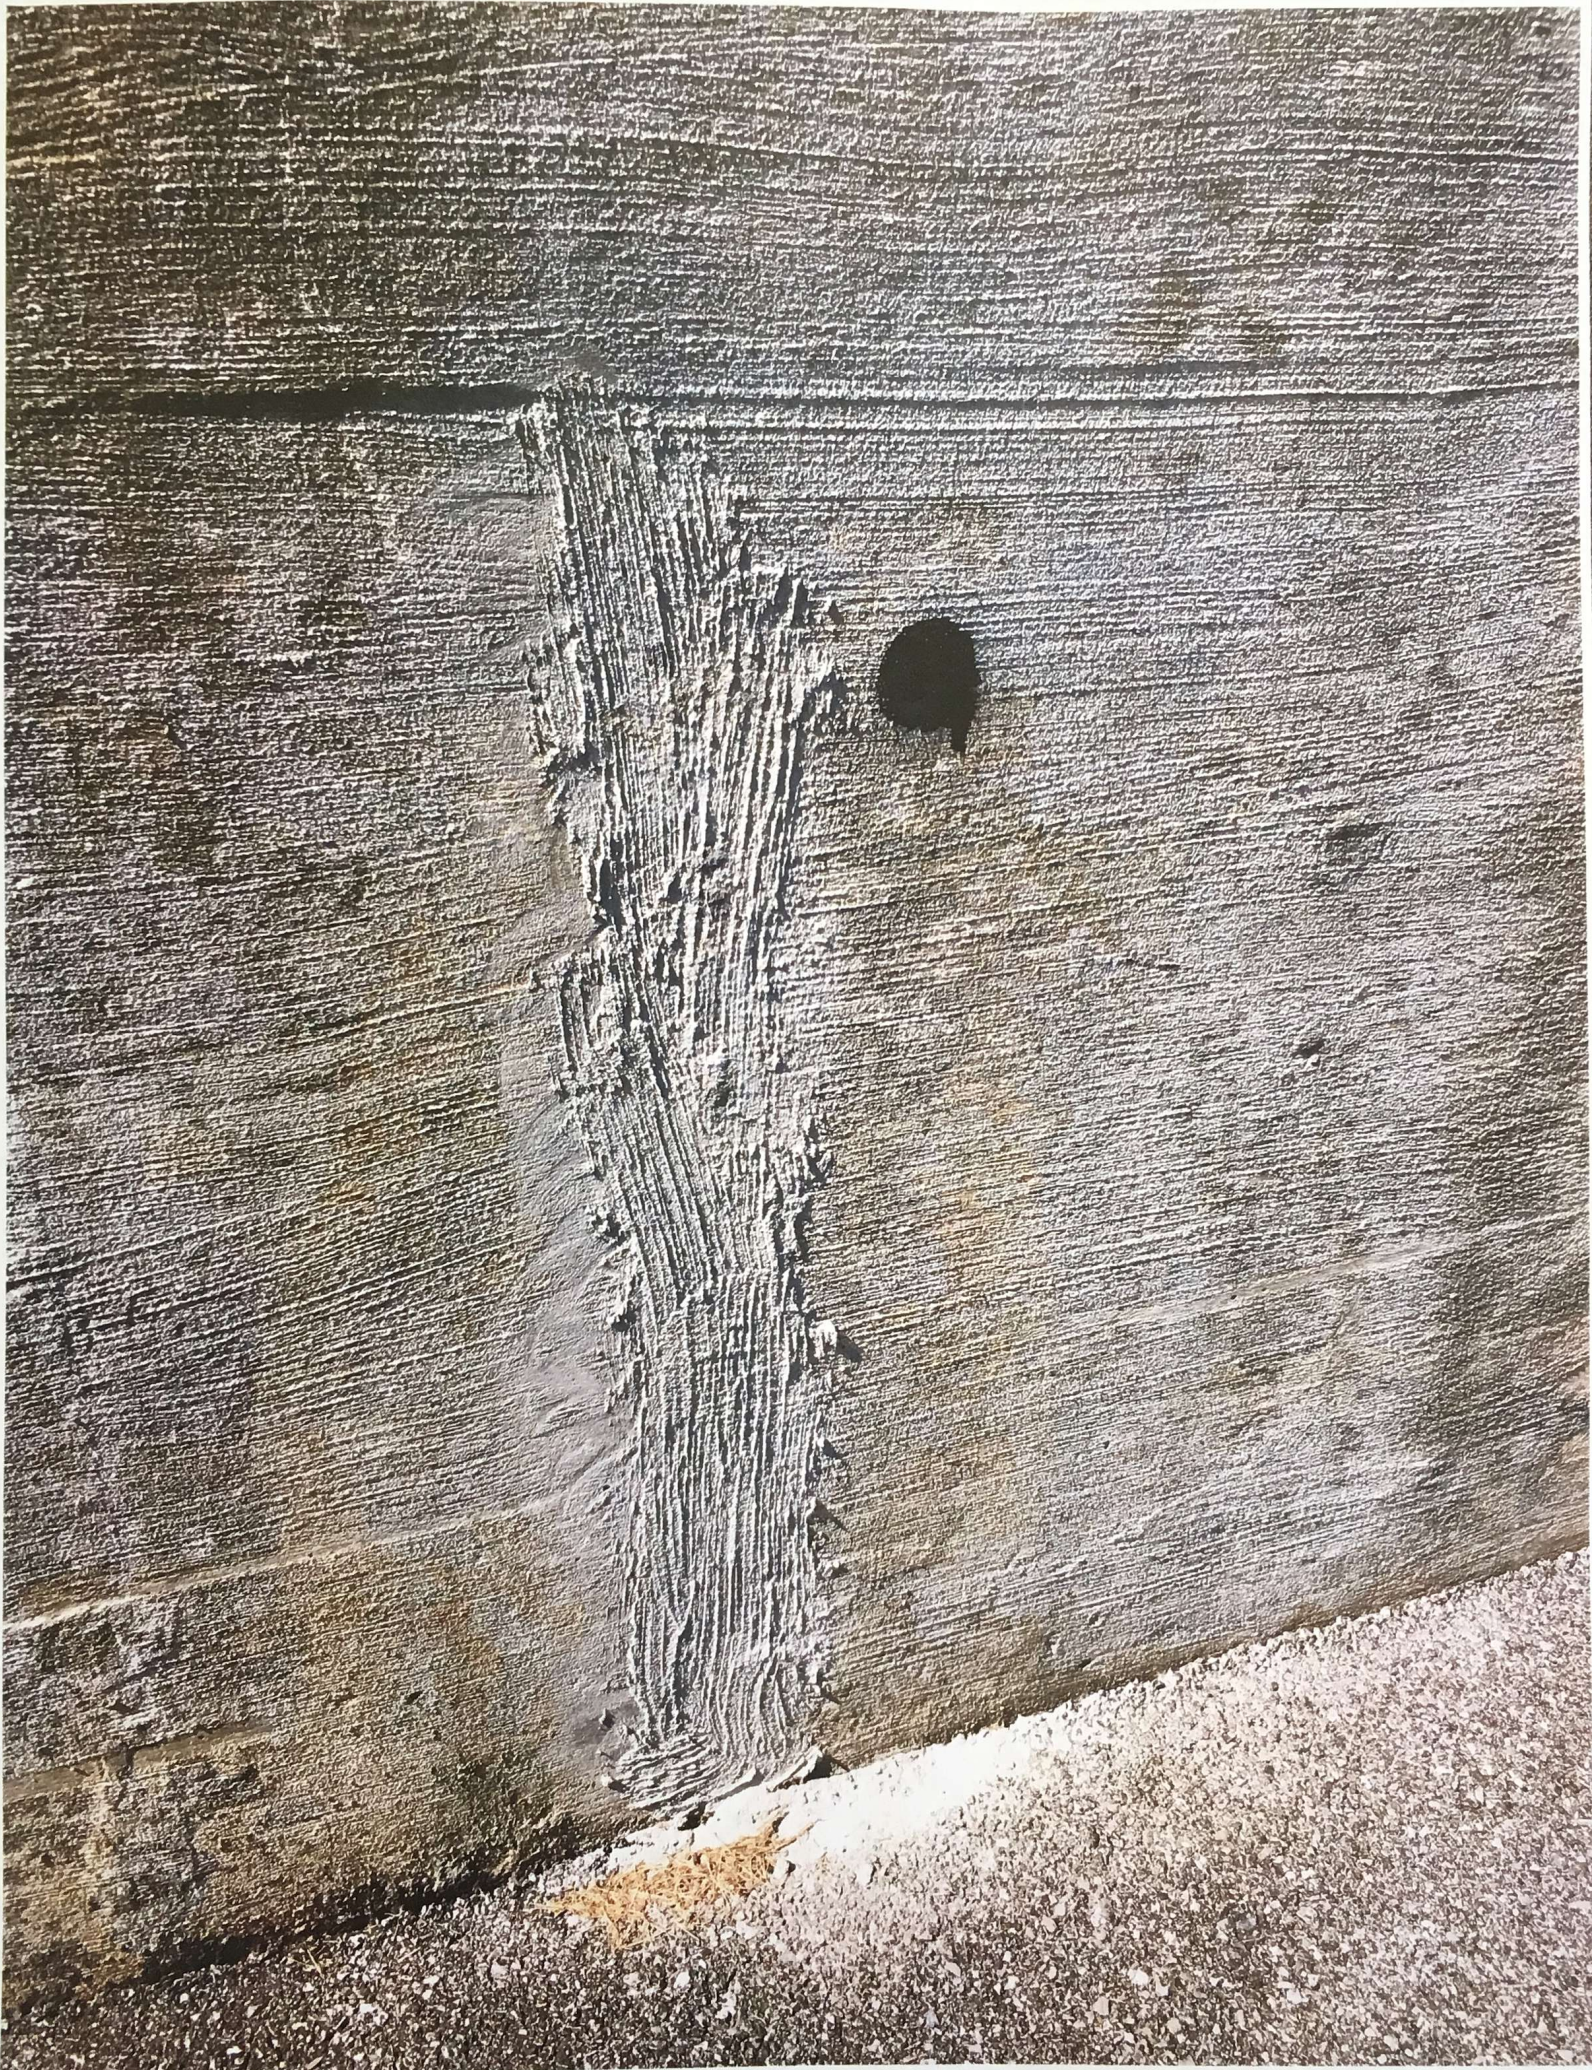
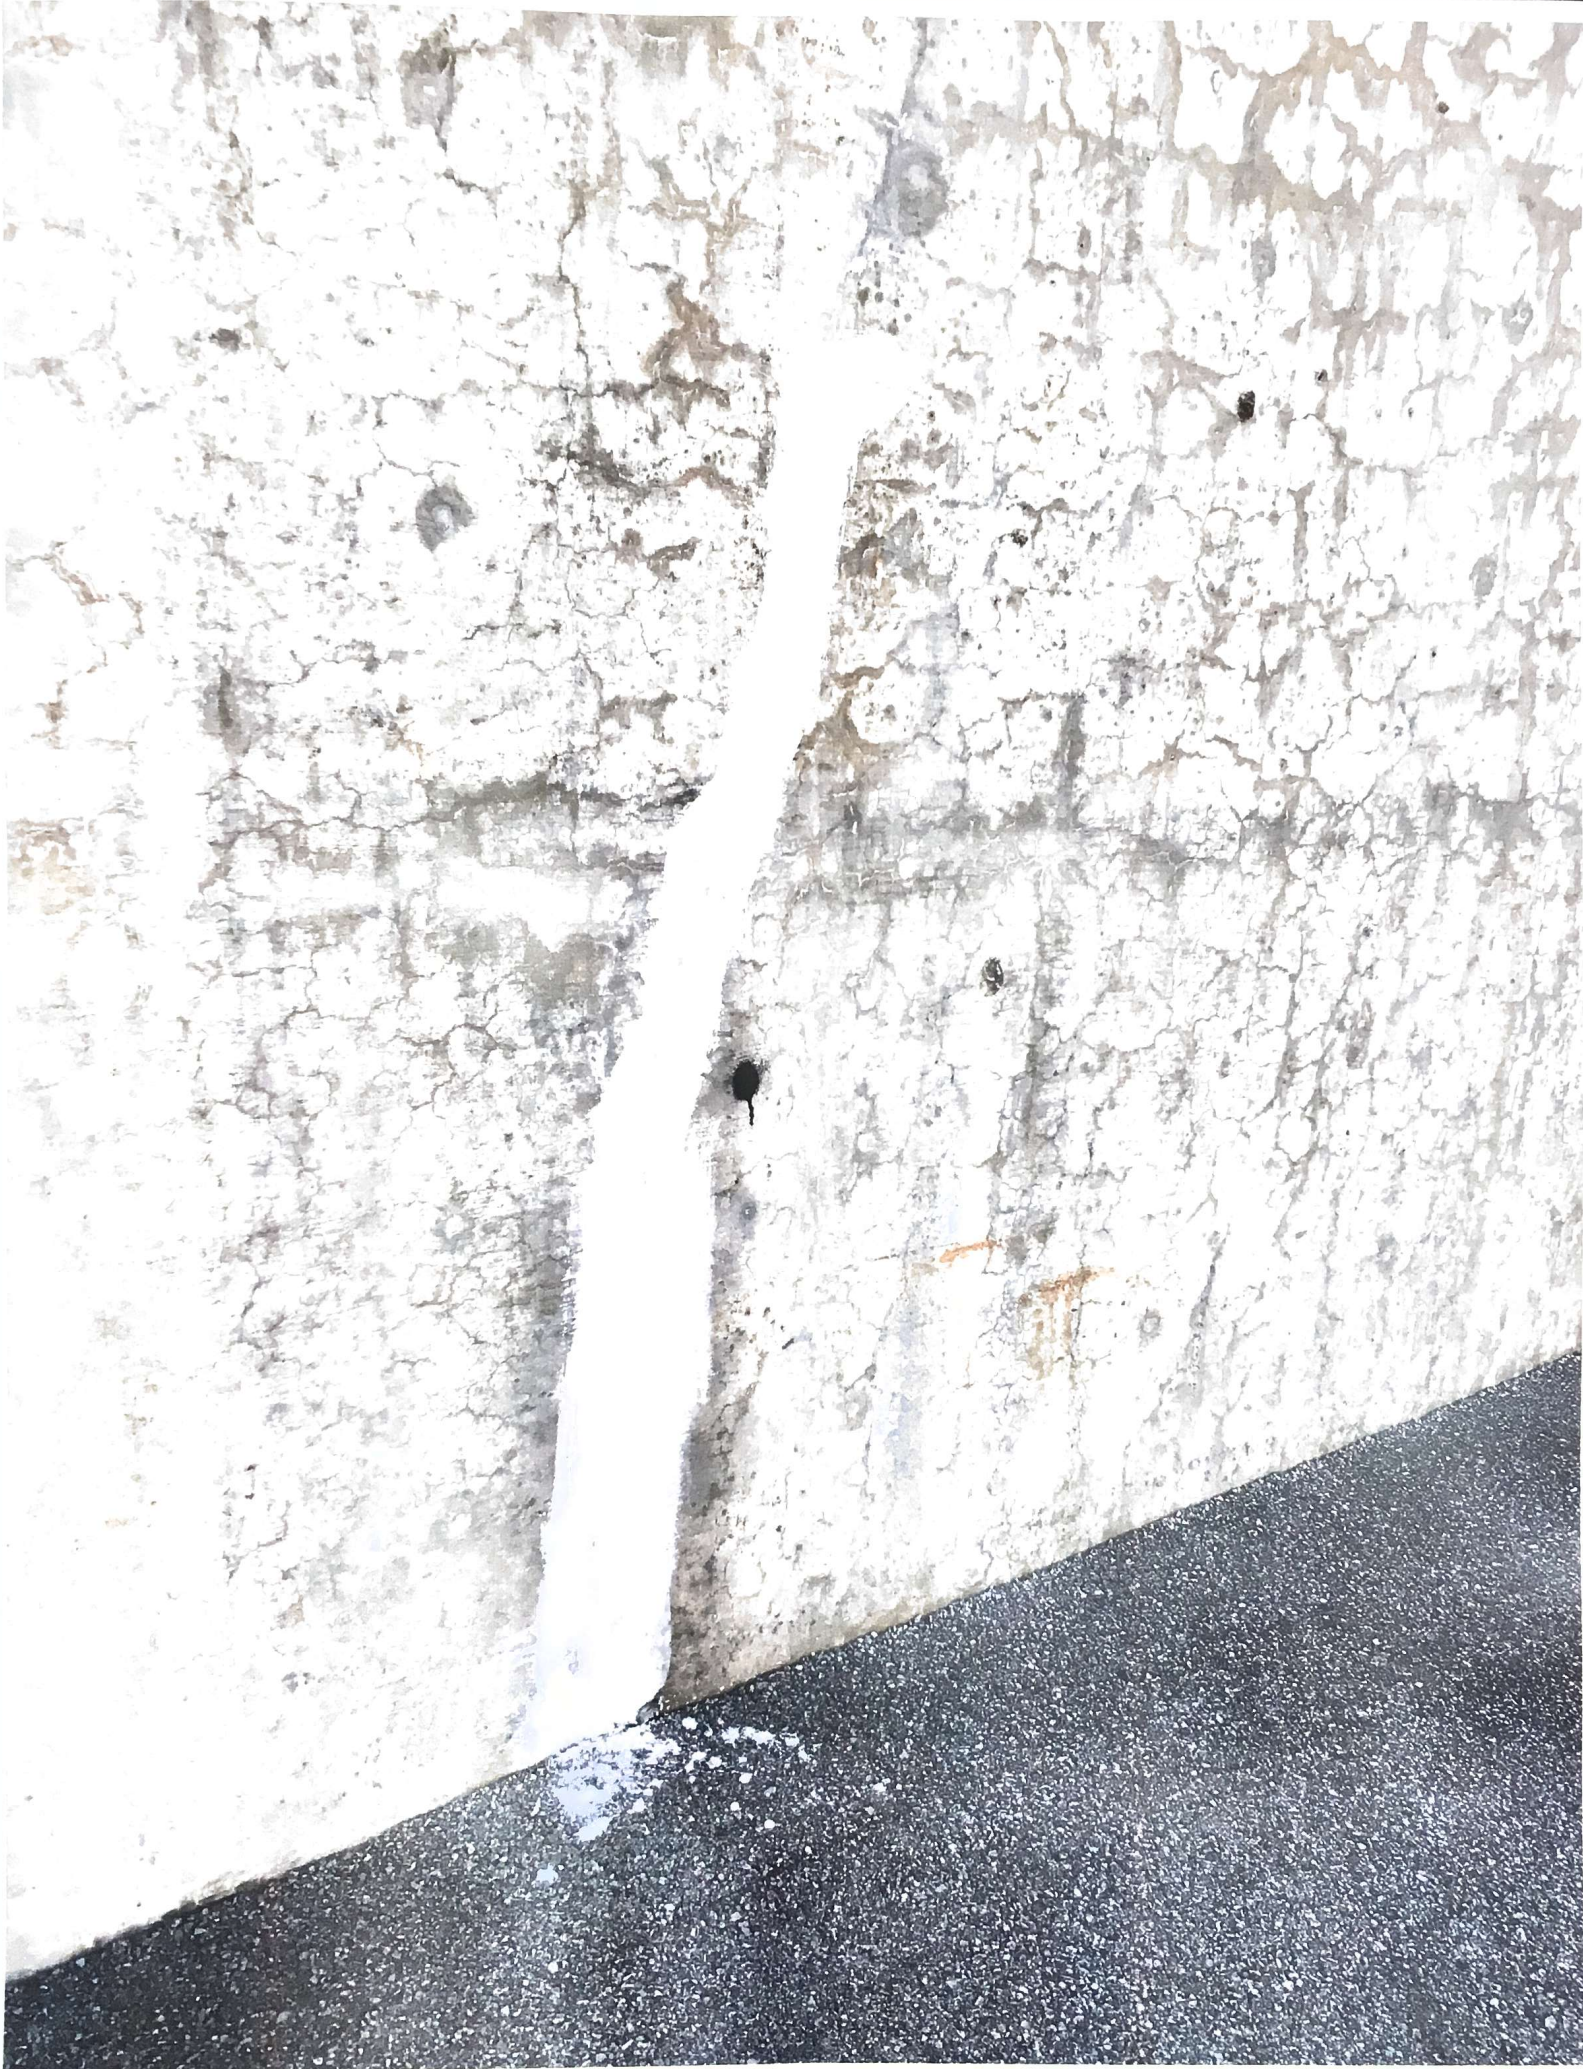
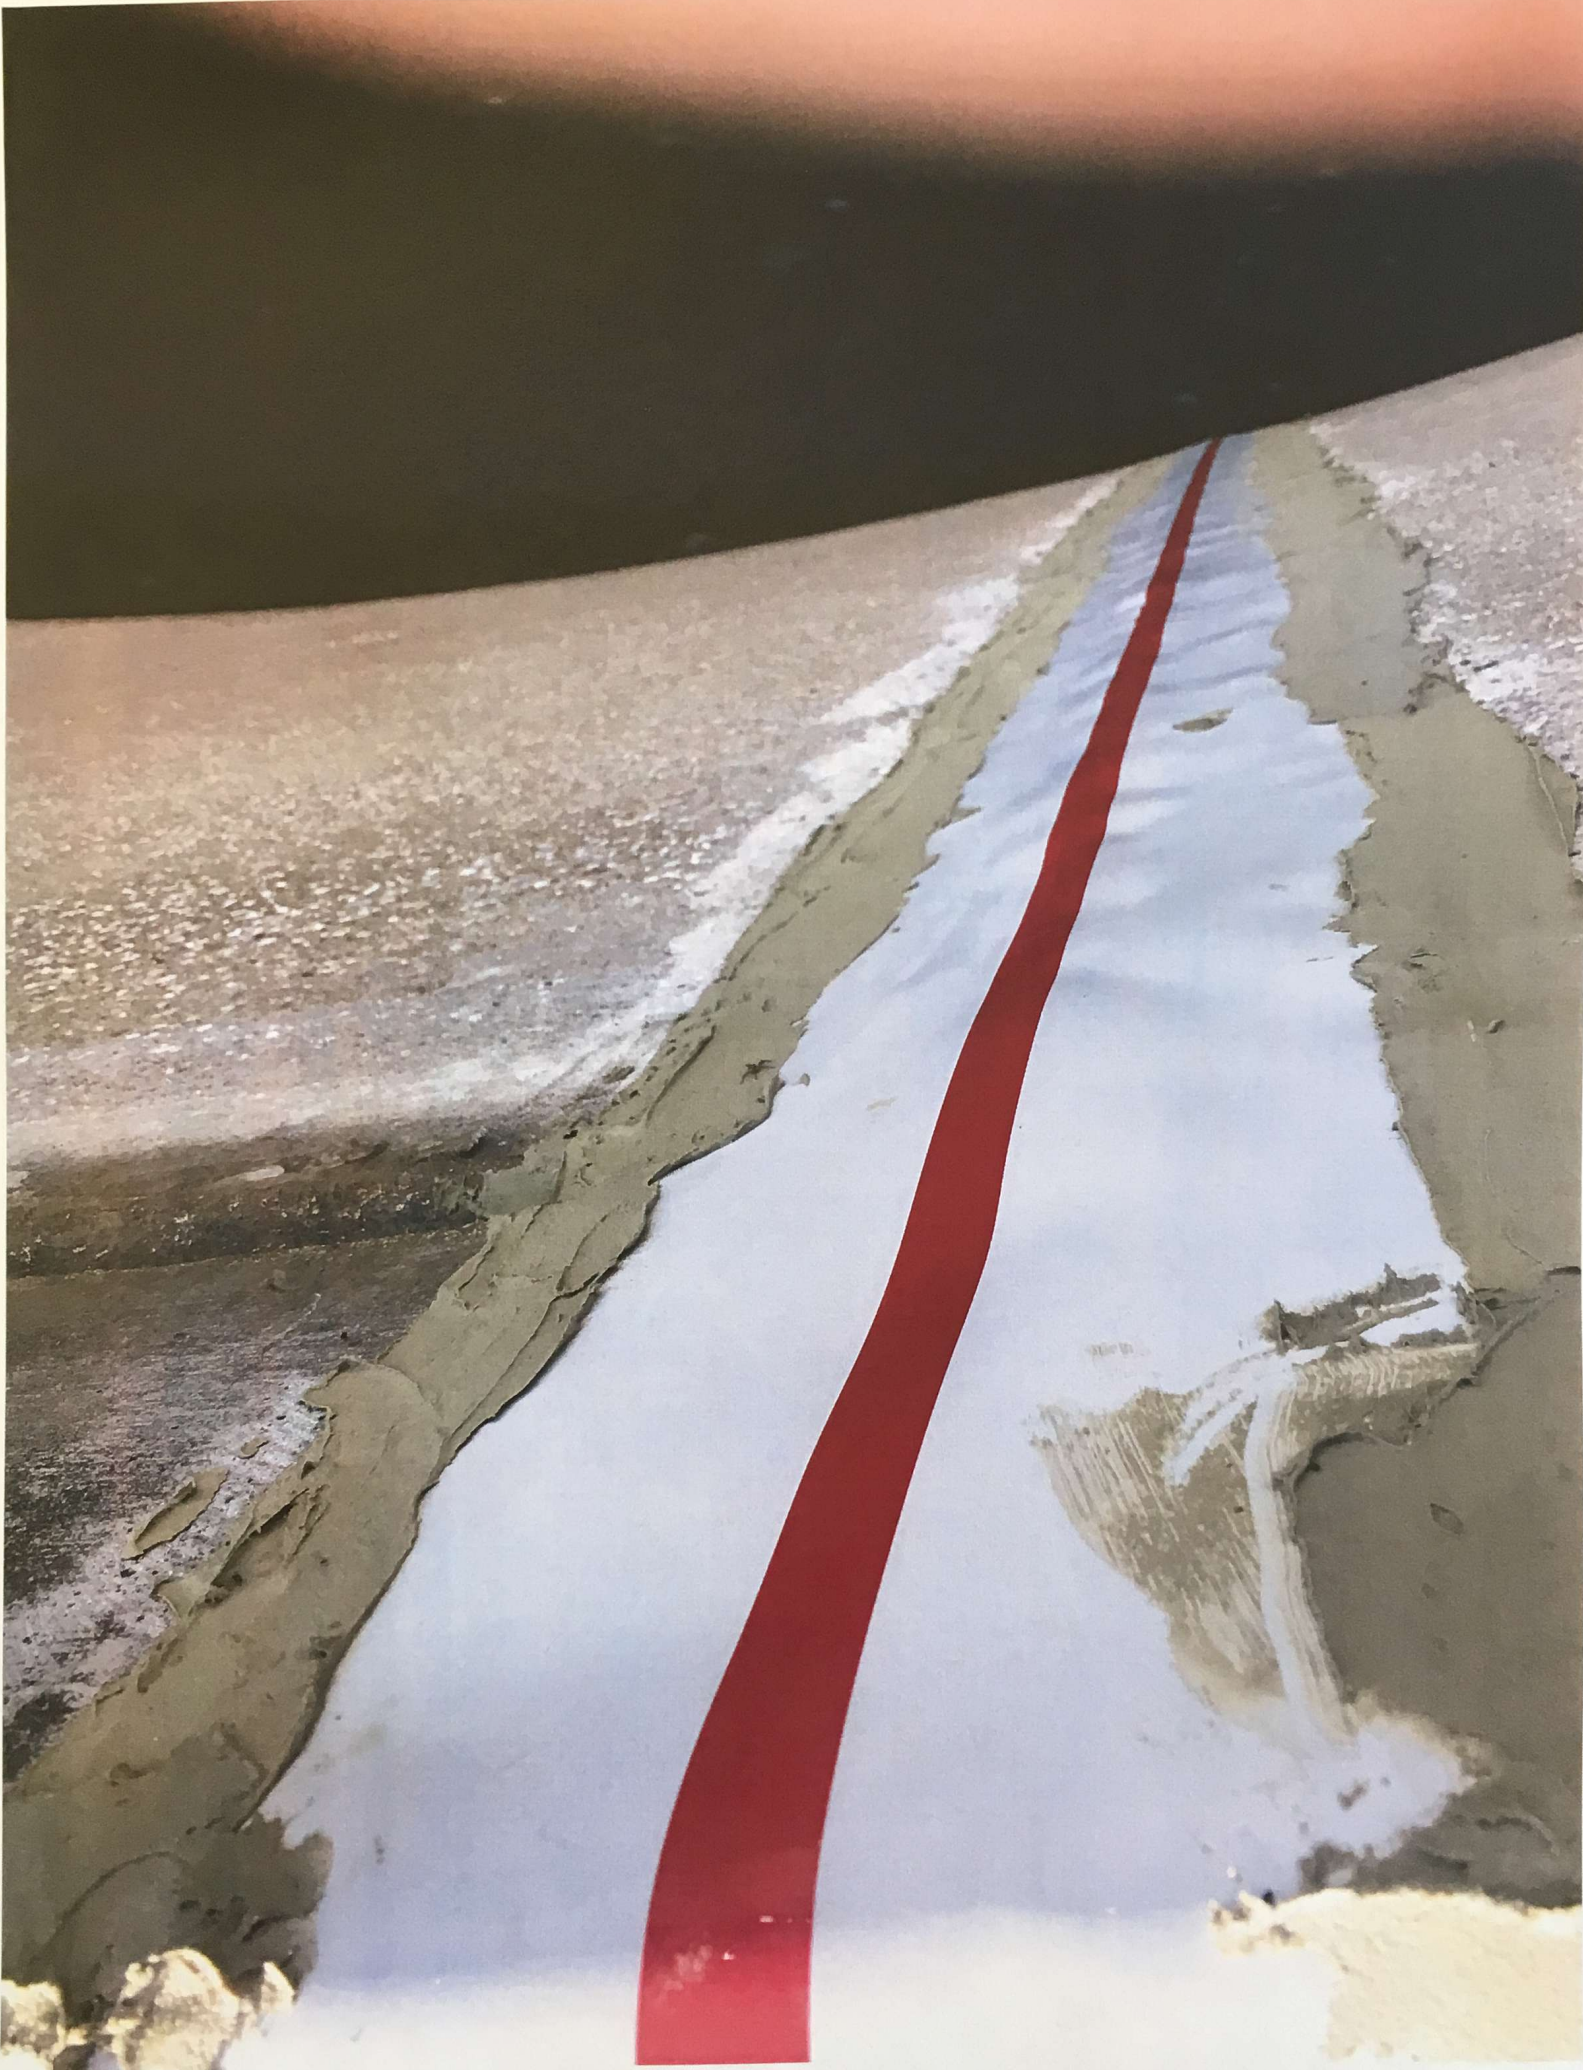
Photographs of completed work follow this letter. They are attached in the same order (Photo #1 – 5) as in your Inspection report. Please note that the photo sent of the expansion joint repair is from the inside of the basin showing that the joint was completely redone.

- Repair of minor cracks in walls of Process Trains 1 and 2 (repaired from the outside of the basin): These repairs were completed by staff in-house before the May 1, 2019 timeline in our letter dated March 6, 2019.
- Repair of leaking expansion joint (which must be repaired from the inside of the basin): This repair was completed by Roberts McNutt in July following the process train being drained and cleaned by SWU staff during a period of relatively dry weather. Repair of the expansion joint was therefore completed prior to the September 1, 2019 timeline given to you in the March 6, 2019 response letter.
