RE: Van Buren WWTP - Main Inspection (Crawford Co)

AFIN: 17-00062 NPDES Permit No.: AR0021482

WATER DIVISION INSPECTION REPORT AFIN: 17-00062 | PERMIT #: AR0021482 DATE: 12/18/2018 COUNTY: 17 Crawford PDS #: 106184 MEDIA: WN K A N Department of Environmental Quality GPS LAT: 35.418936 LONG: -94.338544 LOCATION: Entrance **FACILITY INFORMATION** INSPECTION INFORMATION FACILITY TYPE: INSPECTOR ID#: Van Buren WWTP - Main 71330 S - State 1 - Municipal LOCATION: FACILITY EVALUATION RATING INSPECTION TYPE 1401 Port Road 3 - Satisfactory **Compliance Evaluation** DATE(S): ENTRY TIME: EXIT TIME PERMIT EFFECTIVE DATE: Van Buren 12/18/2018 10:00 12:00 1/1/2015 **RESPONSIBLE OFFICIAL** PERMIT EXPIRATION DATE: NAME: / TITLE 12/31/2019 Steve Dufresne / FAYETTEVILLE SHALE RELATED: N COMPANY Van Buren Municipal Utilities FAYETTEVILLE SHALE VIOLATIONS: N MAILING ADDRESS: **INSPECTION PARTICIPANTS** PO Drawer 1269 NAME/TITLE/PHONE/FAX/EMAIL/ET CITY, STATE, ZIP: James Dunn/Chief Plant Van Buren AR 72956 Operator/479.474.5067/james@vbmu.arcoxmail.com PHONE & EXT: / FAX: 479.474.5067 Kim Redo/Environmental Coordinator/479.474.0941/kim@vbmu.arcoxmail.com steve@vbmu.arcoxmail.com Brandon Myers/Operato

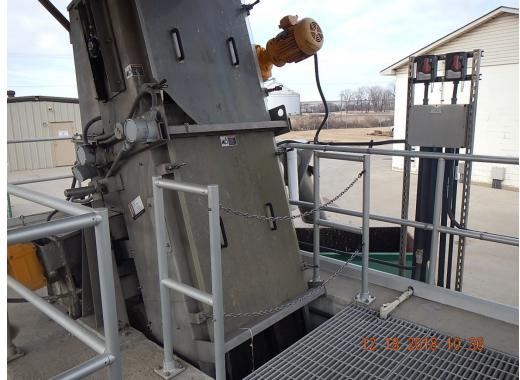
Water Division Photographic Evidence Sheet Location: Van Buren WWTP - Main Photographer: Dannielle Gray Date: 12/18/2018 Time: 1036 Witness: None Photo #: 1

Description: Auto clean bar screen at headworks

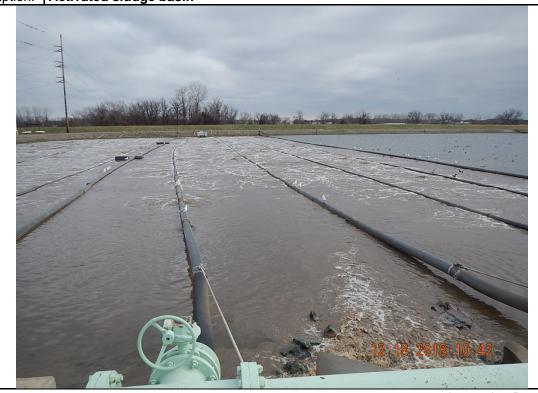
Witness:
 None
 Photo #:
 2

Description: Activated sludge basin

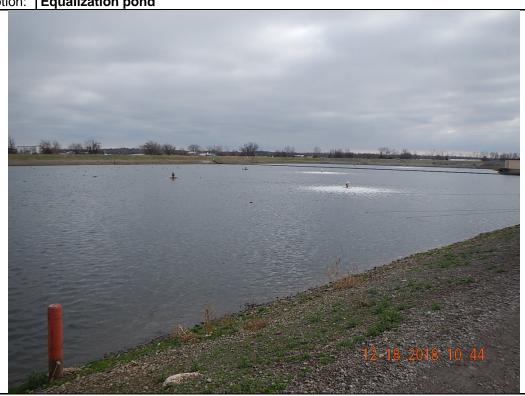
Water Division Photographic Evidence Sheet Location: Van Buren WWTP - Main Photographer: Dannielle Gray Witness: None Description: Equalization pond
