WATER DIVISION INSPECTION REPORT

AFIN: **52-00073** PERMIT #: **AR0022365** DATE: **10/30/2019**

FACILITY INFORMATION
NAME:
Camden Water Utilities
LOCATION:
101 Ouachita 197
CITY:
Camden, AR 71701
RESPONSIBLE OFFICIAL
NAME: / TITLE

FACILITY EVALUATION RATING: INSPECTION TYPE: SSO/Collection System

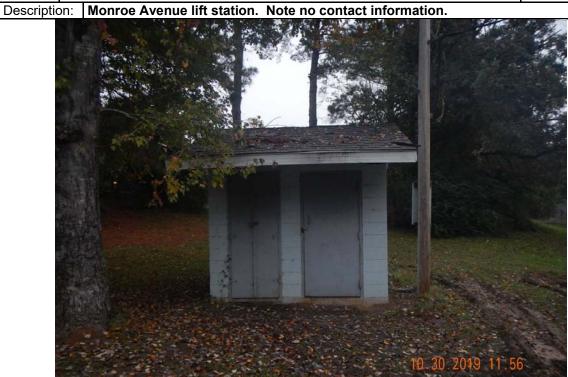
Water Division Photographic Evidence Sheet								
Location:	Location: Camden Water Utilities							
Photograp	her:	Michael Young	Date	: :	10/30/2019	Time:	11:56	
Witness:						Photo #:	1

- There is no emergency contact information posted (see Photo 1).
- There are indications of recent high-levels (see Photos 2-3).
- Electrical components are not covered and there are wires exposed (see Photo 3).

Michael Young with ADEQ did a SSO/Collection System Inspection on October 30, 2019. This letter is to show the corrective action that Camden Water Utilities has taken to correct each violation. During Mr. Young's inspection, he noticed that there wasn't any after-hours emergency contact information posted on three of our lift stations. Monroe Avenue lift station, Memory lane lift station, and Ouachita 46 lift station. Signs were put up at all three of these lift stations informing the public if red light is flashing please report it to (870) 818-2183.

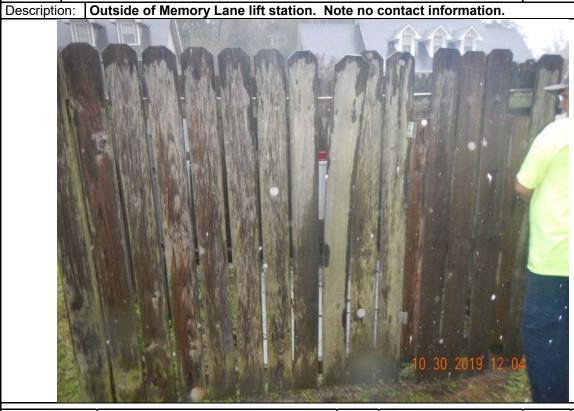
Water Division Photographic Evidence Sheet							
Location:	Location: Camden Water Utilities						
Photograp	her:	Michael Young		Date:	10/30/2019	Time:	12:15
Witness:						Photo #	: 5
				_

• There is no emergency contact information posted (see Photo 5).

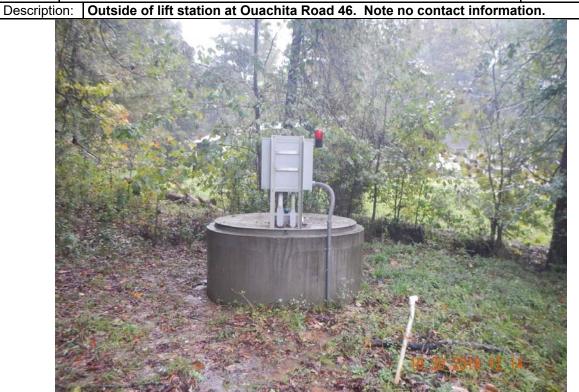
Water Division Photographic Evidence Sheet								
Location:	Location: Camden Water Utilities							
Photograp	her:	Michael Young	Date:	10/30/2019	Time:	12:15		
Witness:	Witness: Photo #: 7

• There is no emergency contact information posted (see Photos 7-8).
