ARKANSAS  
Department of Environmental Quality

On June 8, 2011, I performed a reconnaissance inspection of the collection system in response to a complaint. The complainant alleges that raw sewage had overflowed a manhole located behind 931 North Main and sewage was evident on the ground. This inspection was conducted in accordance with the provisions of the Federal Clean Water Act, the Arkansas Water and Air Pollution Control Act, and the regulations promulgated thereunder. This inspection revealed the following:

<p style="text-align: center;">UNITED STATES ENVIRONMENTAL PROTECTION AGENCY Washington, D.C. 20460</p> <h2 style="text-align: center;">NPDES Compliance Inspection Report</h2>	Form Approved OMB No. 2040-0003
--	------------------------------------

**Water Division NPDES Photographic Evidence Sheet**

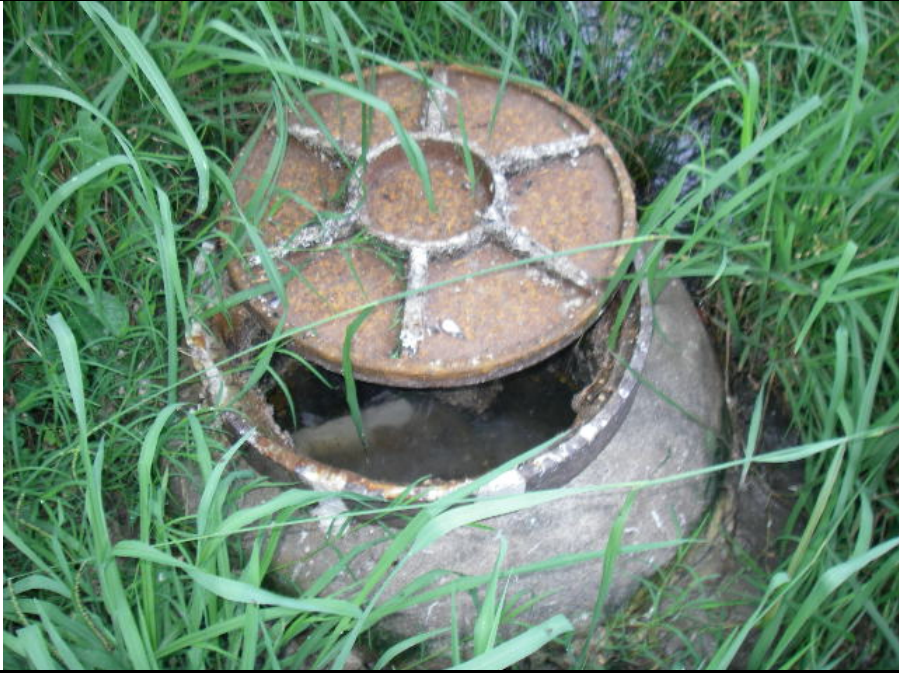
**Photo #** 1    **Of** 4      **Date:** 06-08-11    **Time:** 1013

**Description:** Manhole located behind the 900 block of North Main which had overflowed.

1. A 24 hrs Sanitary Sewer Overflow Report was submitted before the end of the day via the ADEQ website.
2. Truman's Septic Service was contracted to vacuum up all of the contaminated area.
3. After all contamination was removed, lime was spread on the affected area.
4. The customer has been put on notice to maintain their grease trap.
5. Both customers with damaged clean-outs have repaired their lids.
6. This line has also been placed on a continued maintenance schedule to be kept clear and monitored for future problems.

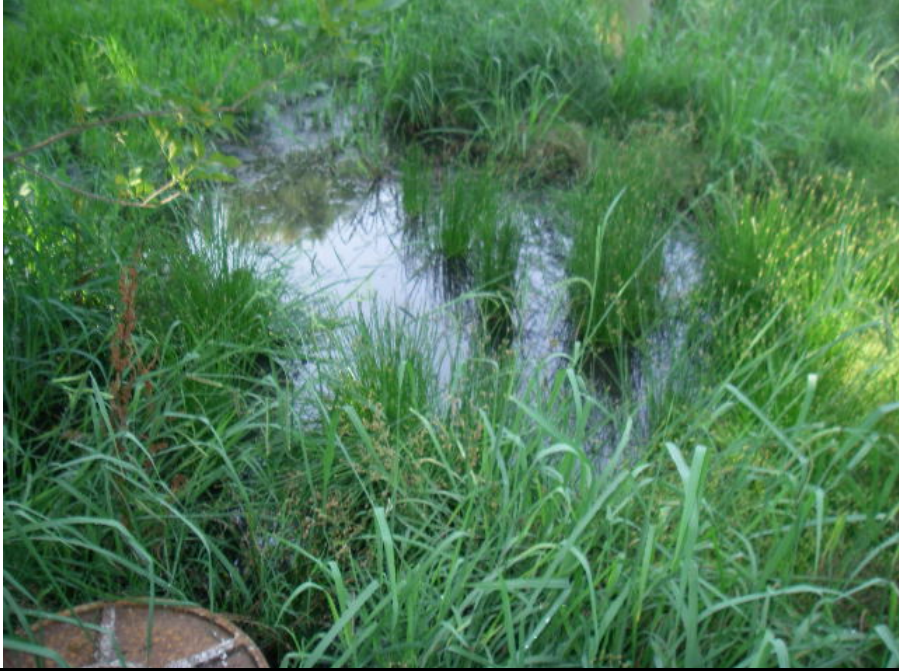
**Photo #** 2    **Of** 4      **Date:** 06-08-11    **Time:** 1013

**Description:** Standing sewage and water located adjacent to the manhole.

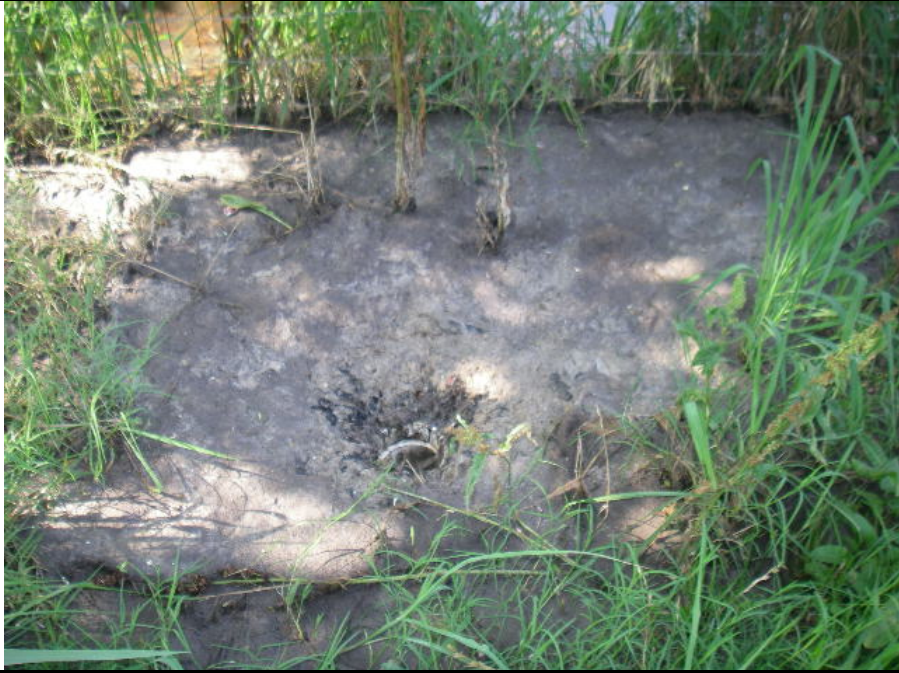
<b>Photo #</b>	3	<b>Of</b>	4	<b>Date:</b>	06-08-11	<b>Time:</b>	0952
----------------	---	-----------	---	--------------	----------	--------------	------

<b>Description:</b>	Sewage overflow from clean-out located at the residence adjacent to 931 N. Main Street.						
---------------------	---	--	--	--	--	--	--

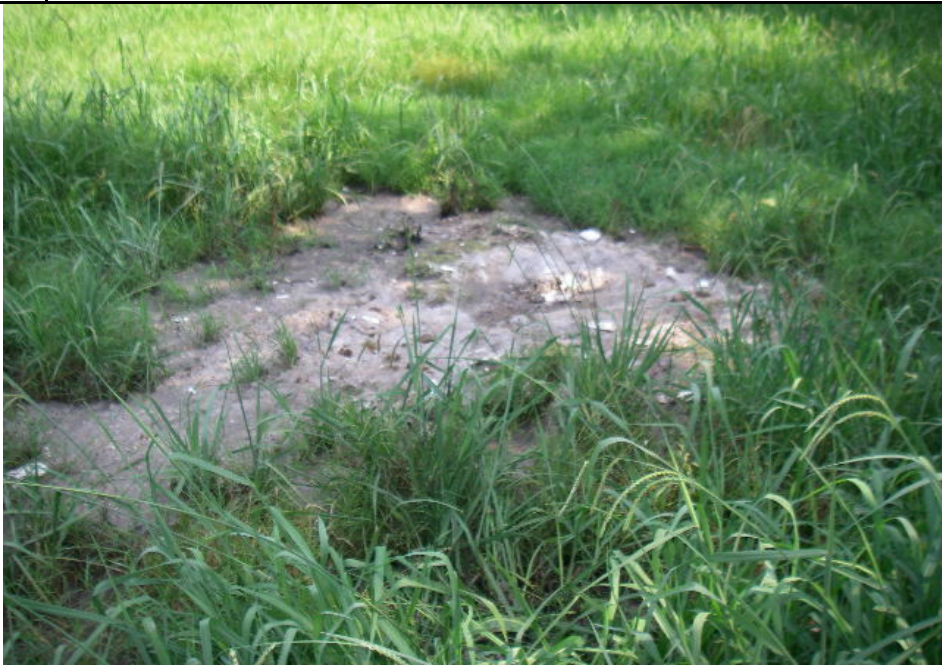
<b>Photo #</b>	4	<b>Of</b>	4	<b>Date:</b>	06-08-11	<b>Time:</b>	1013
----------------	---	-----------	---	--------------	----------	--------------	------

**A sanitary sewer overflow had occurred behind the residence of 931 North Main Street in Mulberry. At time of the inspection, raw sewage was observed on the ground adjacent to the manhole and in the location of two cleanouts. City officials confirmed that an overflow had occurred due to an apparent grease build up in the sewer line.**

<b>Description:</b>	Sewage overflow located behind 931 N. Main Street, apparent line from Mulberry Lodge.						
---------------------	---	--	--	--	--	--	--
