**RE: Facility Inspection of JM Oilfield Services (Cleburne Co)**  
**AFIN: 12-00456 Permit No.: 5071-W**

**ARKANSAS DEPARTMENT OF ENVIRONMENTAL QUALITY**  
**NO DISCHARGE INDUSTRIAL PERMIT INSPECTION FORM**

Water Division No Discharge Industrial Photographic Evidence Sheet							
--	--	--	--	--	--	--	--

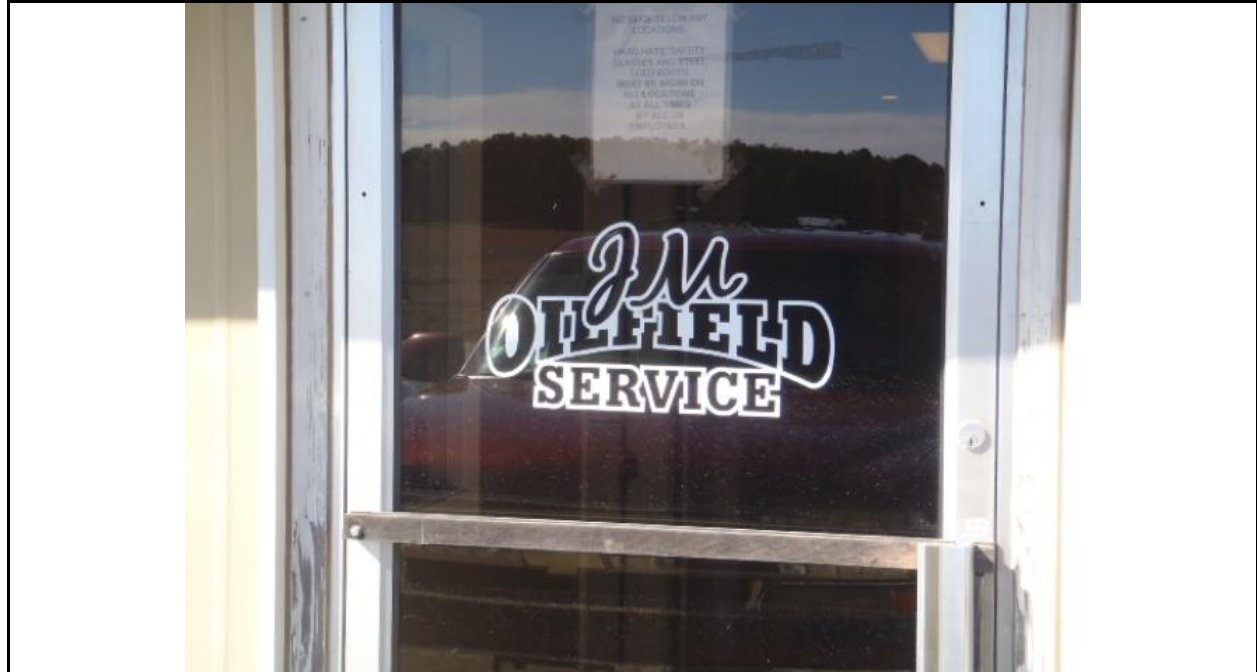
<b>Photo #</b>	1	<b>Of</b>	4	<b>Date:</b>	02/11/2013	<b>Time:</b>	1142
----------------	---	-----------	---	--------------	------------	--------------	------

<b>Description:</b>	Site ID						
---------------------	---------	--	--	--	--	--	--

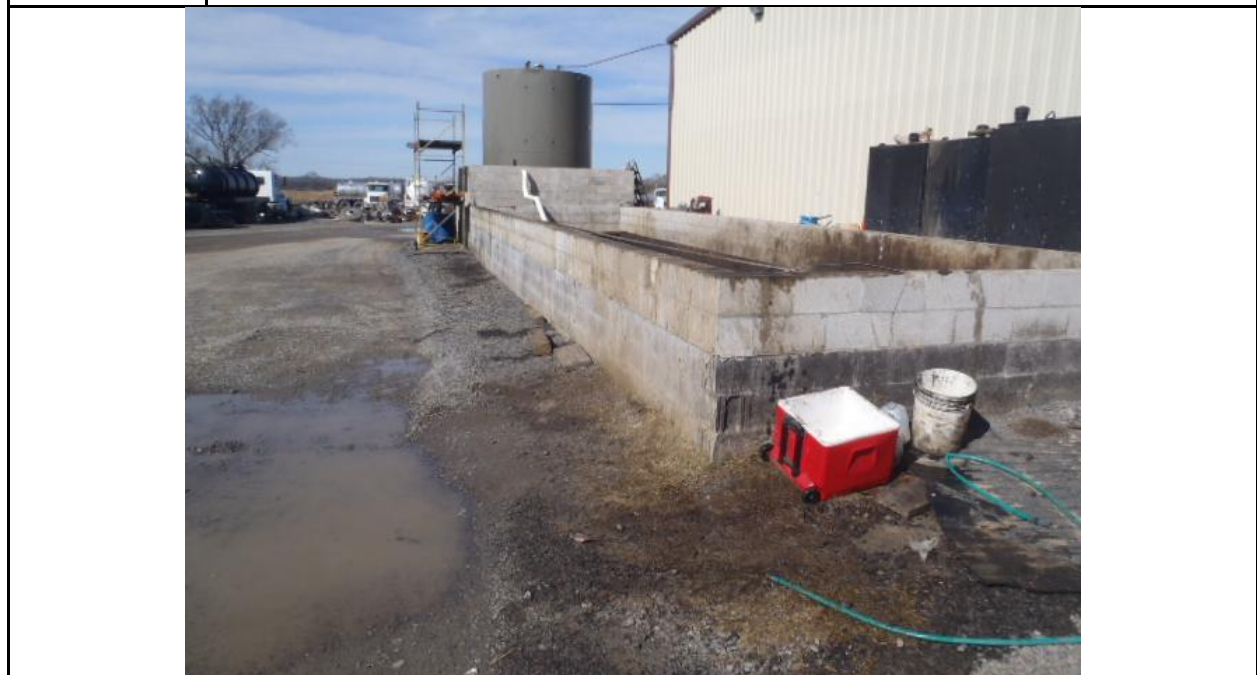
<b>Photo #</b>	2	<b>Of</b>	4	<b>Date:</b>	02/11/2013	<b>Time:</b>	1152
----------------	---	-----------	---	--------------	------------	--------------	------

There were numerous spills on the ground around the storage facility. This is in violation of Specific Condition number 2 of your permit. While not violations, there were a few inches of oil/water in the secondary containment that prevented complete inspection of the facility.  
PDS #070075

<b>Description:</b>	Secondary containment for truck wash storage tank. Note: Spills						
---------------------	---	--	--	--	--	--	--

1. All spill's identified by inspector on February 11, 2013 around waste storage system have been cleaned up and waste disposed of in accordance with state laws and regulations.
2. JM Oilfield Services operates a 24 / 7 fleet of approximately 35 tractor trailer and straight trucks. All normal operations of a fleet of vehicles this size takes place at 4 Melody Ln. , Quitman, AR 72131. Commercial Vehicles are washed, serviced, and fueled at this location.

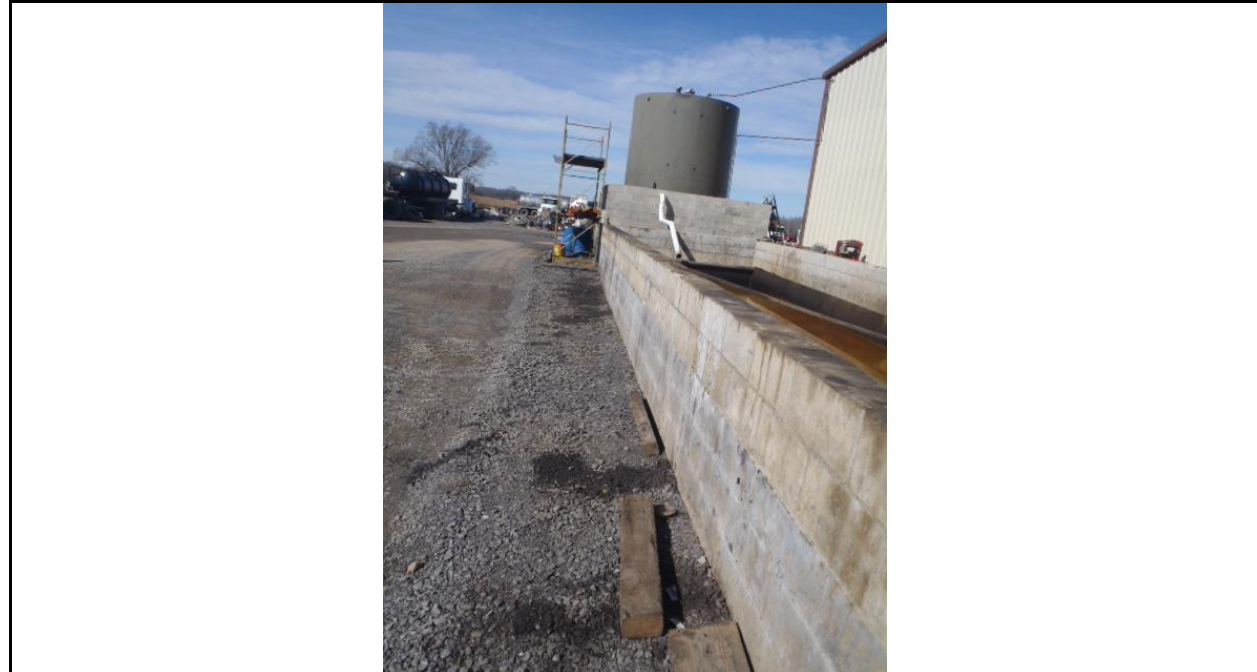
<b>Photo #</b>	3	<b>Of</b>	4	<b>Date:</b>	02/11/2013	<b>Time:</b>	1153
----------------	---	-----------	---	--------------	------------	--------------	------

<b>Description:</b>	Exterior of holding tank						
---------------------	--------------------------	--	--	--	--	--	--

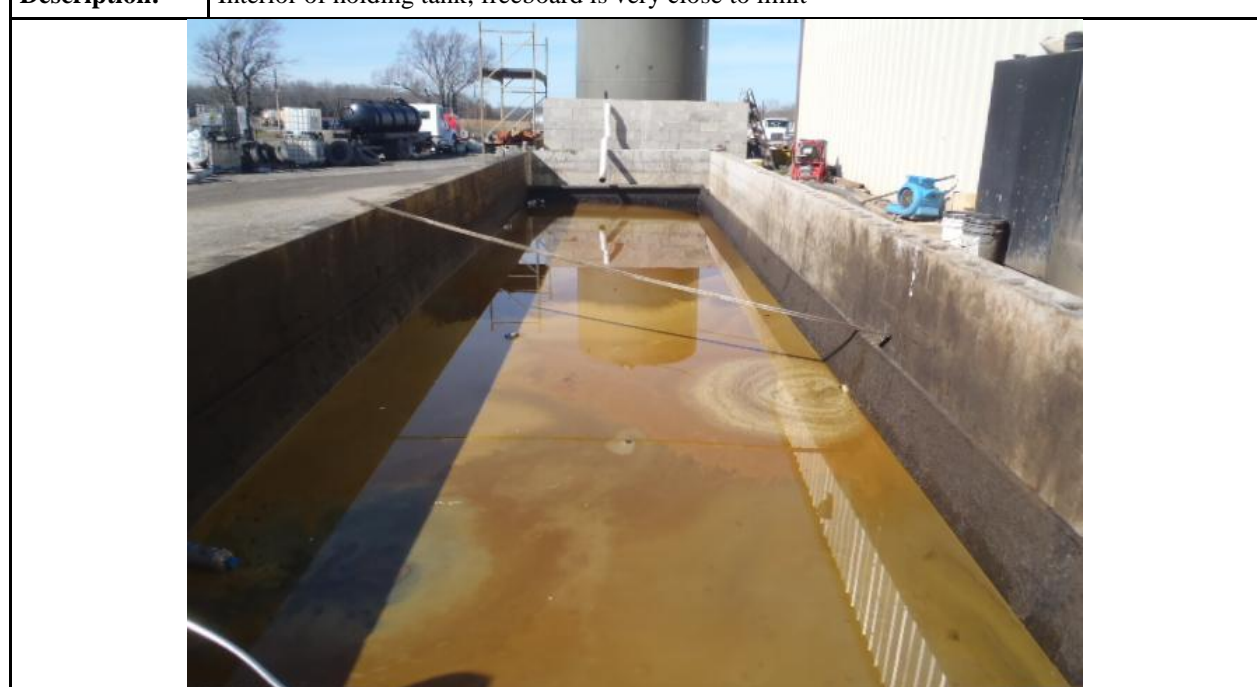
<b>Photo #</b>	4	<b>Of</b>	4	<b>Date:</b>	02/11/2013	<b>Time:</b>	1154
----------------	---	-----------	---	--------------	------------	--------------	------

<b>Description:</b>	Interior of holding tank; freeboard is very close to limit						
---------------------	--	--	--	--	--	--	--
