**UNITED STATES ENVIRONMENTAL PROTECTION AGENCY**  
 Washington, D.C. 20460  
**NPDES Compliance Inspection Report**

Name and Location of Facility Inspected (For industrial users discharging to POTW, also include POTW name and NPDES permit number) Elkins Water Department (discharges to City of Fayetteville POTW – Permit #AR0020010) 111 Walker St. Elkins, Arkansas 72727	Entry Time /Date 10:15 AM / 07-12-07	Permit Effective Date 06/01/06
	Exit Time/Date 11:55 AM / 07-12-07	Permit Expiration Date 05/31/11
Name(s) of On-Site Representative(s)/Title(s)/Phone and Fax Number(s) Kevin Caler / Elkins Water & Sewer Superintendent / 479-643-3121, 479-879-5869 (cell)	Other Facility Data	
Name, Address of Responsible Official/Title/Phone and Fax Number Kevin Caler, Elkins Water & Sewer Superintendent / 479-643-3121, 479-879-5869 (cell) P.O. Box 332, Elkins, AR 72727	SSO Location GPS: 36 02 27.812 -94 03 21.419	
	Contacted Yes <input checked="" type="checkbox"/> No <input type="checkbox"/>

**Arkansas Department of Environmental Quality (ADEQ)  
Official Photograph Sheet**

<b>Location:</b>		Elkins Sewage Collection System Release					
<b>Photographer:</b>		John Fazio			<b>Witness:</b>		
<b>Pho

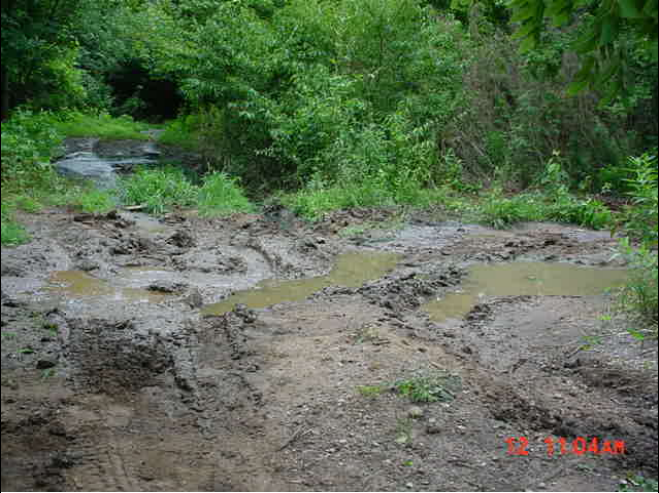
<b>Photographer:</b>		John Fazio			<b>Witness:</b>		
<b>Photo #</b>	2	<b>Of</b>	6		<b>Date:</b>	7/12/07	<b>Time:</b> 1104
<b>Description:</b>		Along Middle Fork of the White River access roads looking at sewage waste impacted areas.

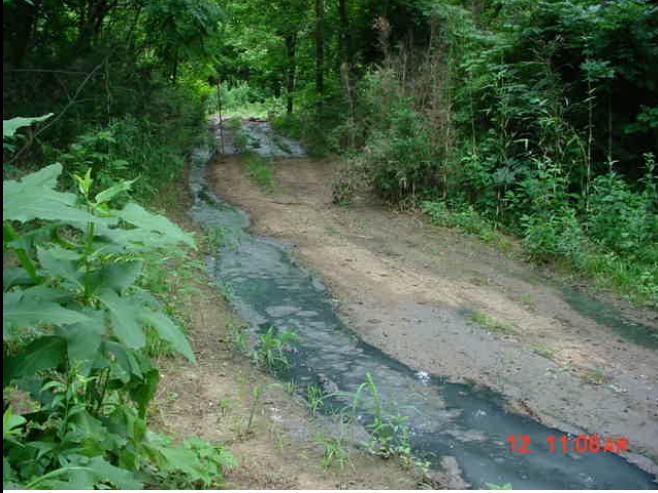
On 7/12/07, I met with Mr. Caler at the Elkin's Water Department. He indicated that he was still trying to secure a vac truck. We drove to the release site. It appeared that during the active leak, waste water had flowed from the cleanout and was directed along various truck ruts in the dirt road and into the Middle Fork of the White River. River flow was relatively high, and there was no visible evidence that a fish kill had occurred. Several puddles of waste/wastewater were present, and waste sludge was widespread along the dirt road and the vegetated areas. I recommended to Mr. Caler that he block off access to the area and contact Arkansas Game & Fish, the City of Fayetteville, the Fayetteville POTW and the Washington County Health Department. We returned to his office and discussed remediation of the impacted area. Because rain was in the immediate forecast, I recommended that he contact a nearby outside source for a vac-truck and begin recovery. I also recommended that he remove and properly dispose of the sludge and impacted soils. He contacted the Fayetteville Water & Sewer, who were to mobilize immediately to the site with a vac-truck.

<b>Location:</b>		Elkins Sewage Collection System Release						
<b>Photographer:</b>		John Fazio			<b>Witness:</b>			
<b>Photo #</b>	3	<b>Of</b>	6		<b>Date:</b>	7/12/07	<b>Time:</b>	1106
<b>Description:</b>		Liquid waste accumulated in vehicle ruts.

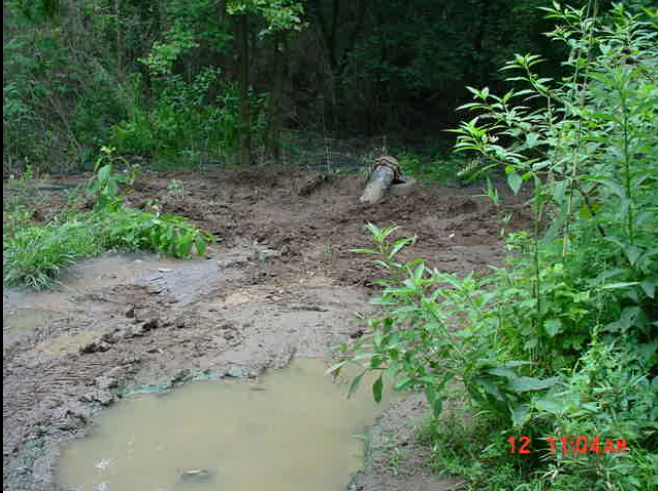
A sanitary sewer overflow (SSO) investigation was conducted in response to a report received on 7/11/07 from Kevin Caler, Elkins Water Department that a cleanout on an 8" force main had been damaged and had allowed for a release of raw sewage to the environment adjacent to and into the Middle Fork of the White River. The force main cleanout is located on the north side of Hwy 16 just west of the Middle Fork of the White River bridge, approximately 0.4 miles upstream from Lake Sequoyah. According to Mr. Caler, it appeared that the cleanout had been damaged on an unknown date by a vehicle. The damage was not reported to the City of Elkins by the driver. The cleanout is located near in an area accessed for fishing (see next page).

<b>Photographer:</b>		John Fazio			<b>Witness:</b>			
<b>Photo #</b>	4	<b>Of</b>	6		<b>Date:</b>	7/12/07	<b>Time:</b>	1104
<b>Description:</b>		Impacted area around 8" force main cleanout. Cleanout has been repaired and is to be marked/protected in future.

The aforementioned violation requires your immediate attention. Please submit a written response to this finding to the Water Division Enforcement Section detailing the circumstances of the release, the amount of waste estimated to have been released, the area impacted by the release and cleanup efforts. Please include in your response photographs documenting remediation results, as well as copies of disposal manifests and/or receipts documenting proper disposal of removed liquids and excavated sludge and soils. This response should contain documentation describing the course of action taken to prevent future releases at this location. This response is due no later than August 9, 2007.

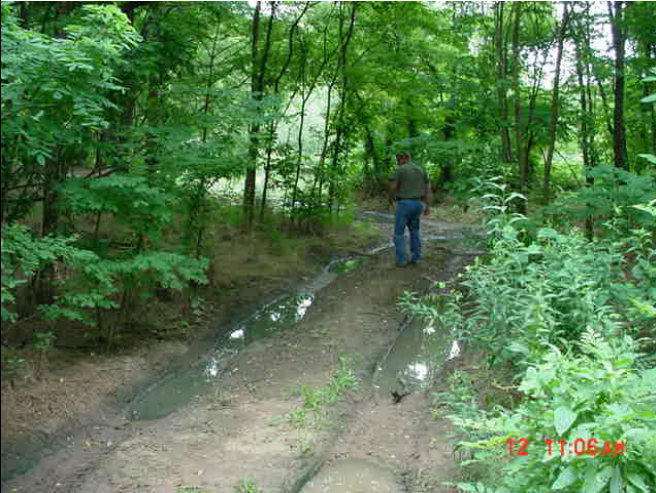
<b>Location:</b>		Elkins Sewage Collection System Release					
<b>Photographer:</b>		John Fazio			<b>Witness:</b>		
<b>Photo #</b>	5	<b>Of</b>	6		<b>Date:</b>	7/12/07	<b>Time:</b> 1106
<b>Description:</b>		Liquid waste traveled along ruts and into the Middle Fork of the White River. River is located at end of road seen in background.
