NPDES Compliance Inspection Report

Name and Location of Facility Inspected (<i>For industrial users discharging to POTW, also include POTW name and NPDES permit number</i>) Eastside Treatment Plant – Jonesboro City Water and Light 5205 Ingles Rd. Jonesboro, AR Craighead Co.	Entry Time/Date 1055 11/26/2007	Permit Effective Date December 1, 2006
	Exit Time/Date 1100 11/26/2007	Permit Expiration Date November 30, 2011
Name(s) of On-Site Representative(s)/Title(s)/Phone and Fax Number(s) Susan Merideth/Treatment Superintendent/870-930-3387 – via telephone	Other Facility Data	
Name, Address of Responsible Official/Title/Phone and Fax Number Ronald Bowen/Manager/870-930-3300 Jonesboro City Water and Light P.O. Box 1289 Jonesboro, AR 72403-1289	Contacted Yes <input type="checkbox"/> No <input checked="" type="checkbox"/>

Water Division NPDES Photographic Evidence Sheet

Location: Hwy. 18 and Commerce Dr. – Jonesboro CWL East Manhole

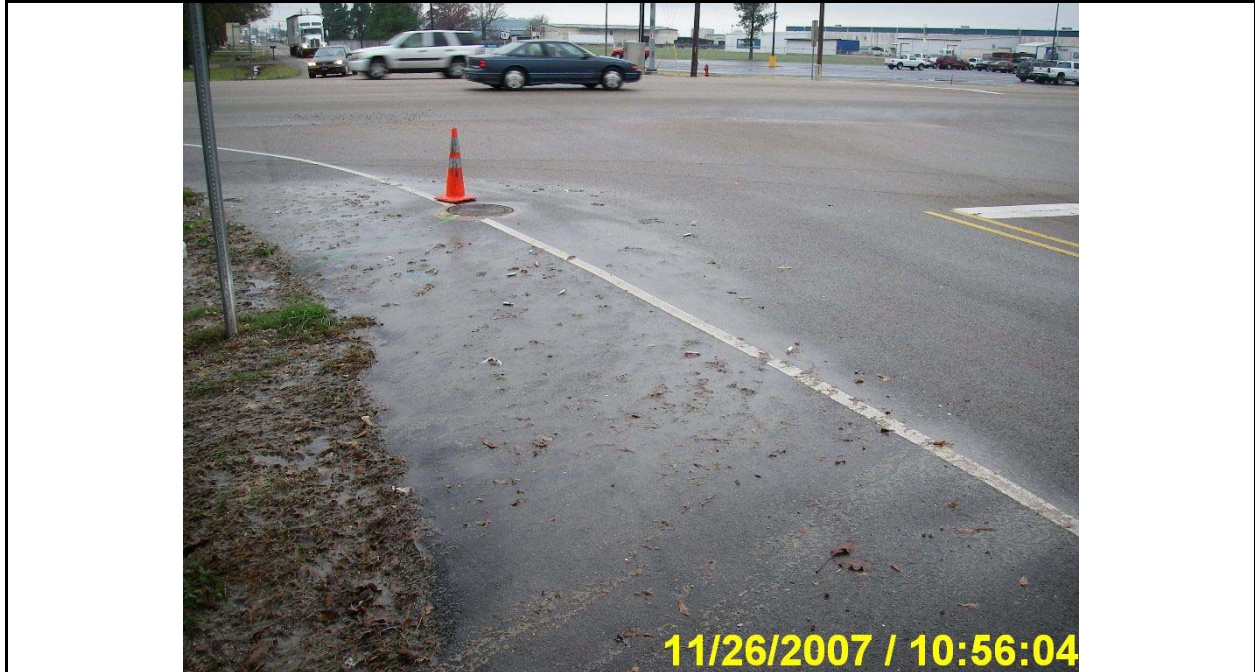
Photo # 1 **Of** 2 **Date:** 11/26/2007 **Time:** 1056

This SSO inspection was conducted following heavy rainfall as a follow-up to an SSO inspection on 11/21/2007. Although the manhole at the corner of Hwy. 18 and Commerce Dr. was not observed overflowing during this visit, there were solids in the immediate area around the manhole indicating a recent overflow.

Description: Evidence of recent overflow from manhole. (Paper, plastics and other solids)

Contact was made with Jonesboro City Water and Light Treatment Superintendent Susan Merideth regarding this matter. She advised they had been waiting for the manhole to stop overflowing so they could complete cleanup of the area. She reiterated from our discussion on 11/21/2007, collection system upgrades in the area were currently underway.

CWL has historically reported overflows as required by the permit and it appears this overflow was addressed in a timely matter and reported as required. Evidence of collection system improvement was visible in the adjacent field. A recent review of the ADEQ – NPDES Database reveals this overflow was reported as required by the permit. No letter will be sent.

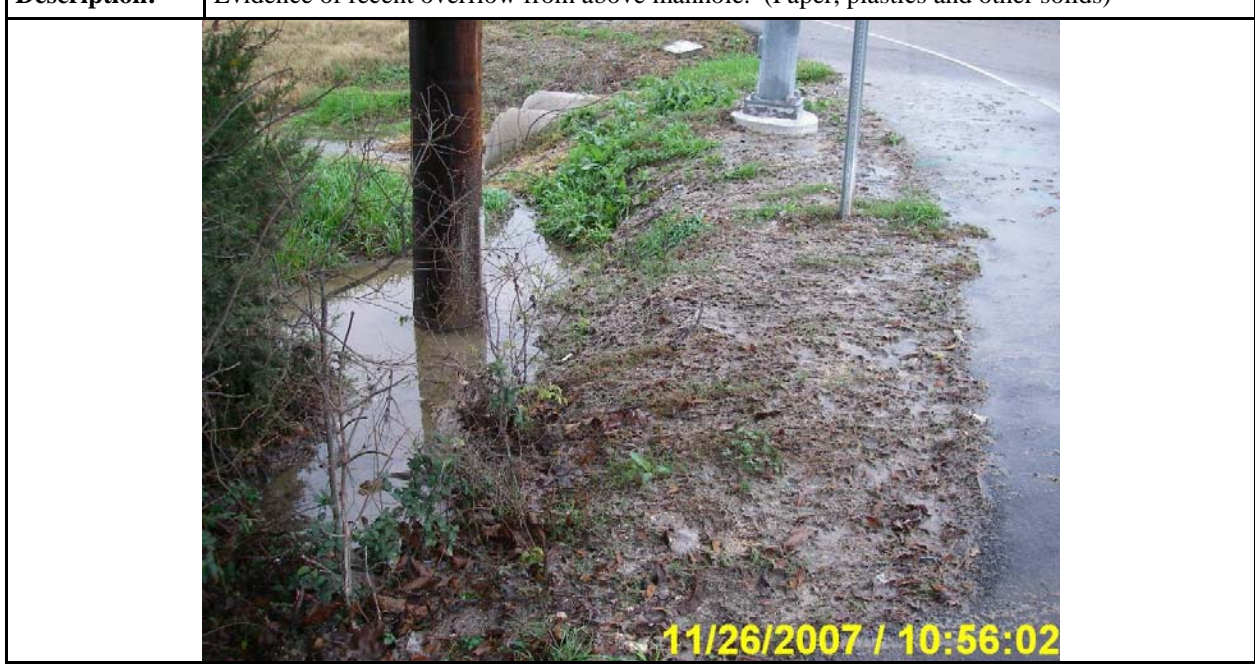
Photo # 2 **Of** 2 **Date:** 11/26/2007 **Time:** 1056

Description: Evidence of recent overflow from above manhole. (Paper, plastics and other solids)
