NPDES Compliance Inspection Report

Name and Location of Facility Inspected (For industrial users discharging to POTW, also include POTW name and NPDES permit number) Pocahontas Wastewater Treatment Plant 2 miles down Swan Cove Road off Old County Rd. (South along Black River) Pocahontas, AR Randolph Co.	Entry Time/Date 0900 3/24/2008	Permit Effective Date February 1, 2004
	Exit Time/Date 0920 3/24/2008	Permit Expiration Date January 31, 2009
Name(s) of On-Site Representative(s)/Title(s)/Phone and Fax Number(s) William G. Daniel/Manager Pocahontas Water and Sewer/870-892-3222 Jim Bergman & Bruce Brodell	Other Facility Data	
Name, Address of Responsible Official/Title/Phone and Fax Number William G. Daniel / Manager/870-892-3222 Pocahontas Water and Sewer 207 Highway #67 South Pocahontas, AR 72455	Contacted Yes <input checked="" type="checkbox"/> No <input type="checkbox"/>

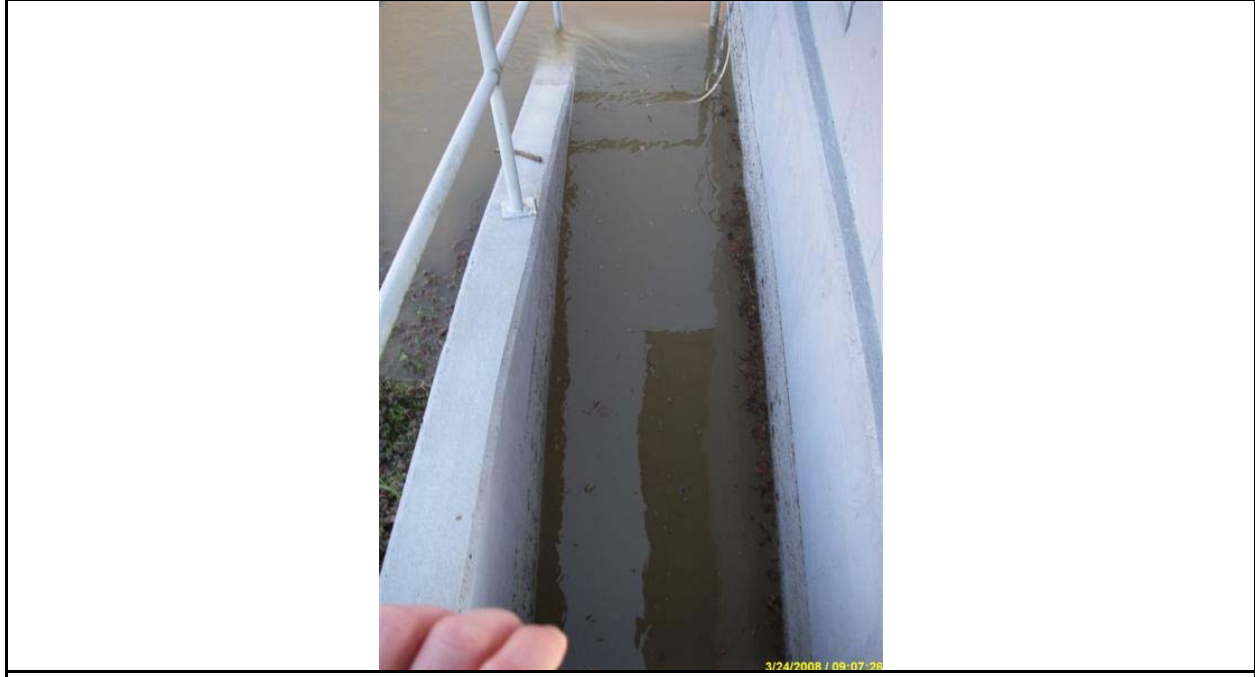
Location:	City of Pocahontas WWTP						
Photographer:	Brent Walker			Witness:	None		
Photo #	1	Of	2	Date:	3/24/2008	Time:	0907
Description:	Flooded effluent flume.

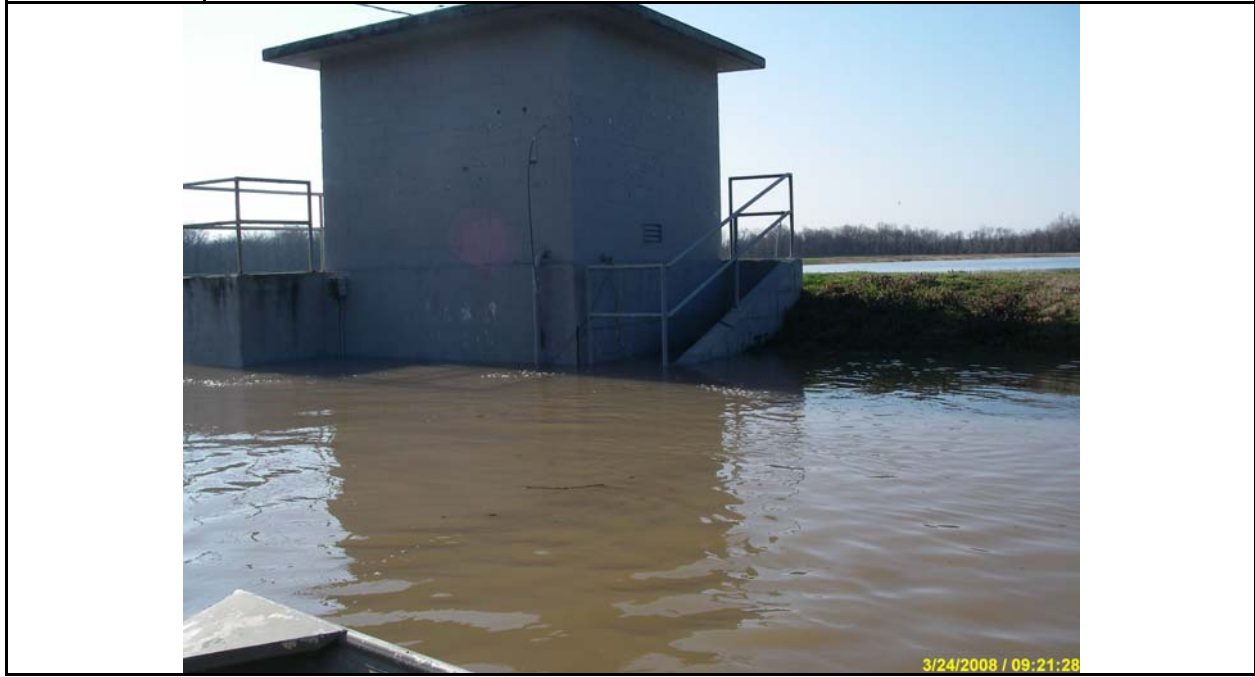
Photographer:	Brent Walker			Witness:	None		
Photo #	2	Of	2	Date:	3/24/2008	Time:	0921
Description:	Chlorine equipment building and effluent flume.
