A R K A N S A S
Department of Environmental Quality

RE: Quarterly Inspection; AFIN 32-00042; Permit Number 0200-S3N-R1.

Class 3 Landfill Inspection

Site Name	Entergy- Independence Plant	County	Independence	AFIN	32-0042
Facility Address	555 Point Ferry , Newark, AR 72562	Phone Number	870-799-8761 Entergy 870-799-3565 HW	Permit Number	0200-S3N-R1
Permittee Address	555 Point Ferry , Newark, AR 72562	E-Mail Address	krichmond@headwaters.com		PDS # 081236
Date	12-3-14	Entry Time	1235	Exit Time	1410

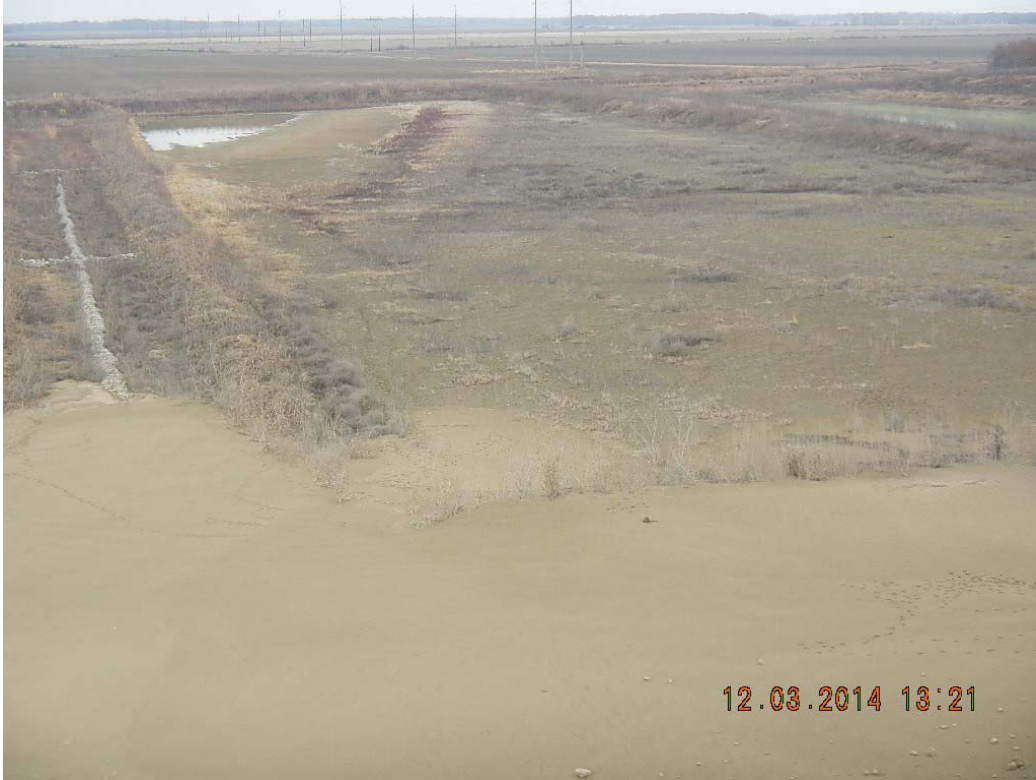
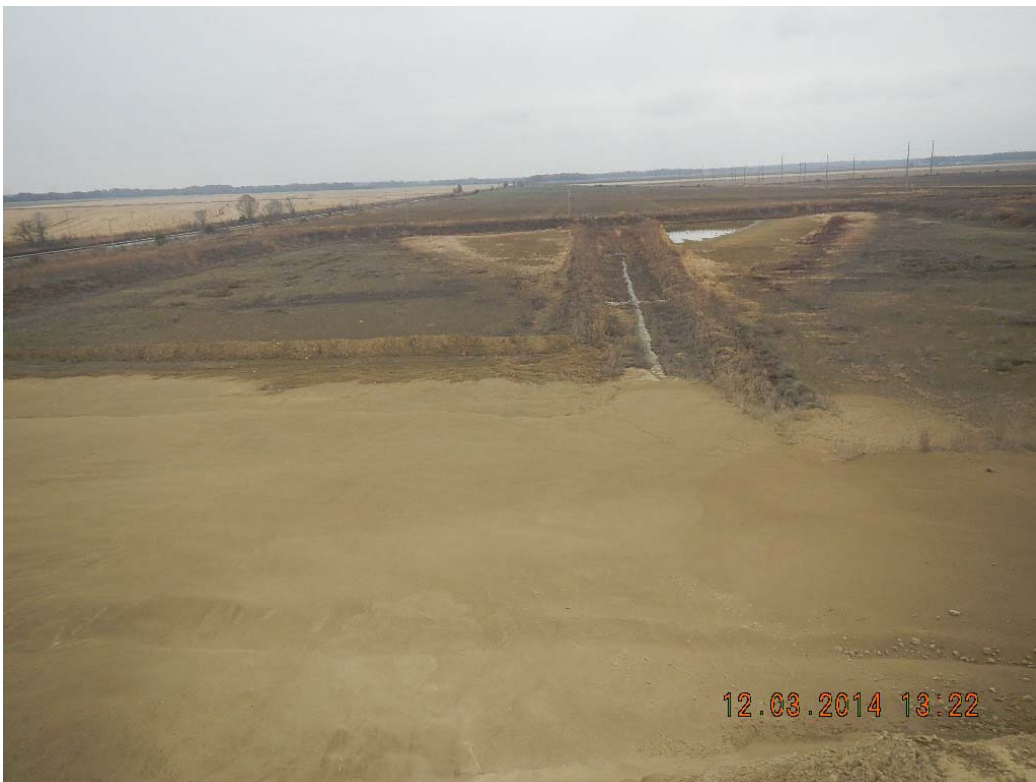
Permit 0200-S3N-R1
Photos 1 & 2

518(b) Control Systems Required - Run-on and run-off control systems shall be constructed, operated and maintained as necessary to meet the requirements of this section.

The fly ash has breached over the top of the run-off containment berm on the south half of Cell 15. See attached photos 1 & 2

Photographs documenting the correction and reconstruction of the containment berm were received from Keith Richmond, Facility Operator, on December 4, 2014. See attached photos 3 & 4.
