RE: City of Mountain View Inspection (Stone Co)
AFIN: 69-00011 **NPDES Permit No.: AR0020117**

WATER DIVISION INSPECTION REPORT

AFIN: 69-00011	PERMIT #: AR0020117	DATE: 3/23/2017
COUNTY: 69 Stone	PDS #: 096245	MEDIA: WN
GPS LAT: 35.875021 LONG: -92.117550 LOCATION: General Area

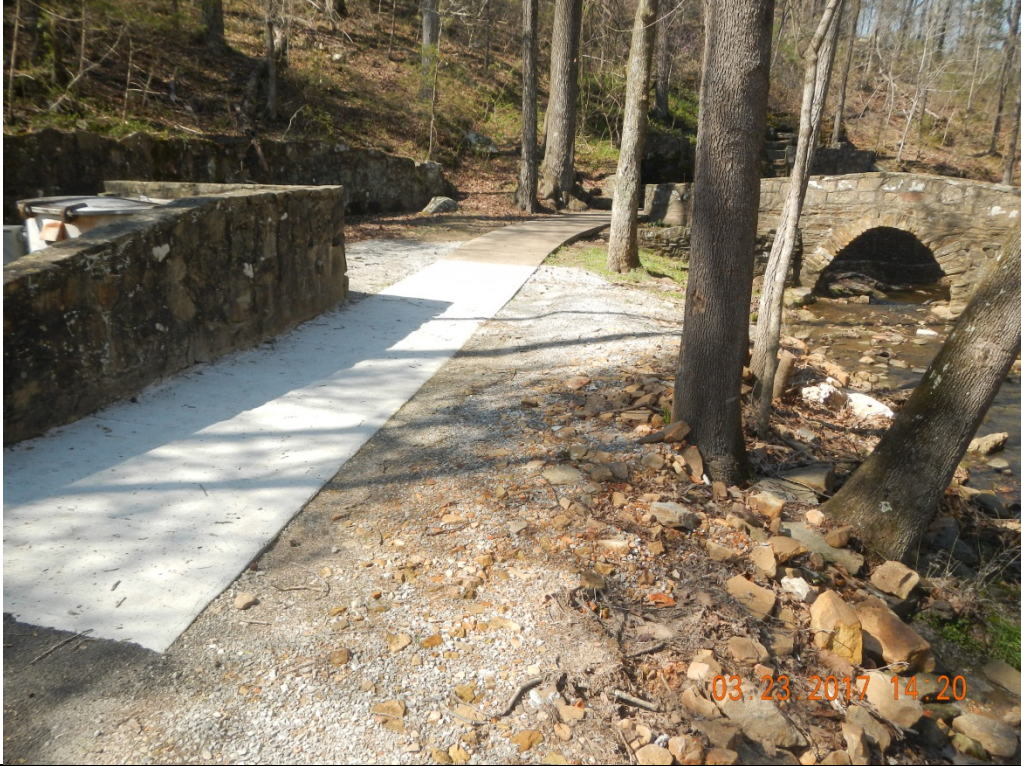
Location:	Park Ave. Mountain View, AR				
Photographer:	Skyler Schlick	Date:	3/23/2017	Time:	1520
Witness:				Photo #:	1
Description:	Lift station on the left and Whitewater Creek on the right.

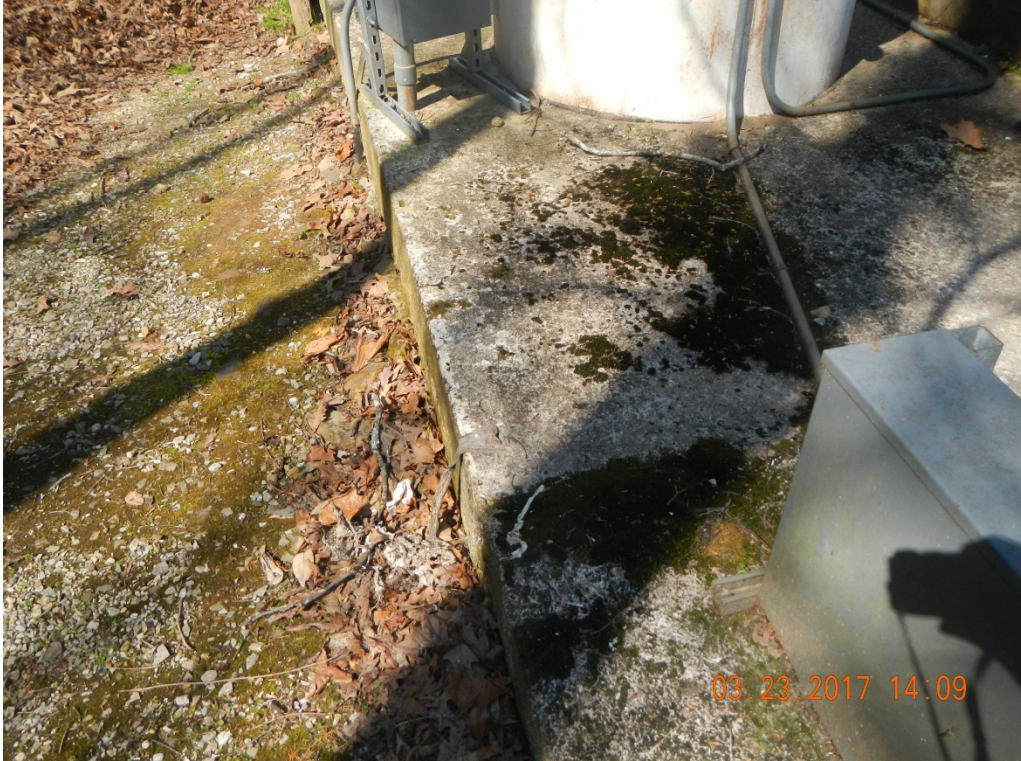
Photographer:	Skyler Schlick	Date:	3/23/2017	Time:	1509
Witness:				Photo #:	2
Description:	Toilet paper on edge of concrete pad where lift station is located.

This is in response to your letter dated April 5, 2017. Summary of Findings item (1.) The Lift Station #1 at Park Avenue has been pressure washed and cleaned as shown in the enclosed photo. Also noted was a violation of Part II, Condition 5, B of the Permit I understand this condition of the Permit, and it will be immediately corrected. If any other information is needed please let me know.

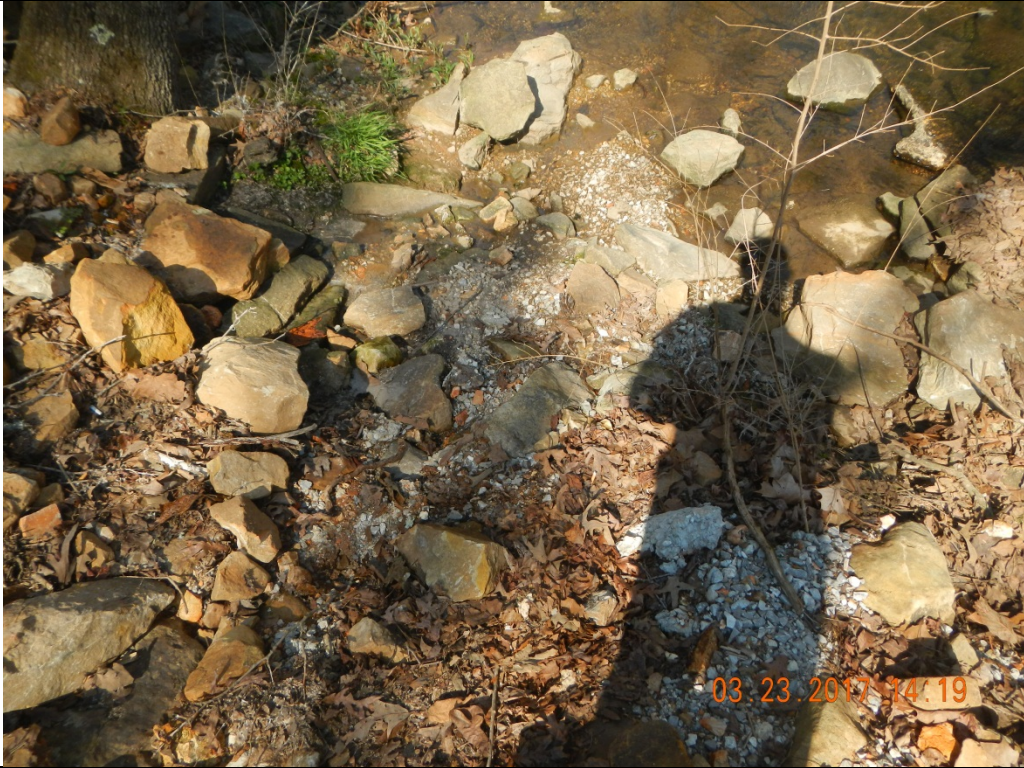
The site was investigated on March 23, 2017 after a reported fish kill of 200 fish. There were no dead fish observed in a 300ft section of Whitewater Creek. The water was fairly clear and no visual abnormalities were noted in the water. There is a lift station within approximately 25ft of Whitewater Creek. There was toilet paper that was observed on the concrete pad of the lift station. Additionally, there appeared to be an erosive path (flow indicators) on the bank of Whitewater Creek where the SSO entered the creek. The City of Mountain View was contacted view phone on March 24, 2017. Debbie Walker confirmed that there was a SSO of approximately 3,000 gallons at this location. Ms. Walker said there was no environmental concern noted.

Location:	Park Ave. Mountain View, AR				
Photographer:	Skyler Schlick	Date:	3/23/2017	Time:	1519
Witness:				Photo #:	3
Description:	Area where SSO appeared to flow into Whitewater Creek.

The SSO was reported on March 21, 2017 and the SSO likely occurred at night on March 18, 2017. An environmental concern would be if any raw sewage from a lift station reached waters of the State. In the future, these incidences need to be reported within 24 hours of becoming aware of the incident and a written report is due to the Department within five days.

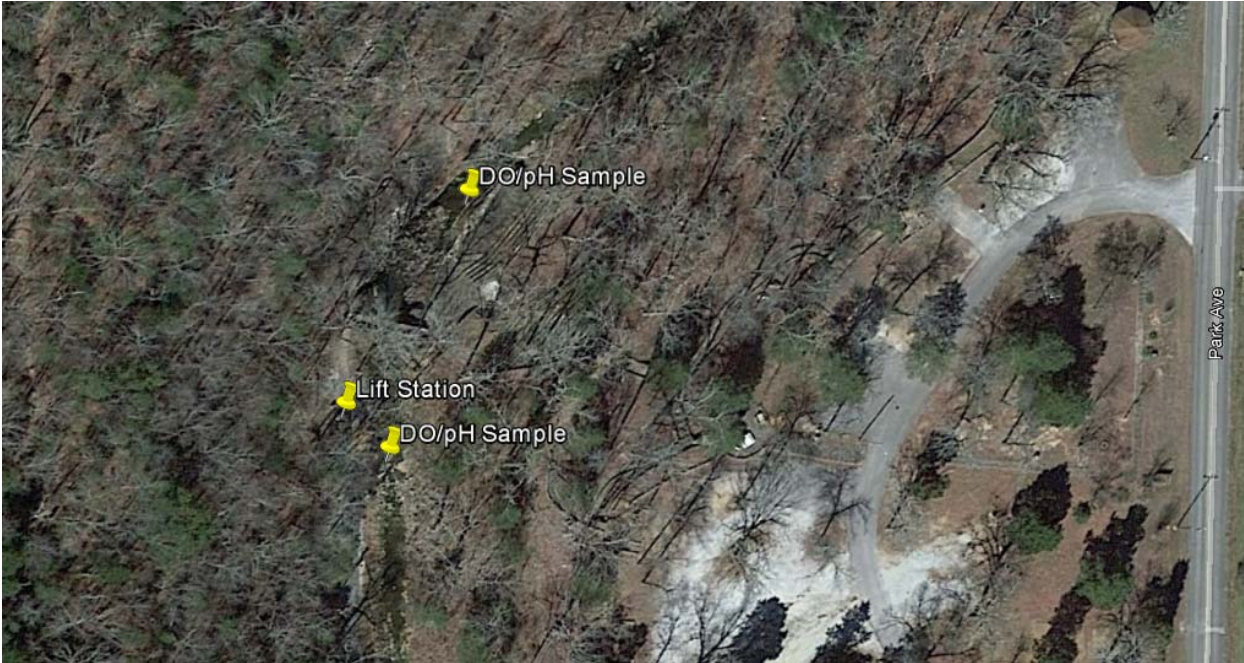
A Dissolved Oxygen (DO) reading was recorded (10.03mg/l) north of the SSO location in Whitewater Creek. A second DO reading was recorded (10.15 mg/l) south of the SSO location in Whitewater Creek. Readings for A pH were also recorded for Whitewater Creek and are as follows: 8.27 s.u. north of the SSO location and 8.19 s.u. south of the SSO location.

Figure 1. Aerial view of complaint location depicting lift station and sampling locations (Google Earth Image date March 4, 2016).
