WATER DIVISION INSPECTION REPORT

AFIN: **57-00423** PERMIT #: **AR0036692** DATE: 4/28/2017

City of Mena WWTP

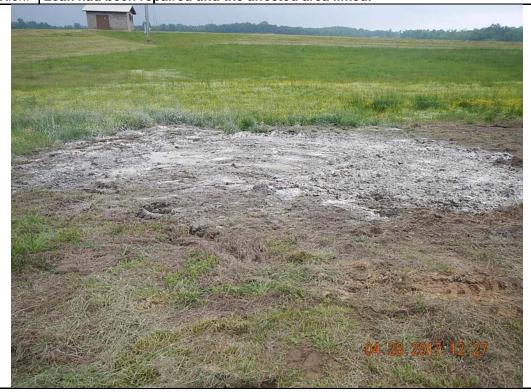
A reconnaissance inspection of this facility was conducted on April 28, 2017 due to the report of a leak in the sixteen inch force main that enters the lagoon. Upon arrival, I met with the Wastewater Supervisor, Mike Spencer. Mr. Spencer stated that he had discovered the leak occurring on Monday, April 24. Repairs to the line had just been completed the morning of April 28 prior to my arrival. Mr. Spencer stated that the line had been excavated and a collar was placed around the hole in the line. The hole was approximately the size of a quarter according to Mr. Spencer. While I was there, lime was spread across the excavation site.

Mr. Spencer estimated the leak to be approximately 1000 gallons a day. The leak surfaced in a low area at the facility that Mr. Spencer stated stays wet most of the year due to the amount of stormwater runoff and groundwater that accumulates in that area. The leaked wastewater entered a surface drainage along the westside of the lagoons and entered the unnamed tributary (UT) of Prairie Creek next to Outfall 001. Other than some mild turbidity resulting from the excavation no visible issues were noted in the tributary below the outfall.

Water Division Photographic Evidence Sheet					
Location: Mena WWTP					
Photograpl	her: Greg Kremers	Date:	4/28/2017	Time:	1227
Witness: Mike Spencer, City of Mena				Photo #	# : 1
Description: Leak had been repaired and the affected area limed.
