RE: Quarterly Inspection conducted on September 19, 2017
AFIN 04-00472
Permit Number 0297-SC-R1

Compost Inspection

Site Name	Bentonville Compost	County	Benton	AFIN	04-00472
Facility Address	2000 N.W. "A" Street, Bentonville	Phone number	479-271-5954	Permit number	0297-SC-R1
Permittee Address	115 West Central, Bentonville, AR	E-Mail Address		PDS #	099451
Date	9/19/2017	Entry time	1300	Exit time	1335
Classification Type	<input type="checkbox"/> Y – Yard Waste	<input checked="" type="checkbox"/> O – Source Separated Organic Waste	<input type="checkbox"/> S – Mixed Solid Waste

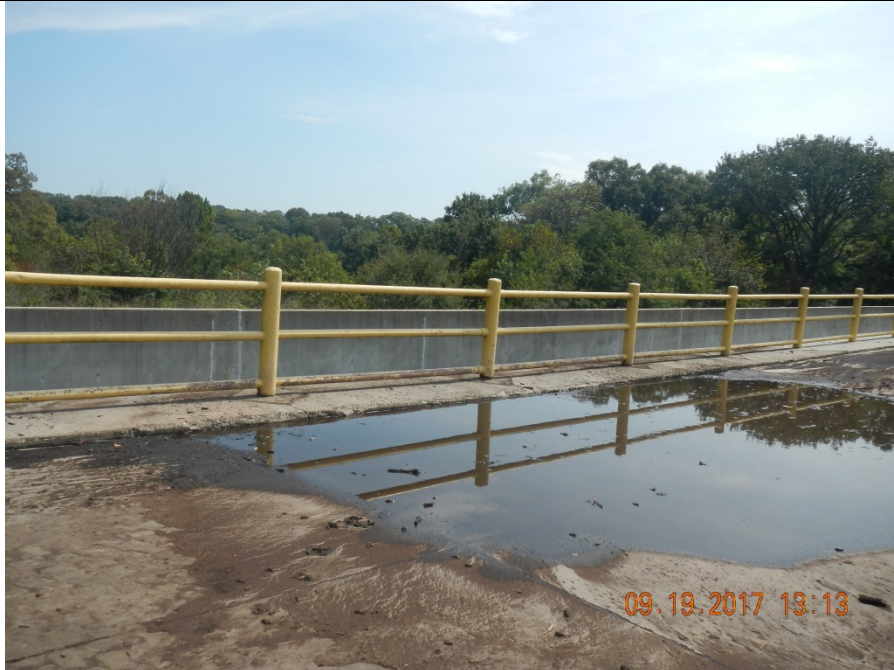
Location	Bentonville Compost			Permit	0297-SC-R1	AFIN	04-00472
Photographer	Alana Wallace		AW	Witness	None		
Photo #	3	Of	7	Date	9/19/2017	Time	1313
Description	Ponding water on east side of composting pad.

The city has engaged professional services of the engineering firm Morrison-Shipley, Inc., to sample and prepare a feasibility study report concerning the settling of this structure. The data of core samples obtained are currently under analysis. A consensus for future repair or replacement of the compost pad will follow receipt of this report.

In the interim, all standing water will be manually pumped into the Compost Catch Basin immediately following rain or snow events.

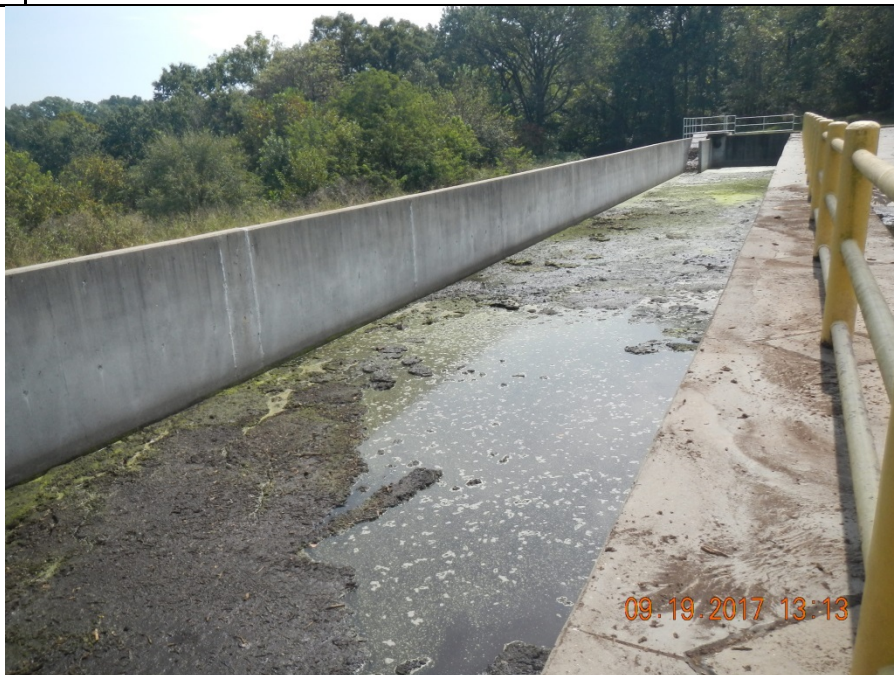
Location	Bentonville Compost			Permit	0297-SC-R1	AFIN	04-00472
Photographer	Alana Wallace		AW	Witness	None		
Photo #	4	Of	7	Date	9/19/2017	Time	1313
Description	Detention pond at east side of composting pad.

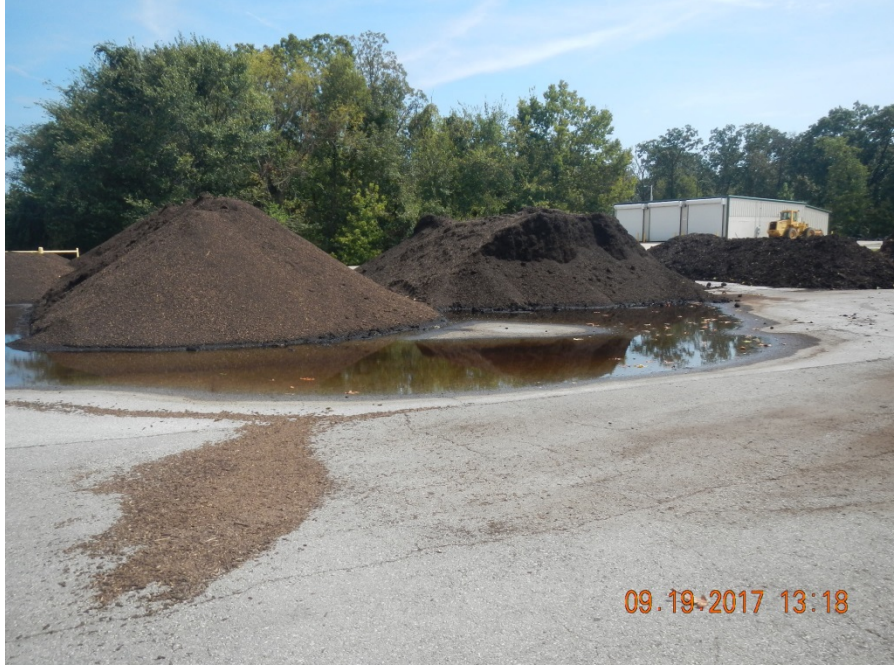
Location	Bentonville Compost			Permit	0297-SC-R1	AFIN	04-00472
Photographer	Alana Wallace		AW	Witness	None		
Photo #	5	Of	7	Date	9/19/2017	Time	1318
Description	Ponding water at finished compost.

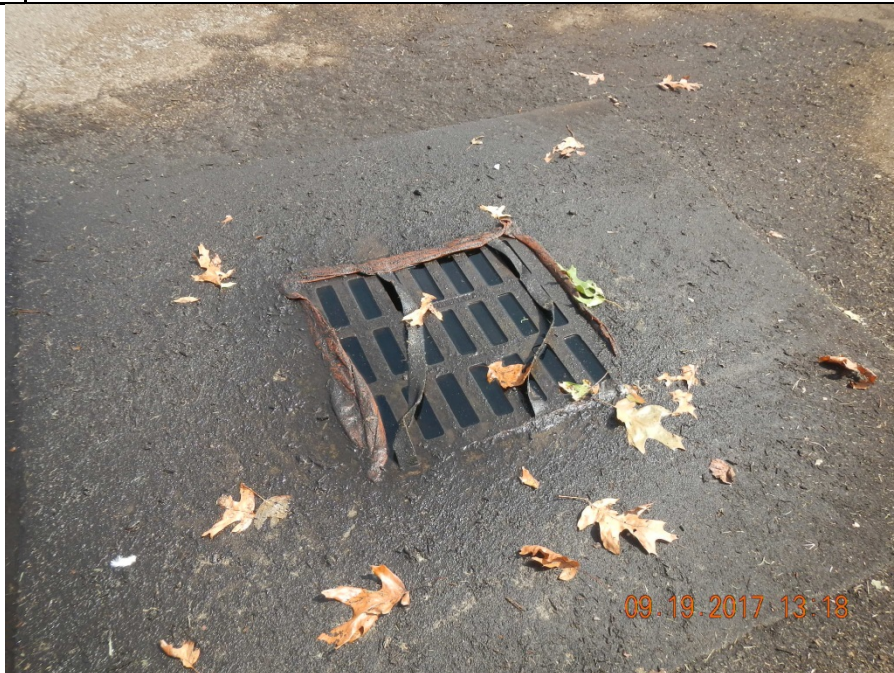
Location	Bentonville Compost			Permit	0297-SC-R1	AFIN	04-00472
Photographer	Alana Wallace		AW	Witness	None		
Photo #	6	Of	7	Date	9/19/2017	Time	1318
Description	Clogged drain at finished compost.

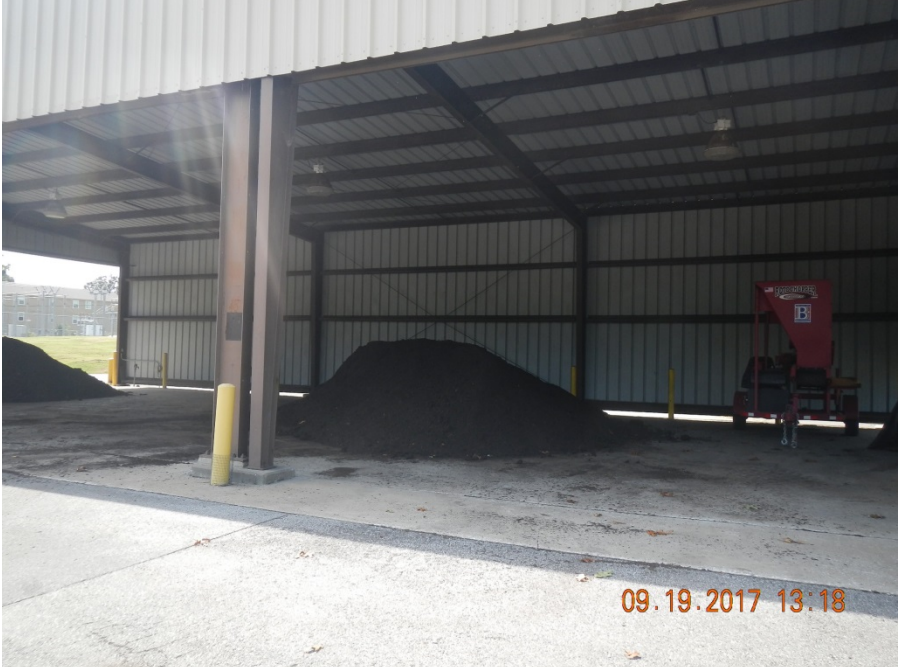
Location	Bentonville Compost				Permit	0297-SC-R1	AFIN	04-00472
Photographer	Alana Wallace			AW	Witness	None		
Photo #	7	Of	7		Date	9/19/2017	Time	1318
Description	Covered finished compost.
