#### RE: Quarterly Inspection conducted on March 21, 2018 AFIN 18-00094 Permit Number 0245-S1-R1

# Arkansas Department of Environmental Quality Office of Land Resources -Solid Waste Management Class 1 Landfill Inspection

Site Name	Crittenden County Class 1 Landfill	County	Crittenden	AFIN	18-00094							
Facility Address	1299 Khun Rd. West Memphis, AR 72301	Phone Number LF: 870-732-4290 Off: 870-732-6580 Permit Number			0245-S1-R1							
Permittee Address	Crittenden Co. Judge	E-Mail Address	arredllc@swb.net		<b>PDS #</b> 102050							
Date	3/21/2018	Entry Time	0930	Exit Time	1130							
	Regulation 22	2 – Operation	al Standards									
	Category 1											
Regulation	Item Description			Comments								
411(l)	Adequate employee facilities											
421(a)(b)	Record keeping meets requirements specified by regulations											
417	Access requirements											
411(j)	Adequate provisions for backup equipment											
421(d)	Waste receipt records, ticket system maintained											
411(k)	Telephone system & written emergency response plan on site											
423(b)	Annual compliance inspection by registered professional enginee	r

#### RE: Corrective Action Plan for Quarterly

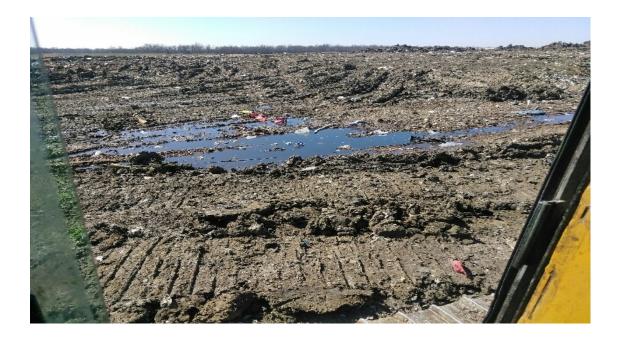
Category 2 (continued)											
	Regulation	Item Description					Comn	nents			
	427	Surface Water Controls									
Х	411(h)(1)	Contouring prevents surface water flowing into or the	hrough waste	Surfac Photo	face water was standing on top of the landfill in Cell 3, which was not contoured to drain. (Refer to					er to	
	418(a)(b)	Run-on/off control system present and adequate		Thoto							
	411(h)(2)	Surface water control prevents off-site sediment accumulation									
	411(i);427(f)	Adequate maintenance of intermediate/final cover vegetation									
	415	Gas monitoring program									
	<b>411(o)</b>	Leachate leaks or evidence of leachate seepage									
	426	Survey controls									
	429	Leachate collection system									
	420	Liquid Restrictions									
	Category 3										
	Regulation	Item Description					Comn	nents			
	412	Implementation of hazardous/unauthorized waste ex	clusion plan

As noted on your Routine Class 1 Landfill Inspection on 3/21/2018 Regulation 411 (h) (i) Contouring Prevents Surface Water Flowing Into or Through Waste was observed. (See picture below This picture was taken by SANTEK WASTE SERVICES staff day of Quarterly Inspection March 21, 2018

Within 24hrs of Noted Allegations 411(h) (i) The Complete Area was surveyed. The Correction was made by cutting and filling in such away to allow for positive drainage. In addition Management has Trained Staff and Operators on the importance of Run on and Run off Procedures. (See Pictures Below of Correction Made.)

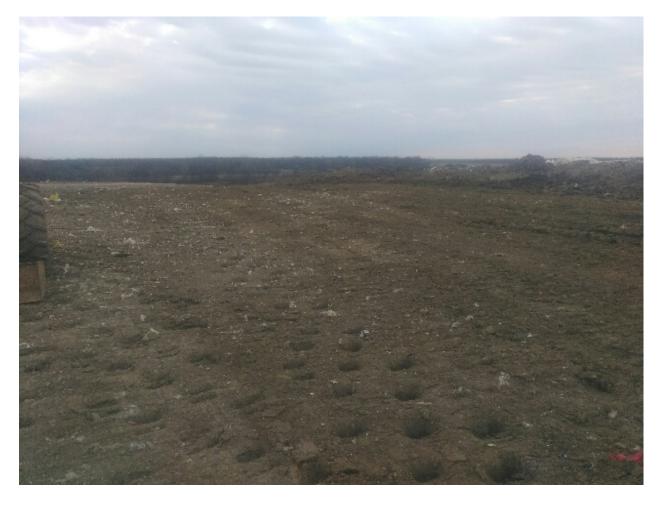
Top of Cell 3 looking East

As The pictures above illustrates That 411 (h)(i) has been corrected. If you have any further questions, please do not hesitate to contact me at (423)650-3095 or <u>jpreston@santekenviro.com</u>
