RE: Forrest City Wastewater Treatment Facility Inspection (St. Francis Co)
AFIN: 62-00070
NPDES Permit No.: AR0020087

VA/A TED I		LOF	COTI		DEDODT
		WATER DIVISION INSPECTION REPORT						
	ADLY	ΑF	IN: 62-00070 PE	RMIT #: AR0020	087			OATE: 7/31/2018
Δ	RKANSAS	CC	DUNTY: 62 St. Fr a	ncis	PDS:	#: 104432	:	MEDIA: WN
	partment of Environmental Quality	GF	PS LAT: 34.97920	4 LONG: -90.807	788 L	OCATION	1: G e	eneral Area
	FACILITY INFORMAT		IN:	SPEC	TION INF	ORN	MATION	
FO	rrest City Water Utilities			FACILITY TYPE: 1 - Municipal	INSPECT	ror id#: 75 S - Sta :	to	
LOCA	TION:		-	FACILITY EVALUATION RATING				N TYPE:
320 SFC 209 crry:				3 - Satisfactory	•			liance Evaluation
	rrest City, AR 72336				TRY TIME:	EXIT TIME:		PERMIT EFFECTIVE DATE:
RESPONSIBLE OFFICIAL			7/31/2018 09	9:00	12:00		11/1/2017	
NAME	: / TITLE							PERMIT EXPIRATION DATE: 10/31/2022

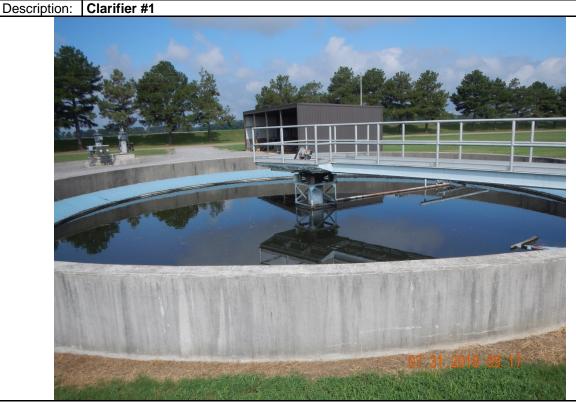
Water Division Photographic Evidence Sheet							
Location:	For	rest City Water Utilities, 320 SF	FC 209, St. F	rancis County, AR	1			
Photograp	her:	Steven L. Henderson	Date:	7/31/2018	Time:	9:17		
Witness:	N/A				Photo #:	5

Description: Clarifier #2

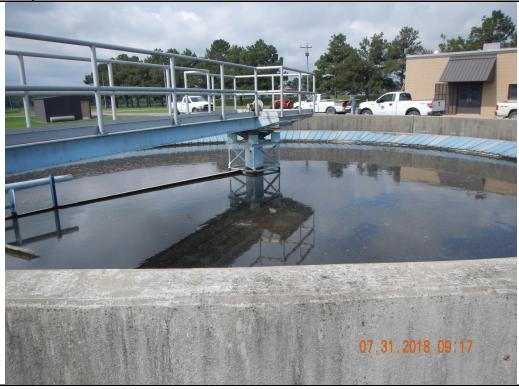
Photographer:	Steven L. Henderson	Date:	7/31/2018	Time:	9:22
Witness: N/A				Photo #:	6

Description: Stabilized EQ basin

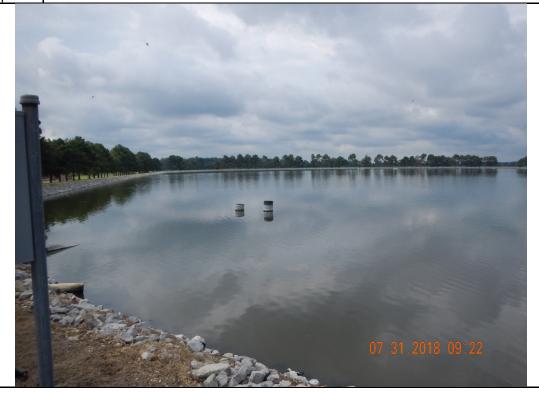
Water Division Photographic Evidence Sheet Location: Forrest City Water Utilities, 320 SFC 209, St. Francis County, AR Photographer: Steven L. Henderson Date: 7/31/2018 Time: 9:22 Witness: N/A Photo #: 7

Description: Stabilized EQ basin

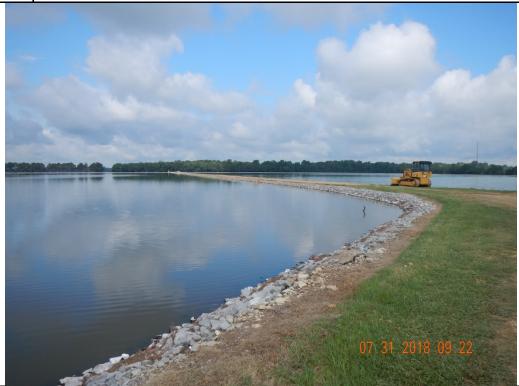
Photographer:Steven L. HendersonDate:7/31/2018Time:9:22Witness:N/APhoto #:8

Description: Stabilization of EQ basin in progress.

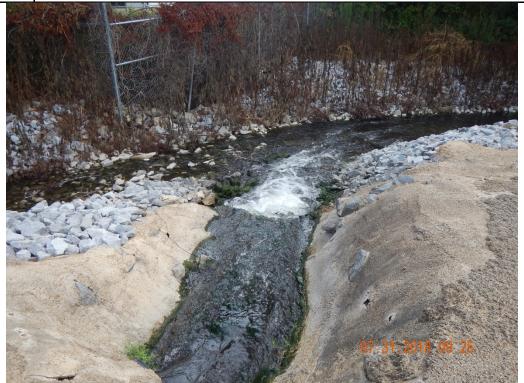
Photographer:	Steven L. Henderson	Date:	7/31/2018	Time:	9:26
Witness: N/A				Photo #:	12

Description: Effluent at Outfall 001
