RE: Eco-Vista, LLC Inspection  
AFIN: 72-00144 Permit No.: ARR000231

## WATER DIVISION INSPECTION REPORT

AFIN: <b>72-00144</b>	PERMIT #: <b>ARR000231</b>	DATE: <b>10/01/2020</b>
COUNTY: <b>72 Washington</b>	PDS #: <b>114271</b>	MEDIA: <b>WN</b>
GPS LAT: <b>36.140556</b> LONG: <b>-94.262500</b> LOCATION: <b>General Area</b>

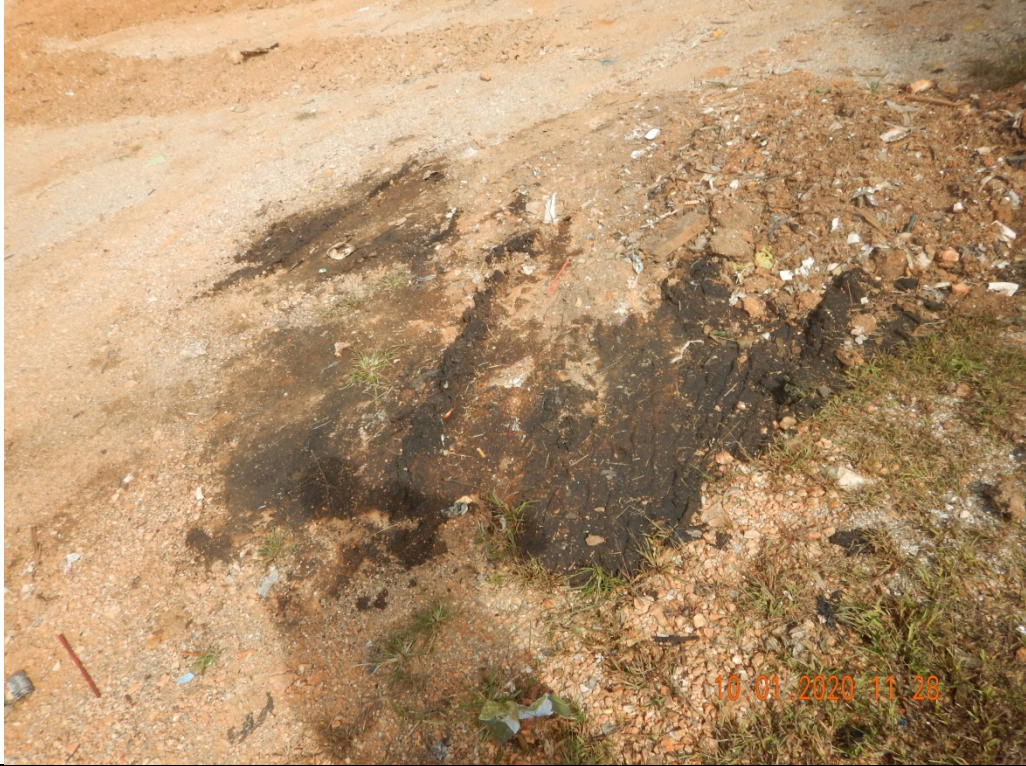
Location:	<b>Eco-Vista, LLC</b>		
Photographer:	<b>Garrett Grimes, District 1 Inspector</b>	Date:	<b>10/01/2020</b>
Time:		Photo #:	<b>3</b>
Witness:			
Description:	<b>Oil on the ground in the maintenance area near Outfall 004.</b>

**Comment:** Spilled oil was observed on the ground and adjacent to buildings where prior oil spills seeped through the walls and onto the ground. In addition, a pump for the leak detection system was leaking. Areas where spills and leaks have occurred must be remediated as per the facility's good housekeeping program. Leaking equipment must be repaired as part of proper operation and maintenance at the facility.

Response: Eco-Vista has cleaned the oil staining and repaired the pump. SWPPP/SPCCP training was conducted and BMPs were reviewed.

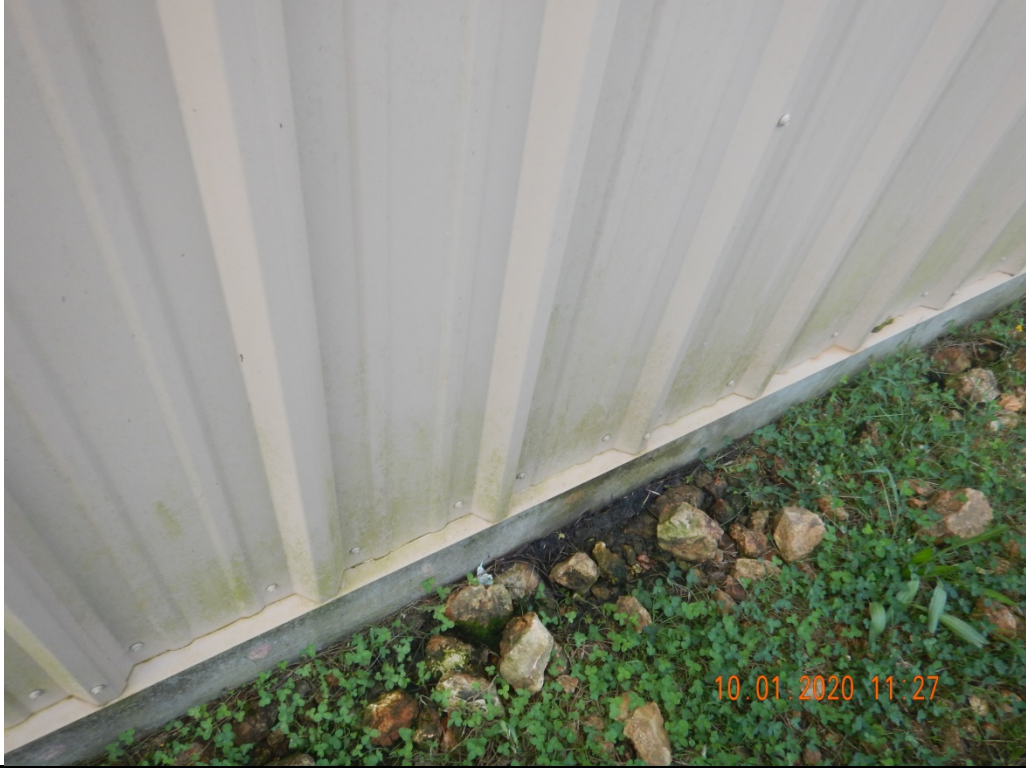
Photographer:	<b>Garrett Grimes, District 1 Inspector</b>	Date:	<b>10/01/2020</b>
Time:		Photo #:	<b>4</b>
Witness:			
Description:	<b>Oil on ground outside of a building in the maintenance area.</b>

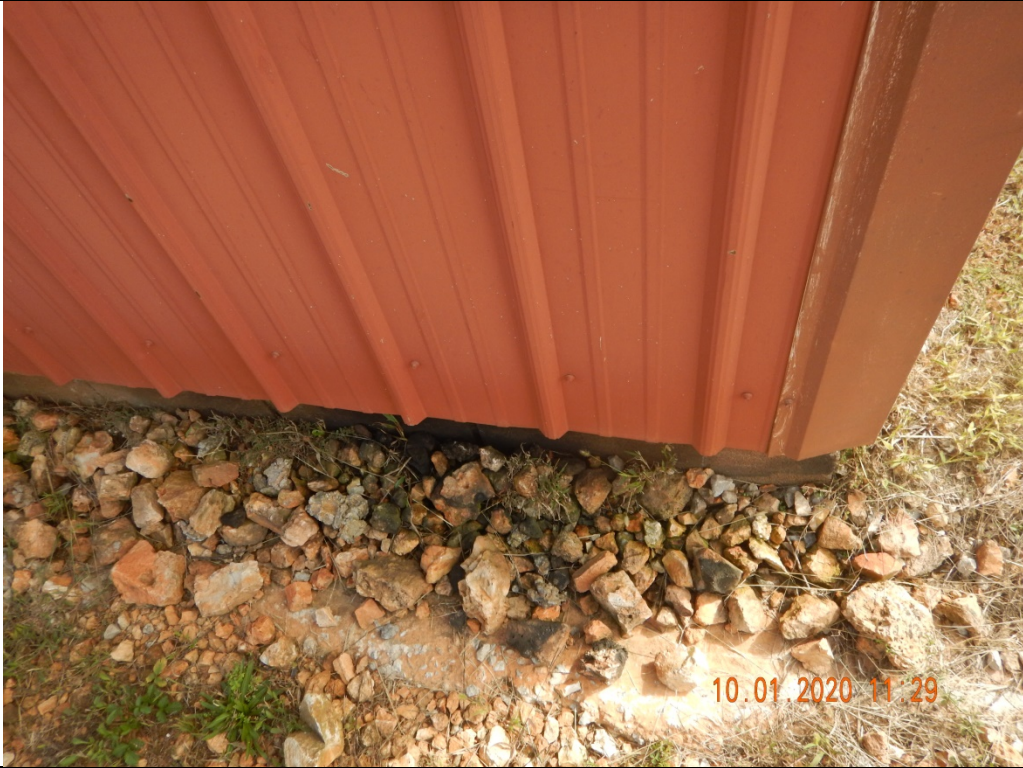
Location:	<b>Eco-Vista, LLC</b>				
Photographer:	<b>Garrett Grimes, District 1 Inspector</b>	Date:	<b>10/01/2020</b>	Time:	<b>11:29</b>
Witness:				Photo #:	<b>5</b>
Description:	<b>Oil spill.</b>

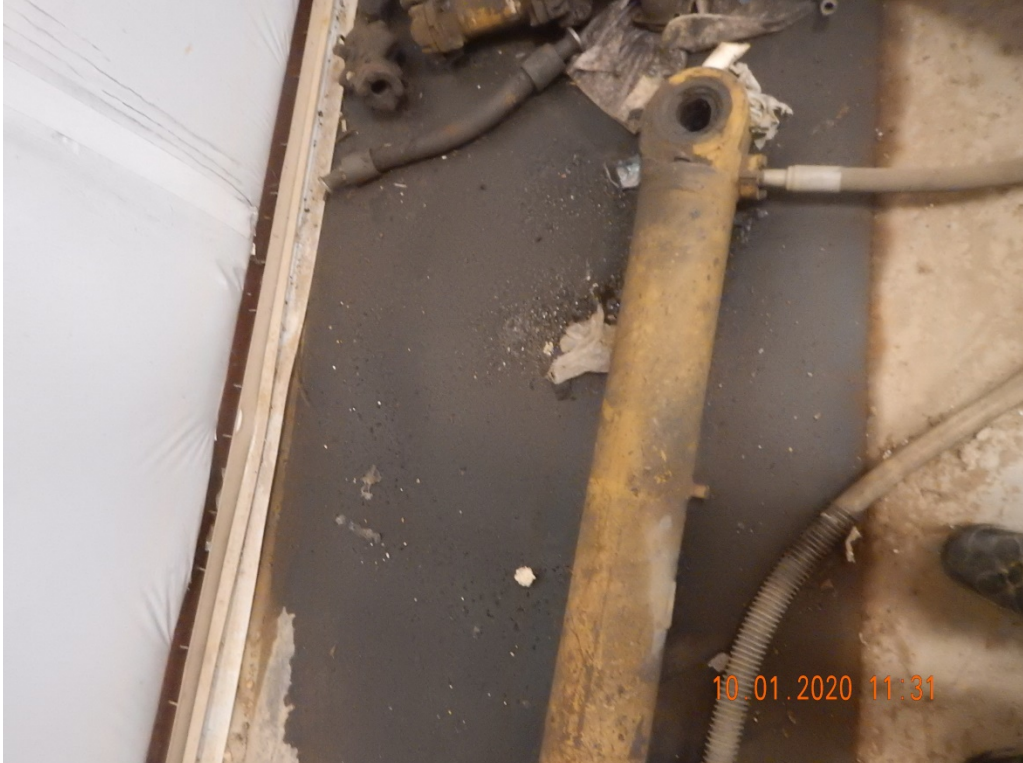
Photographer:	<b>Garrett Grimes, District 1 Inspector</b>	Date:	<b>10/01/2020</b>	Time:	<b>11:31</b>
Witness:				Photo #:	<b>6</b>
Description:	<b>Oil spill in a maintenance building.</b>

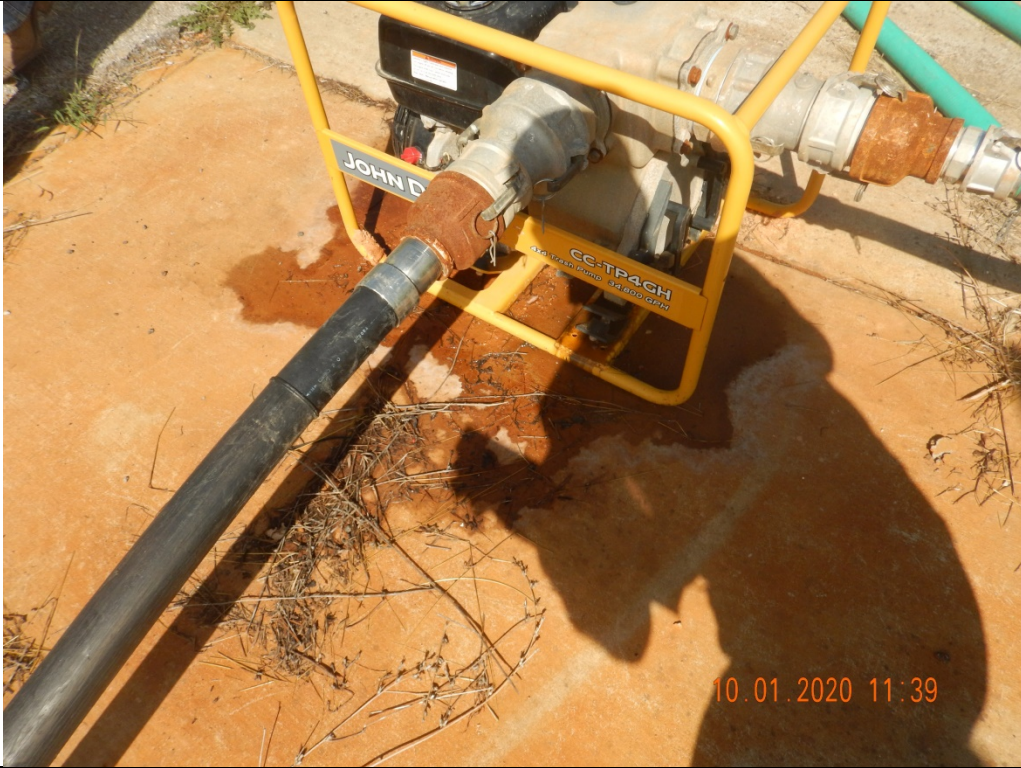
Location:	<b>Eco-Vista, LLC</b>				
Photographer:	<b>Garrett Grimes, District 1 Inspector</b>	Date:	<b>10/01/2020</b>	Time:	<b>11:39</b>
Witness:				Photo #:	<b>7</b>
Description:	<b>Leaking leak detection system pump.</b>

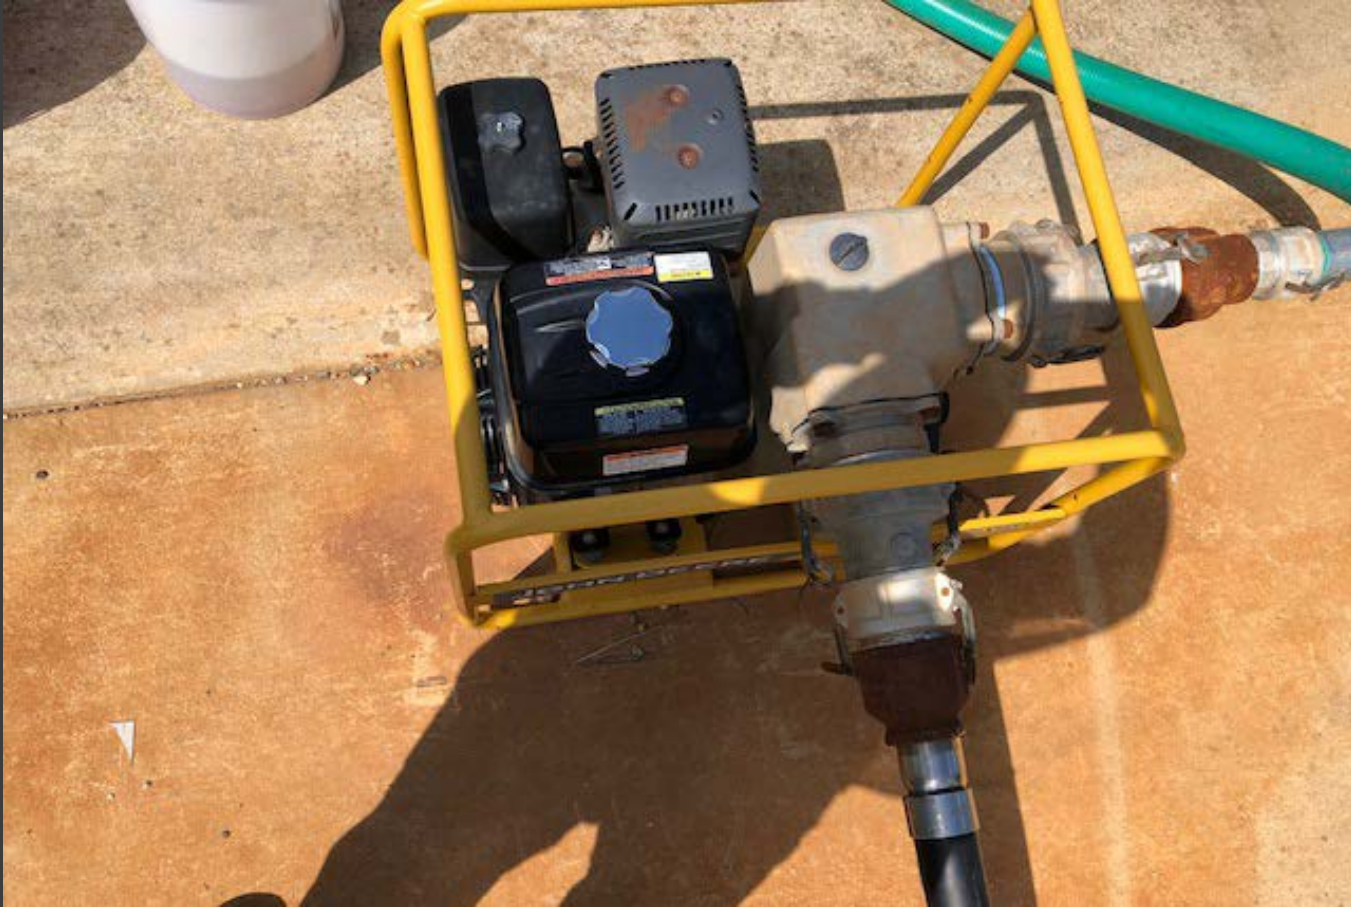
Repaired  
Pump

**Comment: Please submit photographs of the remediated area and repaired equipment.**
