RE: NLRWU - Faulkner Lake Inspection

OFFICE OF WATER QUALITY INSPECTION REPORT

AFIN: 60-00274 | PERMIT #: AR0020303 | DATE: 1/13/2021

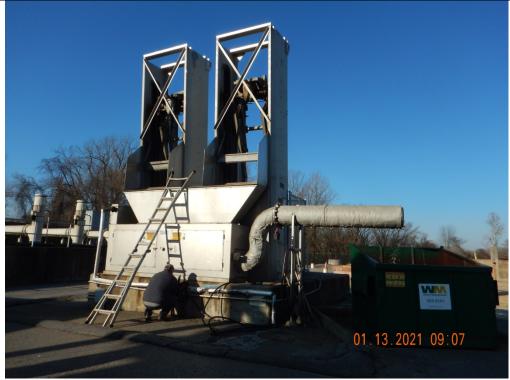
Office of Water Quality Photographic Evidence Sheet										
Location:	NLR	WU - Faulkner Lake									
Photograpl	her:	Jason Bolenbaugh	Date:	1/13/2021	Time:	09:07					
Witness:					Photo #	: 1

Description: DSCN1850: Bar Screens #1 and #2 with solids emptying into dumpster.

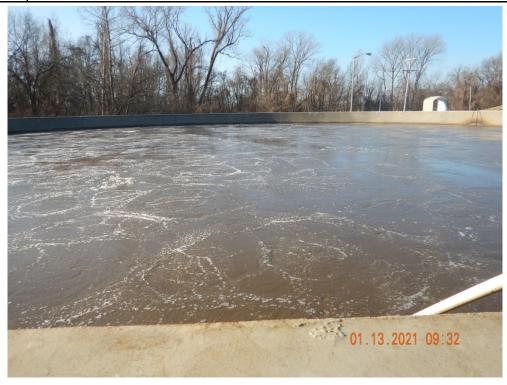
Photographer: Jason Bolenbaugh	Date: 1/13/2021	Time:	09:32
Witness:		Photo #	: 6

Description: DSCN1871: Aeration Basin #1.

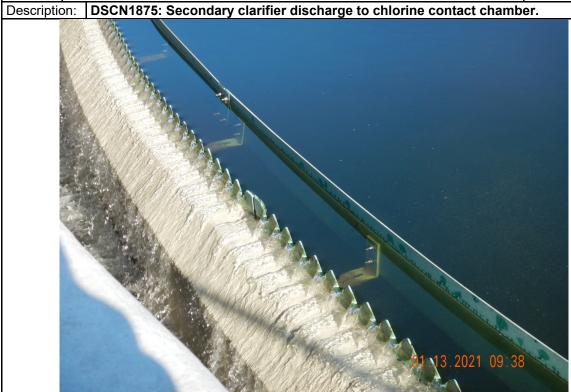
Photographer:Jason BolenbaughDate:1/13/2021Time:09:38Witness:Photo #:8

Office of Water Quality Photographic Evidence Sheet						
Location:	NLF	RWU - Faulkner Lake				
Photograpl	her:	Jason Bolenbaugh	Date:	1/13/2021	Time:	09:48
Witness:					Photo #	: 9
Description: DSCN1876: Chlorine gas monitor, visual alarm and digital detection meter. Audible

- The chlorine gas building is monitored using SCADA but also includes an exterior digital meter, monitor, and audible and visual alarms to protect staff if a chlorine gas leak occurs. The SCADA will provide an alarm when the Cl₂ reading is 0.3 ppm. Currently, staff cannot turn off noticeable leaks using SCADA but the plant is working towards implementing those changes.

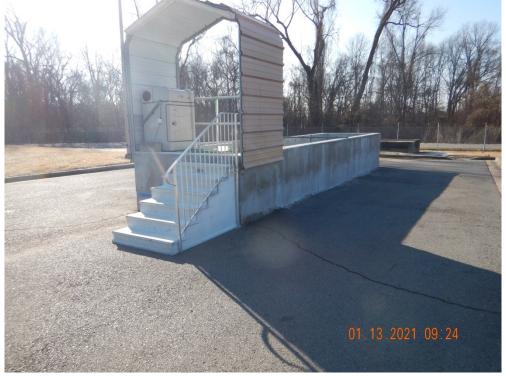
Office of Water Quality Photographic Evidence Sheet						
Location: I	NLR	WU - Faulkner Lake				
Photograph	er:	Jason Bolenbaugh	Date:	1/13/2021	Time:	09:24
Witness:					Photo #:	11

Description: DSCN1860: Effluent composite sampler and Parshall Flume.

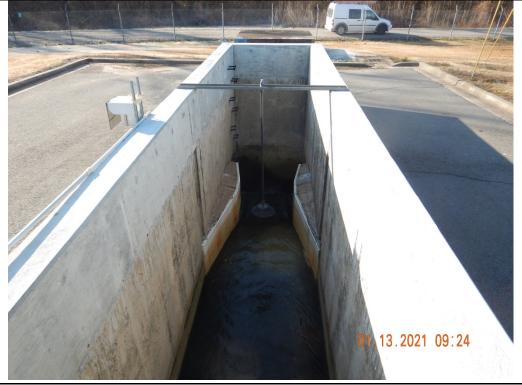
Coation: NLRWU - Faulkner Lake Photographer: Jason Bolenbaugh Witness: Date: 1/13/2021 Date: 1/13/2021 Time: 09:24 Photo #: 13

- No notable changes have occurred at the facility since the previous inspection in July, 2019. The effluent parshall flume walls were increased 36-inches due to previous flood events.

Description: DSCN1861: Effluent 4' Parshall Flume.

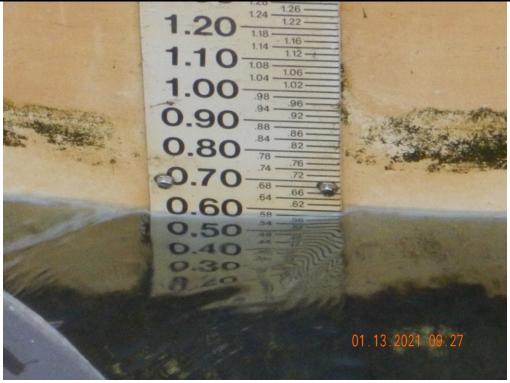
Photographer: Jason Bole	nbaugh	Date:	1/13/2021	Time:	09:27
Witness:				Photo #	: 14

Description: DSCN1867: Effluent 4' Parshall Flume staff gauge (primary measurement).

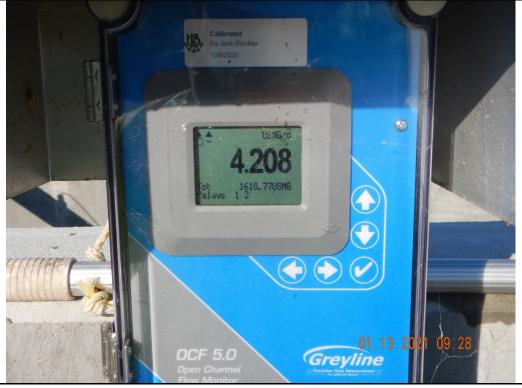
Coation: NLRWU - Faulkner Lake Photographer: Jason Bolenbaugh Witness: Date: 1/13/2021 Date: 1/13/2021 Date: 1/13/2021 Time: 09:28 Photo #: 15

3. SECONDARY INSTRUMENTS (TOTALIZERS, RECORDERS, ETC.) PROPERLY OPERATED AND MAINTAINED: Greyline Inst Open Channel Flow 5.0 totalizer meter. Calibrated by Jack Strickler on October 8, 2020.	ruments ☑Y ☐N ☐NA ☐NE
CALIBRATION FREQUENCY ADEQUATE: Calibrated by Jack Strickler on October 8, 2020 (annual check). Monthly calibratic checks are conducted.	on ✓Y □N □NA □NE

Description: DSCN1869: Effluent flow totalizer (secondary measurement).

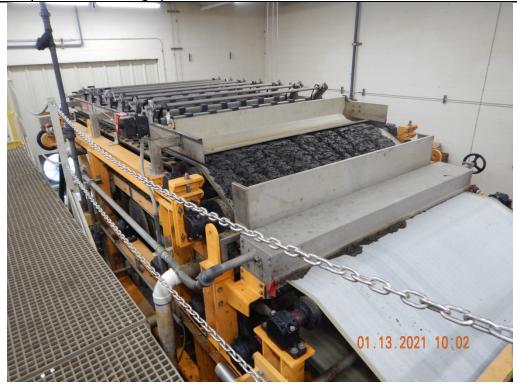
Photographer: Jason Bolenbaugh	Date: 1/13/2021	Time:	10:02
Witness:		Photo #	: 16

Description: **DSCN1879: Sludge press.**

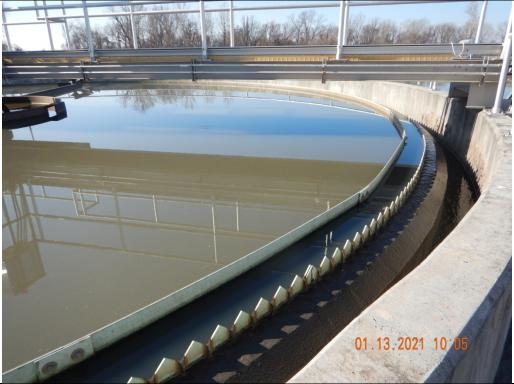
Photographer: Jason Bolenbaugh	Date: 1/13/2021	Time:	10:05
Witness:		Photo #	: 18

Description: DSCN1885: Gravity thickener.
