### OFFICE OF WATER QUALITY INSPECTION REPORT

AFIN: 60-00274 | PERMIT #: AR0020303 | DATE: 1/13/2021

#### **FACILITY INFORMATION** INSPECTION INFORMATION FACILITY TYPE: INSPECTOR ID# **NLRWU - Faulkner Lake** 83321 S - State 1 - Municipal LOCATION FACILITY EVALUATION RATING INSPECTION TYPE: 7400 Baucum Pike 4 - Satisfactory SSO/Collection System DATE(S): ENTRY TIME: **EXIT TIME:** PERMIT EFFECTIVE DATE: **North Little Rock** 1/13/2021 10:10 10:55 6/1/2019 **RESPONSIBLE OFFICIAL** PERMIT EXPIRATION DATE: NAME: / TITLE 5/31/2024 Mr. Michael Clayton / Director FAYETTEVILLE SHALE RELATED: N COMPANY North Little Rock Water Utility FAYETTEVILLE SHALE VIOLATIONS: N MAILING ADDRESS **INSPECTION PARTICIPANTS** P.O. Box 17898 CITY, STATE, ZIP Brent Kirkendoll, Assistant Sup. of Maintenance, North Little Rock AR 72117 **NLRWU** PHONE & EXT: / FAX: 501-945-7186 EMAIL: CONTACTED DURING INSPECTION: No.

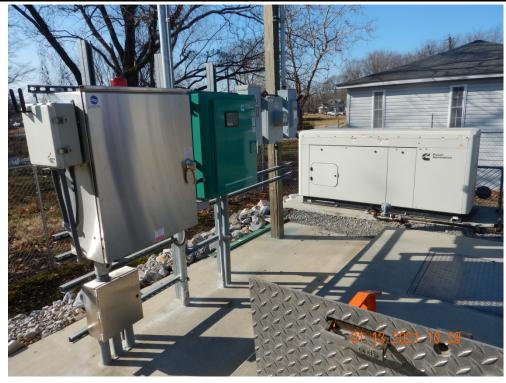
Photographer:Jason BolenbaughDate:1/13/2021Time:10:28Witness:Photo #:2

• This station is located on 10<sup>th</sup> Street midway between F Street and G Street. This station collects wastewater from residential homes. The pump station is large enough to handle all flows. The station's perimeter is fenced entirely and the wet well and controls are locked. There are two, 11 horsepower pumps that are both operational. There was no evidence of recent overflows and no accumulated grease was noticeable in the wet well. The station has a visual and audible alarm and is monitored via SCADA. The station has a permanent backup generator on site that is tested once/week. Staff will visit/inspect the pump station weekly. There isn't any signage located on this pump station that can provide contact information to the public in case of an emergency. Please install signage on the pump station.

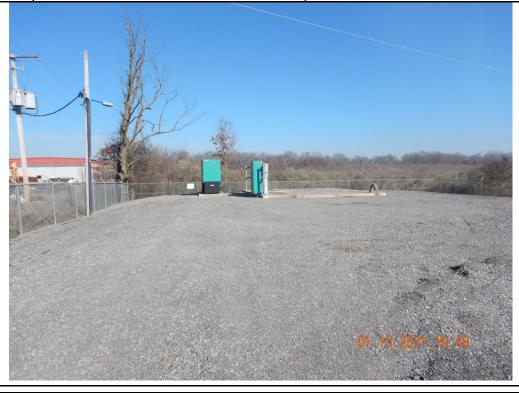
### Office of Water Quality Photographic Evidence SheetLocation:NLRWU - Faulkner LakePhotographer:Jason BolenbaughDate:1/13/2021Time:10:49Witness:Photo #:5

• This station is located on Kinard Road approximately 0.22 miles east of Valentine Road in Galloway. This station collects wastewater from commercial and industrial businesses. The pump station is large enough to handle all flows. The station's perimeter is fenced entirely and the wet well and controls are locked. This station is not operating at its peak ability as there is room and controls for an additional two pumps when future flow increases. Currently only 2 of a possible 4 pumps are installed. There was no evidence of overflows and no accumulated grease was noticeable in the wet well. The station had visual and audible alarms and is monitored via SCADA. The station has a permanent backup generator on site that is tested once/week. Staff will visit/inspect the pump station weekly.

Description: DSCN1893: Overview of the Hill Lake Pump Station.

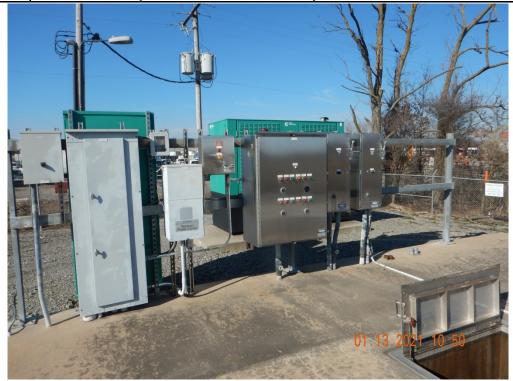
Photographer:Jason BolenbaughDate:1/13/2021Time:10:50Witness:Photo #:6

Description: DSCN1896: Pump station controls with lid open to wet well.
