Subject: Response to DEQ 2021-05-14 Craighead County Class 1 Landfill - Second Quarter

Craighead County Solid Waste Disposal Authority

Re: Second Quarterly Inspection 2021; AFN16-00199; Permit Number 0254-S1-R4

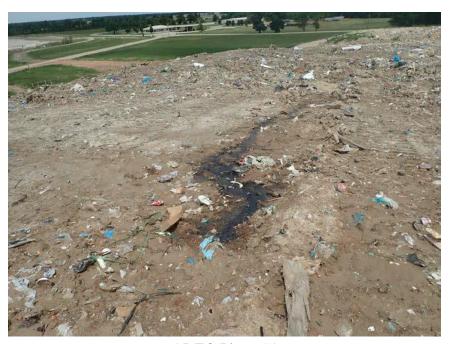
ADEQ Photo #1

Reg. 22.411 (o) Leachate leaks or evidence of leachate seepage.

Comments: Erosion Leachate leaks observed on the north slope of Cell 2. (Refer to Photo #1.)

Response: Due to extremely wet conditions our repairs were delayed; however, the leachate seepage was repaired on May 25, 2021 (See CCSWDA Photo #1).
