**RE: Inspection conducted on May 25, 2021**  
**AFIN 18-00094**  
**Permit Number 0245-S1-R2**

**Division of Environmental Quality**  
**Office of Land Resources - Solid Waste Management**  
**Class 1 Landfill Inspection**

<b>Site Name</b>	Crittenden County Class 1	<b>County</b>	Crittenden	<b>AFIN</b>	18-00094
<b>Facility Address</b>	1299 Khun Rd. West Memphis, AR 72301	<b>Phone Number</b>	LF: 870-732-4290 Off: 870-732-6580	<b>Permit Number</b>	0245-S1-R2
<b>Permittee Address</b>	100 Court Street Marion, AR 72364	<b>E-Mail Address</b>	<a href="mailto:judgewheeless@crittco.com">judgewheeless@crittco.com</a>	<b>PDS #</b>	116095
<b>Date</b>	5/25/2021	<b>Entry Time</b>	1340	<b>Exit Time</b>	1510

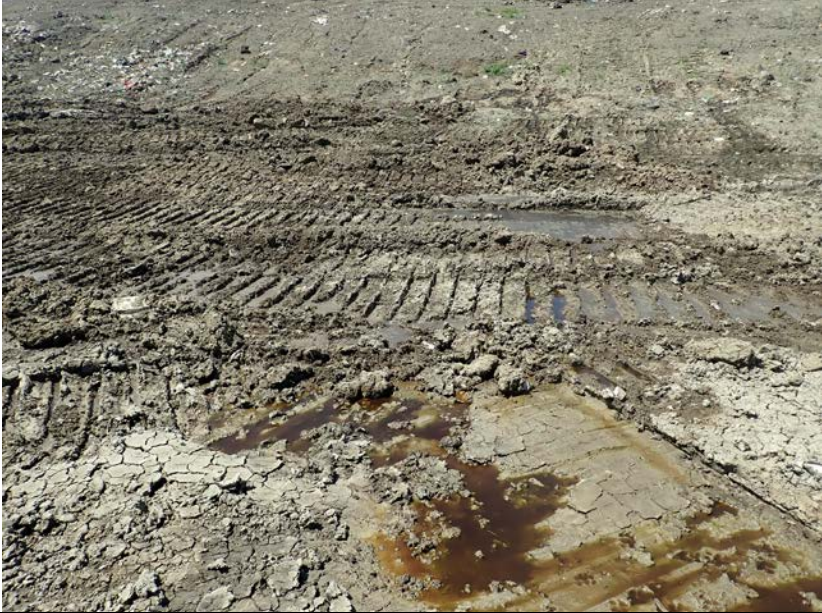
<b>Location</b>	Crittenden County Class 1 Landfill				<b>Permit</b>	0245-S1-R2	<b>AFIN</b>	18-00094
<b>Photographer</b>	Tobin Baker, Inspector				<b>Witness</b>	N/A		
<b>Photo #</b>	1	<b>Of</b>	2		<b>Date</b>	5/25/2021	<b>Time</b>	1440
<b>Description</b>	Leachate observed discharging from the south slope of Cell 4.
