RE: Quarterly Inspection conducted on June 14, 2021
AFIN 03-00051
Permit Number 0249-S1-R2

Division of Environmental Quality
Office of Land Resources - Solid Waste Management
Class 1 Landfill Inspection

Site Name	NABORS Class 1 Landfill	County	Baxter	AFIN	03-00051
Facility Address	Hwy 5 N to CR 16 to site entrance- Three Brothers	Phone Number	870-425-3213	Permit Number	0249-S1-R2
Permittee Address	P.O. Box 1715, Mountain Home, AR 72602	E-Mail Address	Steve.kershaw.engr@gmail.com (Director) judge@baxtercounty.org (Co. Judge)		PDS # 116483
Date	6/14/2021	Entry Time	1140	Exit Time	1300

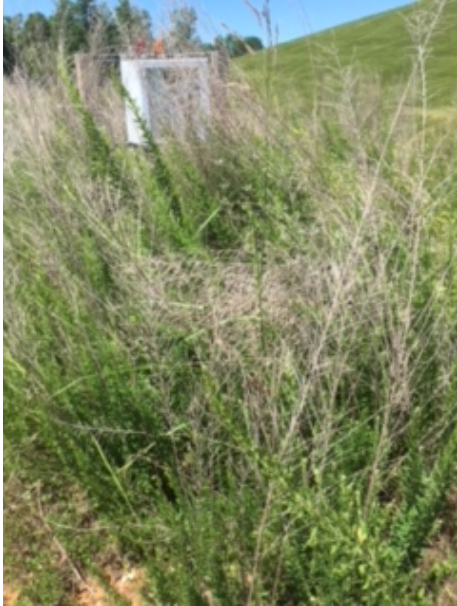
Regulation	Item Description	Comments
411(a)	Operations in accordance with permit documents	
417(c)	Adequate all weather operational roads	Road erosion present between in multiple areas, including the entrance road (new). Vegetative control needed along roads and around LCS panels. (Refer to Photo #1.)
411(c)	Smallest practical area, unloading supervised, single working face	
411(e)	Salvage operations meet approved conditions	
411(f)(1)	Scavenging of waste prohibited	
411(p)	Proper wet weather repairs	
411(b)	Operations by licensed on-site personnel at all times	
411(d)	Waste spread and compacted as unloaded	
411(g)	Litter control provisions maintained	
414(a)	Disease vectors controlled

Location	NABORS Class 1 Landfill			Permit	0249-S1-R2	AFIN	03-00051
Photographer	Darrell Norton, Inspector		<i>DN</i>	Witness	N/A		
Photo #	1	Of	2	Date	6/14/2021	Time	N/A
Description	Example of overgrown vegetation observed around LCS Panel.
