<b>ENVIRONMENTAL QUALITY</b>	<b>OFFICE OF WATER QUALITY</b>				
	<b>INSPECTION REPORT</b>				
	AFIN: 63-00065	PERMIT #: AR0034002	DATE: 6/14/2021		
	COUNTY: 63 Saline	PDS #: 116579	MEDIA: WN		
GPS LAT: 34.592104 LONG: -92.504180 LOCATION: General Area					
<b>FACILITY INFORMATION</b>		<b>INSPECTION INFORMATION</b>			
NAME: <b>Bryant Water Utilities</b> LOCATION: <b>1019 Southwest 2<sup>nd</sup> St.</b> CITY: <b>Bryant</b>		FACILITY TYPE: <b>1 - Municipal</b> INSPECTOR ID#: <b>83321 S - State</b> FACILITY EVALUATION RATING: <b>4 - Satisfactory</b> INSPECTION TYPE: <b>SSO/Collection System</b>			
<b>RESPONSIBLE OFFICIAL</b>		DATE(S):      ENTRY TIME:      EXIT TIME:      PERMIT EFFECTIVE DATE: <b>6/14/2021      09:00      11:20      3/1/2021</b> PERMIT EXPIRATION DATE: <b>2/28/2026</b>			
NAME: / TITLE <b>Allen E. Scott / Mayor</b> COMPANY: <b>City of Bryant</b> MAILING ADDRESS: <b>201 Southwest 3<sup>rd</sup> St.</b> CITY, STATE, ZIP: <b>Bryant AR 72022</b> PHONE & EXT: / FAX: <b>501-943-0999      /</b> EMAIL: <b>ascott@cityofbryant.com</b>		FAYETTEVILLE SHALE RELATED: <b>N</b> FAYETTEVILLE SHALE VIOLATIONS: <b>N</b>

**Office of Water Quality Photographic Evidence Sheet**

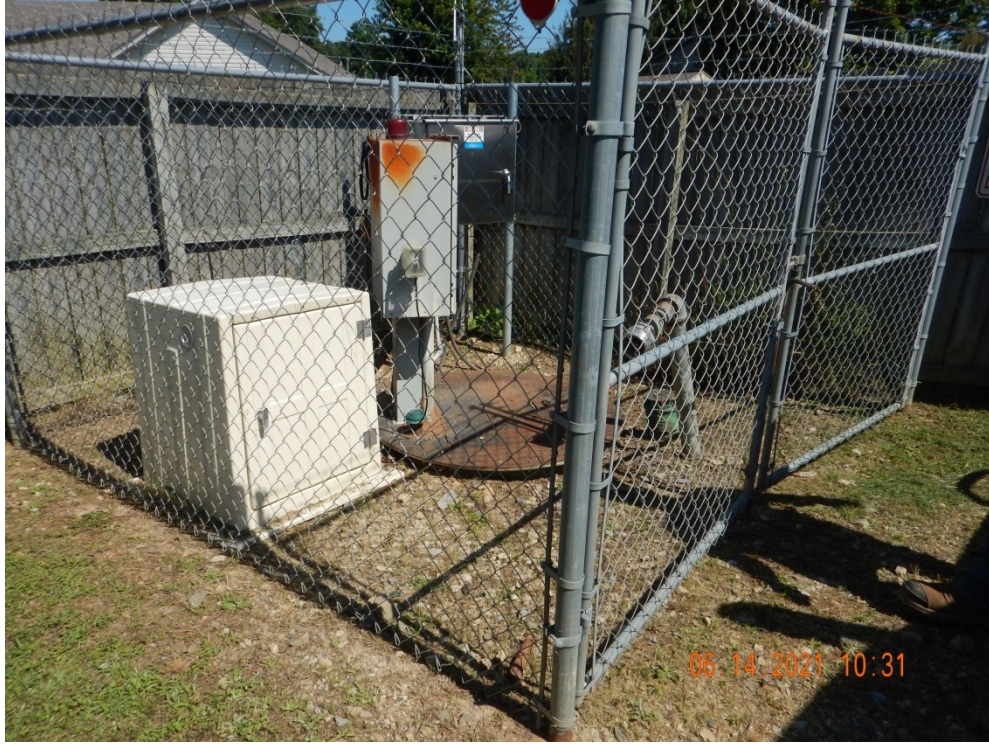
Location:	<b>Bryant Water Utilities</b>		
Photographer:	<b>Jason Bolenbaugh</b>	Date:	<b>6/14/2021</b>
Witness:		Time:	<b>10:31</b>
		Photo #:	<b>1</b>
Description:	<b>DSCN2820: Lift Station #24 – Bryant Meadow #2</b>

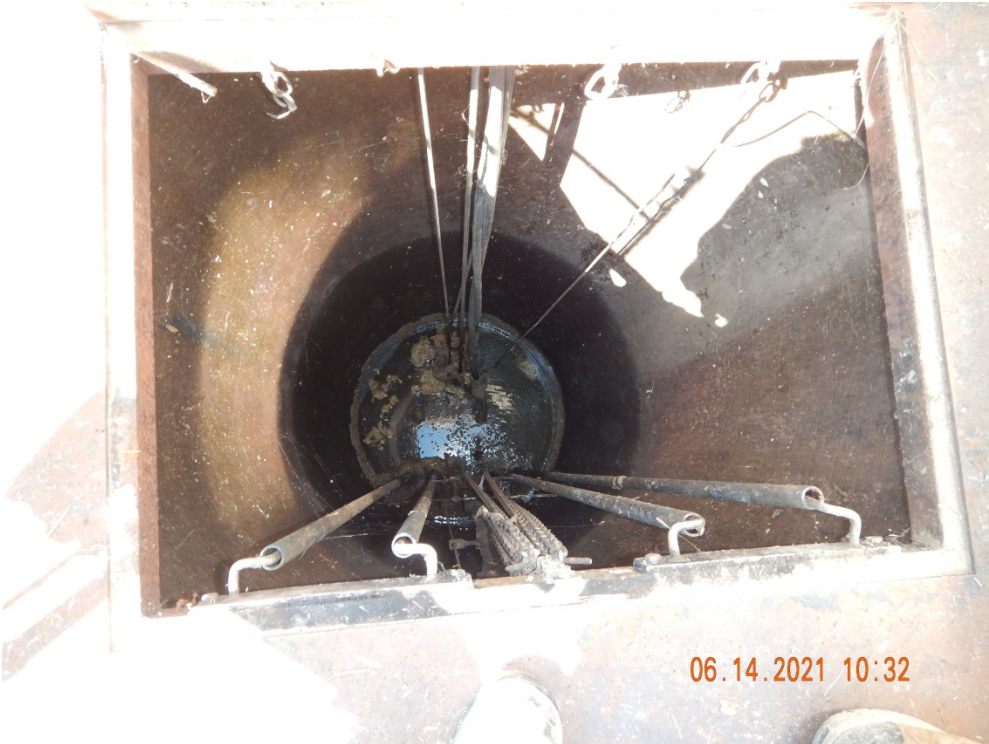
MINIMAL ACCUMULATION OF GREASE AND SOLIDS IN WET WELLS: <b>Only a minor amount of grease had accumulated in the wet well.</b>	<input checked="" type="checkbox"/> S <input type="checkbox"/> M <input type="checkbox"/> U <input type="checkbox"/> NA <input type="checkbox"/> NE
<b>BACKUP POWER AND ALARMS</b>	
PROVISIONS FOR GENERATOR AND/OR EMERGENCY TRANSFER PUMP: <b>A 250KUA portable generator can be installed at this station when needed.</b>	<input checked="" type="checkbox"/> S <input type="checkbox"/> M <input type="checkbox"/> U <input type="checkbox"/> NA <input type="checkbox"/> NE
AUDIBLE/VISUAL ALARM WITH EMERGENCY CONTACT INFORMATION POSTED: <b>This pump station has a visual alarm.</b>	<input checked="" type="checkbox"/> S <input type="checkbox"/> M <input type="checkbox"/> U <input type="checkbox"/> NA <input type="checkbox"/> NE
SCADA SYSTEM (LIST PARAMETERS MONITORED): <b>Yes, this station is monitored using SCADA.</b>	<input checked="" type="checkbox"/> Y <input type="checkbox"/> N <input type="checkbox"/> NA <input type="checkbox"/> NE

Photographer:	<b>Jason Bolenbaugh</b>	Date:	<b>6/14/2021</b>
Witness:		Time:	<b>10:32</b>
		Photo #:	<b>2</b>
Description:	<b>DSCN2822: Lift Station #24 wet well.</b>

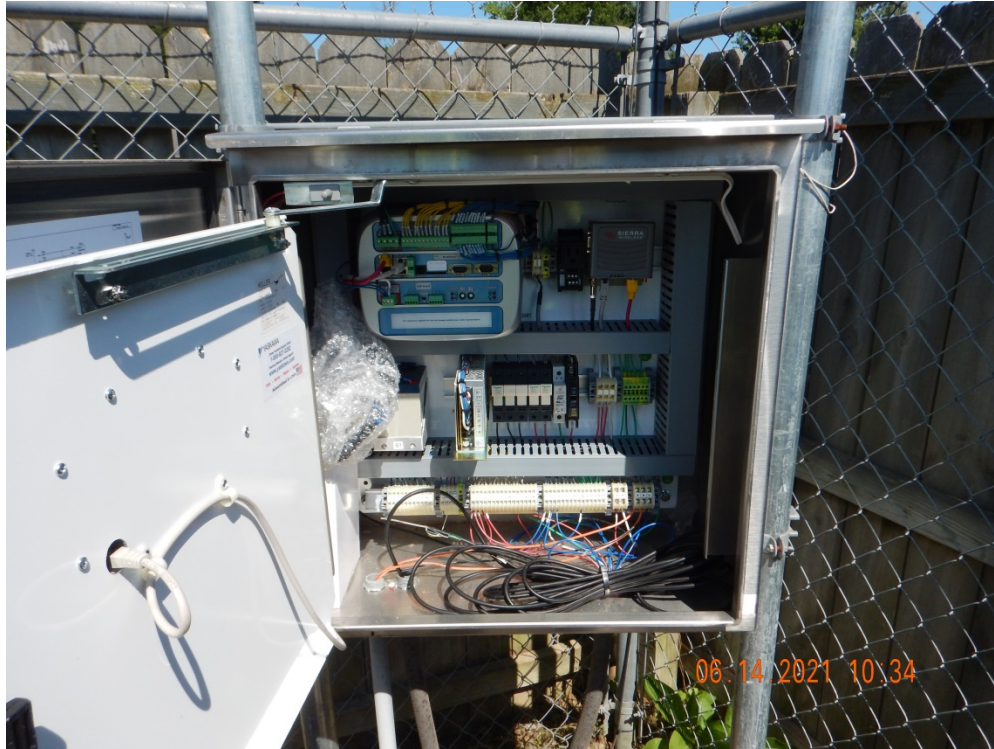
Location:	<b>Bryant Water Utilities</b>		
Photographer:	<b>Jason Bolenbaugh</b>	Date:	<b>6/14/2021</b>
Witness:		Time:	<b>10:34</b>
		Photo #:	<b>3</b>
Description:	<b>DSCN2823: Inside control panel of Lift Station #24.</b>

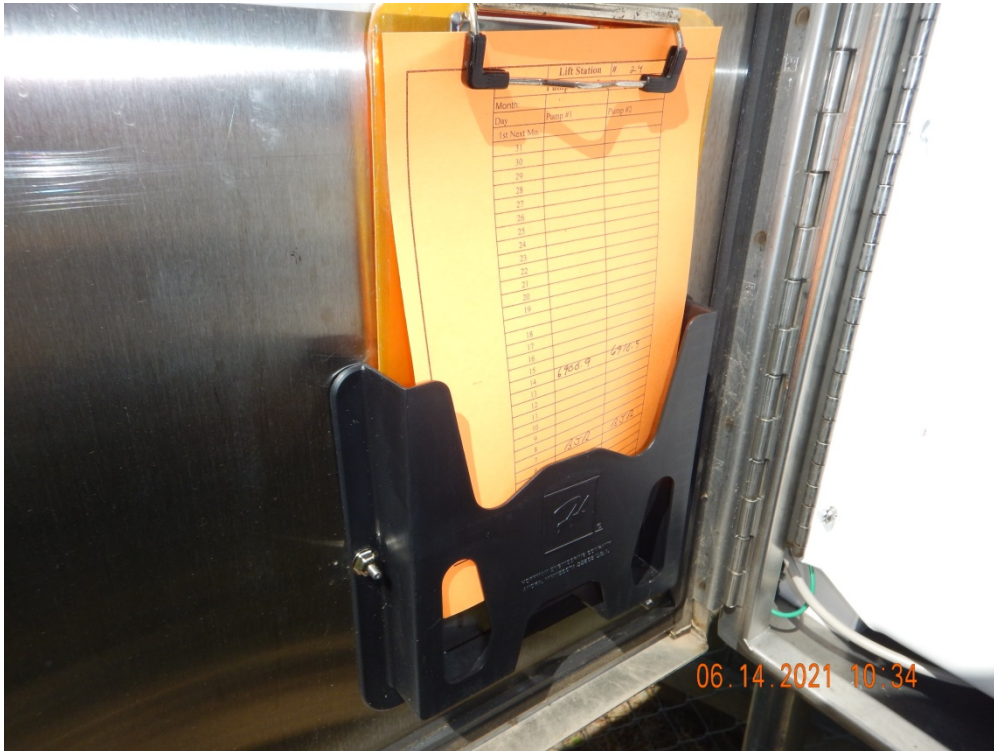
Photographer:	<b>Jason Bolenbaugh</b>	Date:	<b>6/14/2021</b>
Witness:		Time:	<b>10:34</b>
		Photo #:	<b>4</b>
Description:	<b>DSCN2825: Lift Station #24 pump hours log.</b>

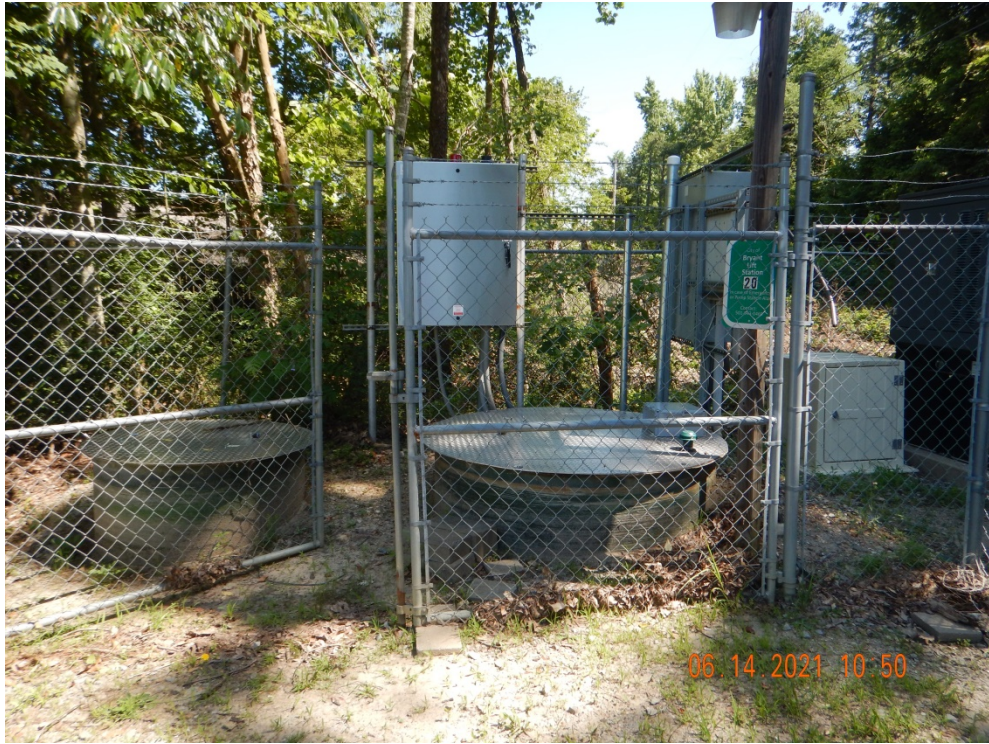
<b>Upgrades of this station included new pumps, panels, and lids.</b>	
<b>GENERAL OPERATION AND MAINTENANCE</b>	<input checked="" type="checkbox"/> S <input type="checkbox"/> M <input type="checkbox"/> U <input type="checkbox"/> NA
CLEAN AND WELL MAINTAINED WITH MINIMAL STORAGE OF UNRELATED EQUIPMENT:	<input checked="" type="checkbox"/> S <input type="checkbox"/> M <input type="checkbox"/> U <input type="checkbox"/> NA <input type="checkbox"/> NE
GATES/DOORS/HATCHES/LIDS/ETC. LOCKED TO PREVENT UNAUTHORIZED ACCESS AND/OR TAMPERING:	<input checked="" type="checkbox"/> S <input type="checkbox"/> M <input type="checkbox"/> U <input type="checkbox"/> NA <input type="checkbox"/> NE
WET WELLS, SUMPS AND PITS ADEQUATELY COVERED, GRATED OR OTHERWISE PROTECTED:	<input checked="" type="checkbox"/> S <input type="checkbox"/> M <input type="checkbox"/> U <input type="checkbox"/> NA <input type="checkbox"/> NE

Location:	<b>Bryant Water Utilities</b>				
Photographer:	<b>Jason Bolenbaugh</b>	Date:	<b>6/14/2021</b>	Time:	<b>10:50</b>
Witness:				Photo #:	<b>5</b>
Description:	<b>DSCN2826: Lift Station #20.</b>

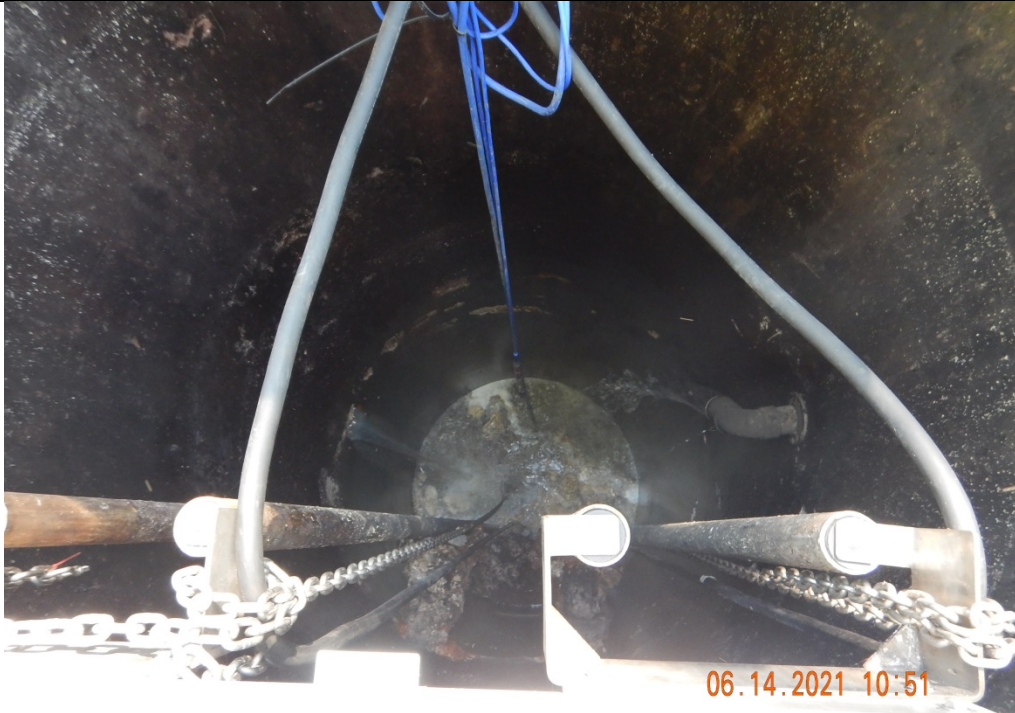
Photographer:	<b>Jason Bolenbaugh</b>	Date:	<b>6/14/2021</b>	Time:	<b>10:51</b>
Witness:				Photo #:	<b>6</b>
Description:	<b>DSCN2828: Lift Station #20 wet well.</b>

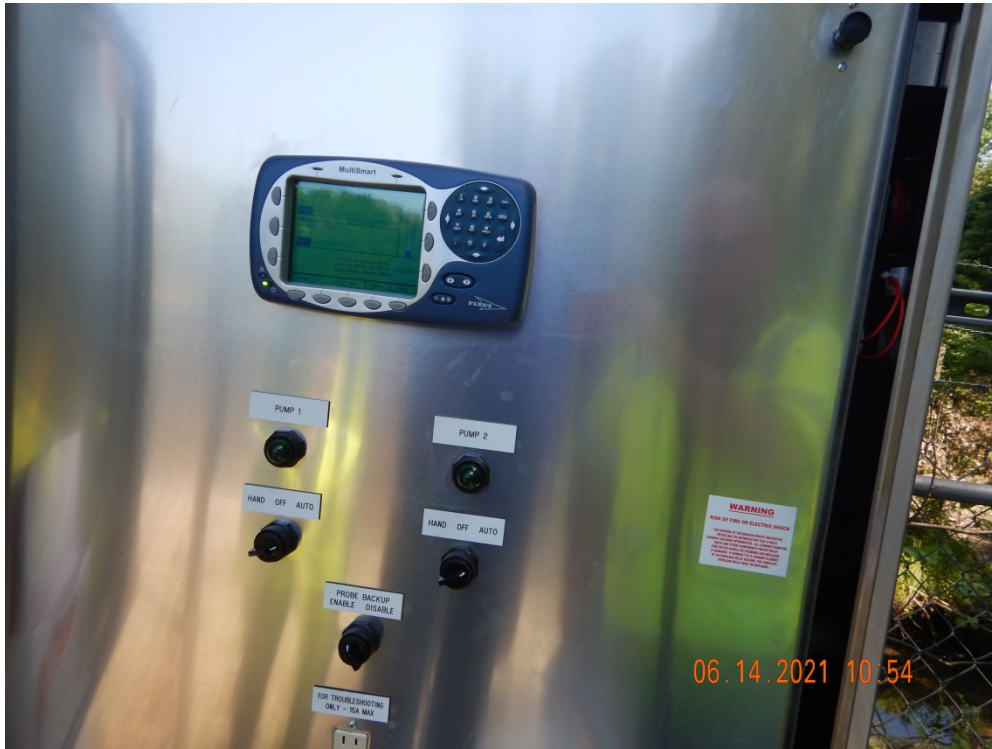
Location:	<b>Bryant Water Utilities</b>				
Photographer:	<b>Jason Bolenbaugh</b>	Date:	<b>6/14/2021</b>	Time:	<b>10:54</b>
Witness:				Photo #:	<b>7</b>
Description:	<b>DSCN2830: Lift Station #20 control panel. Both pumps in the auto position.</b>

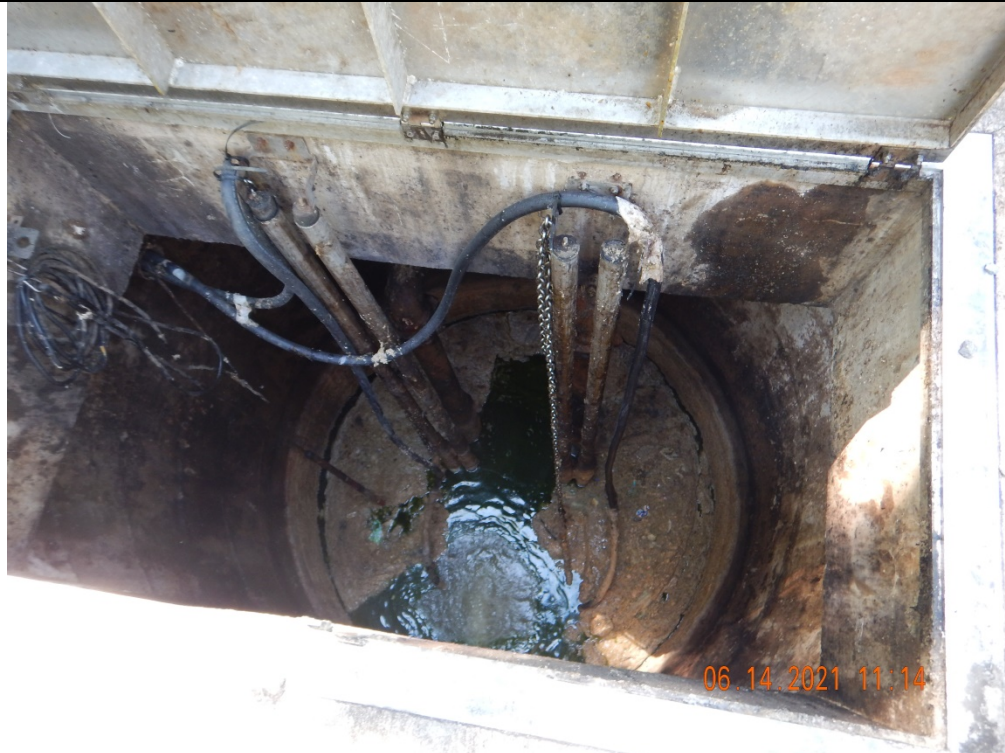
Photographer:	<b>Jason Bolenbaugh</b>	Date:	<b>6/14/2021</b>	Time:	<b>11:14</b>
Witness:				Photo #:	<b>8</b>
Description:	<b>DSCN2833: Lift Station #6 wet well.</b>

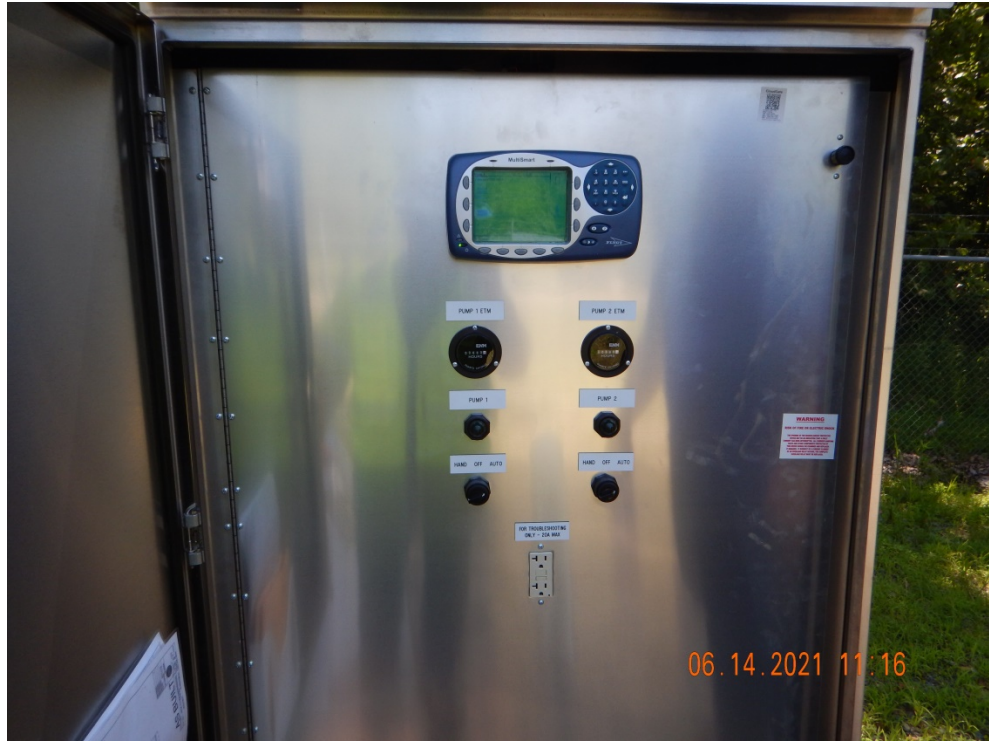
Location:	<b>Bryant Water Utilities</b>		
Photographer:	<b>Jason Bolenbaugh</b>	Date:	<b>6/14/2021</b>
Witness:		Time:	<b>11:16</b>
		Photo #:	<b>9</b>
Description:	<b>DSCN2835: Lift Station #6 control panel with both pumps in the auto position. Pump 1 run hours was 683.5 and Pump 2 run hours was 980.5.</b>
