**RE:** City of Alma Inspections (Crawford Co)

AFIN: 17-00059 NPDES Permit No.: AR0021466

# OFFICE OF WATER QUALITY INSPECTION REPORT

AFIN: 17-00059 | PERMIT #: AR0021466 | DATE: 1/11/2022

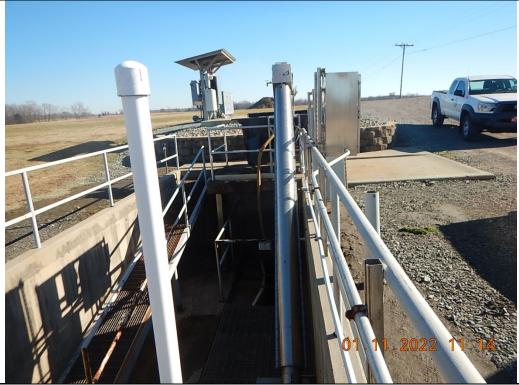
Office of Water Quality Photographic Evidence Sheet										
Location: 0	City	of Alma									
Photograph	er:	Amy Beck		Date:	January 11, 2022	Time:	1114				
Witness: N	IA					Photo #:	1

Description: Preliminary treatment

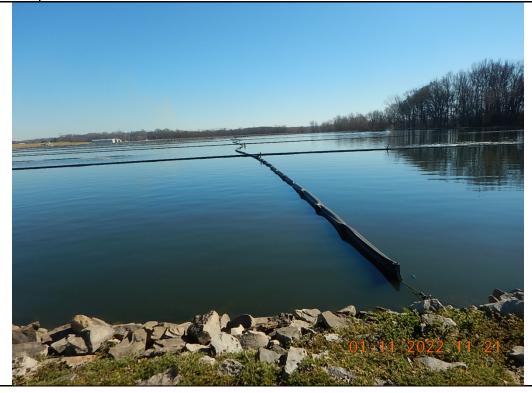
Photographer:	Amy Beck	Date:	January 11, 2022	Time:	1121
Witness: NA				Photo #:	2

Description: Baffles in Pond 1.

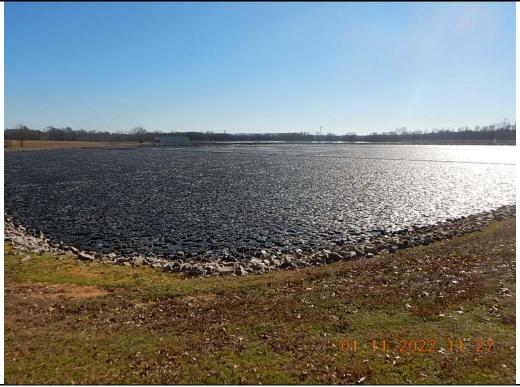
Office of Water Quality Photographic Evidence Sheet										
Location: 0	City	of Alma								
Photographe	er:	Amy Beck	Date:	January 11, 2022	Time:	1127				
Witness: N	Α				Photo #:	5

Description: Pond 3 with floating covers.

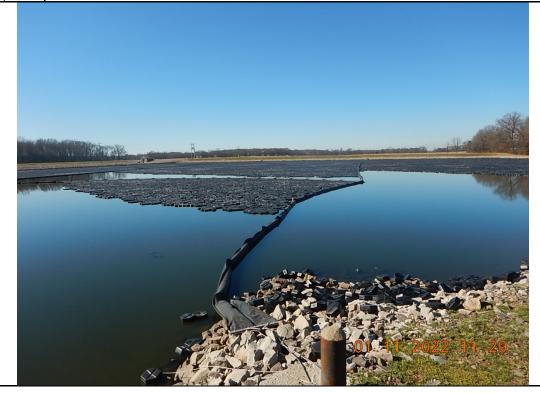
Photographer: Amy Beck Date: January 11, 2022 Time: 1129
Witness: NA Photo #: 6

Description: Baffles in Pond 3.

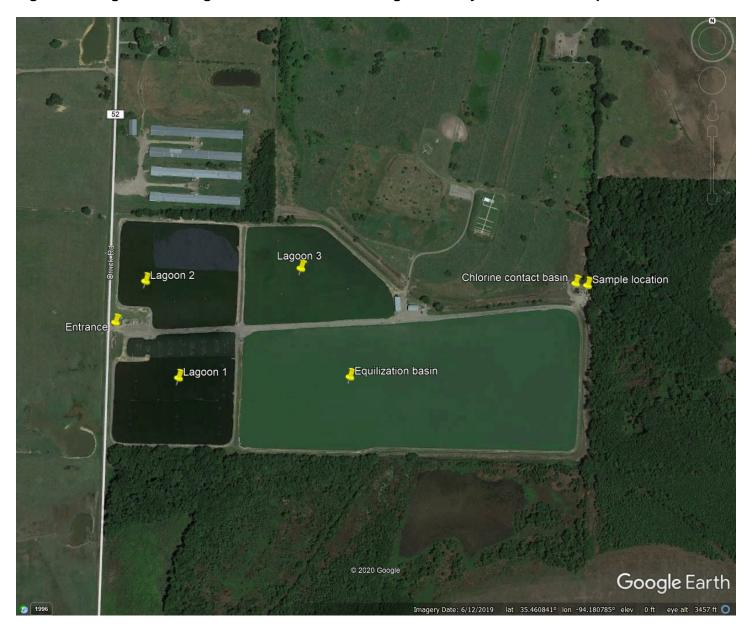
Figure 1. Google Earth image dated June 2019 showing the facility's treatment components.

Treatment consists of bar screen/comminutor, 3 lagoons (in series), chlorine contact chamber (optional), and dechlorination (optional). Pond 1 has one mixed cell followed by two partially mixed cells. Pond 2 is a facultative 2-cell pond. Pond 3 is a facultative 3-cell pond. The facility has the option to chlorinate for disinfection, but it is able to meet FCB limits without disinfection at this time. The system is well-maintained and in good operating condition at this time.
