RE: City of Helena Inspection  
AFIN: 54-00083 Permit No.: AR0043389

<p><b>ENVIRONMENTAL QUALITY</b></p>	<b>OFFICE OF WATER QUALITY INSPECTION REPORT</b>				
	AFIN: <b>54-00083</b>	PERMIT #: <b>AR0043389</b>	DATE: <b>3/2/2022</b>		
	COUNTY: <b>54 Phillips</b>	PDS #: <b>119870</b>	MEDIA: <b>WN</b>		
	GPS LAT: <b>34.518709</b> LONG: <b>-90.586323</b> LOCATION: <b>General Area</b>				
<b>FACILITY INFORMATION</b>		<b>INSPECTION INFORMATION</b>			
NAME: <b>City of Helena</b> LOCATION: <b>Multiple Locations</b> CITY: <b>Helena</b>		FACILITY TYPE: <b>1 - Municipal</b> INSPECTOR ID#: <b>83321 S - State</b> FACILITY EVALUATION RATING: <b>1 - Unsatisfactory</b> INSPECTION TYPE: <b>SSO/Collection System</b>			
<b>RESPONSIBLE OFFICIAL</b>		DATE(S): <b>3/2/2022</b> ENTRY TIME: <b>09:15</b> EXIT TIME: <b>13:30</b> PERMIT EFFECTIVE DATE: <b>3/1/2021</b> PERMIT EXPIRATION DATE: <b>2/28/2026</b>			
NAME / TITLE: <b>Kevin A. Smith / Mayor</b> COMPANY: <b>City of Helena-West Helena</b> MAILING ADDRESS: <b>P.O. Box 248</b> CITY, STATE, ZIP: <b>Helena AR 72342</b> PHONE & EXT: / FAX: <b>870-817-7439</b> / EMAIL: <b>mayor@helena-westhelena.us</b>		FAYETTEVILLE SHALE RELATED: <b>N</b> FAYETTEVILLE SHALE

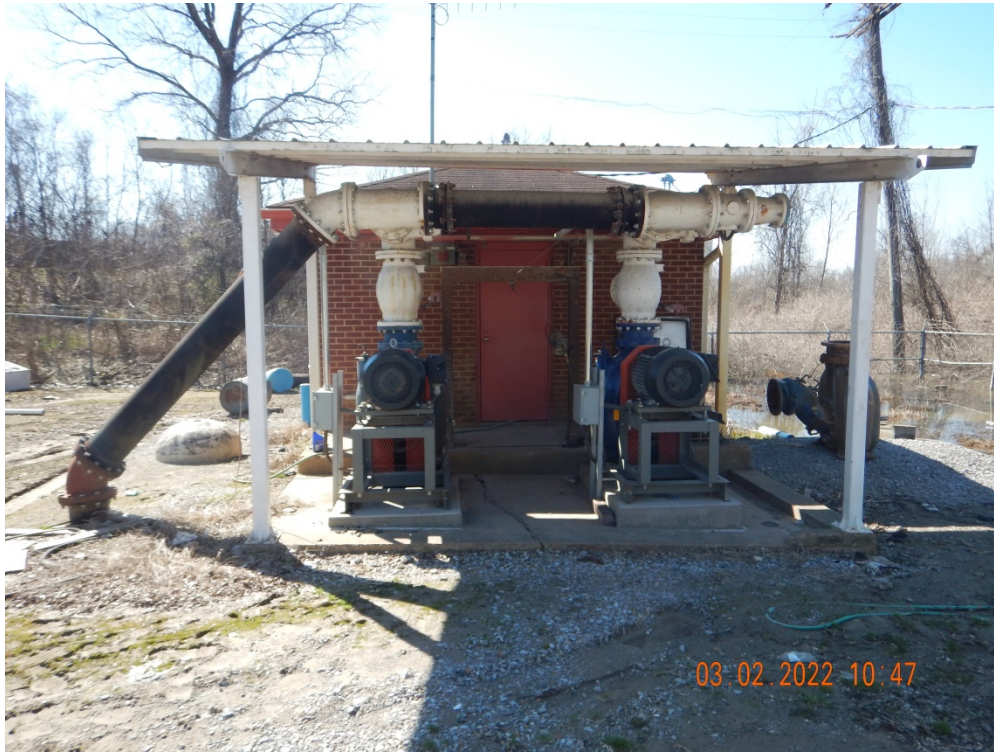
Location:	City of Helena		
Photographer:	Jason Bolenbaugh	Date:	3/22/2022
Witness:		Time:	1047
		Photo #:	1
Description:	DSCN3726: Pump Station 1.

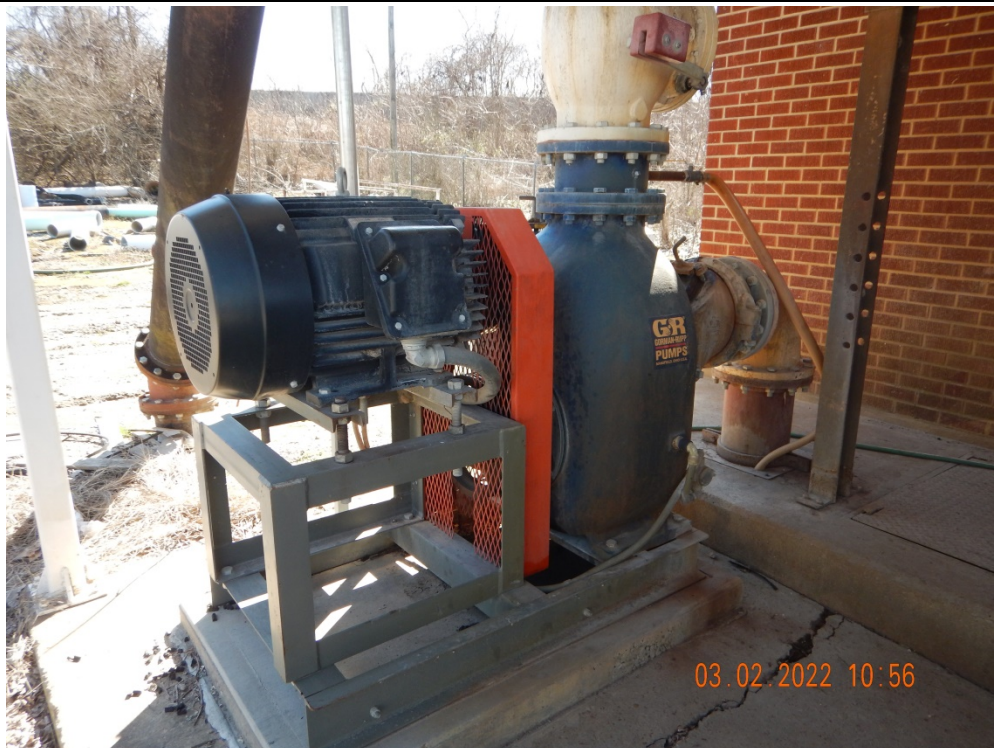
<b>Comments: Pump #1 was not operational at the time of the inspection because the control box has failed and has not been replaced. Pump #1 run time was 14275.87 hours. Pump #2 run time was 24543.90 hours. The last entry in the log book was made on May 13, 2021. Some solids were noted around the station but those could have been removed during maintenance and not properly disposed of.</b>	
<b>GENERAL OPERATION AND MAINTENANCE</b>	<input checked="" type="checkbox"/> S <input type="checkbox"/> M <input type="checkbox"/> U <input type="checkbox"/> NA
CLEAN AND WELL MAINTAINED WITH MINIMAL STORAGE OF UNRELATED EQUIPMENT:	<input checked="" type="checkbox"/> S <input type="checkbox"/> M <input type="checkbox"/> U <input type="checkbox"/> NA <input type="checkbox"/> NE
GATES/DOORS/HATCHES/LIDS/ETC. LOCKED TO PREVENT UNAUTHORIZED ACCESS AND/OR TAMPERING:	<input checked="" type="checkbox"/> S <input type="checkbox"/> M <input type="checkbox"/> U <input type="checkbox"/> NA <input type="checkbox"/> NE

Photographer:	Jason Bolenbaugh	Date:	3/2/2022
Witness:		Time:	1056
		Photo #:	2
Description:	DSCN3737: Closer view of one of the pumps in Pump Station 1.

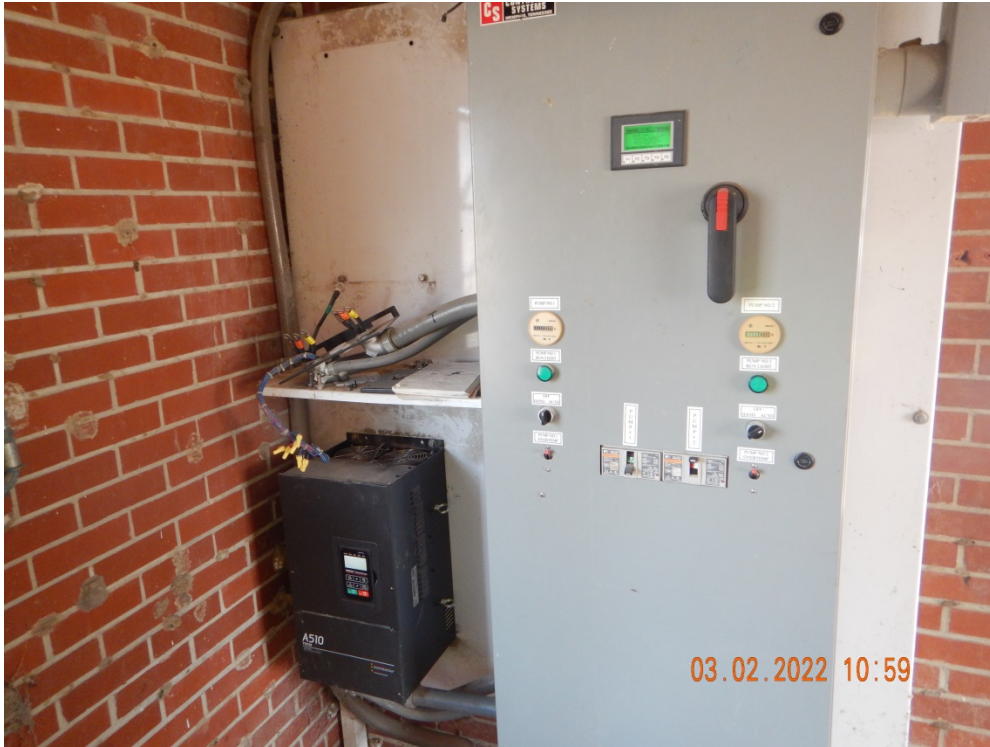
Location:	City of Helena		
Photographer:	Jason Bolenbaugh	Date:	3/2/2022
Witness:		Time:	1059
		Photo #:	3
Description:	DSCN3741: Pump station control panel and boxes (one missing). The control box (black box) for Pump 1 has been removed from the wall.

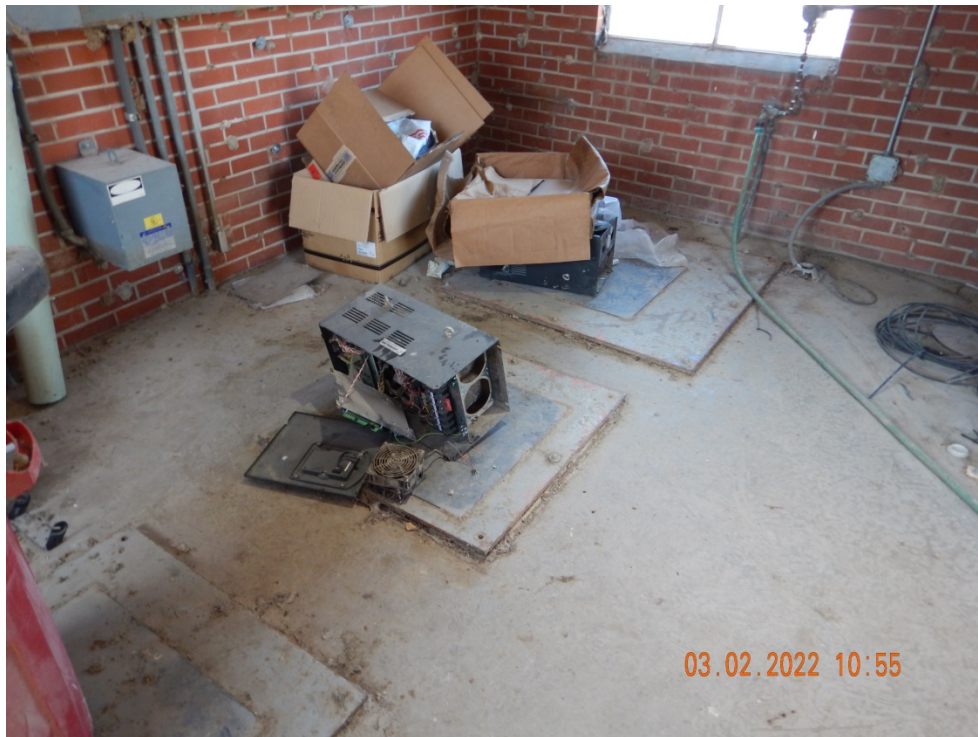
Photographer:	Jason Bolenbaugh	Date:	3/2/2022
Witness:		Time:	1055
		Photo #:	4
Description:	DSCN3736: Pump 1 control box on the floor of the pump station.

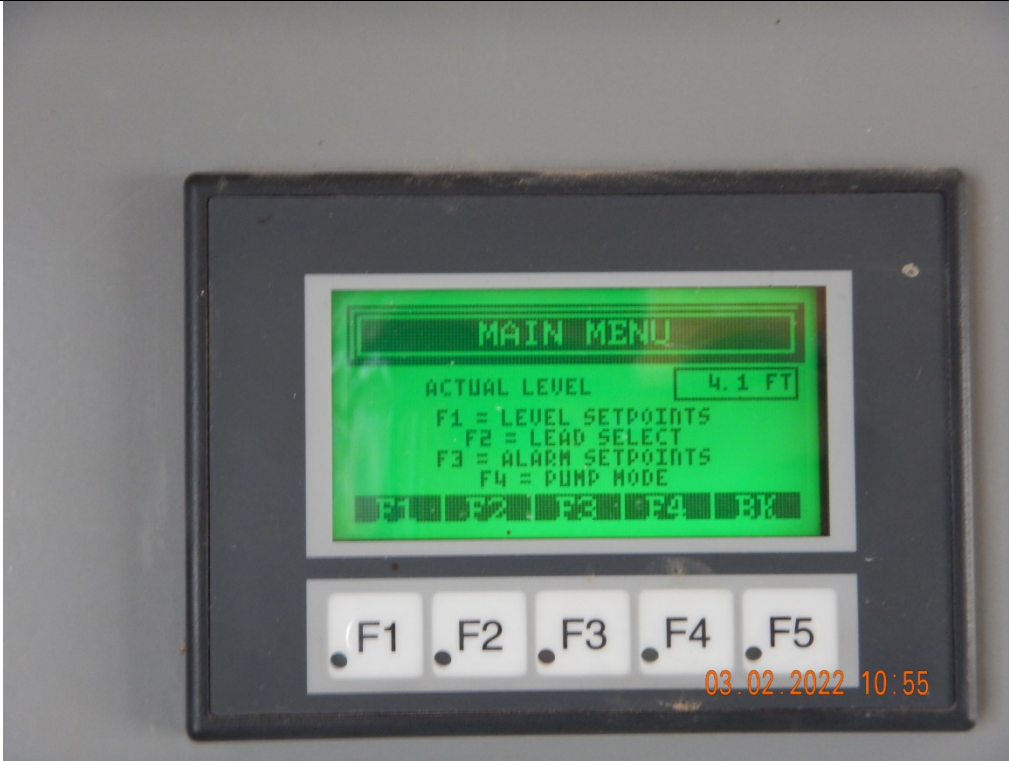
Location:	City of Helena		
Photographer:	Jason Bolenbaugh	Date:	3/2/2022
Witness:		Time:	1055
		Photo #:	5
Description:	DSCN3732: Wet well level reading at 4.1 feet.

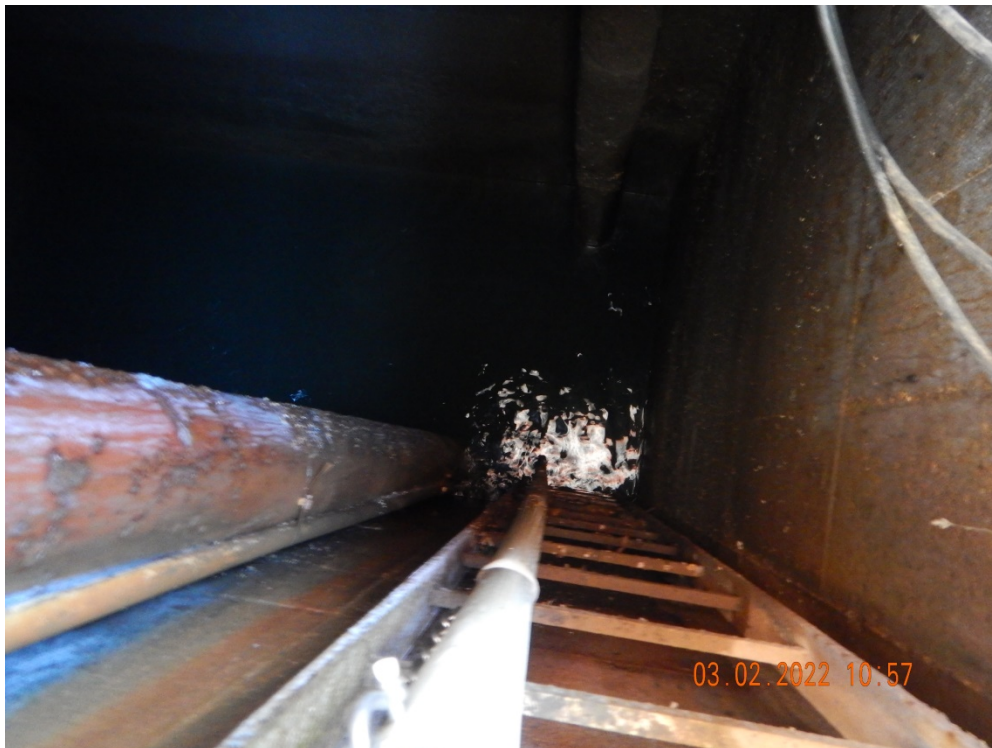
Photographer:	Jason Bolenbaugh	Date:	3/2/2022
Witness:		Time:	1057
		Photo #:	6
Description:	DSCN3739: View of wastewater in the wet well.

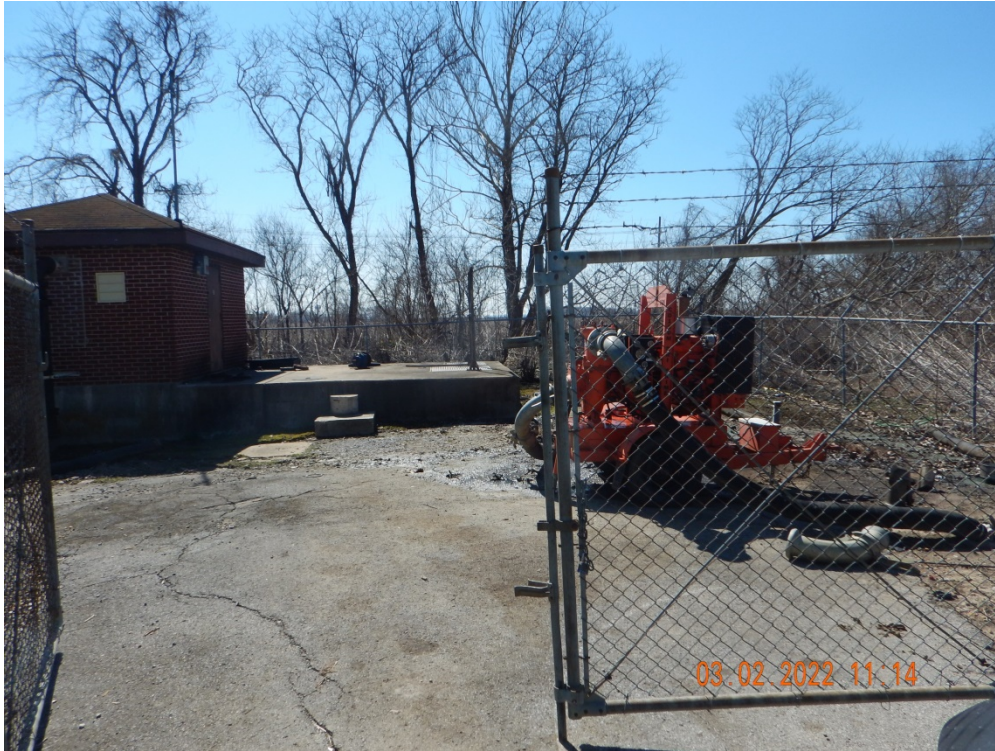
<b>Comments: This pump station does not have a permanent pump that is operational. According to staff a 6-inch bypass pump was delivered to this location before the 2021 calendar year. The bypass pump pumps water from the wet well into the pump stations emergency bypass pipe that then allows wastewater to flow to the treatment plant.</b>	
<b>GENERAL OPERATION AND MAINTENANCE</b>	<input type="checkbox"/> S <input type="checkbox"/> M <input type="checkbox"/> U <input checked="" type="checkbox"/> NA
CLEAN AND WELL MAINTAINED WITH MINIMAL STORAGE OF UNRELATED EQUIPMENT:	<input type="checkbox"/> S <input type="checkbox"/> M <input type="checkbox"/> U <input type="checkbox"/> NA <input checked="" type="checkbox"/> NE
GATES/DOORS/HATCHES/LIDS/ETC. LOCKED TO PREVENT UNAUTHORIZED ACCESS AND/OR TAMPERING:	<input type="checkbox"/> S <input type="checkbox"/> M <input type="checkbox"/> U <input type="checkbox"/> NA <input checked="" type="checkbox"/> NE

Location:	City of Helena		
Photographer:	Jason Bolenbaugh	Date:	3/2/2022
Witness:		Time:	11:14
		Photo #:	7
Description:	DSCN3743: Overview of Pump Station 5. The pump station is in operable. The orange bypass pump has been used since before the 2021 calendar year.

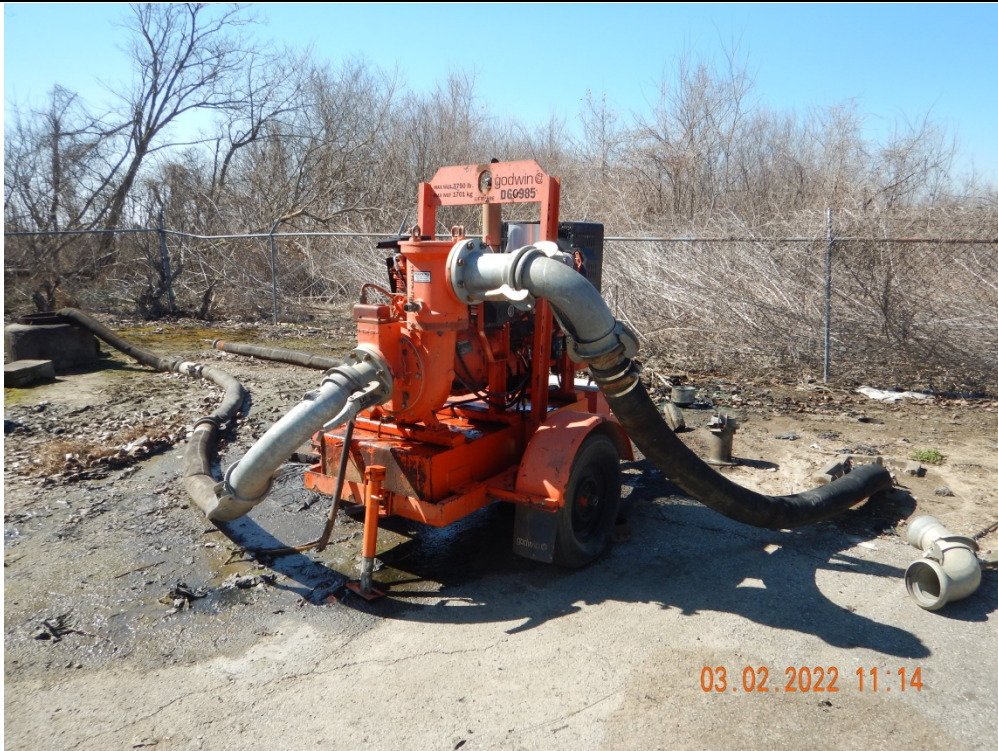
Photographer:	Jason Bolenbaugh	Date:	3/2/2022
Witness:		Time:	11:14
		Photo #:	8
Description:	DSCN3744: Bypass pump used to pump wastewater from Pump Station 5 to the treatment plant.

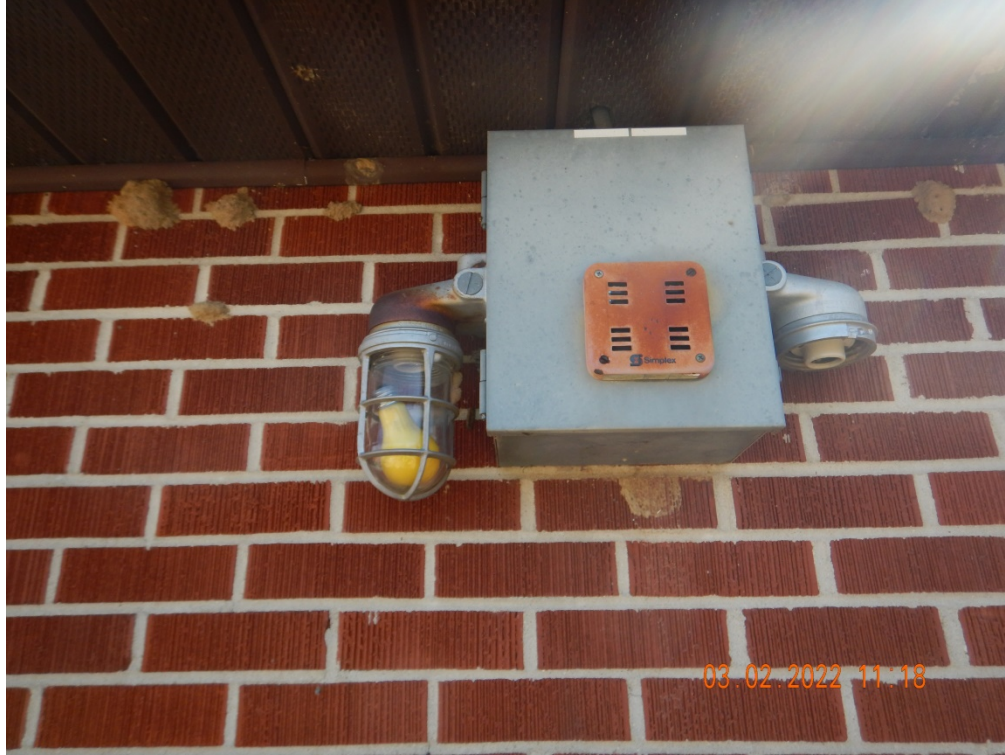
AUDIBLE/VISUAL ALARM WITH EMERGENCY CONTACT INFORMATION POSTED:	<input type="checkbox"/> S <input type="checkbox"/> M <input checked="" type="checkbox"/> U <input type="checkbox"/> NA <input type="checkbox"/> NE
SCADA SYSTEM (LIST PARAMETERS MONITORED):	<input type="checkbox"/> Y <input checked="" type="checkbox"/> N <input type="checkbox"/> NA <input type="checkbox"/> NE
<b>Comments: The light bulb for the visual alarm was not installed. The SCADA for this station was not operational. If the station experiences a problem such as an overflow the permittee relies on staff to find it when they arrive to fuel the bypass pump or if a nearby resident contacts them.</b>

Location:	City of Helena		
Photographer:	Jason Bolenbaugh	Date:	3/2/2022
Witness:		Time:	1118
		Photo #:	9
Description:	DSCN3746: Visual alarm not in operation.

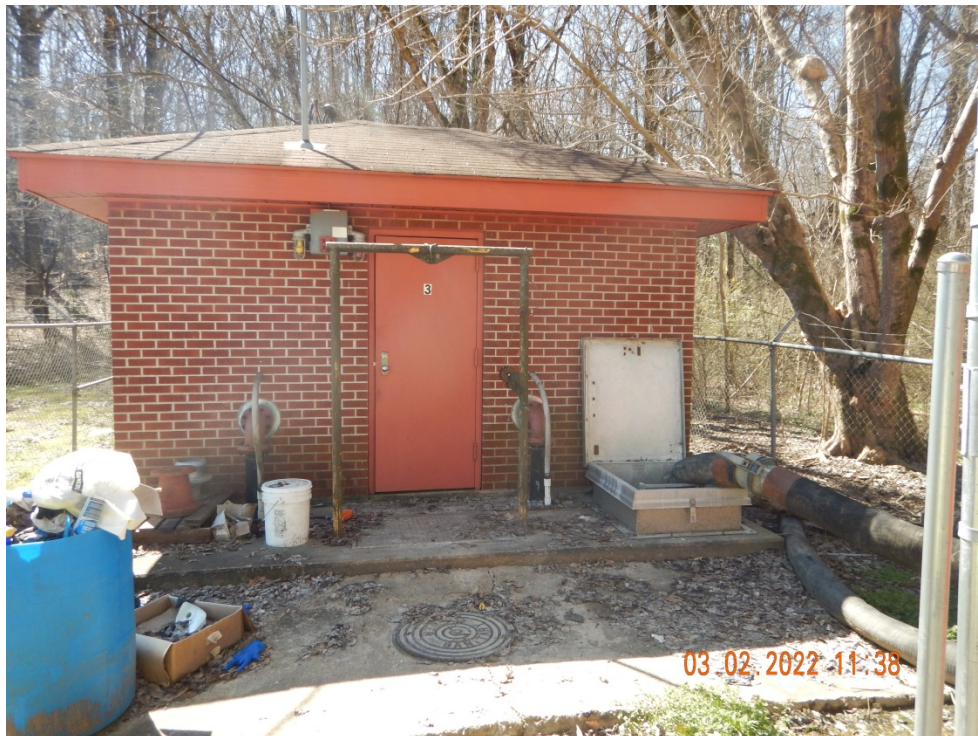
<b>Comments: This pump station does not have a permanent pump that is operational. According to staff an 8-inch bypass pump has been on site since at least March, 2021. The bypass pump pumps water from the wet well into the pump stations emergency bypass pipe that then allows wastewater to Pump Station 5. The permittee has been working on this pump station to install new internal components such as pump baring and impellers. In order to make the primary pump operational a baring will need replaced but Gorman Rupp needs to evaluate the secondary pump to determine what repairs need to made to it to make it operational.</b>	
<b>GENERAL OPERATION AND MAINTENANCE</b>	<input type="checkbox"/> S <input type="checkbox"/> M <input checked="" type="checkbox"/> U <input type="checkbox"/> NA
CLEAN AND WELL MAINTAINED WITH MINIMAL STORAGE OF UNRELATED EQUIPMENT:	<input type="checkbox"/> S <input type="checkbox"/> M <input type="checkbox"/> U <input type="checkbox"/> NA <input checked="" type="checkbox"/> NE

Photographer:	Jason Bolenbaugh	Date:	3/2/2022
Witness:		Time:	1138
		Photo #:	10
Description:	DSCN3748: View of Pump Station 3.

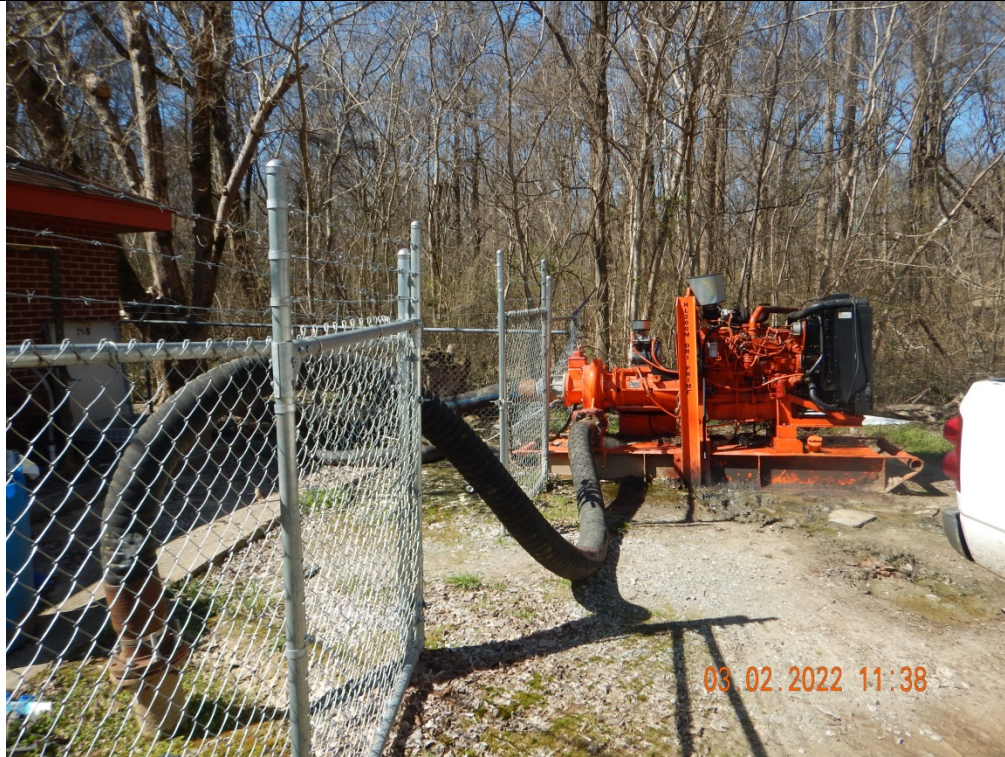
Location:	<b>City of Helena</b>		
Photographer:	<b>Jason Bolenbaugh</b>	Date:	<b>3/2/2022</b>
Witness:		Time:	<b>1138</b>
		Photo #:	<b>11</b>
Description:	<b>DSCN3749: View of the bypass pump at Pump Station 3.</b>

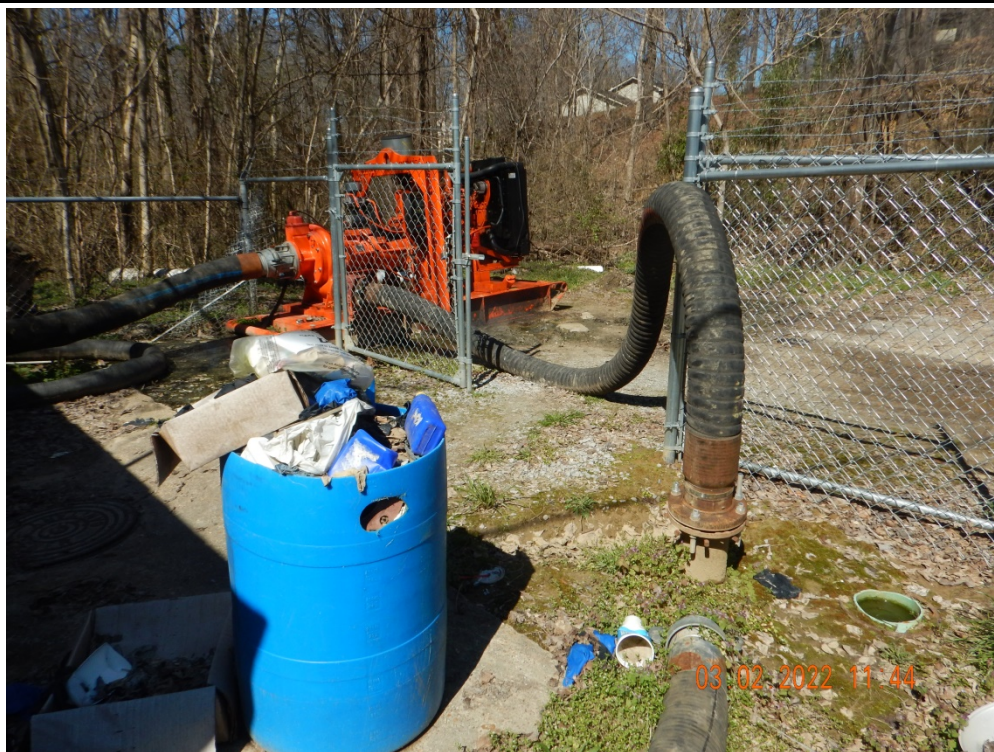
Photographer:	<b>Jason Bolenbaugh</b>	Date:	<b>3/2/2022</b>
Witness:		Time:	<b>1144</b>
		Photo #:	<b>12</b>
Description:	<b>DSCN3750: Wastewater being pumped from the wet well (background) over to the pipe (foreground) sending wastewater to Pump Station 5.</b>
